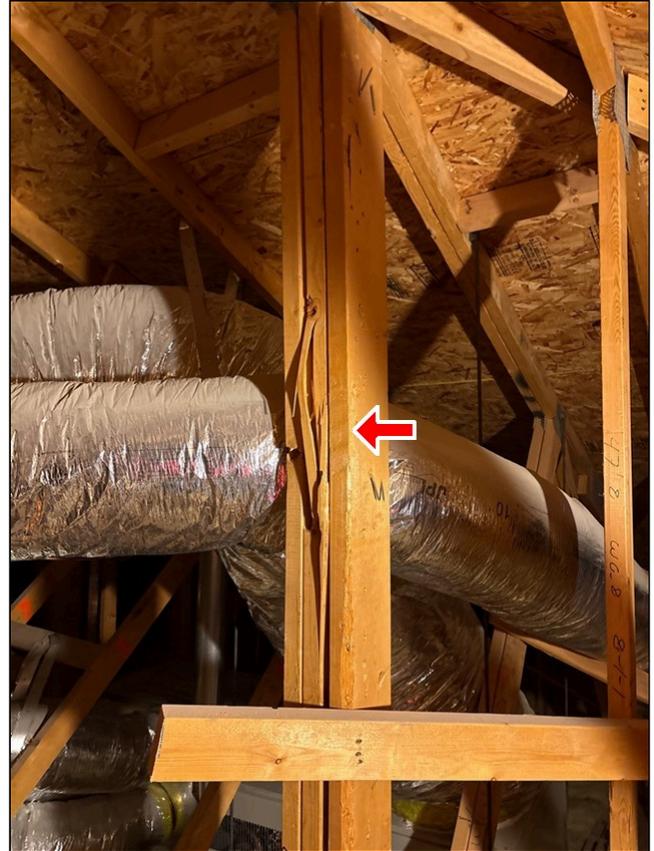
2.3 Item 3 (Picture)

(2) There is evidence of previous repairs or modifications to one or more trusses. Improper truss repairs can allow the roof to sag. Ask the owner or occupant about the reason for the repairs.

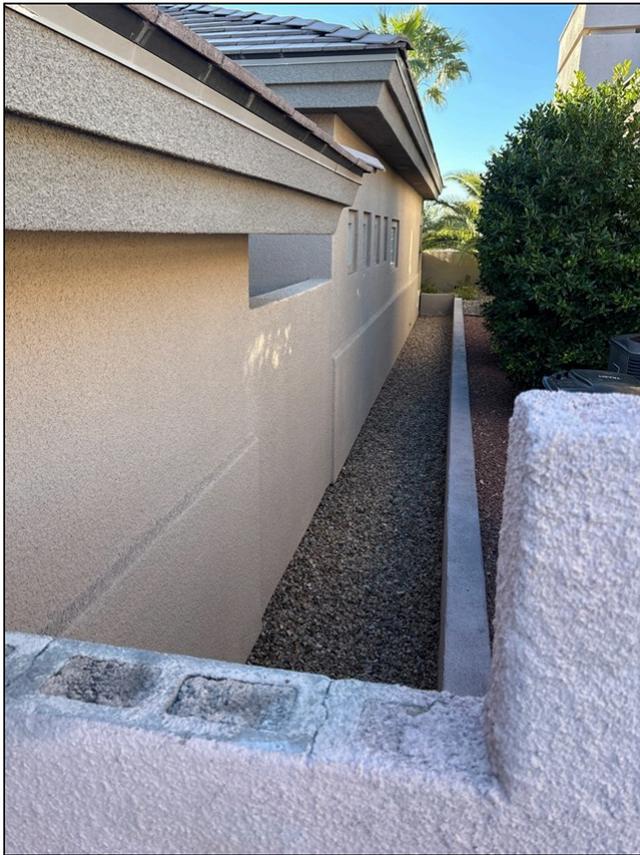
3.1 Item 1 (Picture)

The wall at the right side side of the property is a common wall attached to the adjoining property. The wall is concealed by finished surfaces and was not inspected.

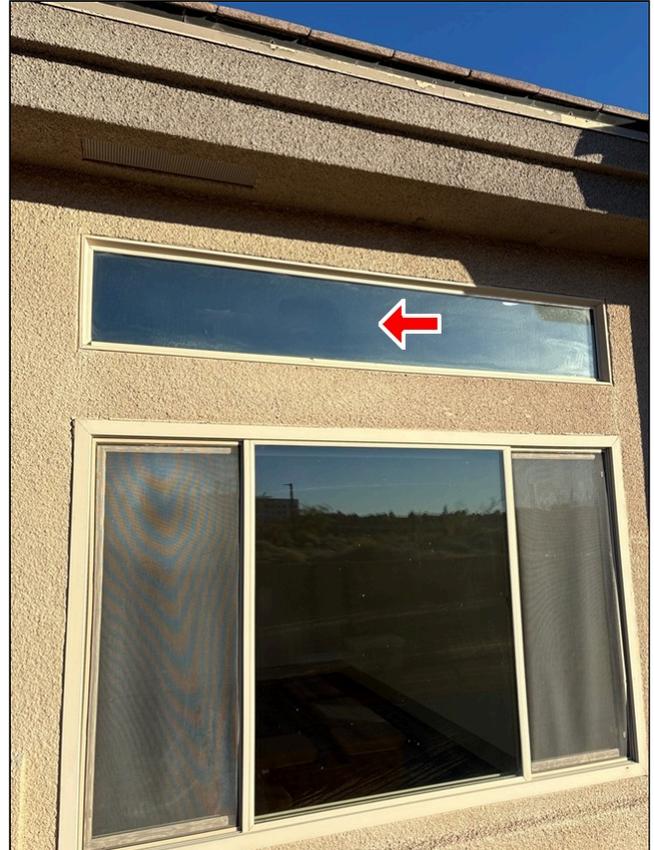
3.10 Item 2 (Picture)

A window(s) have missing or damaged plastic trim around their perimeter. This trim aids in keeping the windows sealed. Recommend a qualified contractor repair or replace any damaged trim.

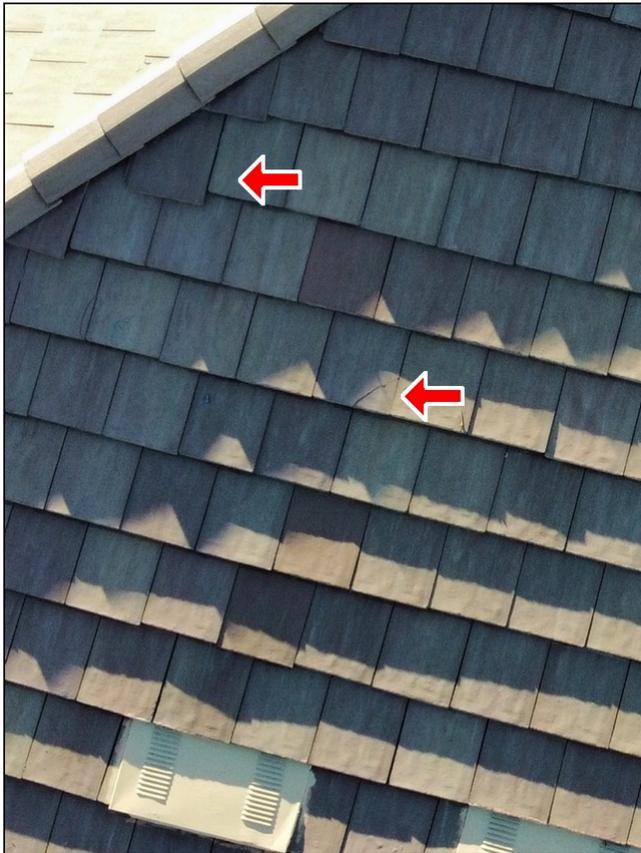
4.2 Item 32 (Picture)

(2) Typical cracking of tiles was observed in a few areas of the roof. Periodic maintenance is needed to correct cracked tiles. Recommend Repair - Seal / replace as necessary.

There are dislodged tiles at various locations leaving the felt underlayment, flashing exposed. A qualified roofing contractor should review the roof covers and repair, replace tiles / underlayment as necessary.

Field tile that have slipped from their original positions were observed. A qualified roofing contractor should view these areas and make any needed repairs to hold tiles securely in the field.

The mastic securing the ridge and or hip tiles has dried out and needs to be replaced. Replacement may be necessary at some or all of the ridge / hip tile. A qualified roofer should review these areas and repair loose tiles as necessary. This is a typical maintenance item.

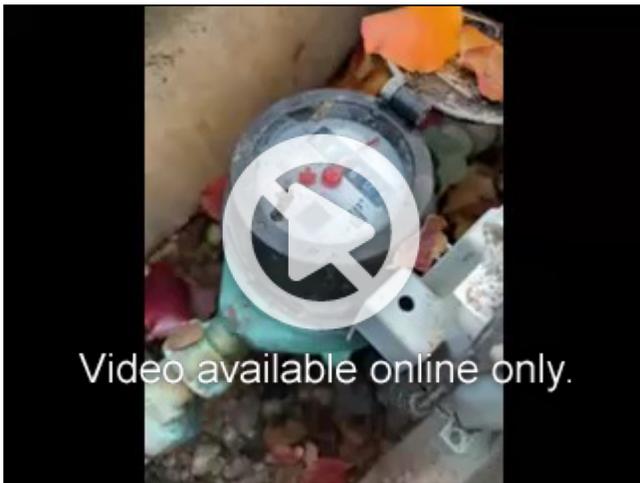
5.3 Item 3 (Video)

(1) The photos show your shut off devices at the front of the house, and water meter. The meter was moving indicating that a leak in the supply lines is present. We recommend that you have a qualified plumber and or leak detection company review and repair as necessary.

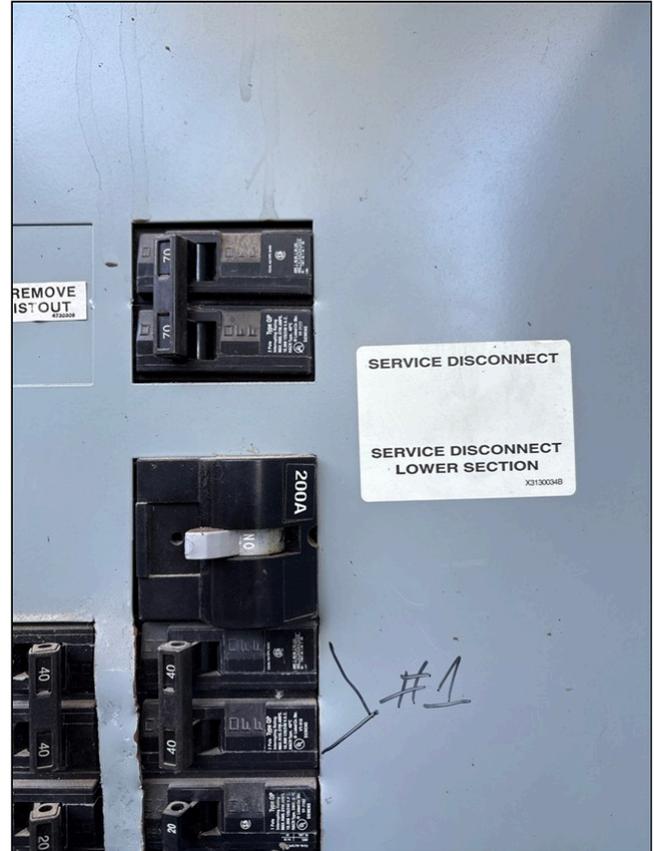
6.3 Item 2 (Picture)

Circuits in the panel are not labeled. While the labeling of the various electrical circuits in the panel is not related to fire hazards or potential electrical shock safety, they do identify which breakers control which circuits, and are important for determining which breakers to turn off when working on the system. If desired, the client can have a licensed electrician identify and label the circuits.

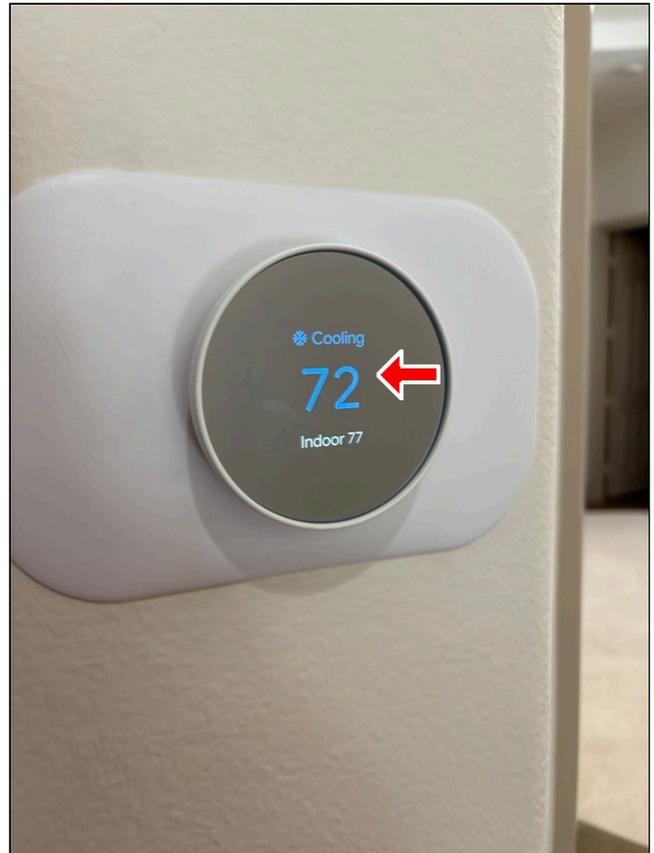
7.7 Item 3 (Picture)

(2) The AC at the right side of the home that includes the master bedroom and that side of the house is not working and did not respond to normal operation and or controls. Have licensed contractor further evaluate and make all necessary repairs.

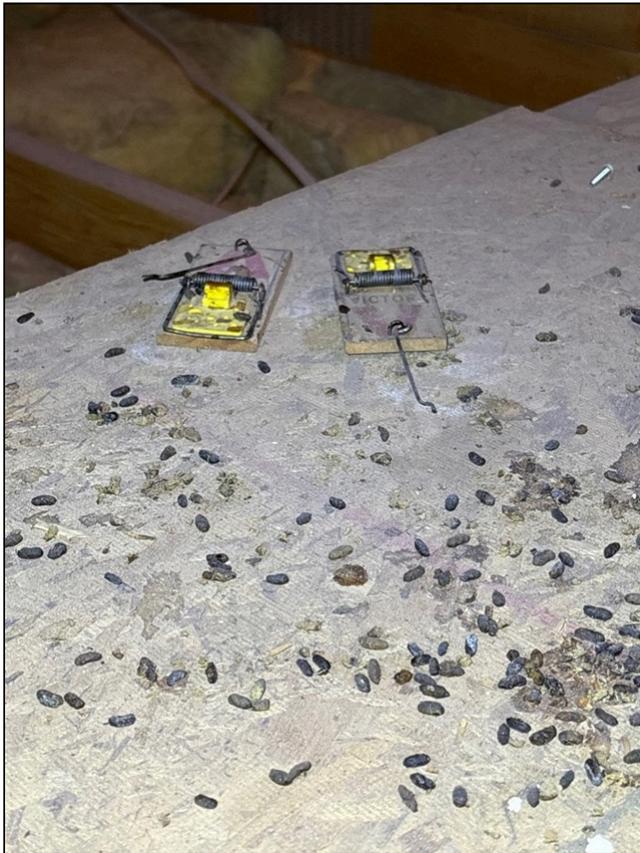
8.0 Item 3 (Picture)

There is an excessive amount of pest droppings located in the attic. It is also noted that there are rodent traps. Have licensed contractor further evaluate and make all necessary repairs.
