FORENSIC ENGINEERING **INVESTIGATIONS**

Crispin Hales, PhD, FIMechE, CEng.

HALES & GOOCH LTD.

Case Example: Process Boiler Explosion

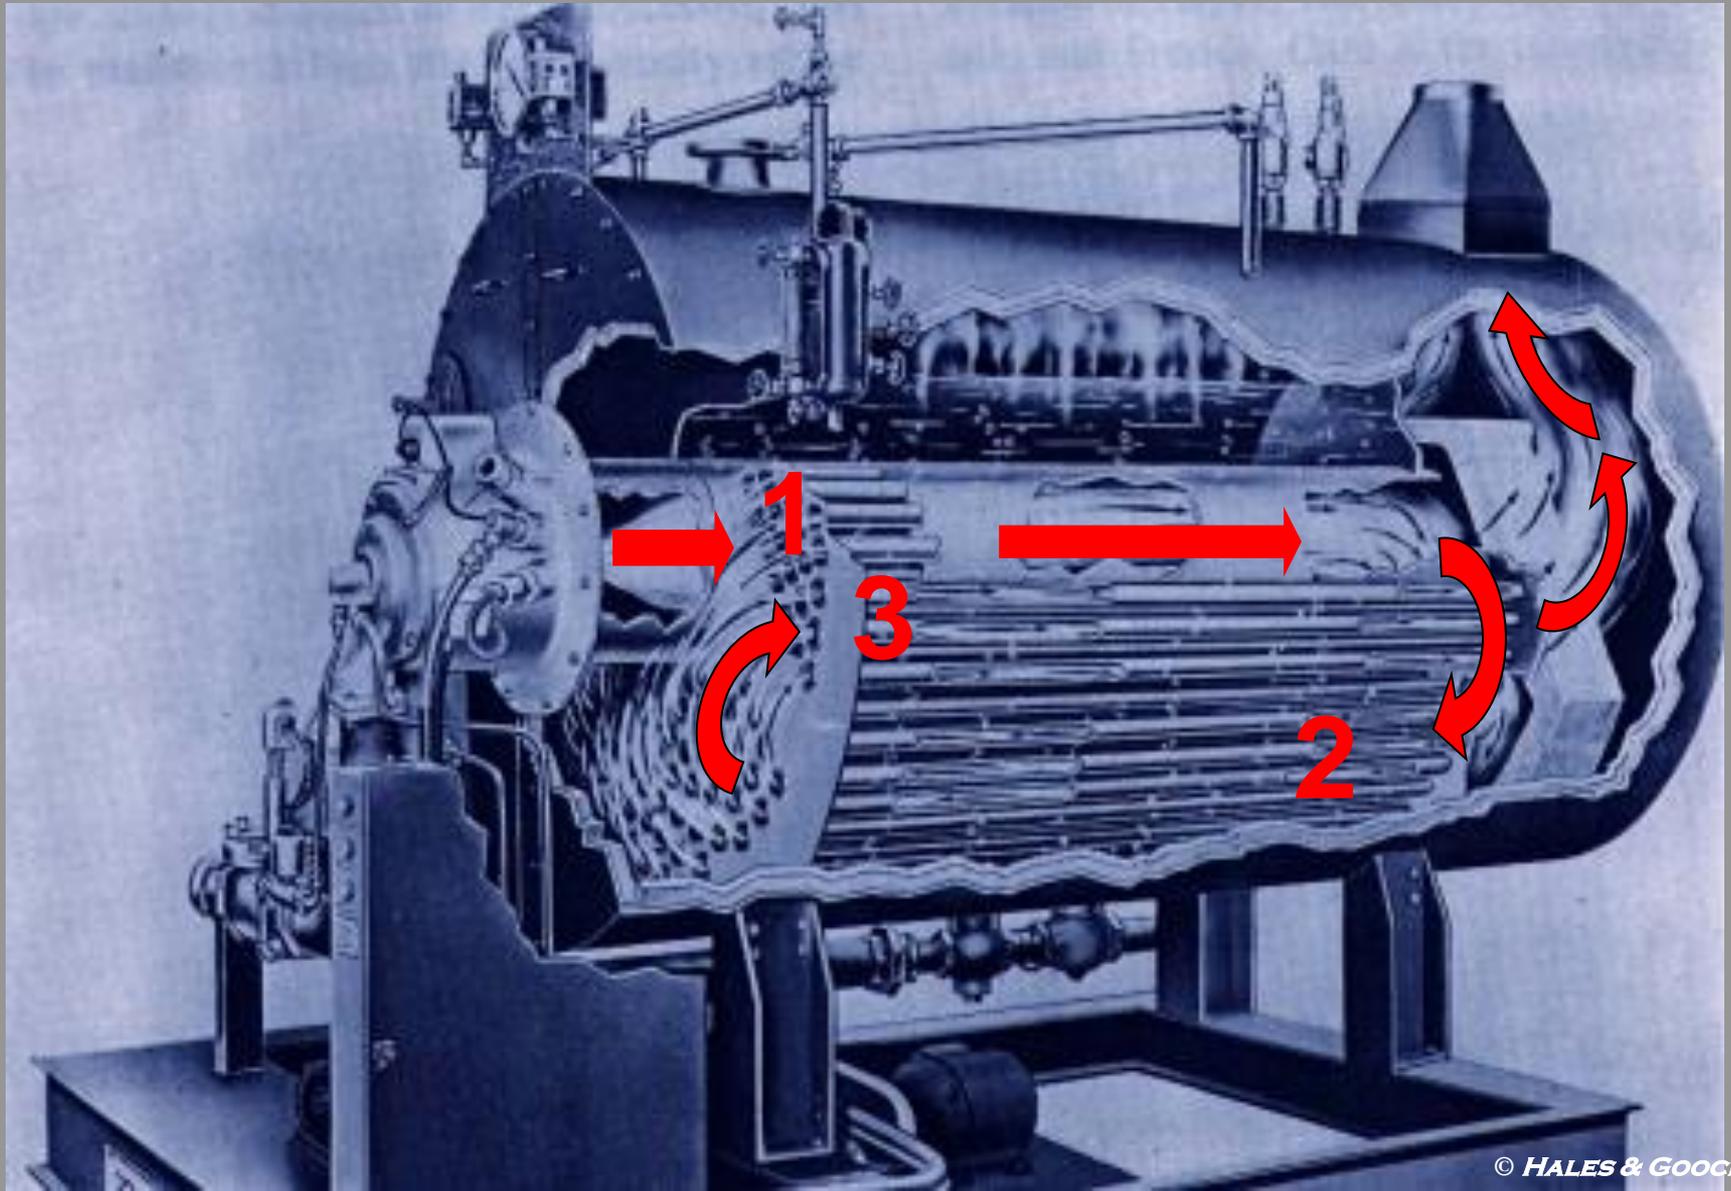
1958 York-Shipley – Installed 1959

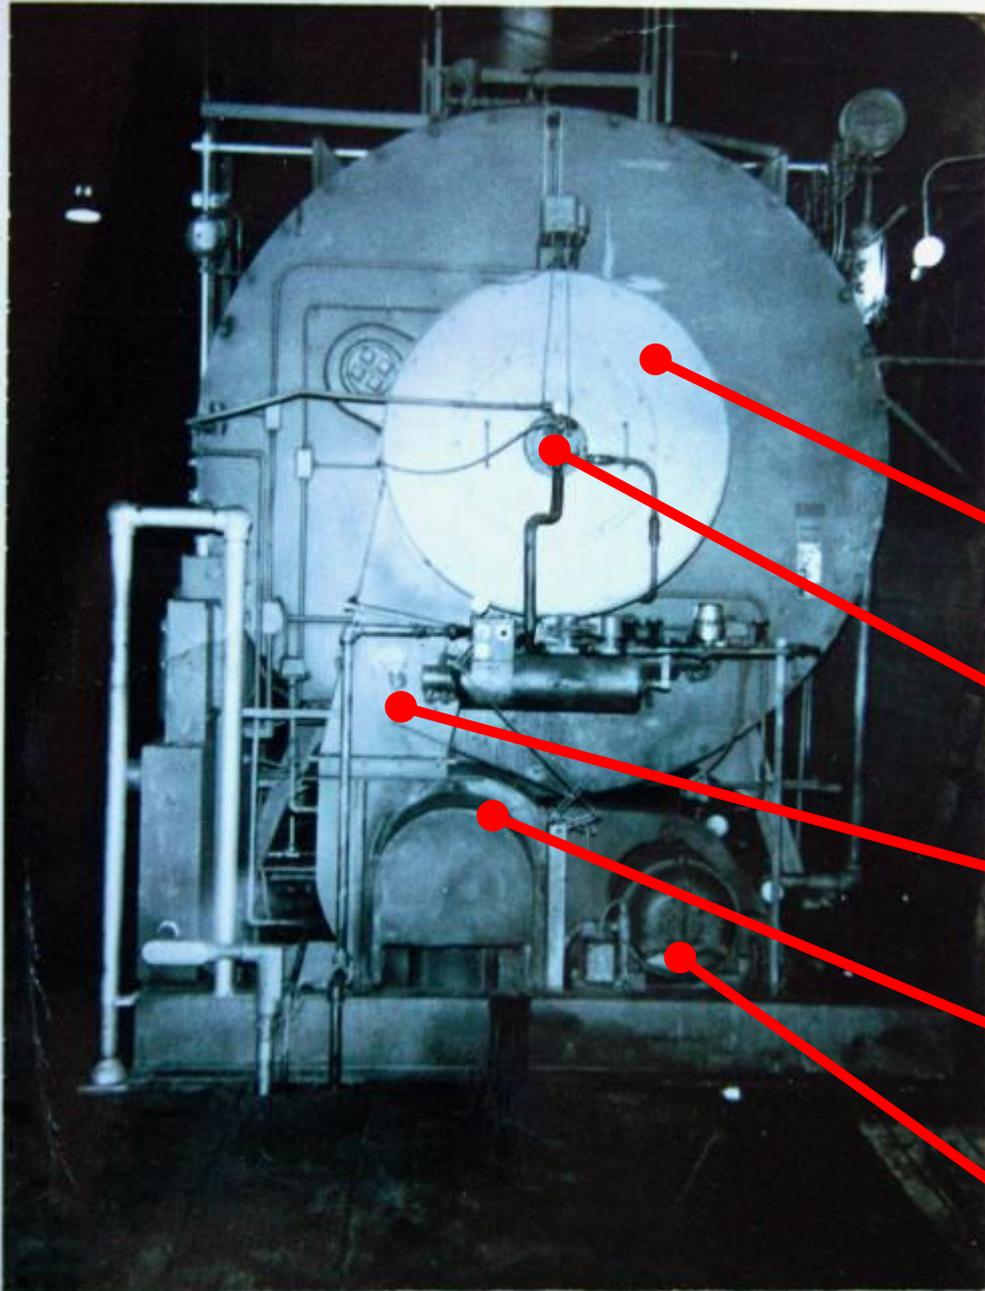
1959
PHOTO TAKEN
WHEN BOILER
INSTALLED

Lightweight wind box

Oil burner in centre

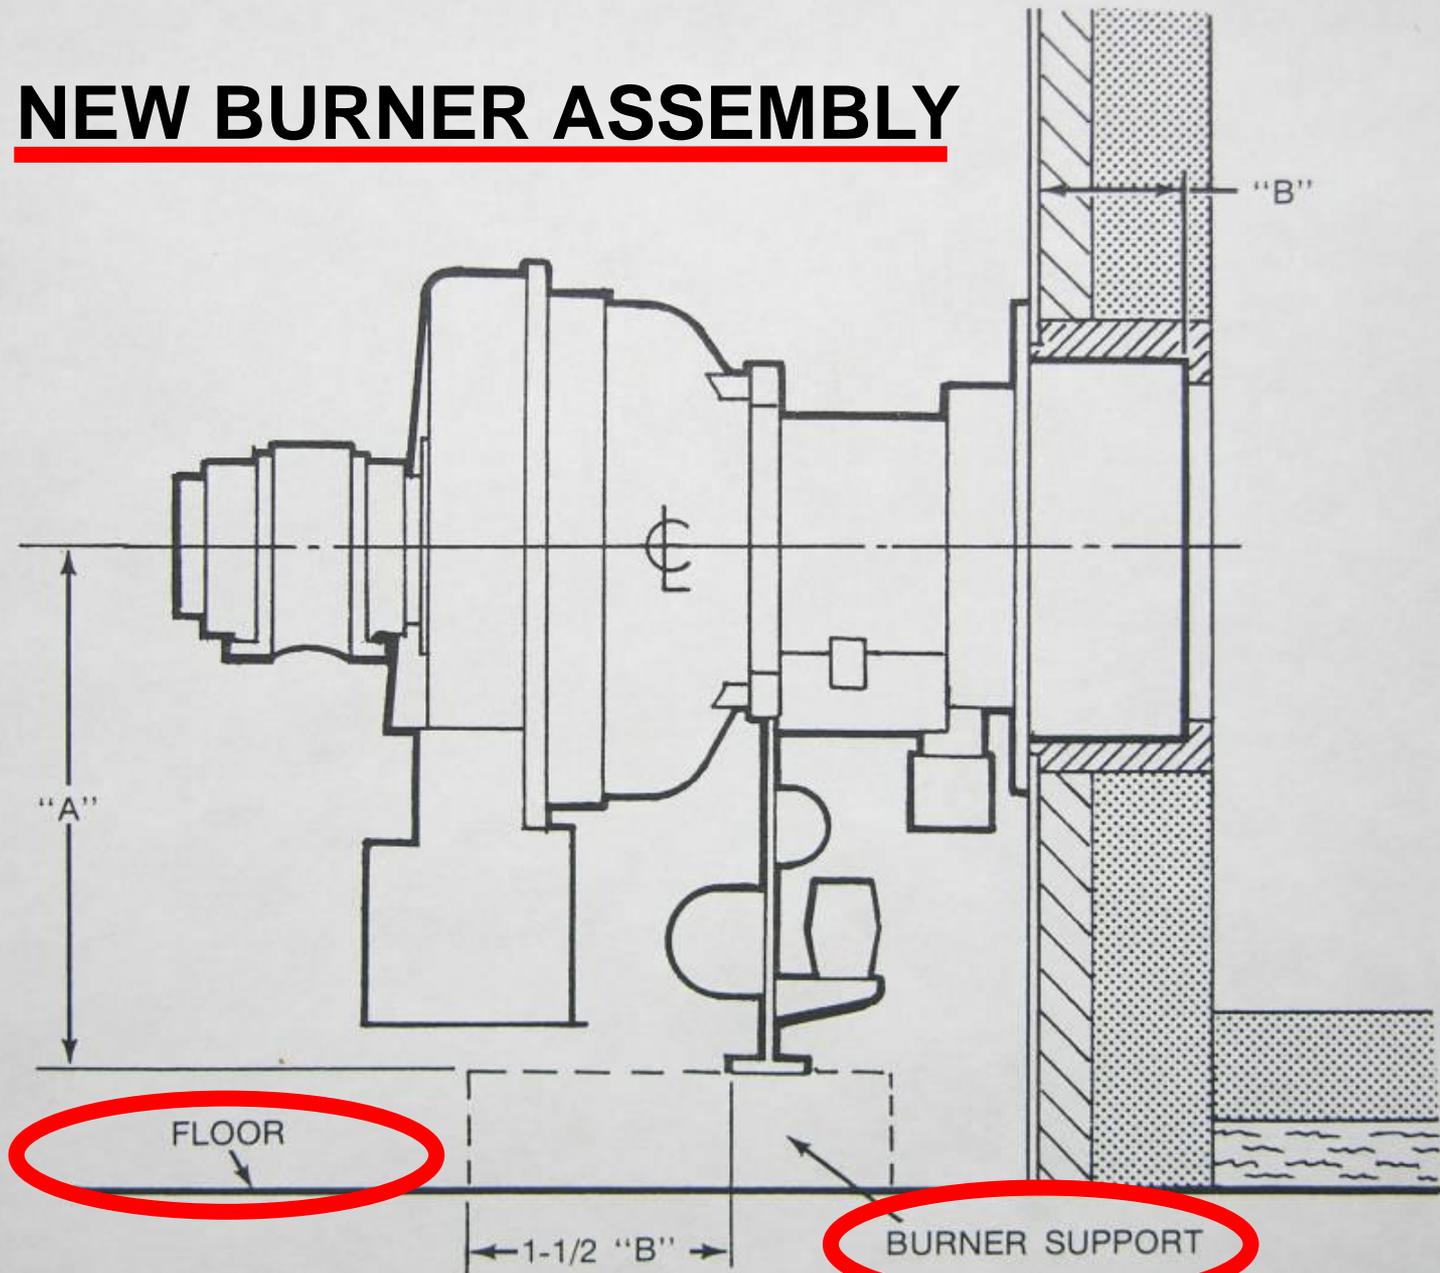
NEW BURNER ASSEMBLY

- Replaced wind box
- One big assembly
- Cantilever mounted
- On boiler, not skid
- Smaller bolt circle

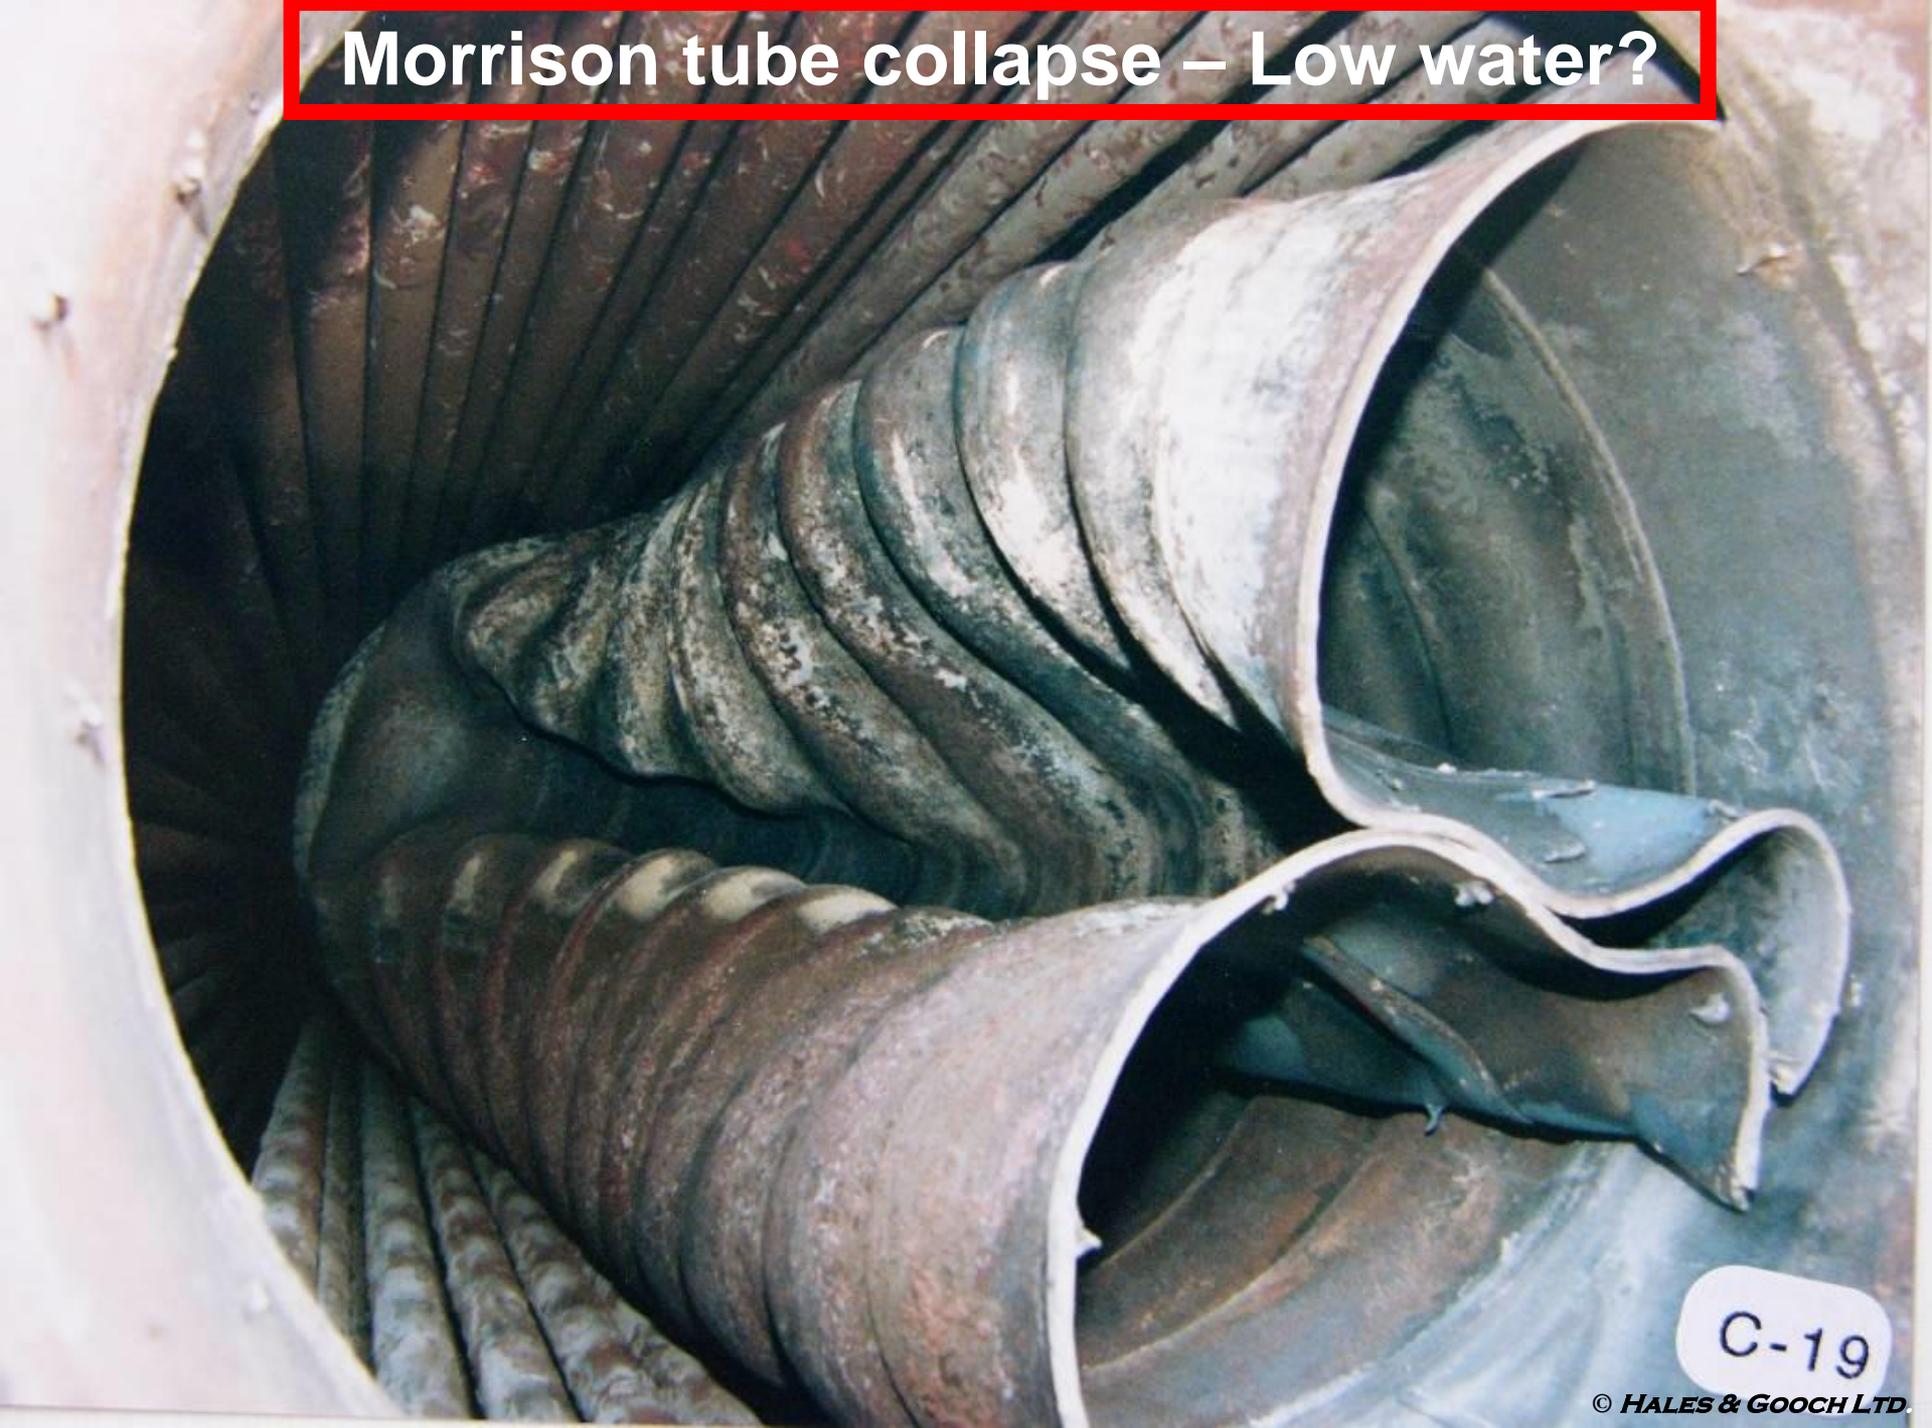
C-6

Morrison tube collapse – Low water?

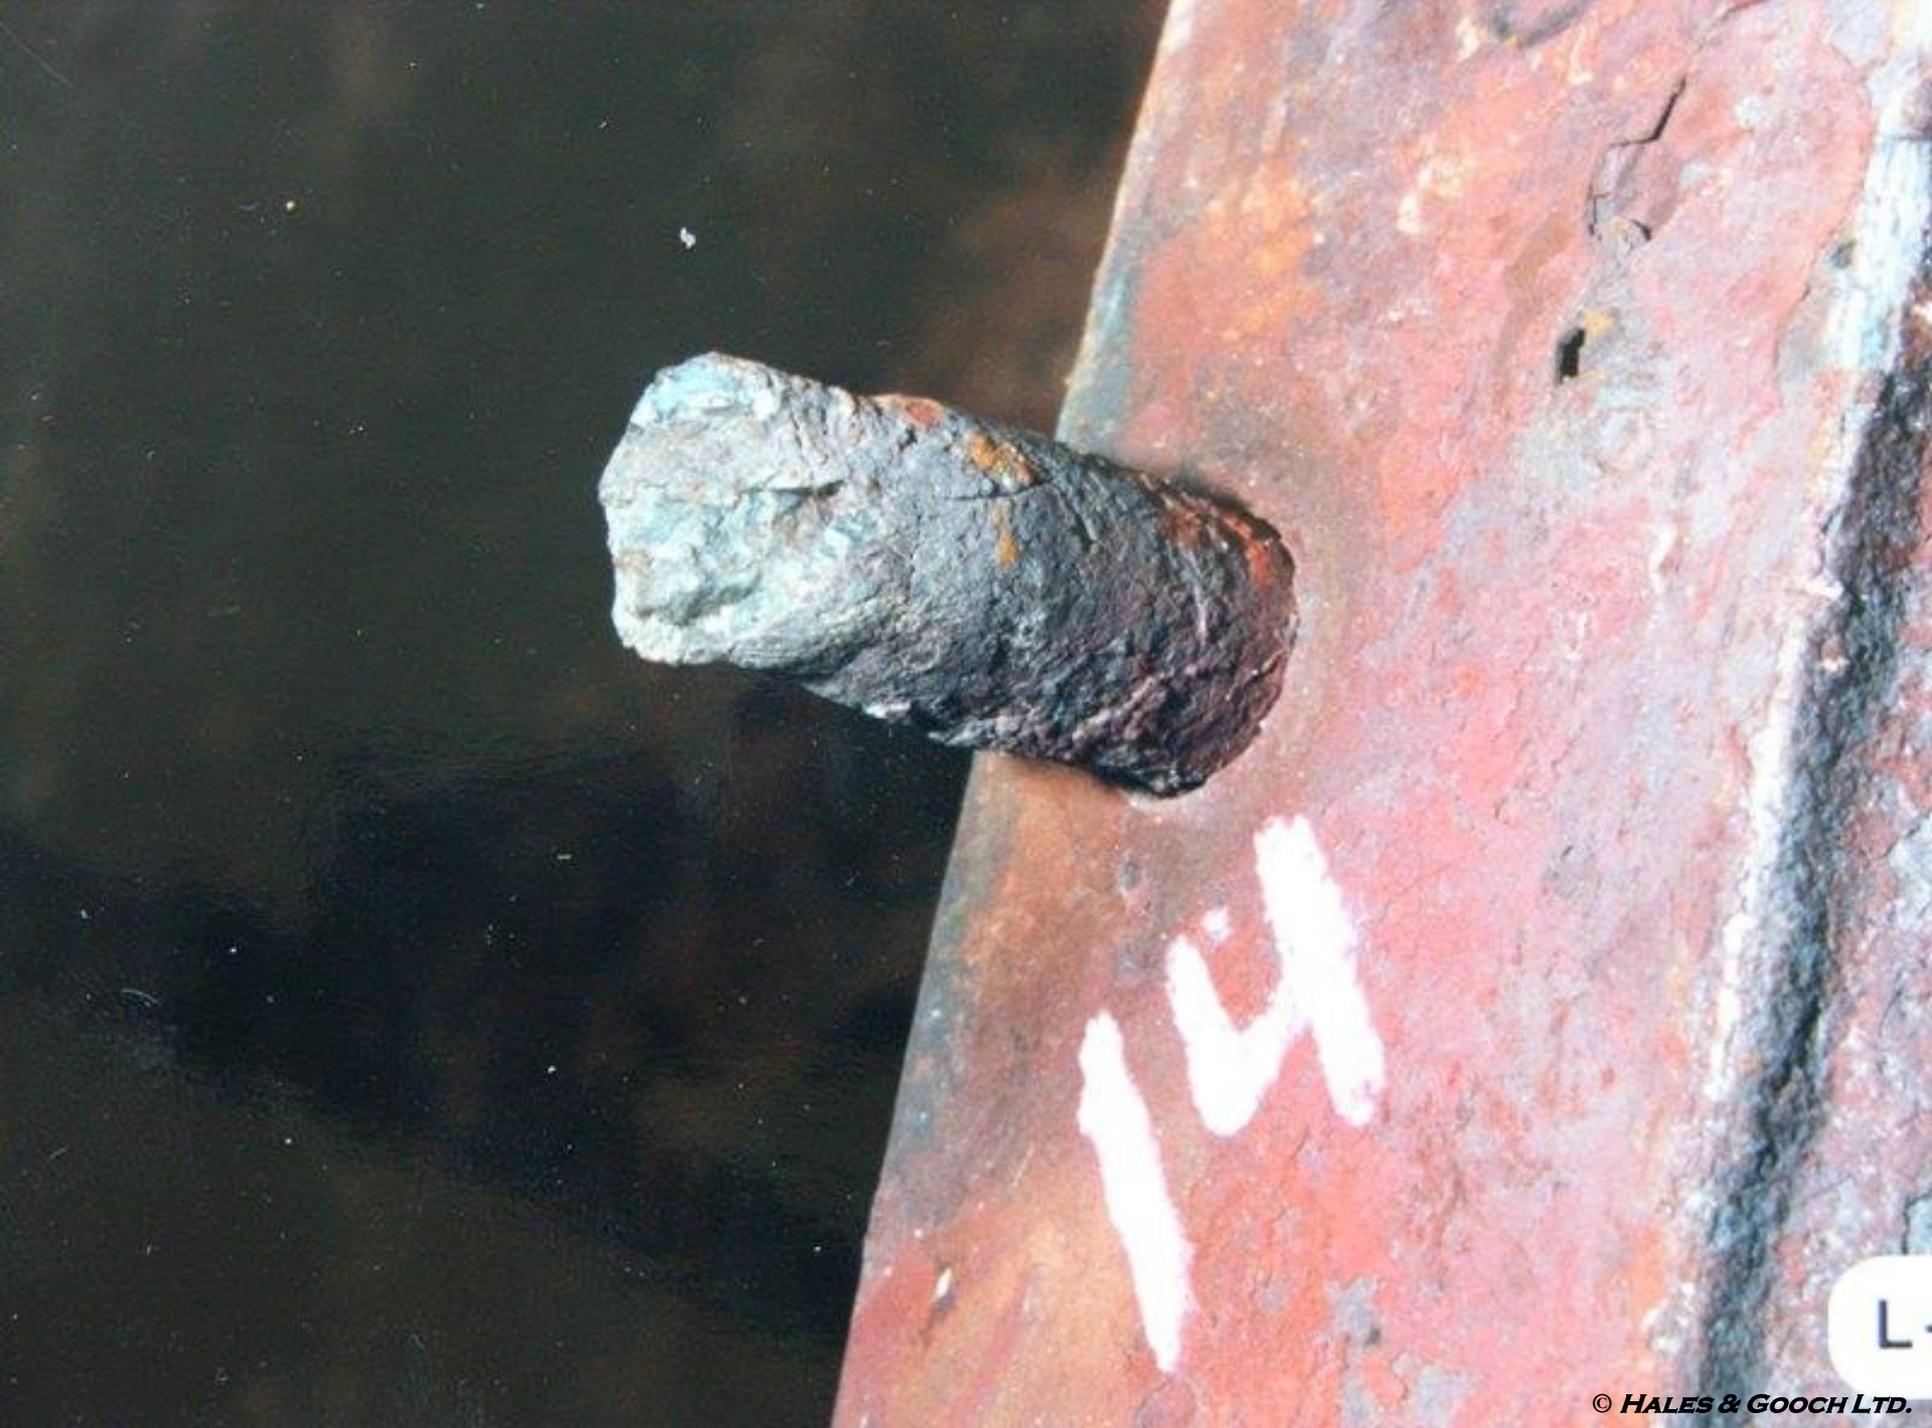
Reconstruction of adapter plate bolting at a lab in Texas

Each bolt told its own story – during the five years each one failed, but in a different way!

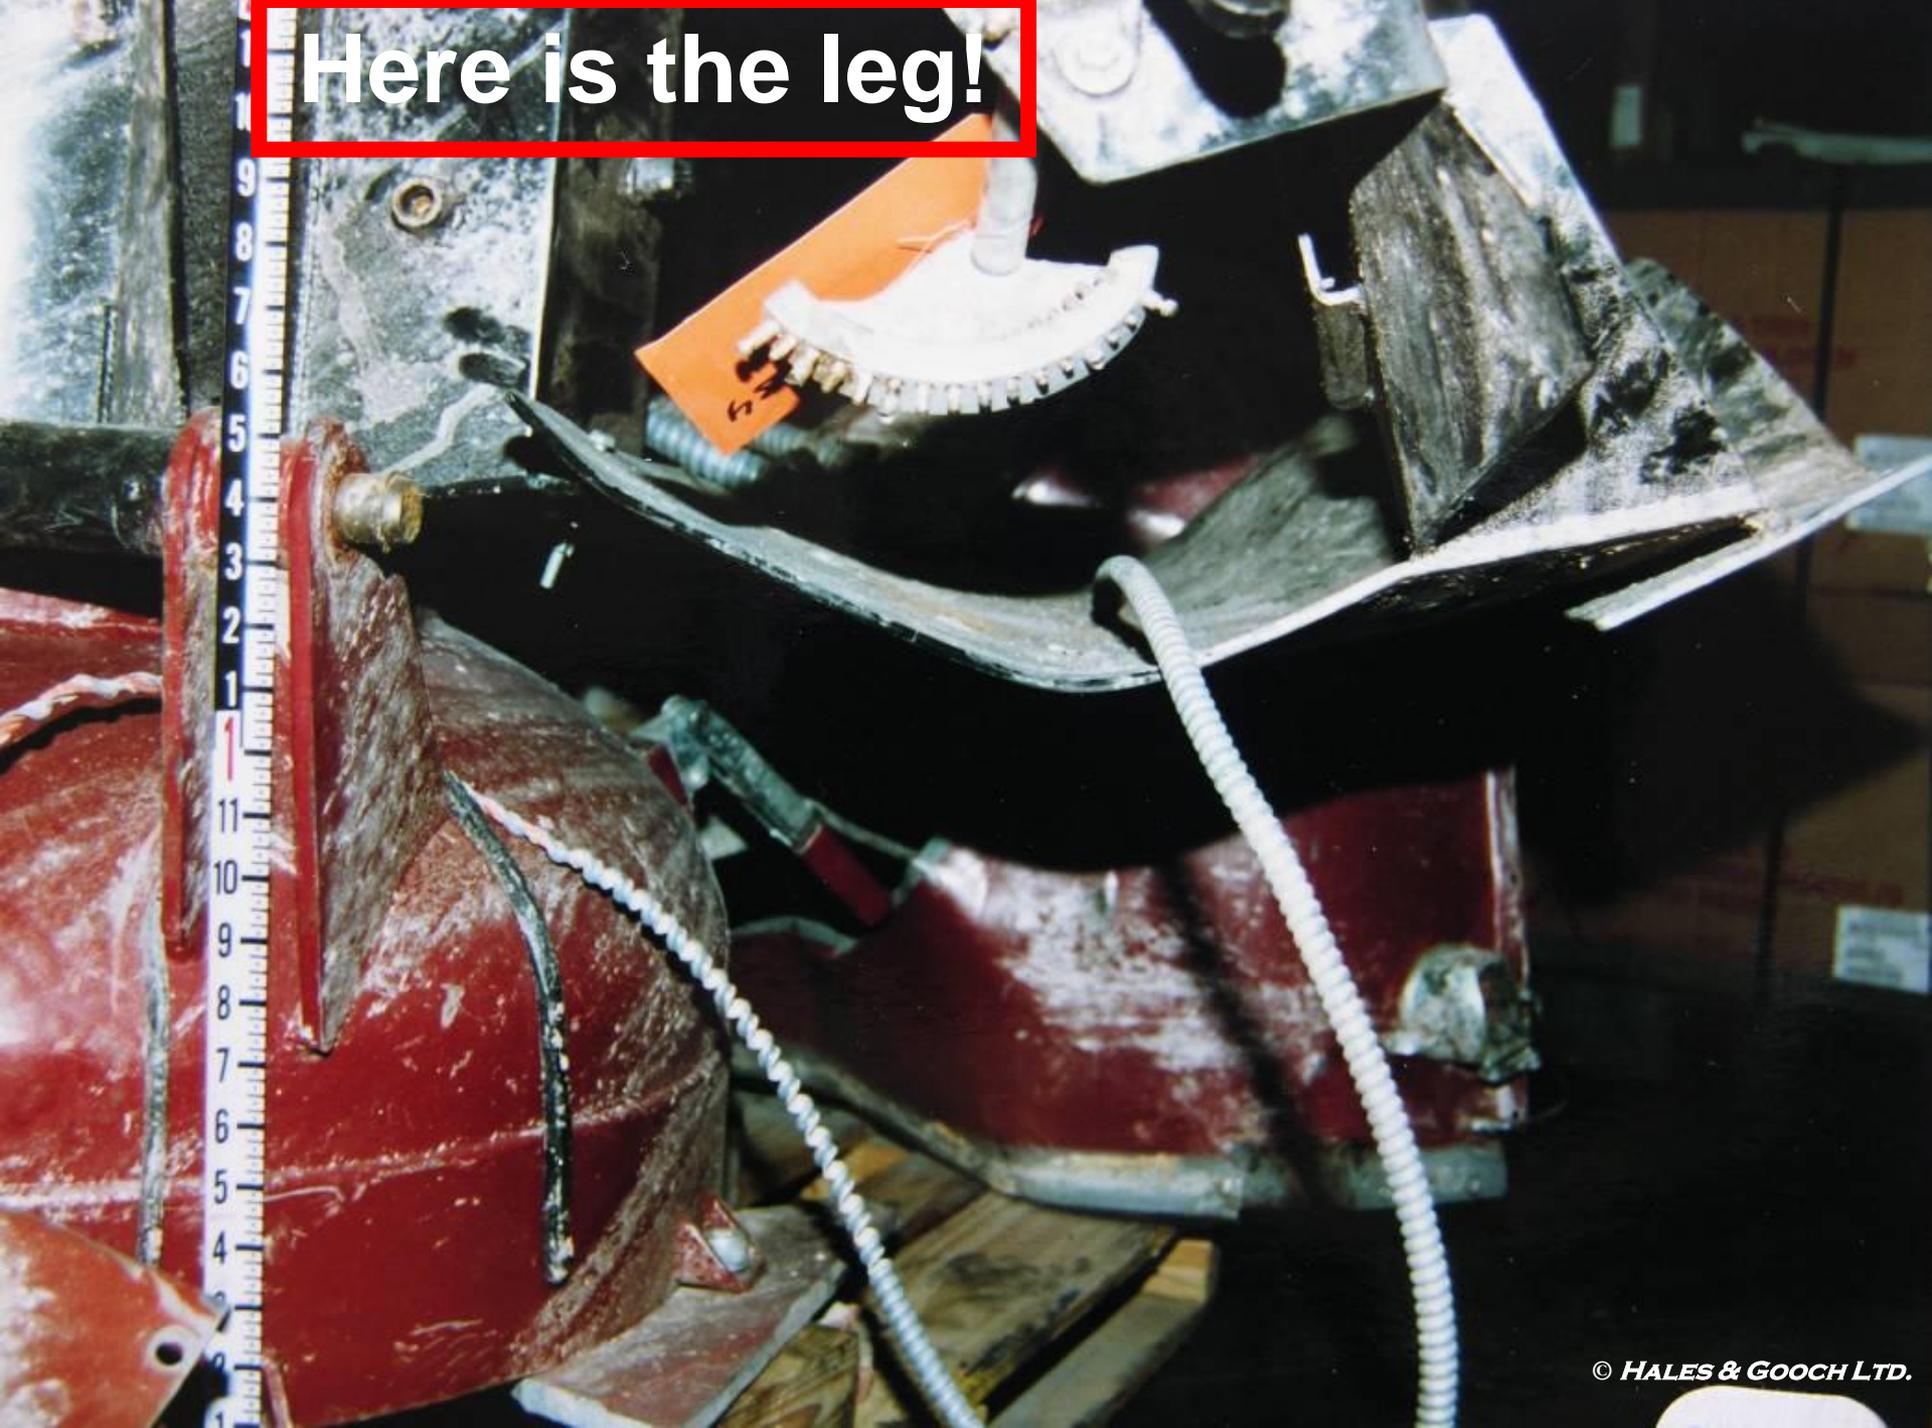
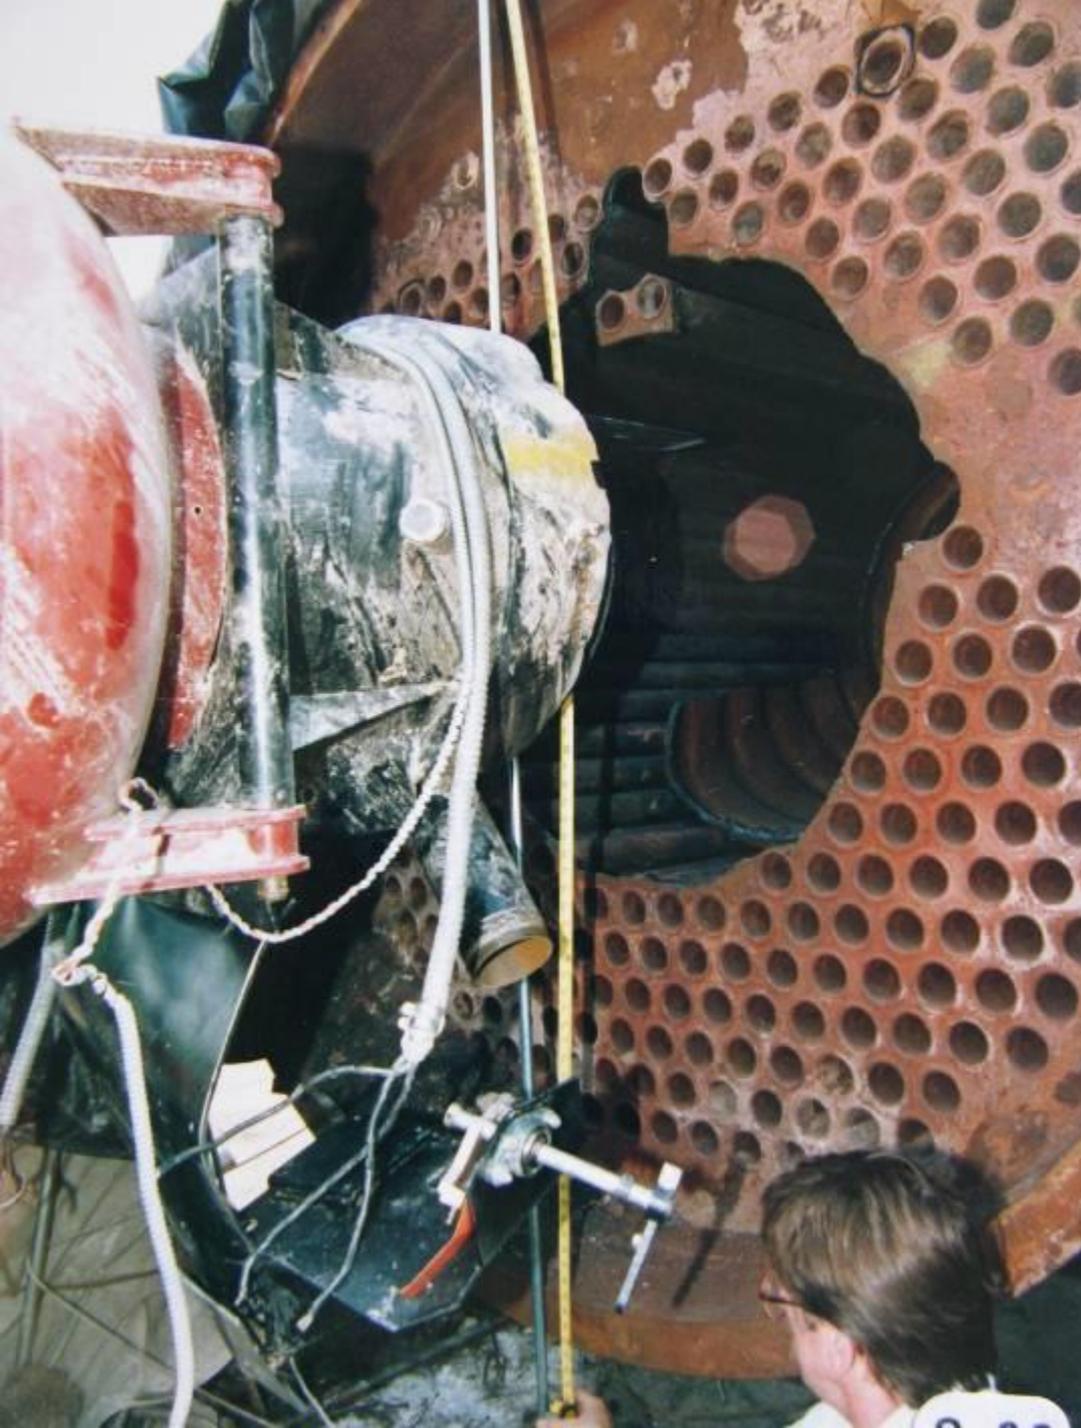
Here is the leg!

CHECKING BURNER LEG HEIGHT/SUPPORT

- Flange already cut out
- Positioning difficult
- Luckily skid all there
- Boiler refitted on skid
- Leg was bent but intact
- Measured accurately
- **No support had ever been fitted under leg!**

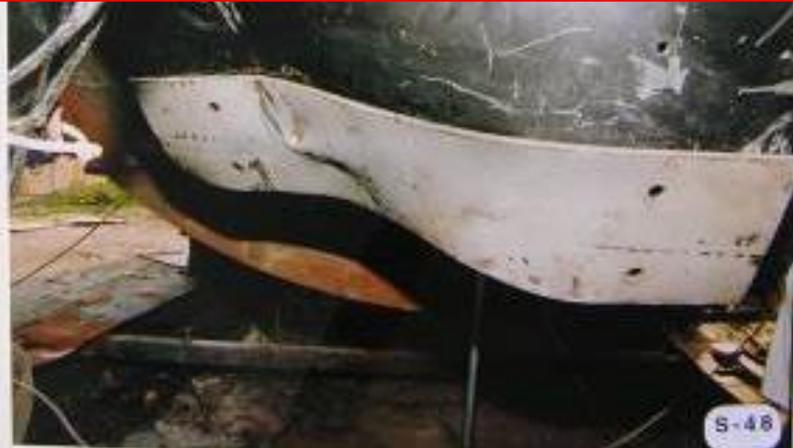
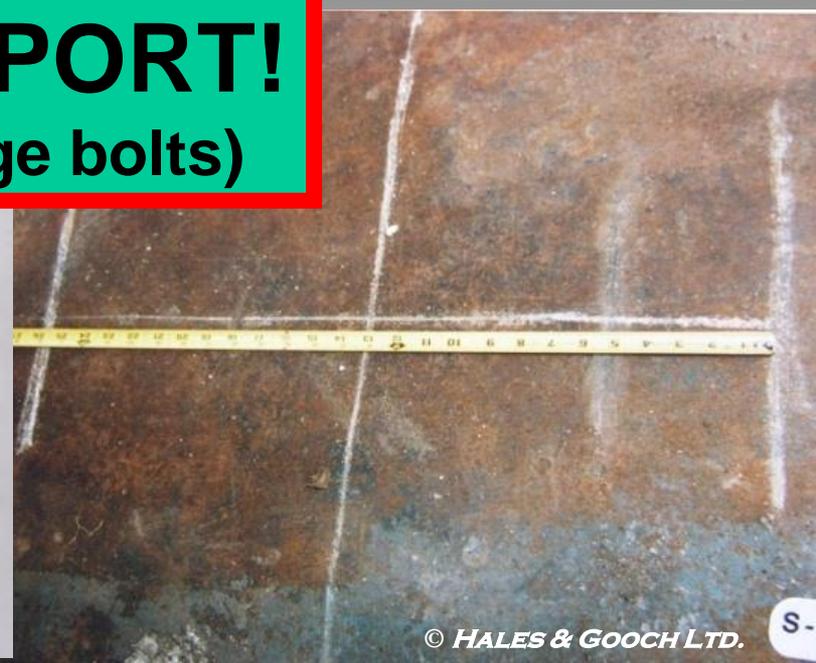
NO BOLTING – NO SUPPORT!
(i.e. Burner was hanging from flange bolts)

- 5.1 The primary cause of the explosion was flame impingement on the inner surface of the furnace (Morrison) tube, leading to a catastrophic collapse of the tube with rapid depressurization and ejection of steam and water.
- 5.2 The flame impingement resulted from angular displacement of the retrofitted burner assembly, during otherwise normal operation of the boiler.
- 5.3 The angular displacement of the burner was the trigger event in a progressive sequence of failures caused by faulty design and manufacture of the support system used to connect the replacement burner to the boiler.

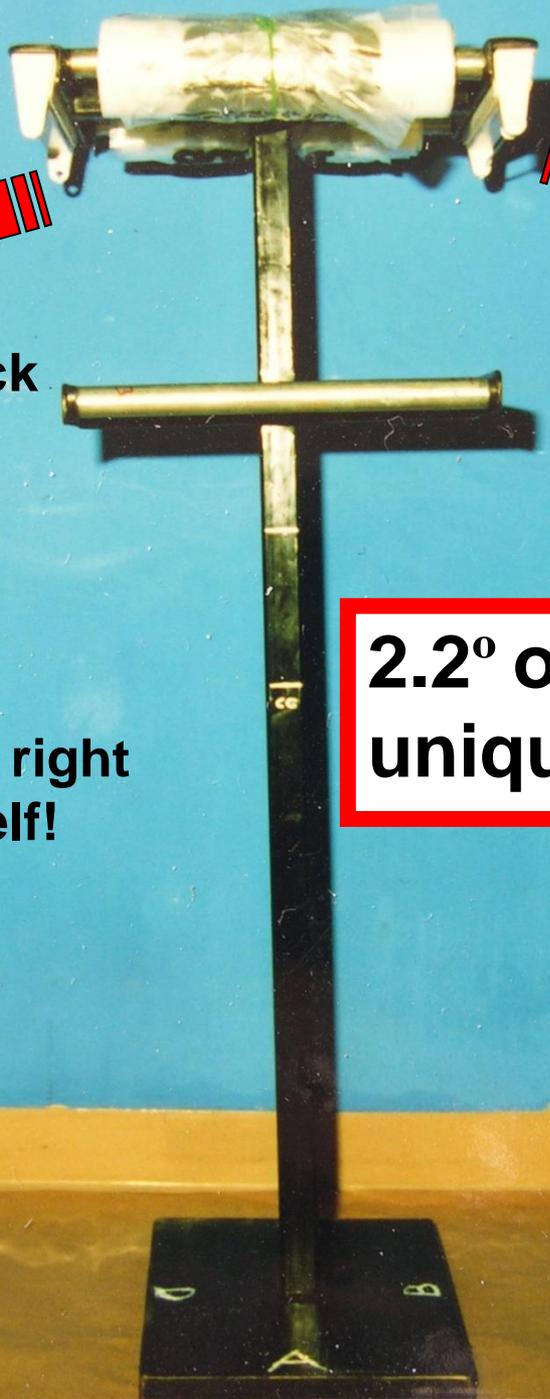
**Then it tips right
over by itself!**

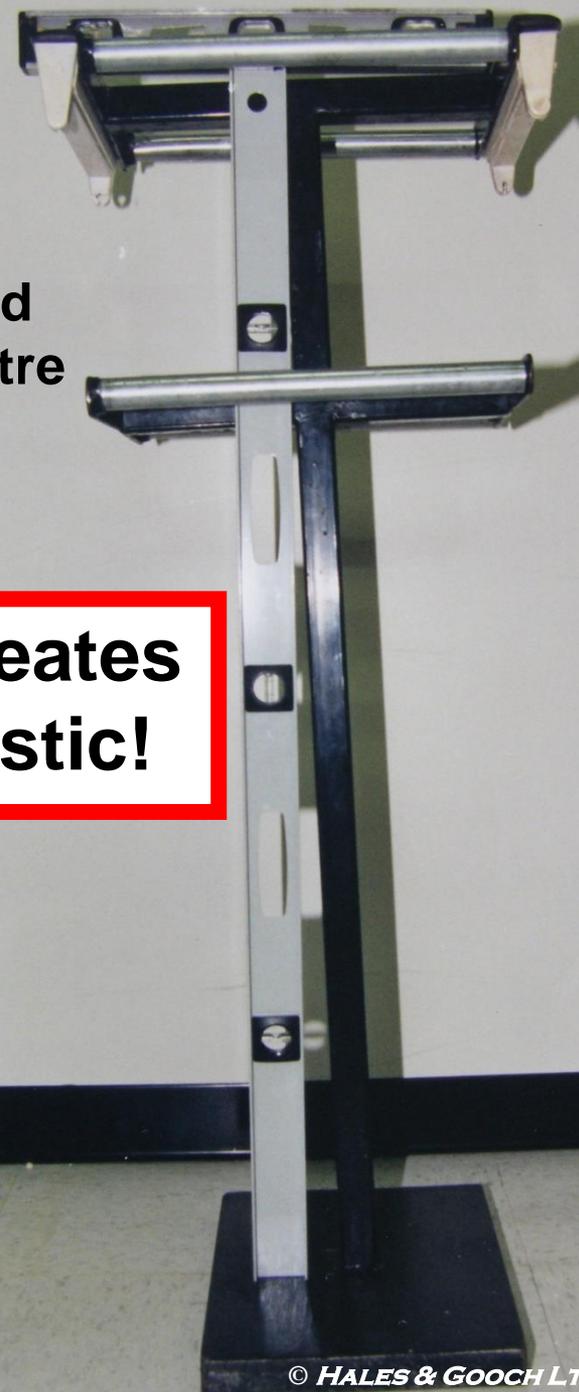
**1
Pull sideways and
it rocks over centre**

**2.2° off vertical creates
unique characteristic!**

- Welder said he made stands vertical
- Store manager said they looked OK to him
- Weber's Law: "Just noticeable difference"
- Grandma just pulled until a bag came off
- Child did nothing, but is now brain-injured
- **So, who should pay the \$2 million claim?**
- Lawsuit took 5 years – store + fabricator paid
- **Key issue - lack of stability in design**

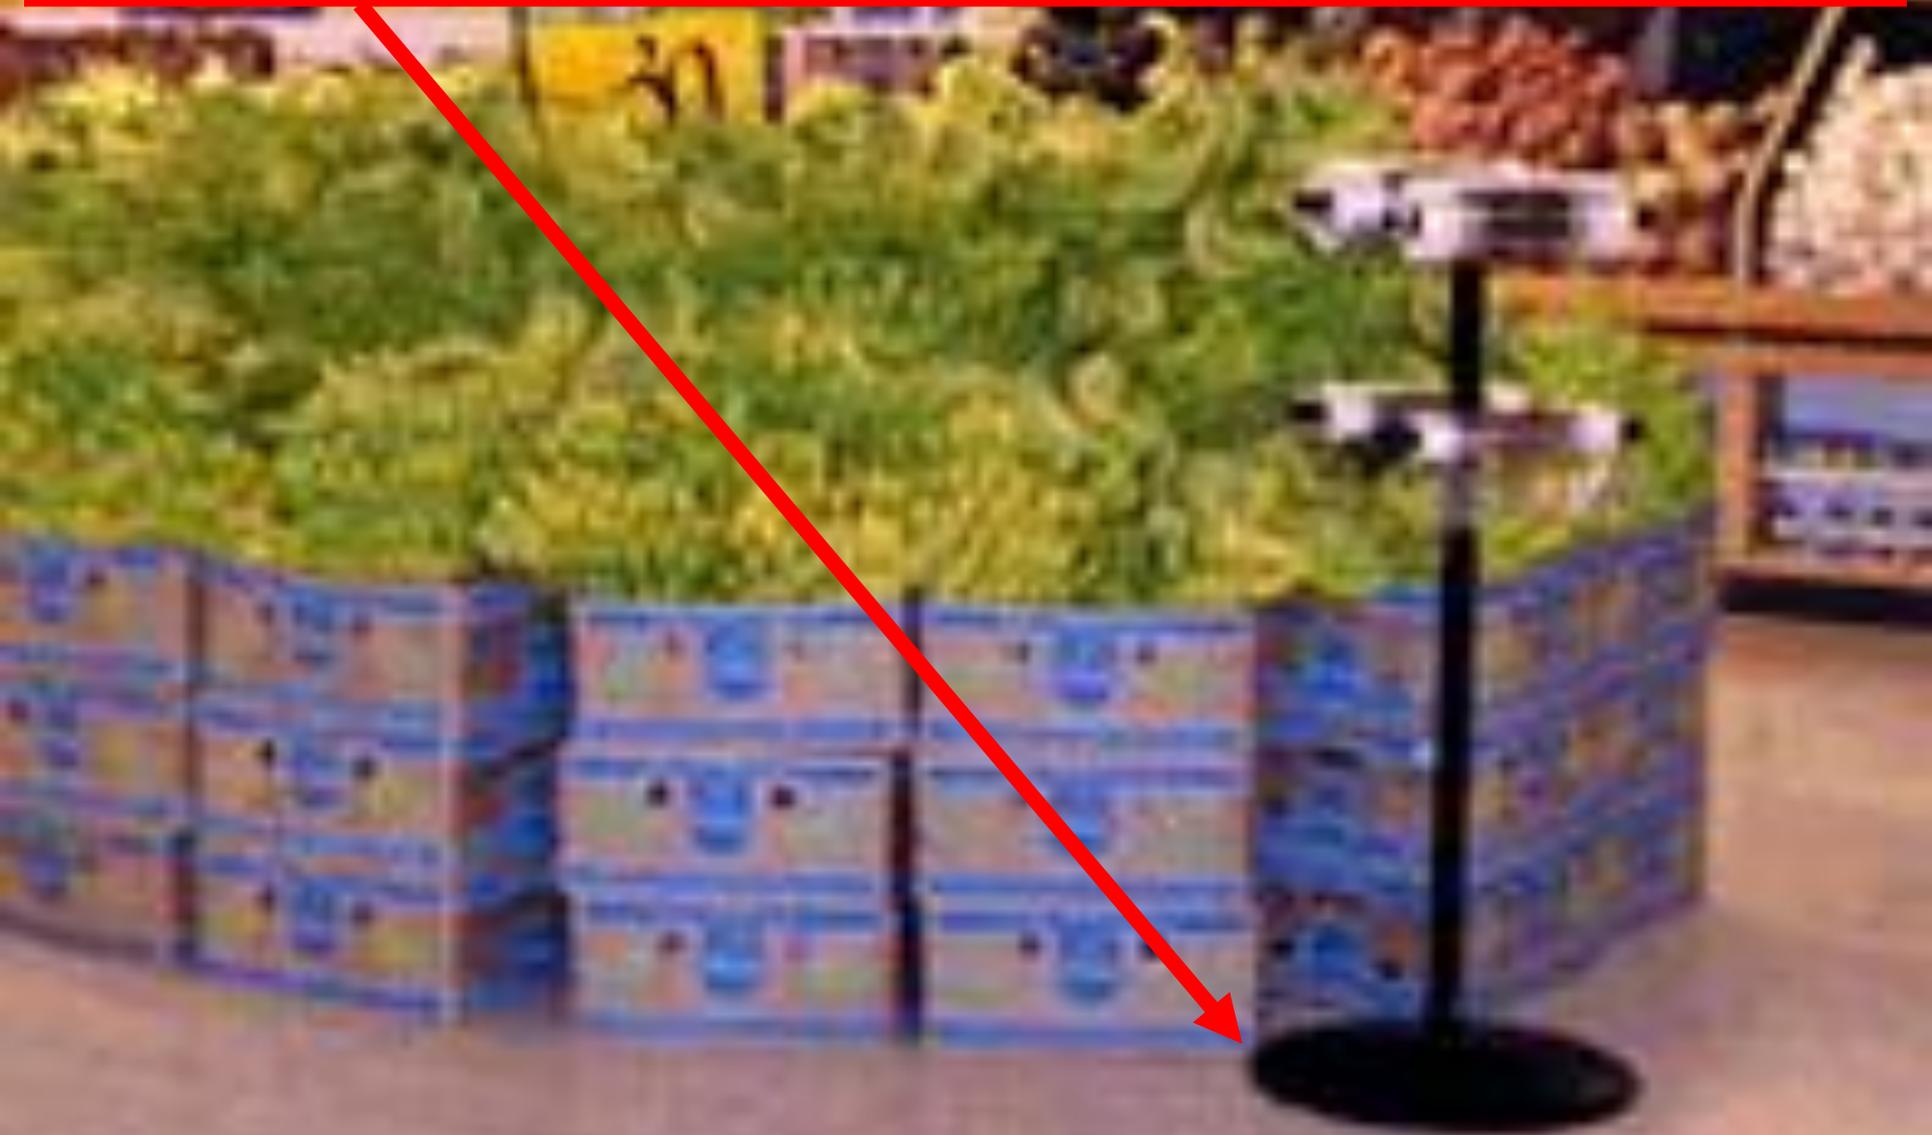
Now they have a heavy circular stable base!

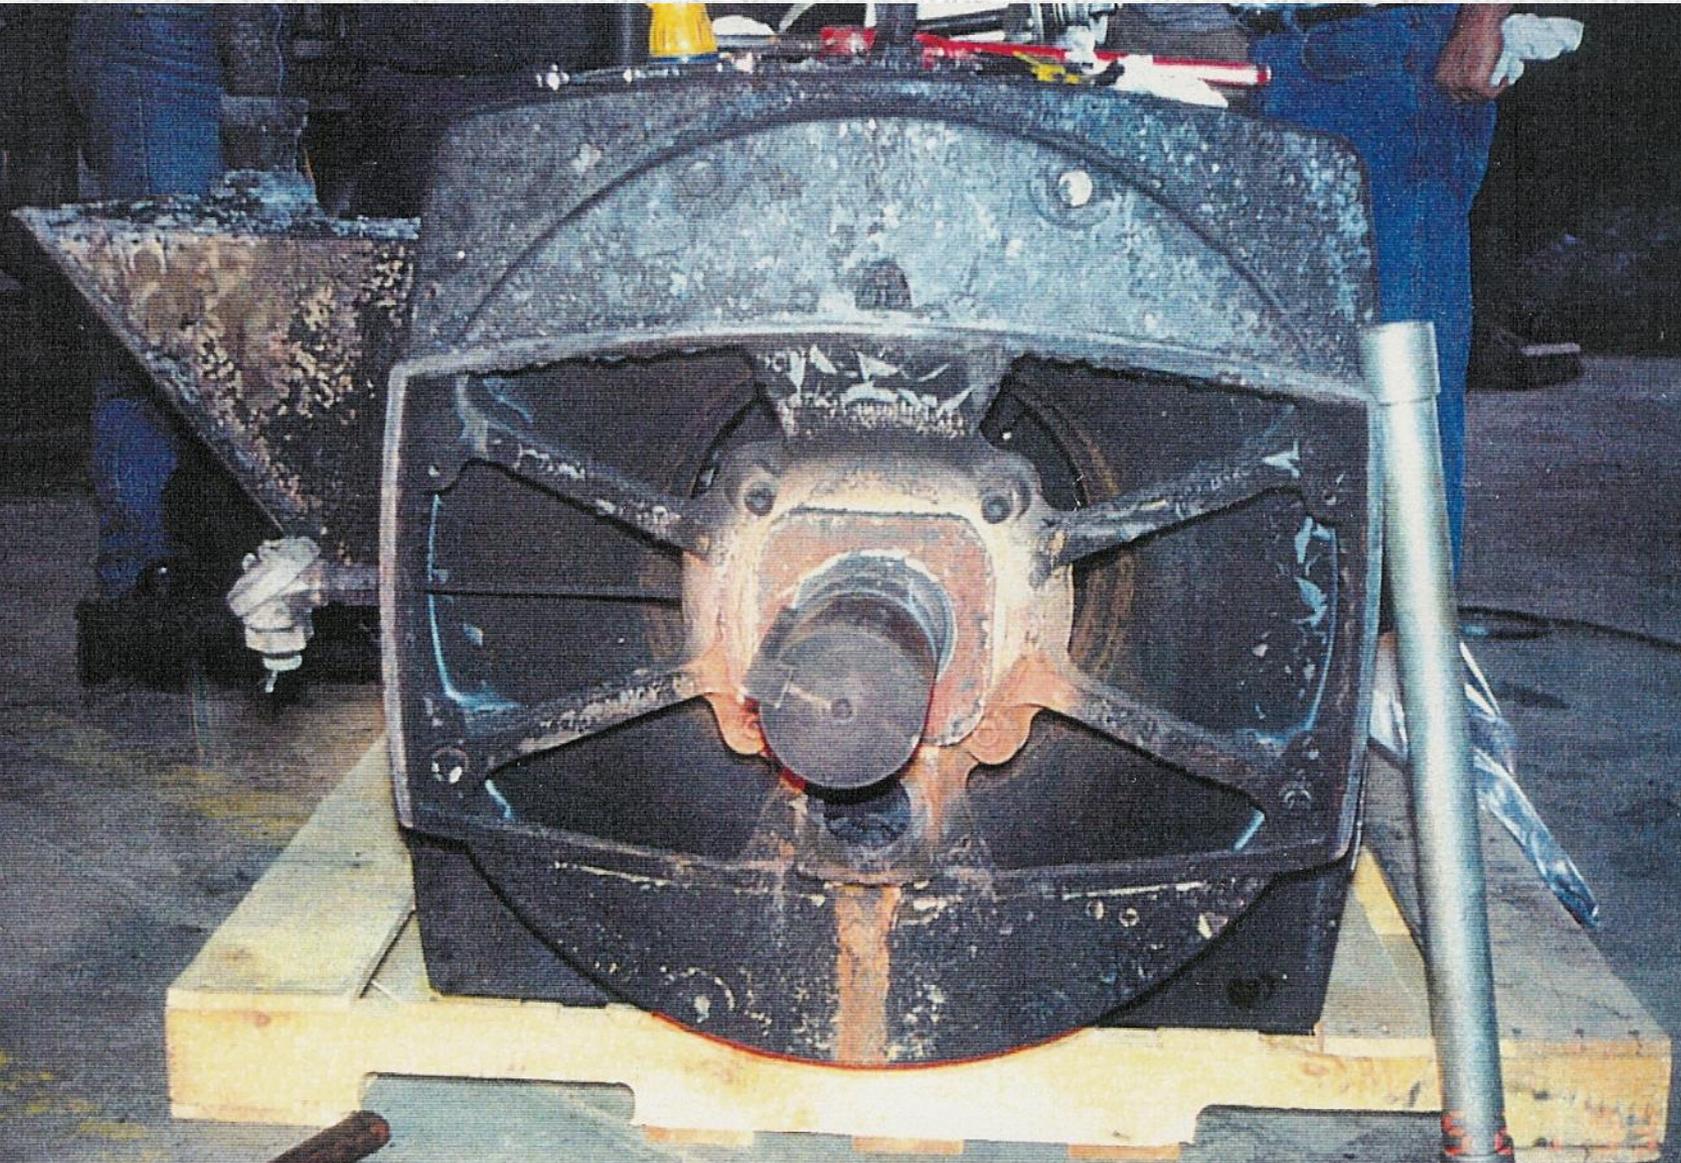
Drive End Bearing

Shroud

... all burned up!

This catastrophic motor failure was caused by improper alignment of the motor shaft to the compressor shaft. Misalignment of the motor to the compressor caused excessive vibration in the motor, extreme overheating, lock-up of the drive-end bearing, and malformation of the shaft.
