FORENSIC ENGINEERING **INVESTIGATIONS**

Crispin Hales, PhD, FIMechE, CEng.

HALES & GOOCH LTD.

Case Example: Process Boiler Explosion

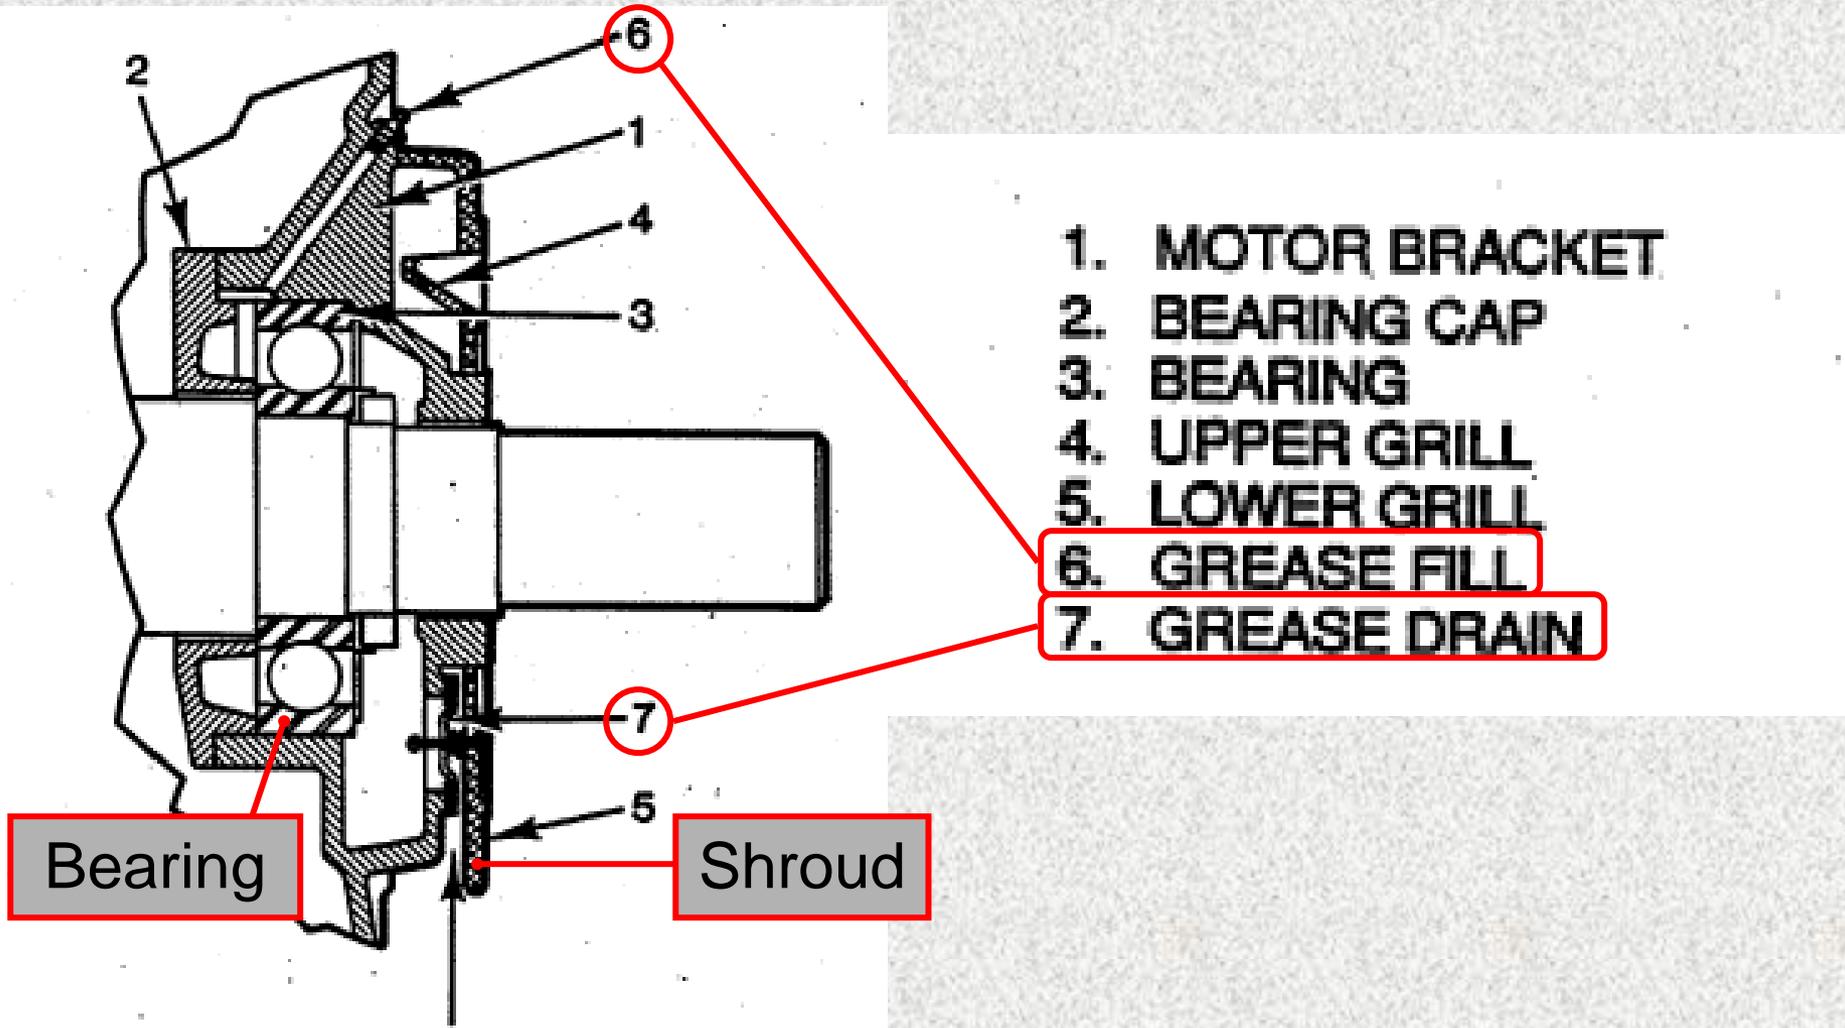
To relubricate bearings, add new grease until clean grease flows from the drain (drain is behind the grill and is automatically activated by the regreasing operation). Grease accumulations at drain should be removed to prevent grease entering the motor. Excess grease in bracket reservoir will be automatically purged while motor is running.

(GREASE DRAINS HERE)

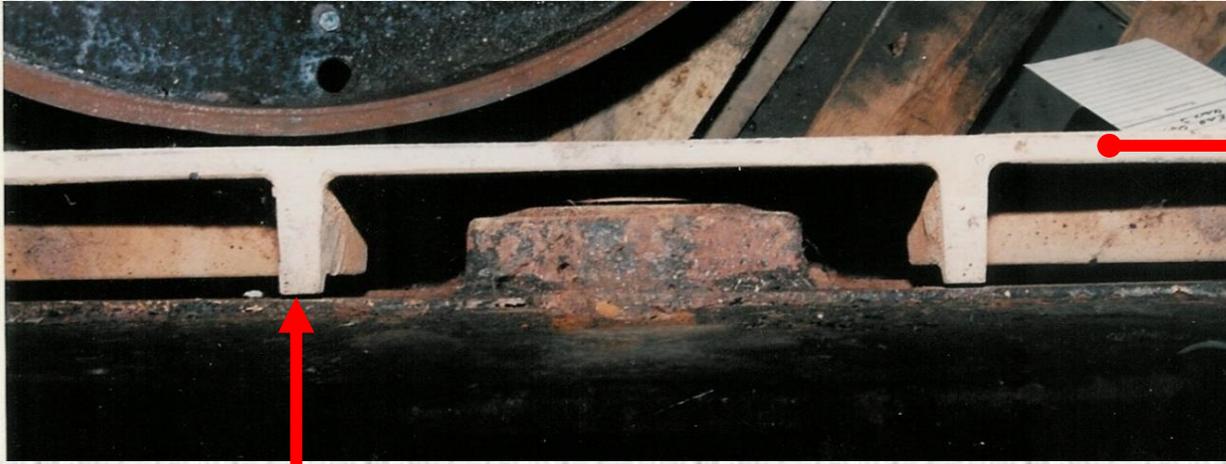
Drive End Shroud

Gap

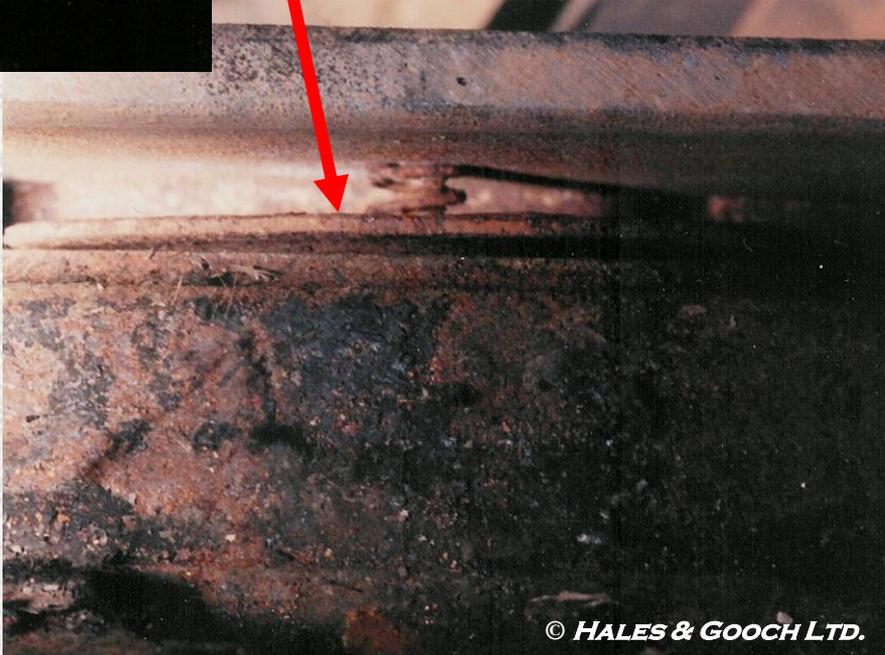
Grease Seal

DRIVE END :

MOTOR

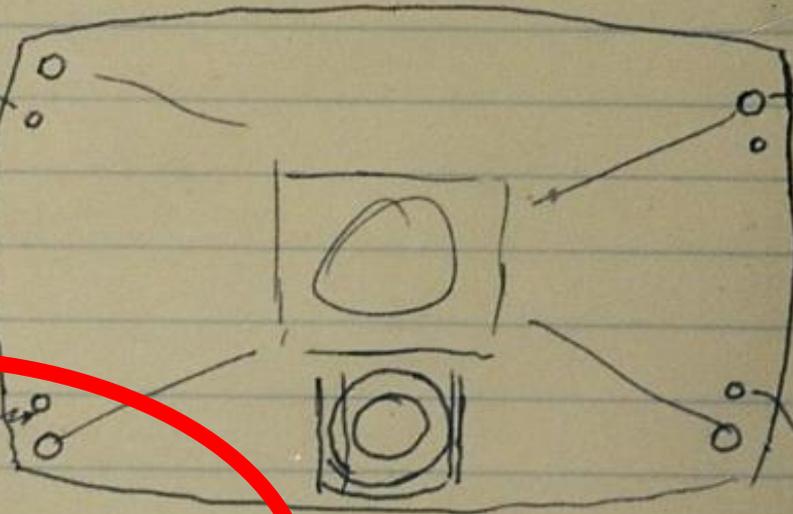
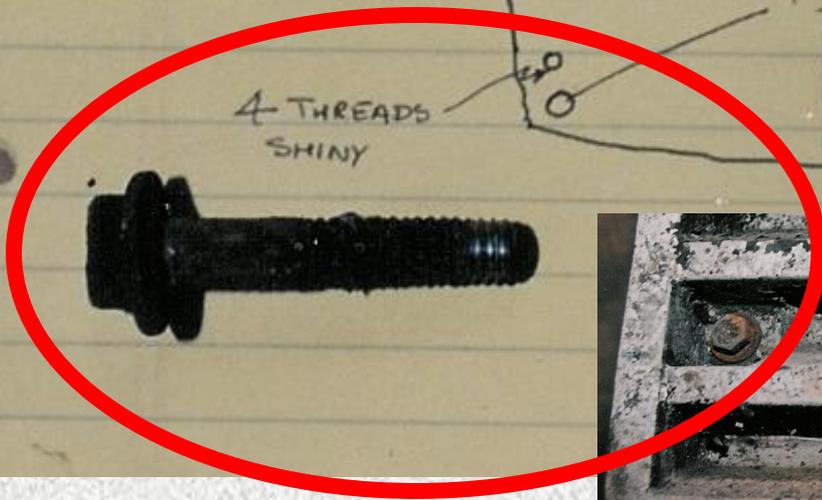
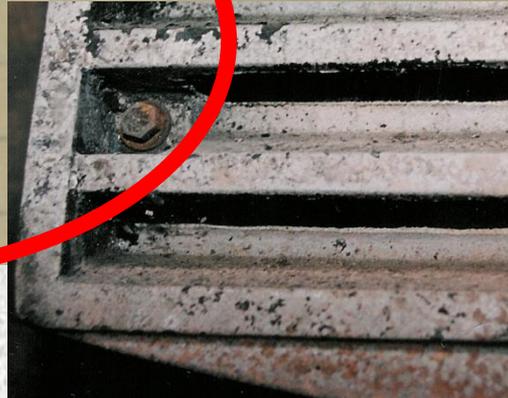
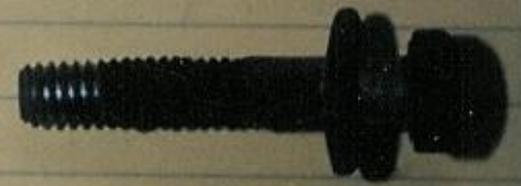
4 THREADS
SHINY

6 1/2 THREADS
SHINY

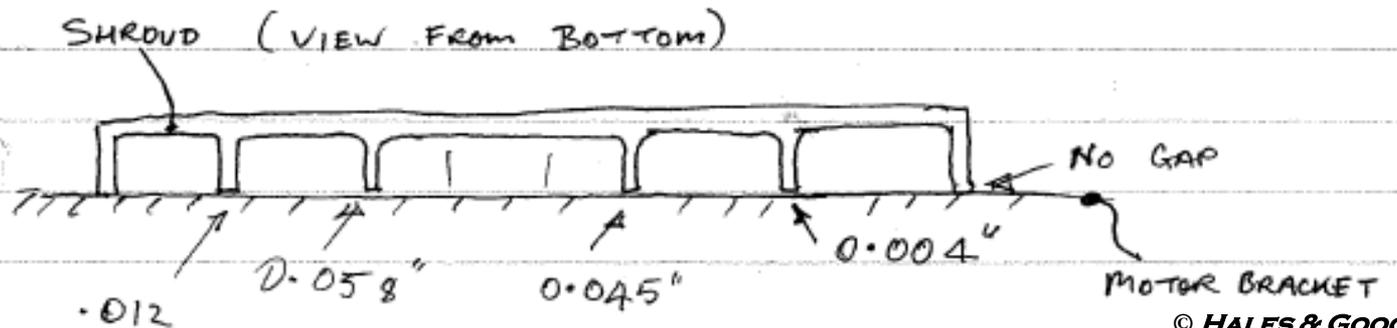
- 16 THREADS/INCH
- ϕ 5/16" BOLTS X 1 3/4" LG.
- WASHERS: 0.075" THICK
- LOOSE FIT THREADS
- IMPACT MARKS AROUND PERIMETER OF SHROUD.
- METALLIC RATTLING IF BOLTS LOOSE

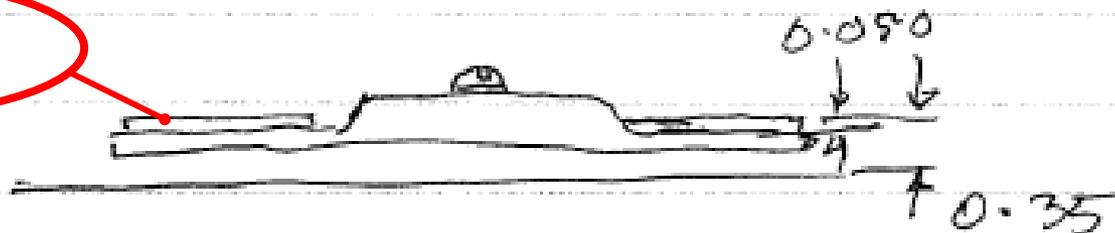
Cork Seal

CLOSED END - NO. 3 - SEAL ON SHROUD.

- Cork washer $0.055''$
- Spring force about same as drive end.
- On non-drive end screw loose.
- Washer stuck on but peels off.

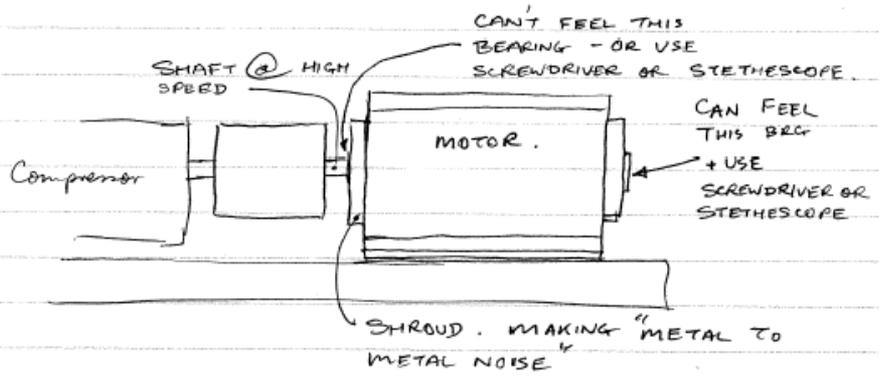
1.

POINTS OF INTEREST ON FAILURE

2. VIBRATING SHROUD :
 + NOISE @ START-UP
- LOOSE ?
 - NOT FITTED CORRECTLY ?
 - BENT ?
 - DISTORTED ?
 - SEAL SPRING BROKEN ?
 - ⇒ RATTLE
 - CRACKED ?

3. AUTOMATIC DRAIN FOR BEARING DEPENDS ON SHROUD + SEAL TOGETHER

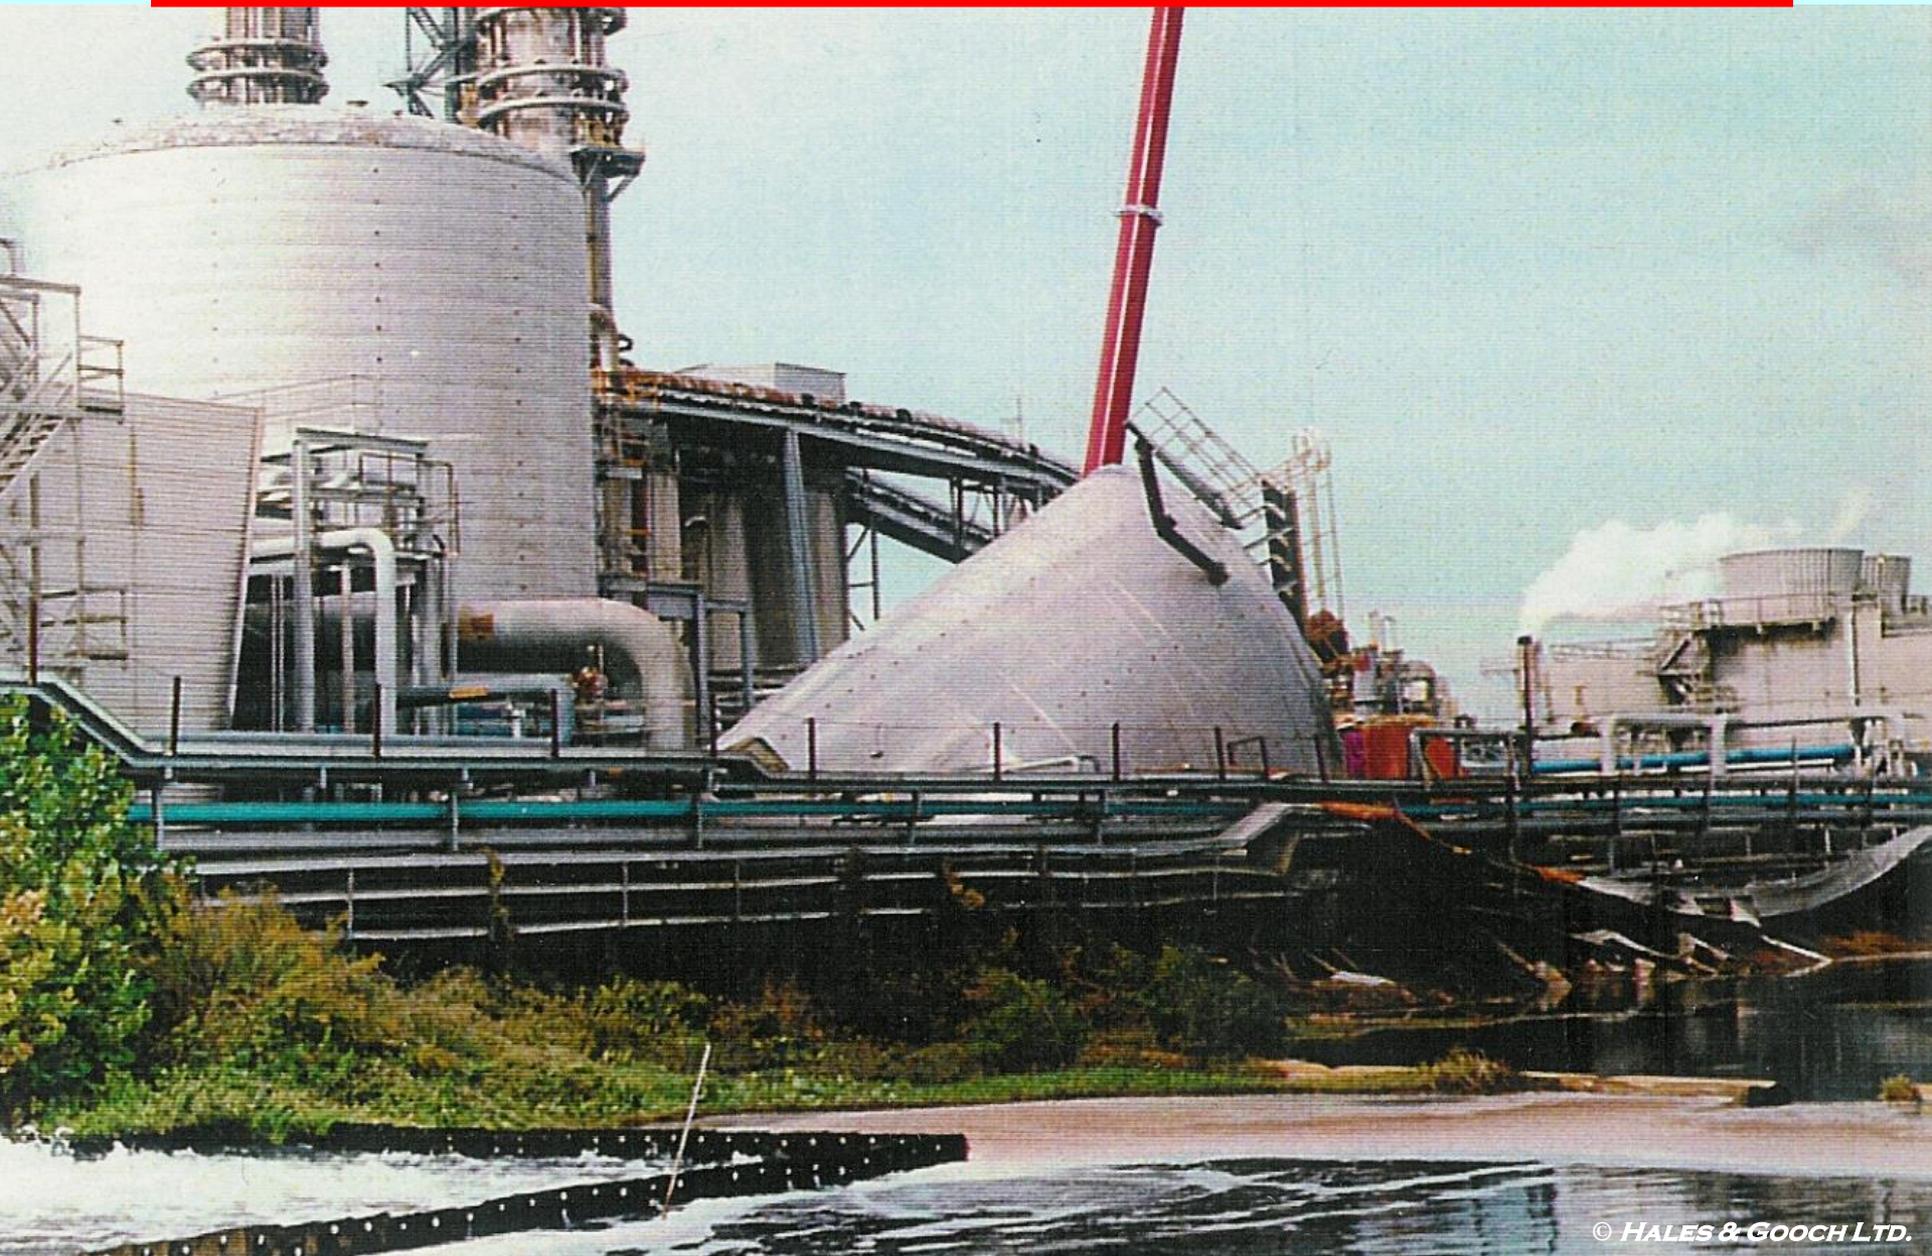
Woomf ... and over she goes!

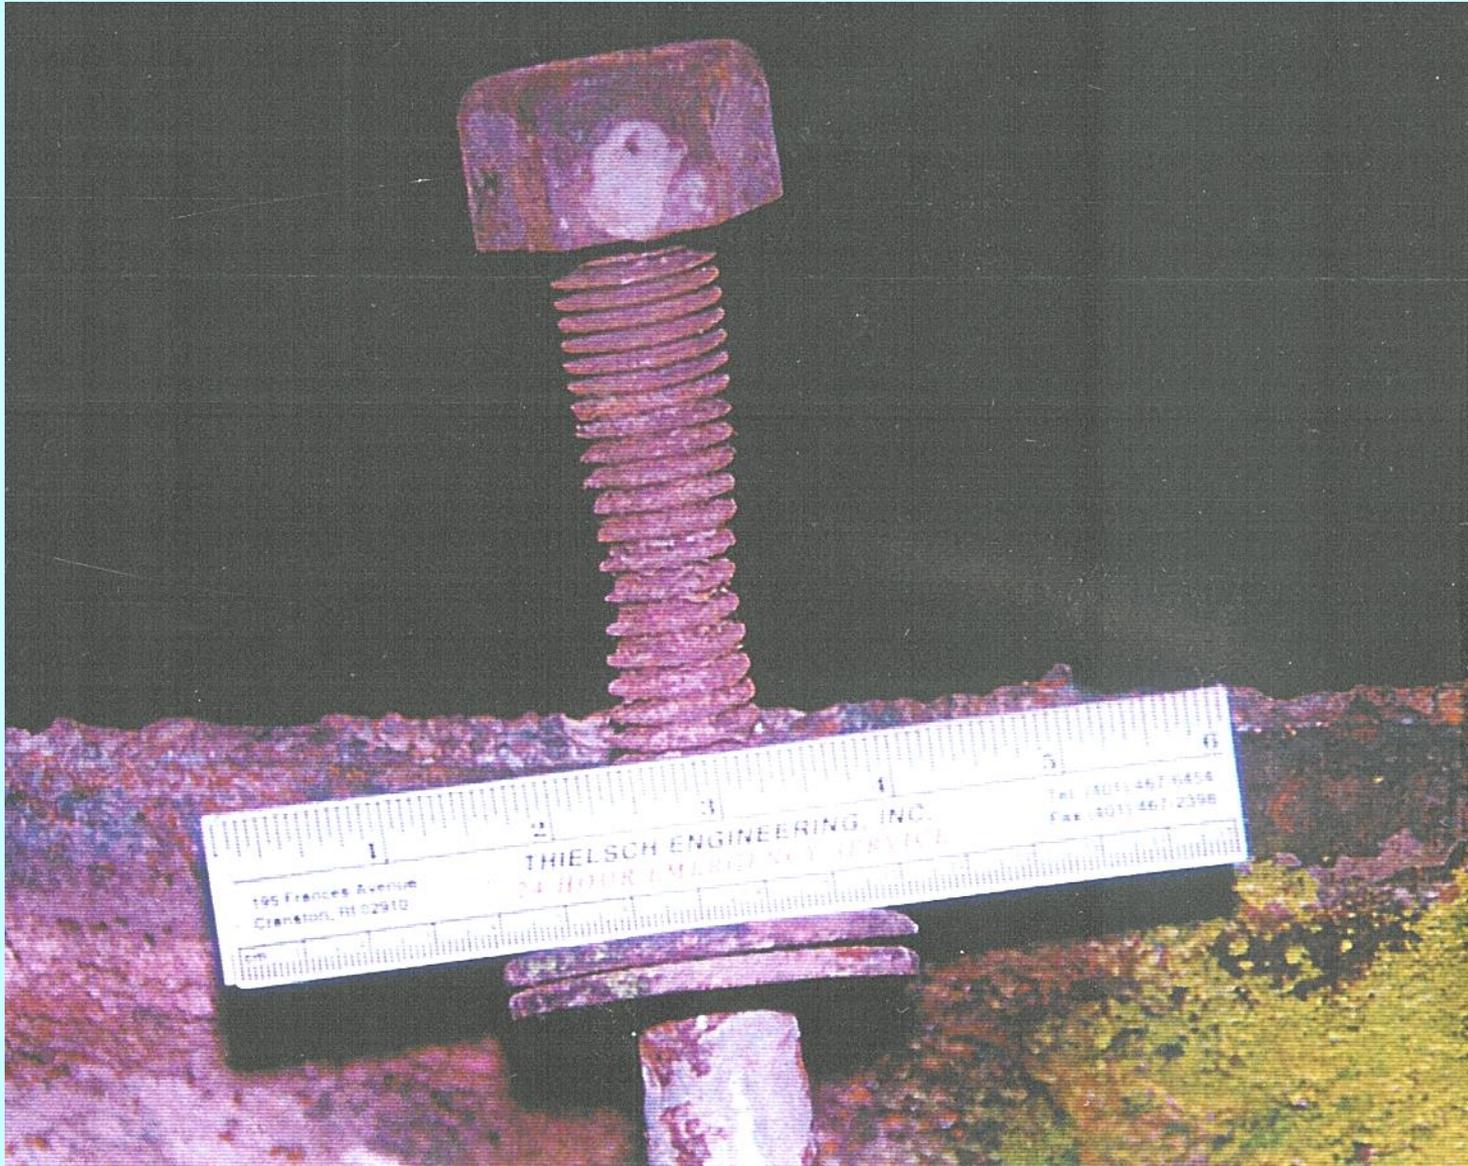
Wall thickness corroded from 0.500" to 0.020" here!!

Hey, look at that!

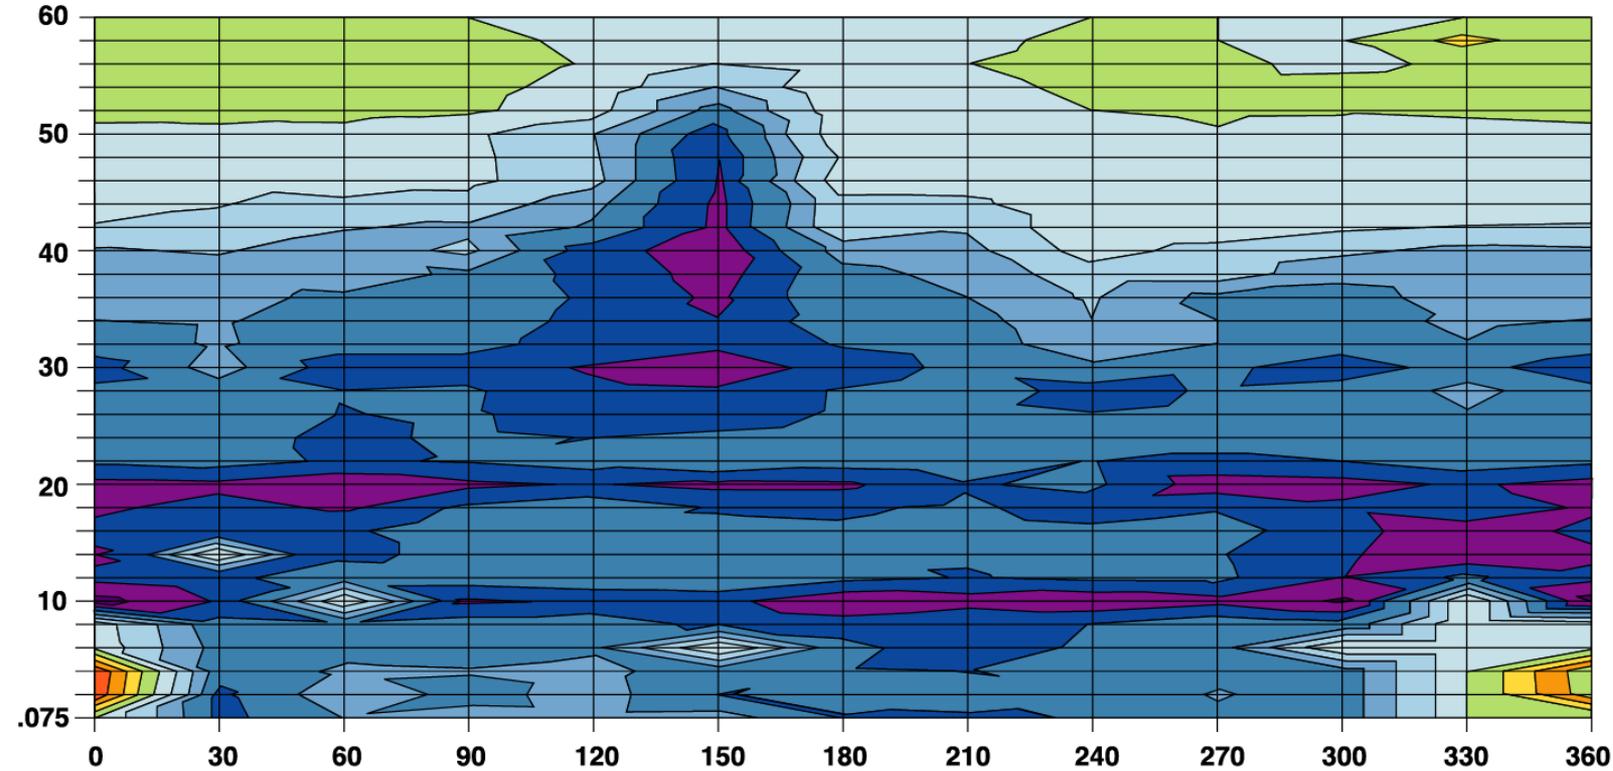
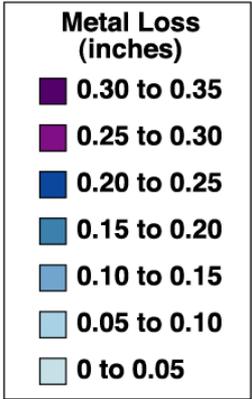
ULTRASONIC THICKNESS EXAMINATION ON NOVEMBER 19, 1996

- Plant did not analyze data in detail
- “Averaging” calculations not to API Standard
- Data showed consistent pattern
- Pattern showed accelerating corrosion

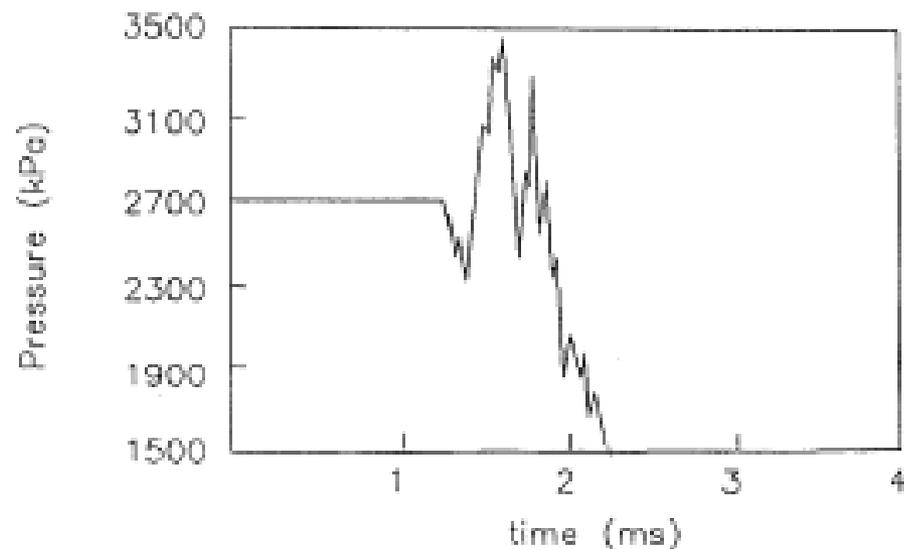
Figure 2: Pressure Response during a BLEVE of R22 in a 1 Litre Tank

Figure 2 shows the pressure-time history as recorded by the transducer at the end of the tank. The fluid inside the tank was 879 g (88 v%) of R22, which was heated to approximately 65 C. The pressure inside the tank at this temperature would be 2700 kPa. As can be seen from the figure, the pressure dropped slightly, then rose to a maximum of 3500 kPa. This result shows that the

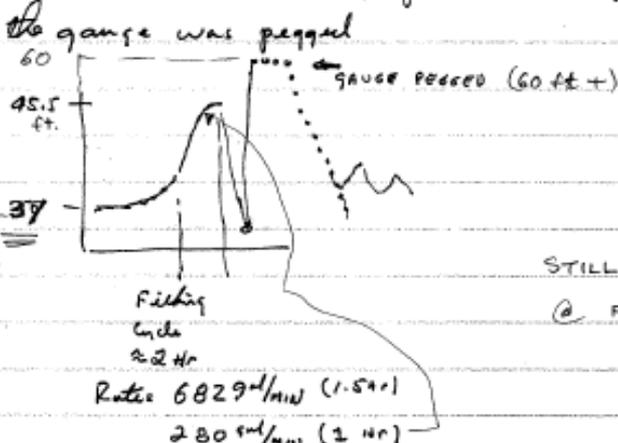
We show a pressure drop followed by a rapid pressure rise
 i.e. Pressure gauge shows height 45.5ft \rightarrow 18.5ft \rightarrow 60ft
 we don't know how high pressure actually reached because
 the gauge was pegged

STILL GOING UP
 @ FAILURE

Started with 353,252 gal @ end 428,026 gal at failure (22% increase over 2 hrs)

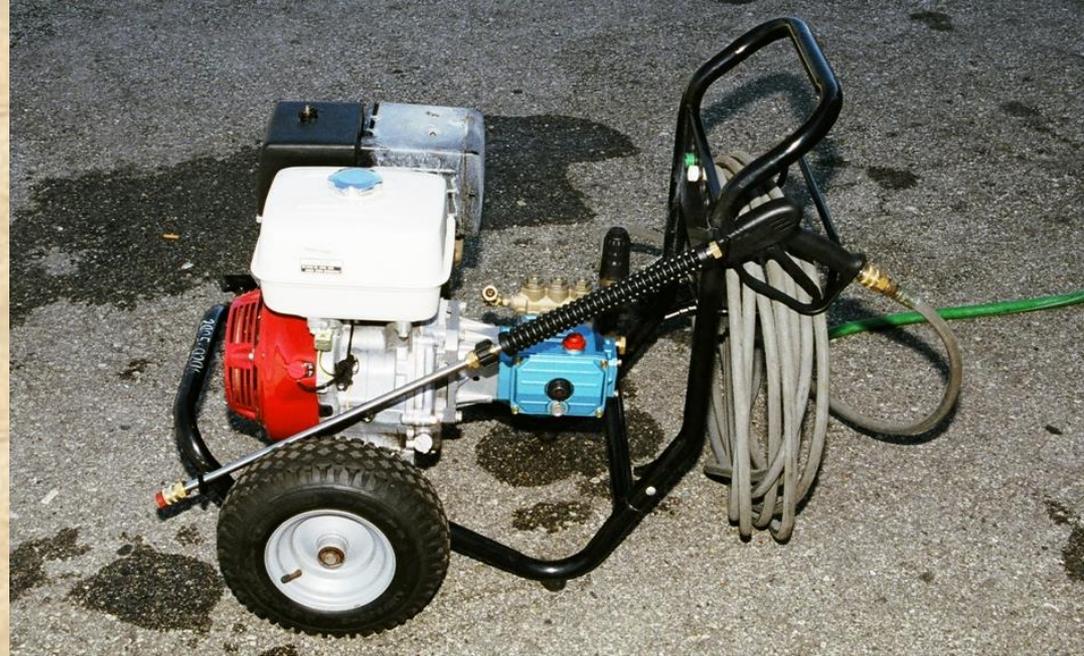
INSPECTION OF EXEMPLAR UNIT

- 4lbs to squeeze trigger without water pressure or pump
- 5lbs to squeeze trigger with water pressure on but no pump
- 25lbs to squeeze trigger when operating with water & pump
- 25lbs to squeeze trigger first time pulled after motor shut off
- 4lbs again once water pressure released from hose when off

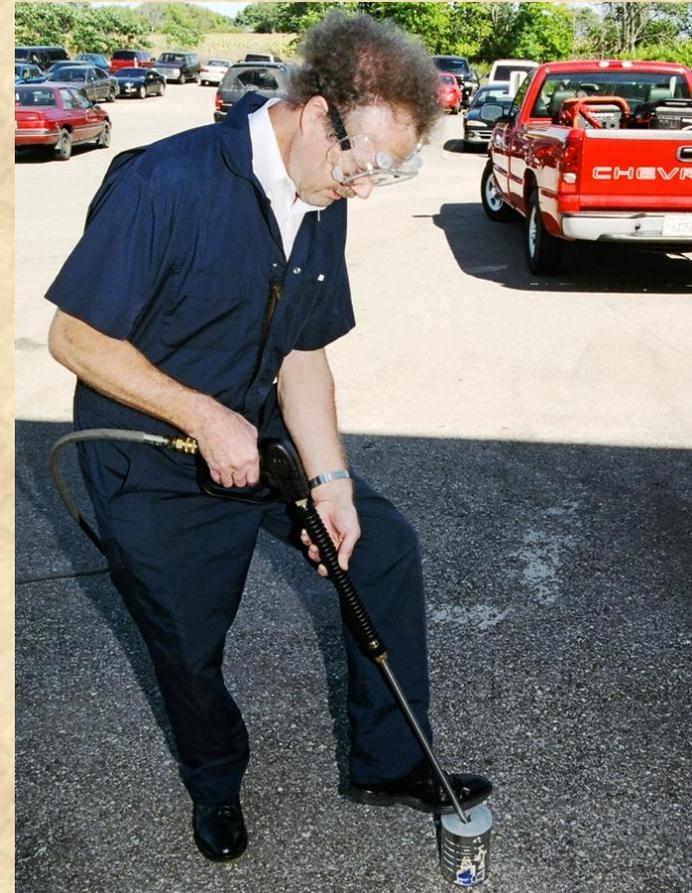
1. Machine operating under full pressure
2. Machine shut off
3. Nozzle inserted into container
4. Squeeze trigger to release pressure
5. Measure volume of water released

Results: 56ml = 3.42 cu. ins.

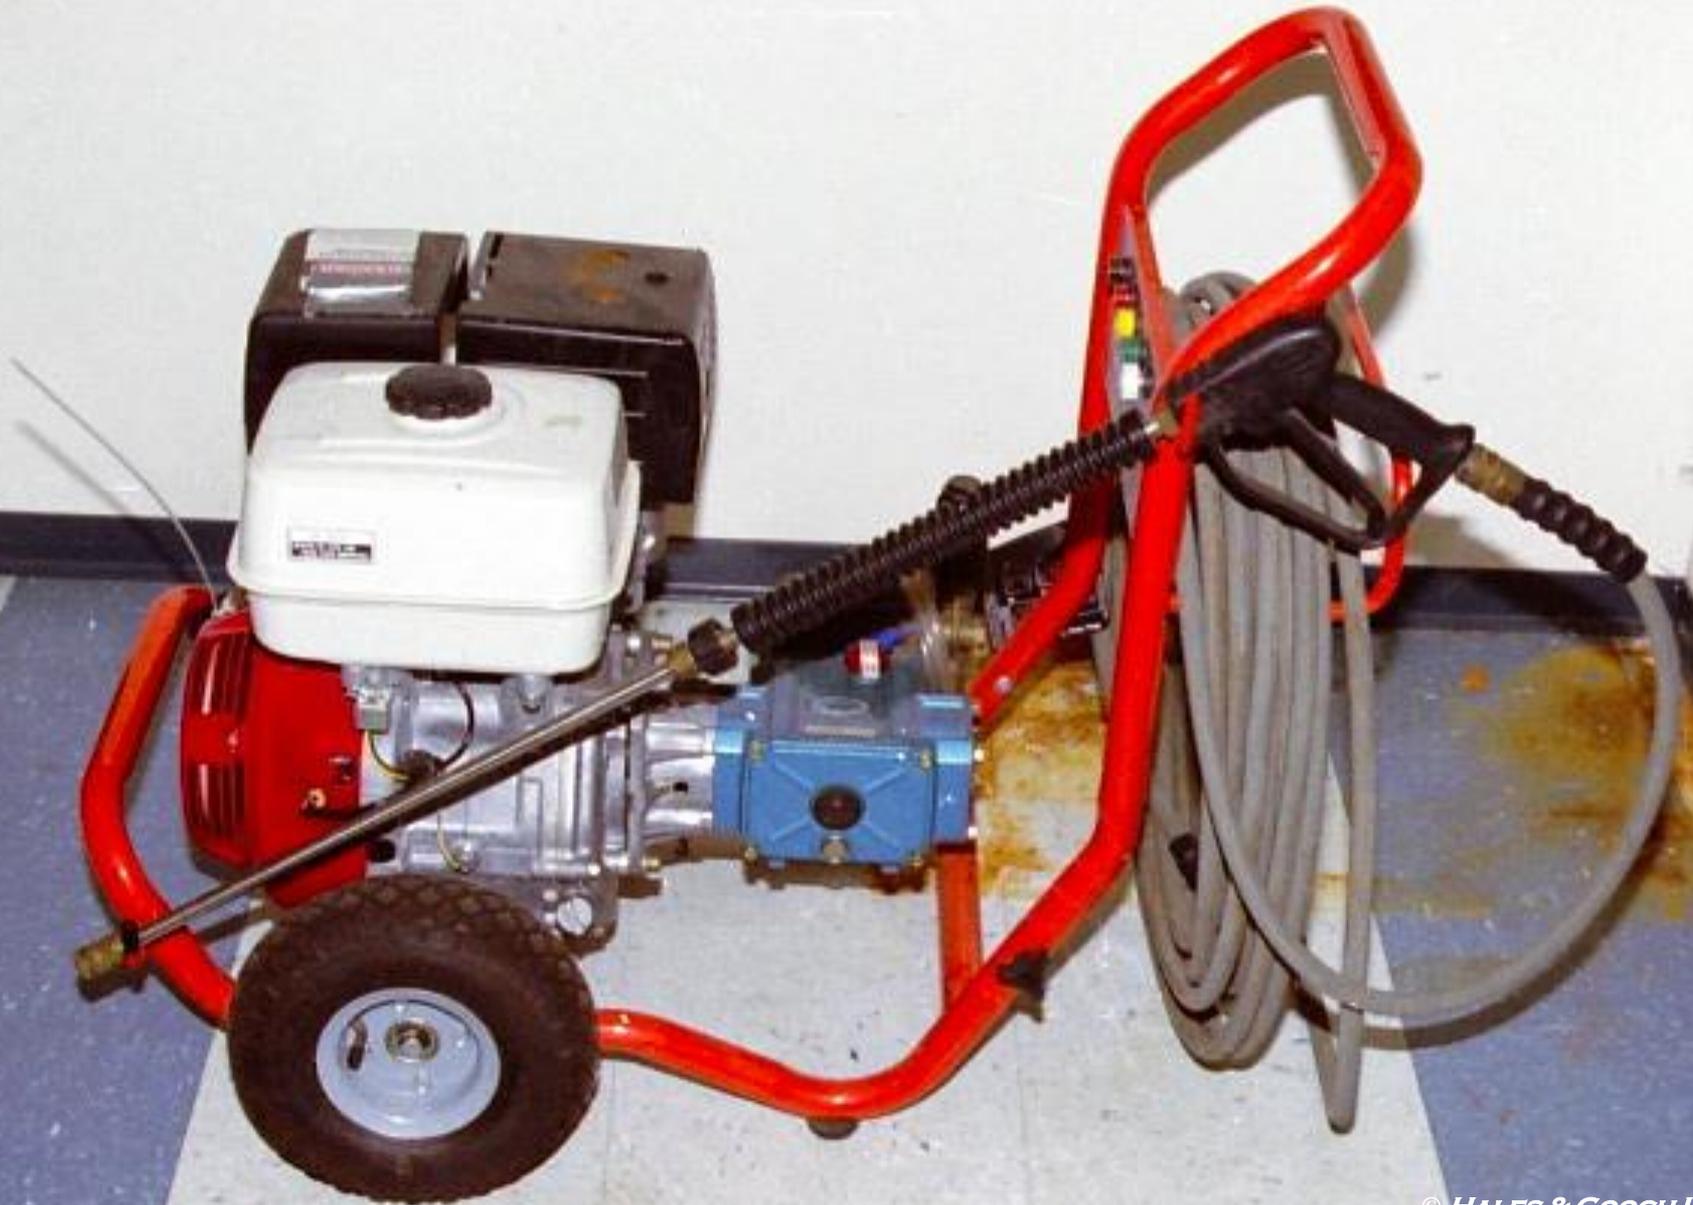
INSPECTION OF ARTIFACT UNIT

- High pressure hose – heavy duty wall thickness
- Difficult to coil even with pressure off – “springs back”
- Lot easier to coil when disconnected from machine & gun
- When pressurized near impossible to coil on hooks
- Hose twists to form “figure-of-eight” when pressurized
- Hose has to be rotated to continue coiling
- Easiest way to overcome problem is to squeeze trigger
- When pressure released then much easier to coil

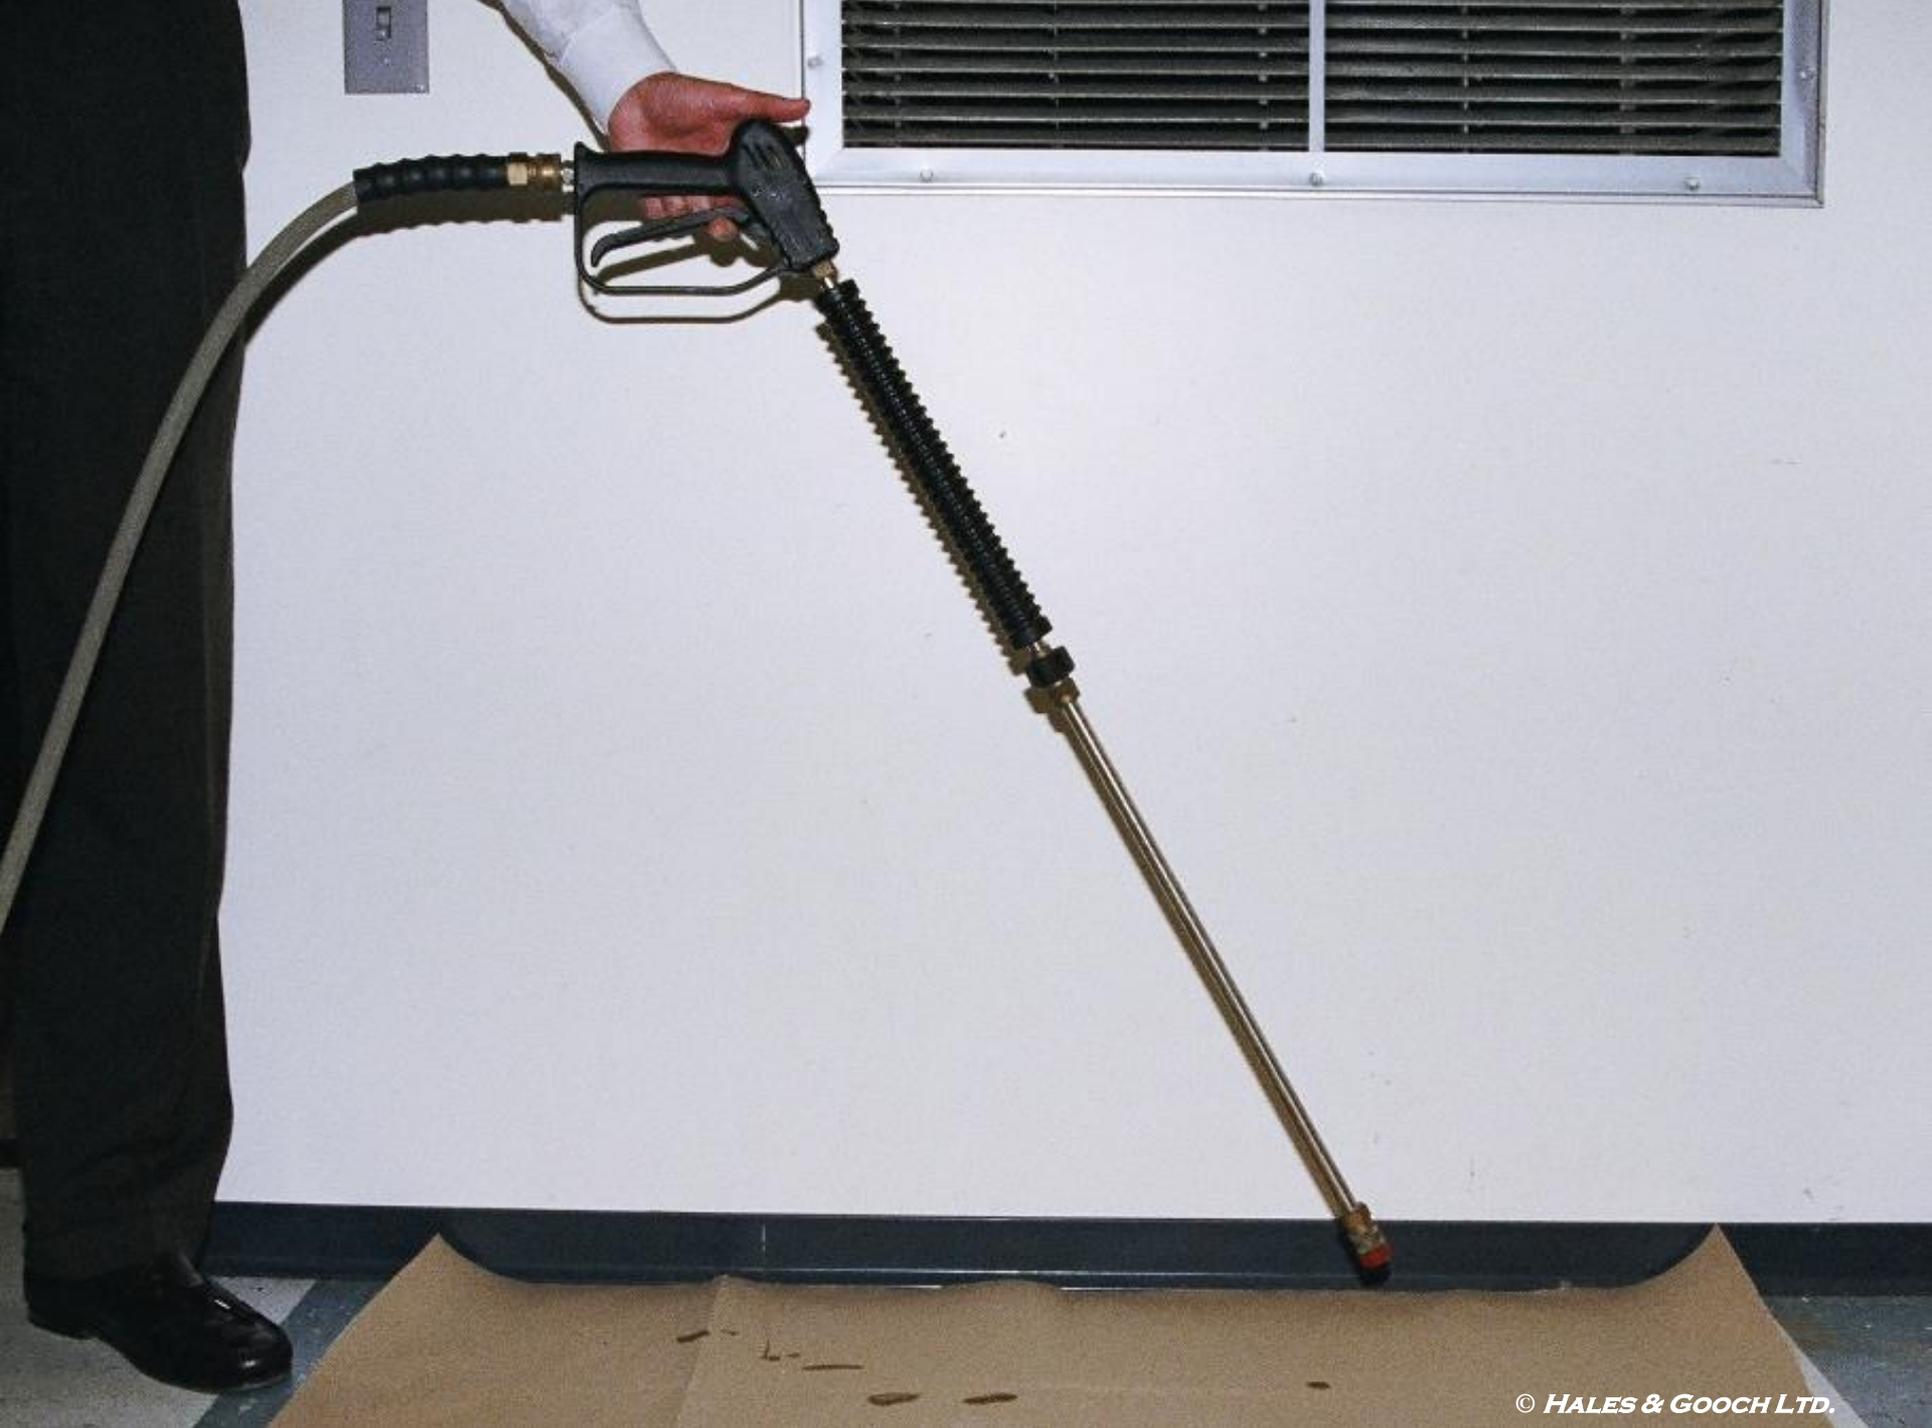
CENTER OF GRAVITY – GUN + HOSE

- **Hose twists up and can't be coiled under pressure**
- **Gun points to ground when picked up by handle**
- **Trigger guard prevents hitting trigger**
- **Trigger hard to squeeze when hose pressurized**
- **Additional force required to point gun upwards**

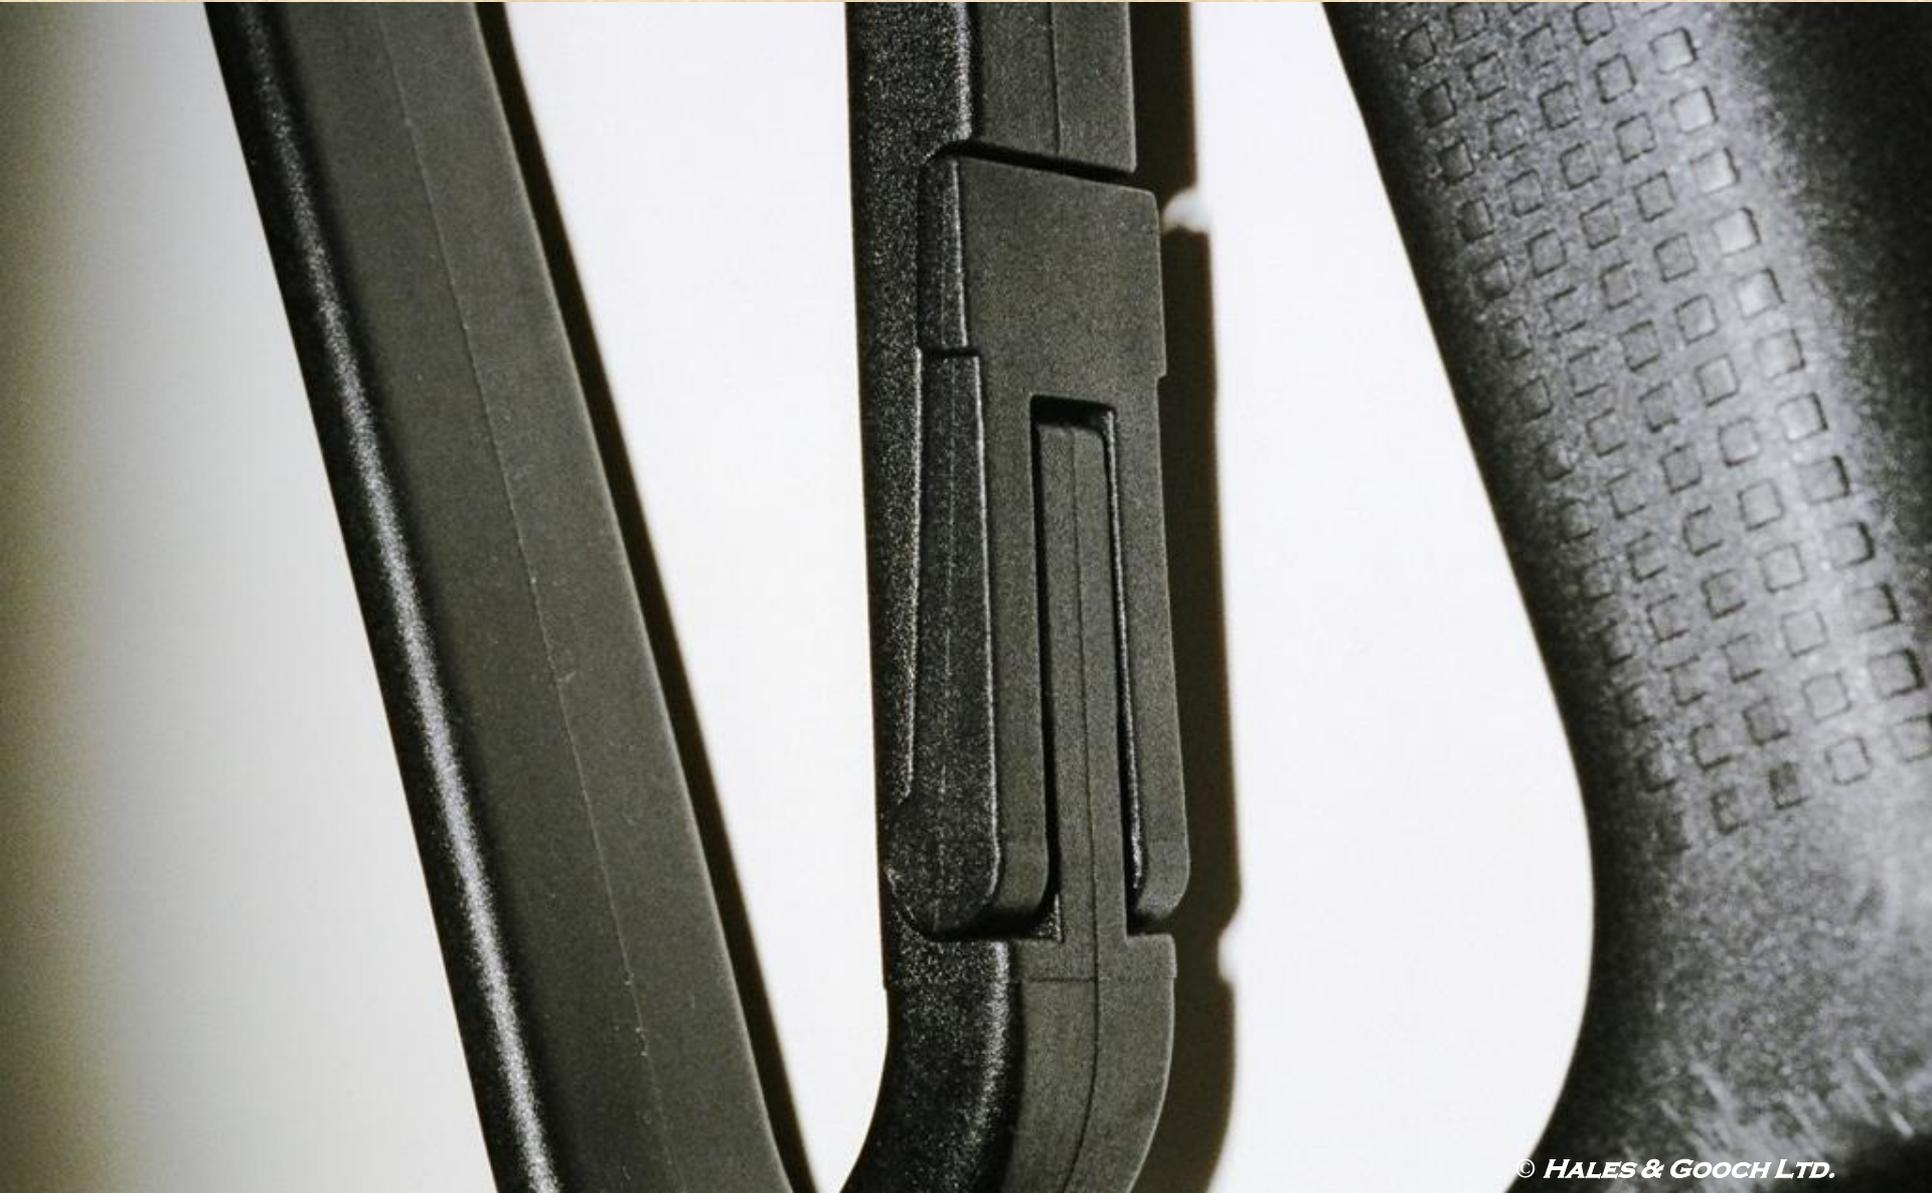
TRIGGER LOCK – USING PROJECTIONS

- **Trigger guard geometry protects trigger**
- **Trigger lock placed in natural position**
- **Projections on lock assist easy use**
- **Over-center geometry with detent action**
- **Hose couplings locked when pressurized**
