FORENSIC ENGINEERING **INVESTIGATIONS**

Crispin Hales, PhD, FIMechE, CEng.

HALES & GOOCH LTD.

Case Example: Process Boiler Explosion

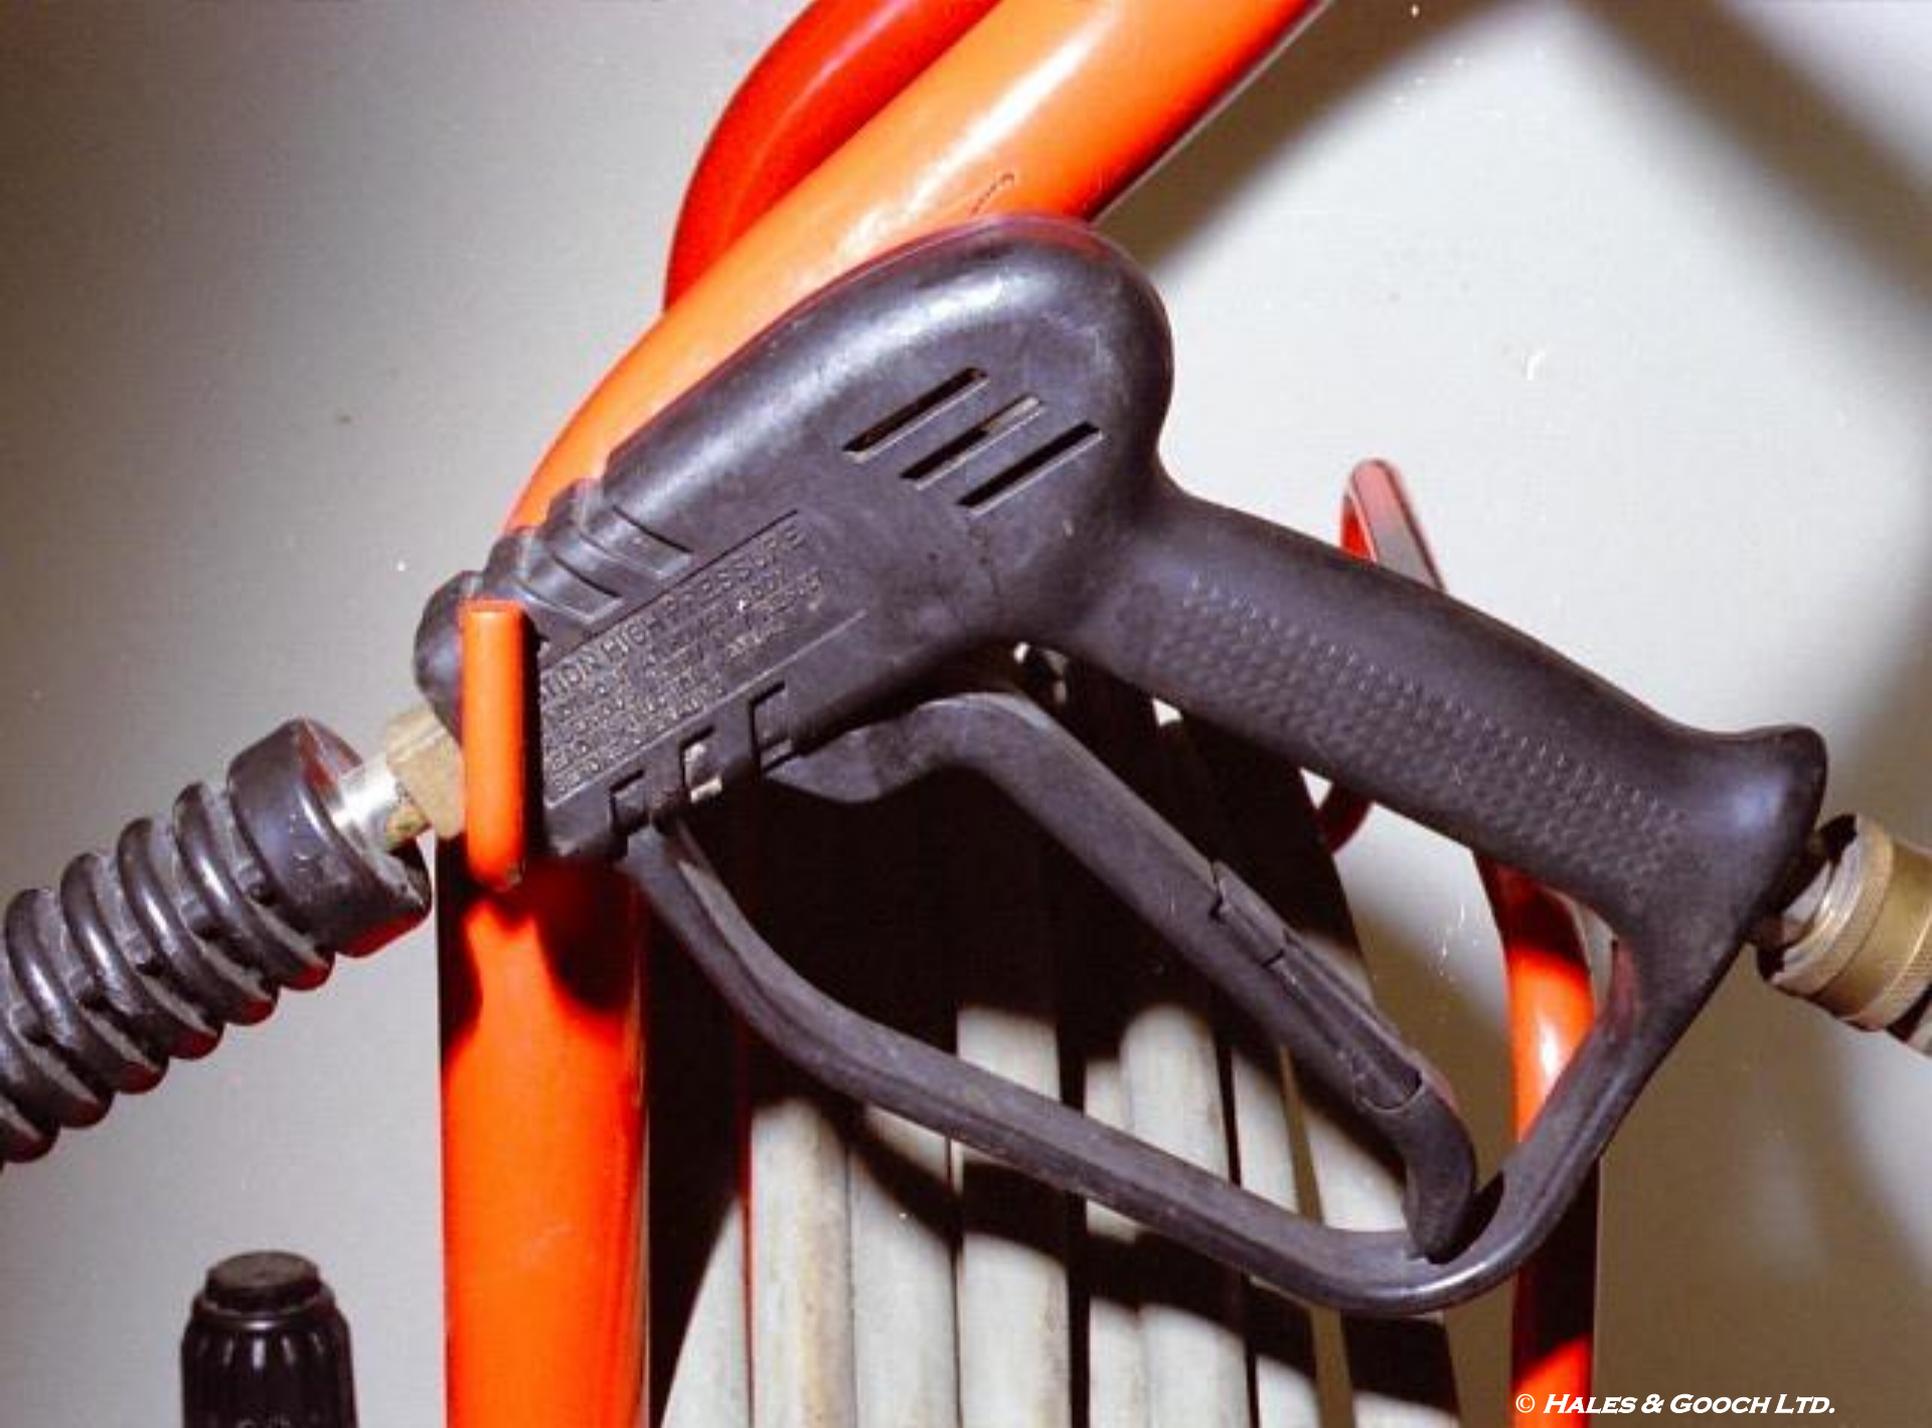
- Hose won't coil when pressurized
- Spray gun won't stay in hooks when pressurized
- Hose connections locked when pressurized
- First notice on box is "3700psi"!
- Hose couplings locked when pressurized
- Warning tag on machine
- Embossed warning on the handle of the gun

CAUTION HIGH PRESSURE
ALWAYS WEAR EYE PROTECTION
DO NOT POINT AT PEOPLE
OR OTHER FLAMMABLE MATERIALS
