**KUHN FAMILY**  
**HOME INSPECTIONS**

INSPECTION REPORT  
123 Main St  
NoWhereVille NJ 00000

INSPECTED BY  
Ryan Kuhn  
Kuhn Family  
Home  
Inspections LLC  
#24GI00152800

INSPECTION DATE  
📅 1/1/2023  
🕒 03:30:00 PM

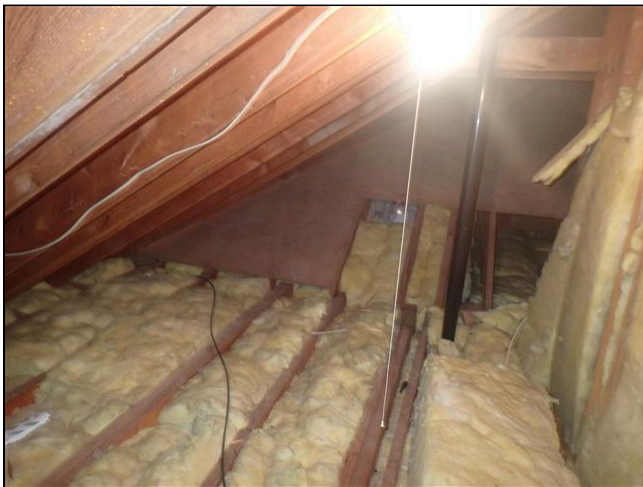
5.0 Item 1 (Picture)

**5.3** (2) Suspect mold was observed at various locations of roof sheathing at attic space over both main house and garage area. Recommend further evaluation by a qualified specialist to assess, test, and determine possible remediation needed to prevent possible health concerns.

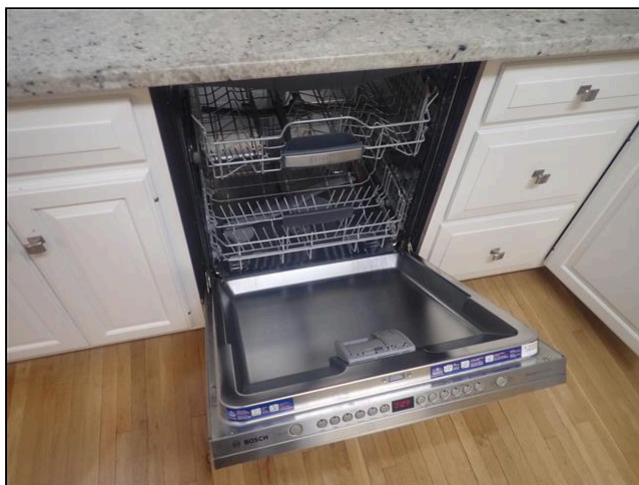
7.3 Item 1 (Picture)

**7.3** The dishwasher operated through one full cycle; however, neither the operation of all cycles or modes nor its cleaning ability was determined.
