Home Inspection Report

Property address: **12431 Bree Ct**

Yucaipa, CA 92399

Inspection date: **Friday, September 9, 2022**

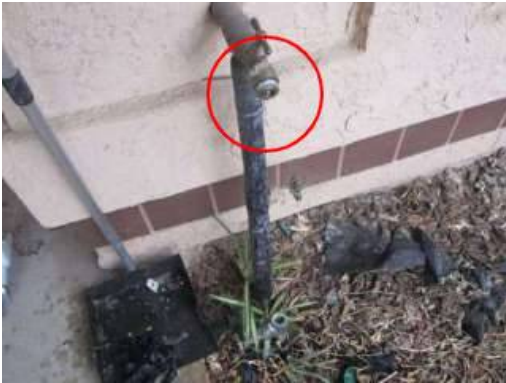
Photo 1-3 Hose bib pipe valve needs replacing

- 1) Photo 1-3 Hose bib pipe valve needs replacing.
- 2) Photo 1-10 Missing window screen.
- 3) Photo 1-11 Screen is on the ground and needs to be replaced.
- 4) Photo 1-14 Broken lattice members around patio structure.
- 5) Photo 1-15 Patio cross members are deteriorating.
- 6) Photo 1-16 Back patio door latch does not work correctly.
- 7) Photo 1-28 Landscaping, many of the valves are broken and do not work correctly. The entire landscaping water system needs to be repaired.
- 8) Photo 2-6 Roofing tiles have slipped or are broken in a few different areas. A licensed roofer should evaluate and repair all issues, you may want to get a roof certificate.
- 9) Photo 3-6 Garage door auto light sensor does not work correctly, does not allow the door to stay down, intermittent.

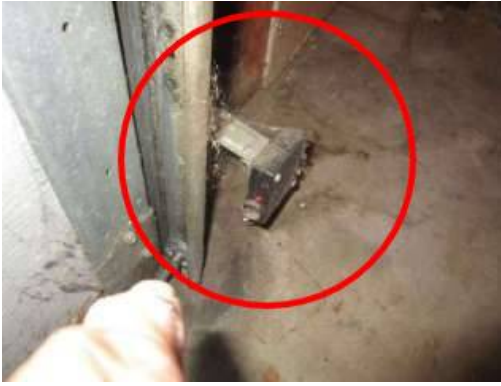
Photo 3-6 Garage door auto light sensor does not work correctly, does not allow the door to stay down, intermittent

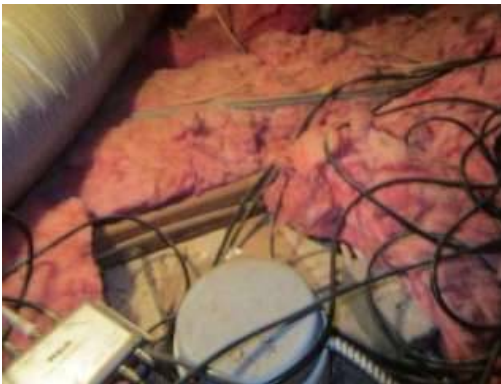
Photo 4-4 Many abandon tv cables have been left in the attic, you may want to remove. (this is not an issue).

- 10) Photo 4-4 Many abandoned tv cables have been left in the attic, you may want to remove them. (this is not an issue)
- 11) Photo 5-3 The fireplace exterior plug does not work correctly, it is also the wrong outdoor plug per code. A licensed electrician should repair it.
