# PROPERTY INSPECTION REPORT

**1234 Buena Vista St**  
**Inspection Prepared For: Happy Client**  
**Agent: Christian Castner - Harcourts Luxury Estates**

**Date of Inspection: 2/6/2019**  
**Year Built: 1944 Size: 2158**

## **Sunset Property Inspection**

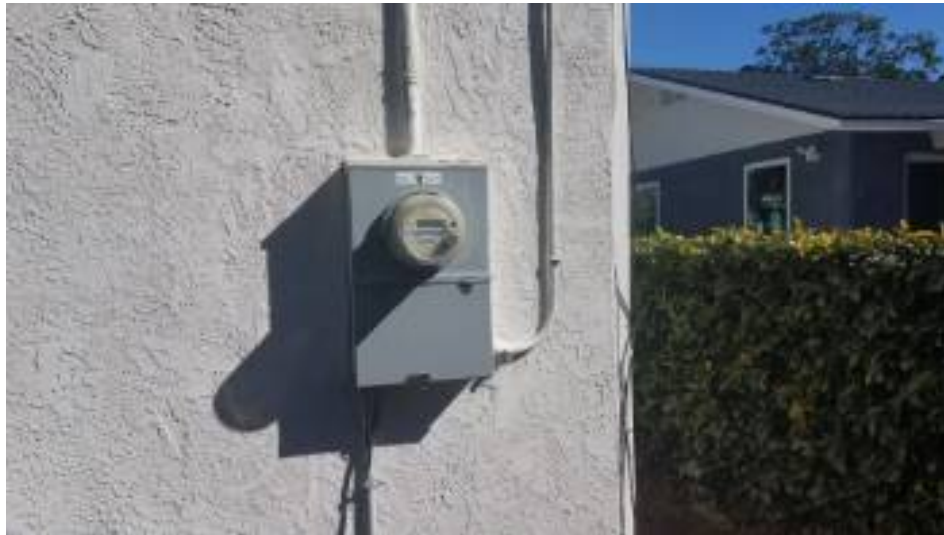
Main Panel Location

Description: **Manufacturer:Murray • Location: Southwest corner of exterior**  
 Observations:  
 • The wiring within the panel appeared satisfactory and functional.  
 • National safety standards require electrical panels to be weatherproof, readily accessible, and have a minimum of thirty-six inches of clear space in front of them for service. Also, they should have a main disconnect, and each circuit within the panel should be clearly labeled. Industry standards only require us to test a representative number of accessible switches, receptacles, and light fixtures. However, we attempt to test every one that is unobstructed, but if a residence is furnished we will obviously not be able to test each one.

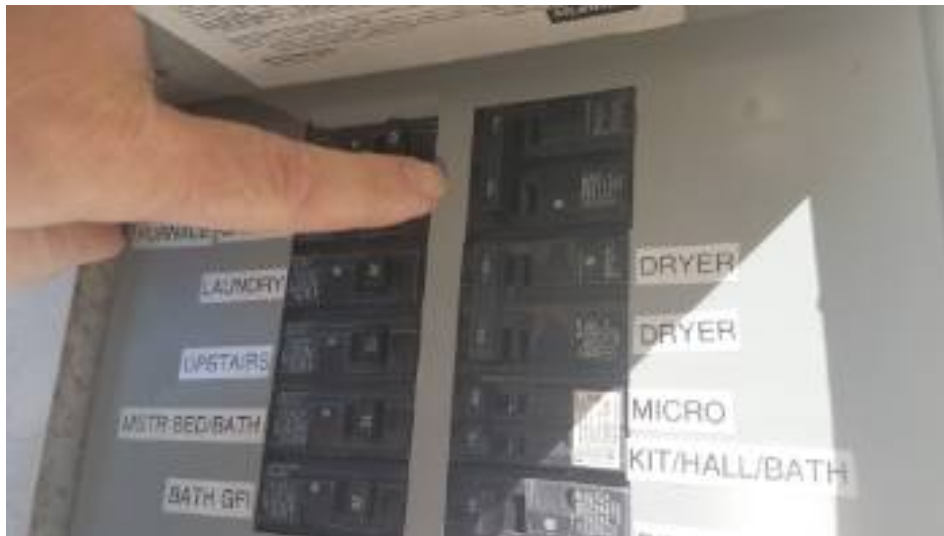
Main Disconnect

- Main electrical disconnect at the 100 amp circuit breaker on panel. See photo below.

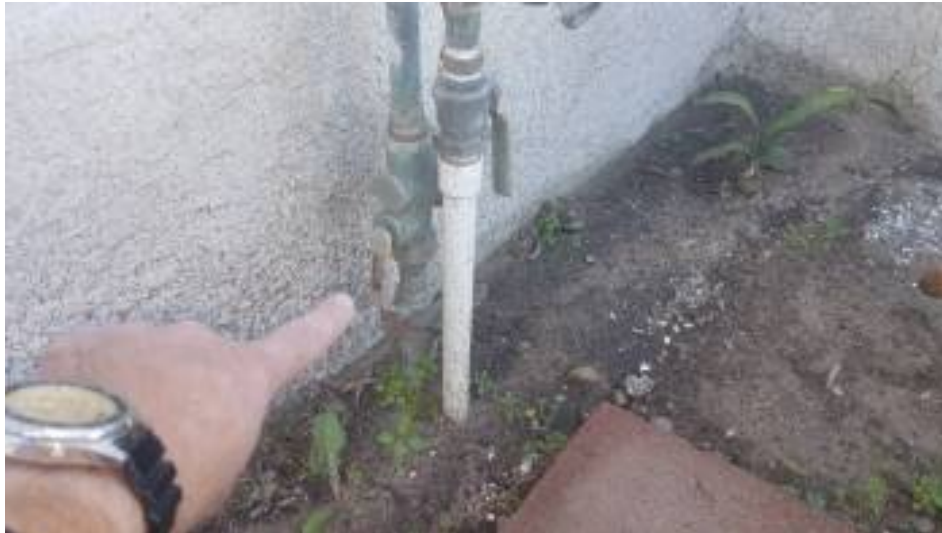
Main Water Shut Off

Location: Front Wall of Exterior. Ground level

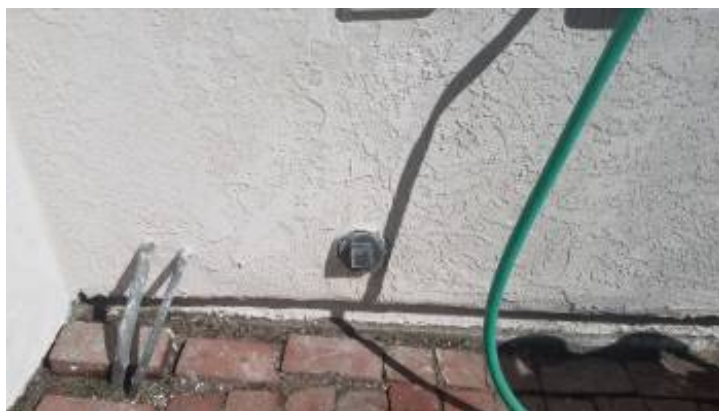
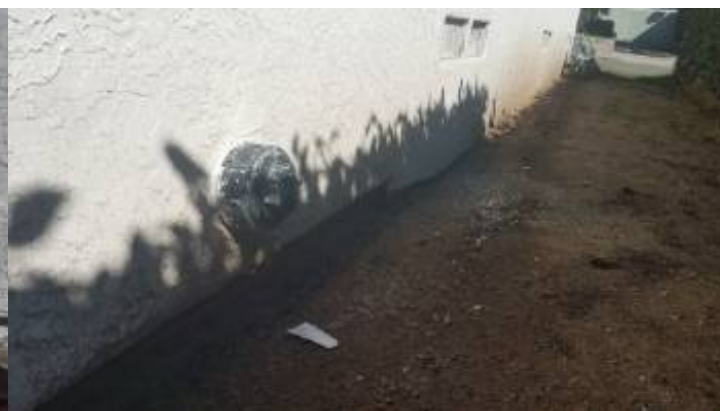
Cleanout Location

- Visible piping appeared serviceable at time of inspection.

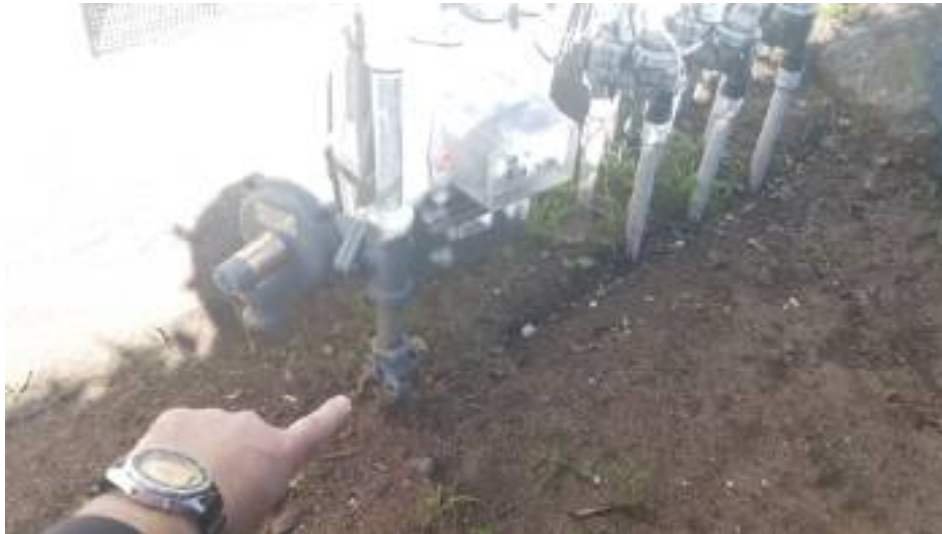
Main Fuel Shut Off

- Public utility gas meter. Interior gas lines were not fully visible. Gas lines are rigid iron pipe. The life expectancy of the gas piping is for the life of the structure.

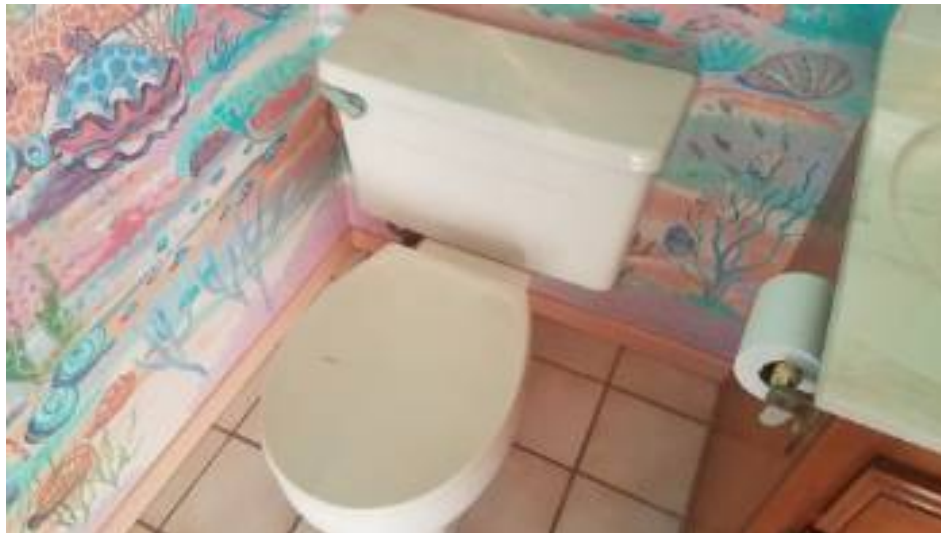
- Operated when tested. No deficiencies noted.
- As of January 1, 2017, building standards/state law require that flow rates for fixtures in the home not exceed 1.6 gpf for toilets, 2.2 gpm for faucets and 2.5 gpm for shower heads. It is beyond the scope of the inspection to determine the flow rates of the plumbing fixtures in the home. Refer to seller.

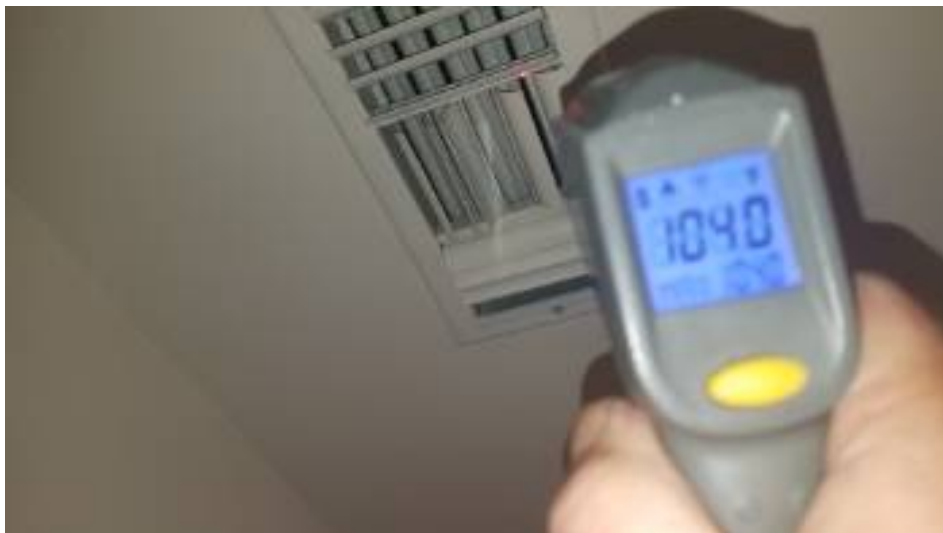
temperature at register

- No deficiencies noted.
- 100+ degrees heating supply air was observed at a representative number of registers - using a laser thermometer.
- Air registers appeared working in every applicable room.
