SODBURY

House Survey Report

123 High Street
Sampletown
Bristol
BS1 1AA

Inspection Date: XX/XX/2023

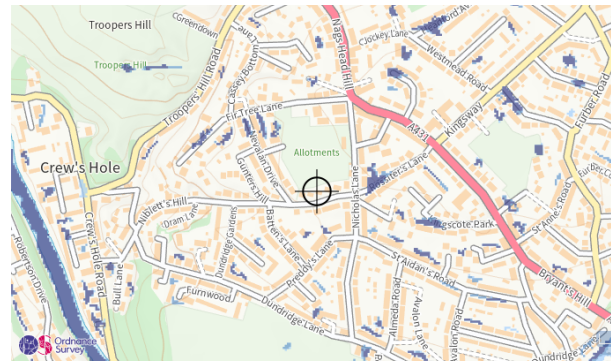
Extent of flooding from surface water

According to data from the Environment Agency, the property is within an area at very low (less than 0.1%) risk of surface water flooding.

I did not note any surface water flood risk when on site.

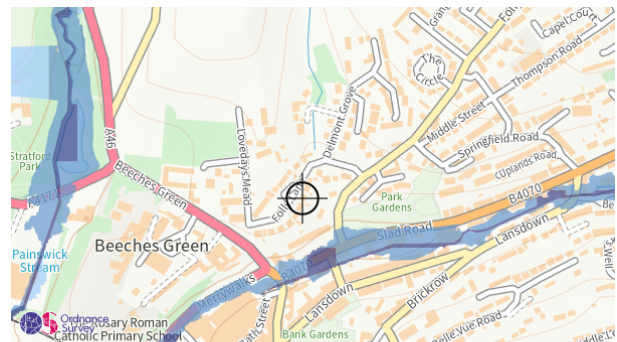
Extent of flooding from rivers or the sea

According to data from the Environment Agency, the property is within an area at very low (less than 0.1%) risk of flooding from rivers and the sea.

I did not note any flood risk from rivers or the sea when on site.

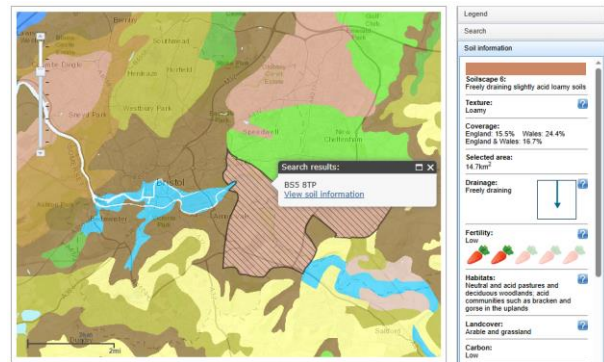
Landfill

According to data provided by DEFRA, there are historic or current landfill sites within 1km of the property. Locations of these are shown in red hatch on the plan provided. However, these are outside of where I would expect there to be any influence on the property, so I do not believe these to be a relevant concern.

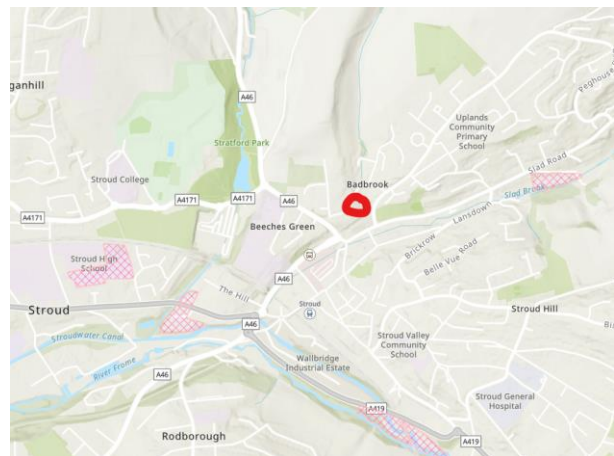
Mining

Past mining activity can cause ground instability in some areas, which is a risk to building stability. This property is located in a known mining area, but there are no records of mine shafts near to the property. However, you may wish to carry out detailed mining searches through your solicitor.

I have seen no evidence of any mining related subsidence to this property or nearby properties.

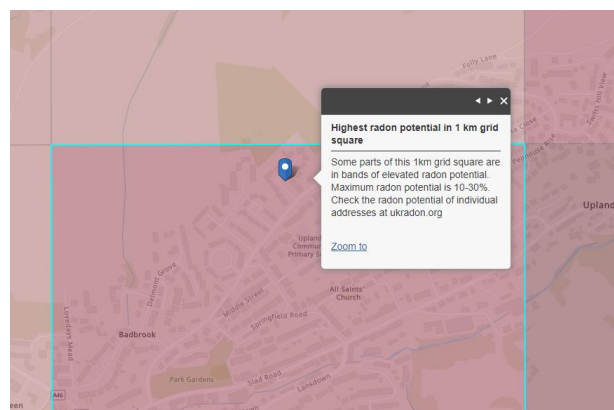
Radon is a natural radioactive gas, which enters buildings from the ground. Exposure to high concentrations increases the risk of lung cancer. Public Health England (PHE) recommends that radon levels should be reduced in homes where the annual average is at or above 200 becquerels per cubic metre (200 Bq m³). This level is termed the Action Level. Public Health England defines

radon Affected Areas as those with 1% chance or more of a house having a radon concentration at or above the Action Level of 200 Bq m⁻³. **This property is located in an area where there is a 10-30% chance of the radon concentration being above the Action Level.** With this in mind, I recommend carrying out radon testing at the property. For further information, please visit www.ukradon.org.
