SODBURY

House Survey Report

123 Sample Road

Inspection Date: XX/XX/2023

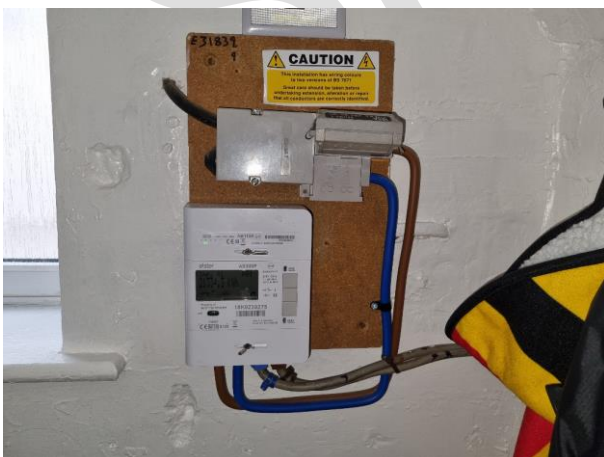
I have seen no Electrical Installation Condition Report for the property from within the last 10 years, so am unable to comment on the condition and safety of the electrical installations and wiring. However, I should note that I have seen nothing within the property to suggest that any of the electrical installations are currently in a dangerous condition.

General photograph of electricity meter.

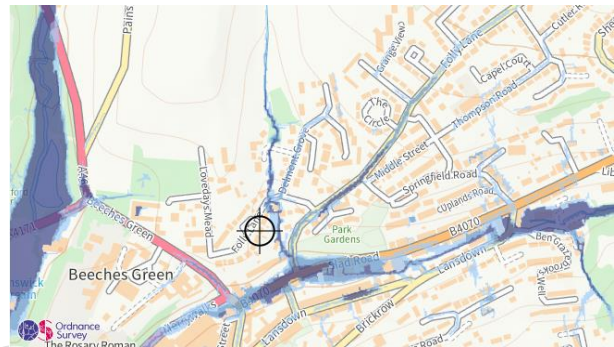
Extent of flooding from surface water

According to data from the Environment Agency, the property is within an area at very low (less than 0.1%) risk of surface water flooding.

I did not note any surface water flood risk when on site. The property is on a heavily sloping site, so it is likely that any surface water would run towards the bottom of the garden and not cause issues for the house.

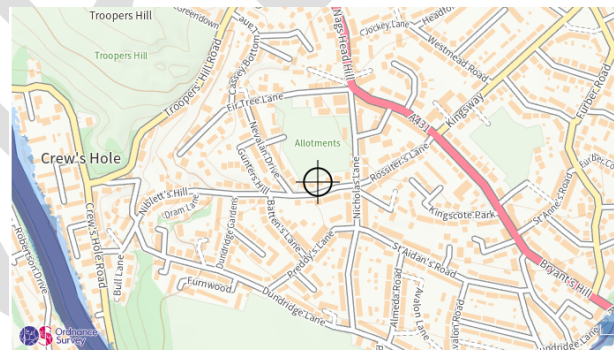
Extent of flooding from rivers or the sea

According to data from the Environment Agency, the property is within an area at very low (less than 0.1%) risk of flooding from rivers and the sea.

I did not note any flood risk from rivers or the sea when on site.

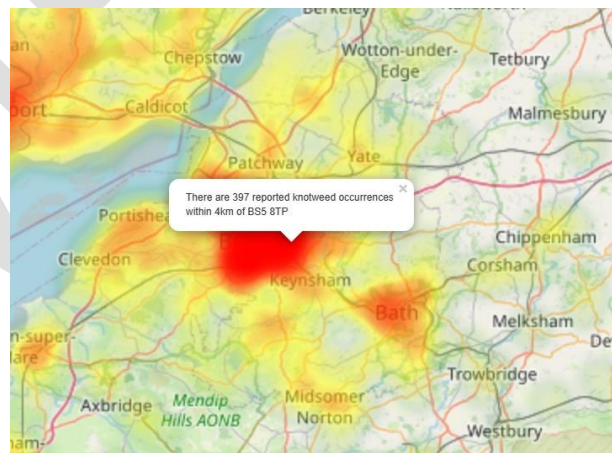
Japanese Knotweed is an invasive weed which can cause damage to buildings and can make a building difficult to mortgage or sell. According to the Environet Japanese Knotweed Heatmap, there are 397 reported occurrences of Japanese Knotweed within 4km of the property, which is a high occurrence rate. I did not note any signs of this or any other invasive weed species during my inspection.
