PROPERTY INSPECTION REPORT

Concerning: 1234 Happy Street, Fun City, TX 77777

By: Amandeep (Andy) Punia, Lic #22380 04/18/2017

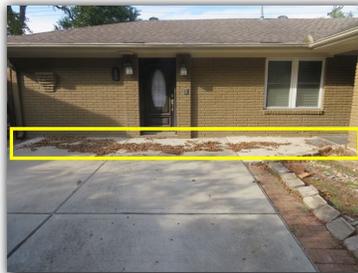
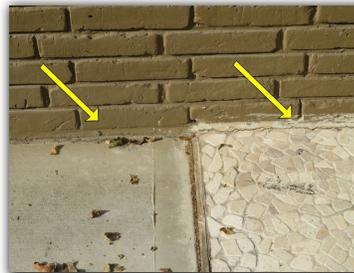
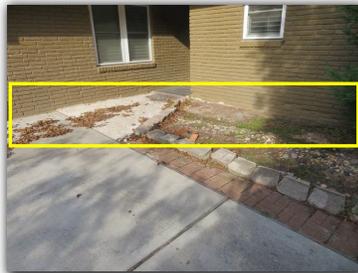
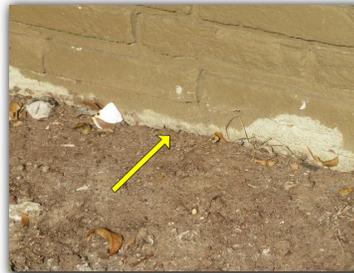
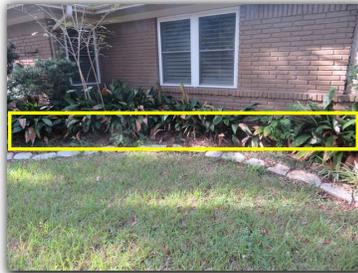
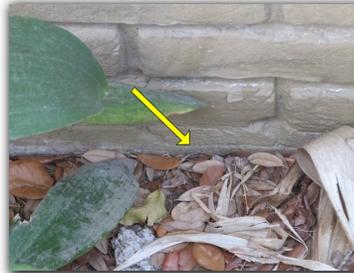
Foundation was not visible at multiple areas due to high soil, grass, foliage, porch, deck, and, driveway . Building standards require minimum foundation exposure above the finished soil grade of at least 6 inches under wood siding and 4 inches under brick veneer.

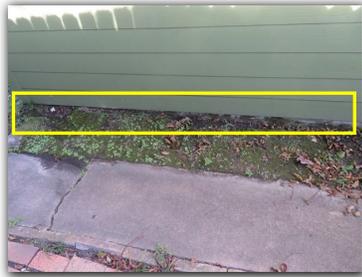
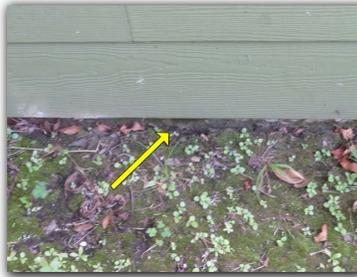
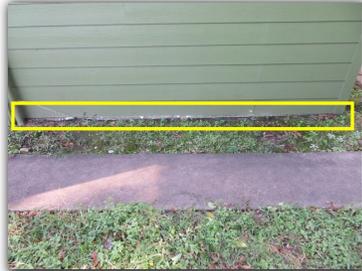
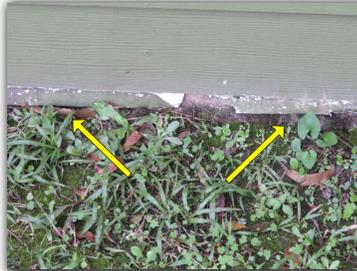
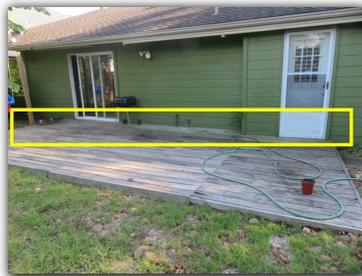
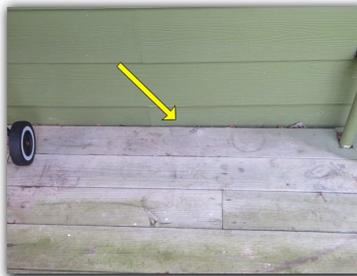
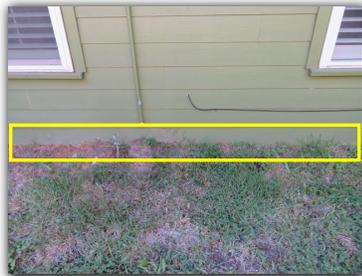
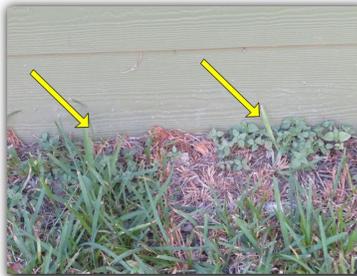
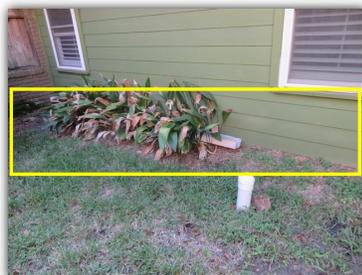
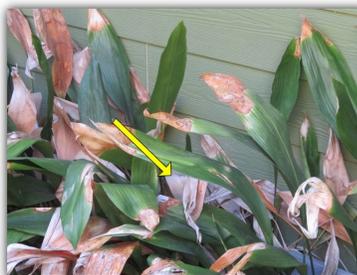
Foundation was not visible in multiple areas. Based on the cracks in the exterior walls, interior walls, ceilings and uneven floors, along with multiple out-of-square doors, it is the opinion of the inspector that the foundation is not performing as intended. See comments and photos in the following sections for details.

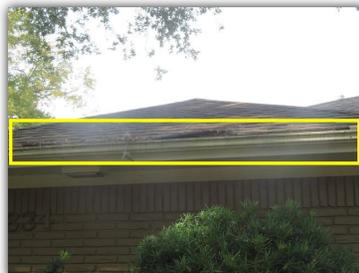
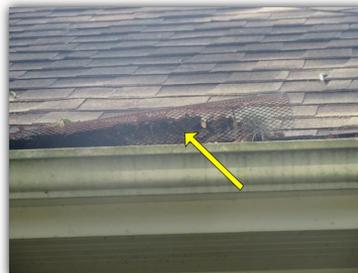
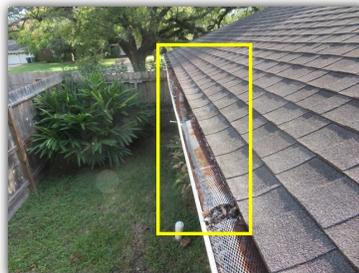
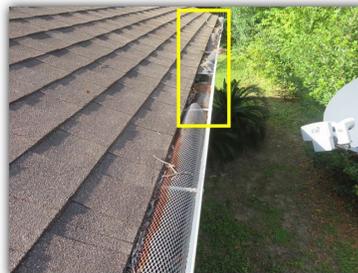
Leaf Guards were observed to be damaged and/or missing in multiple gutters.

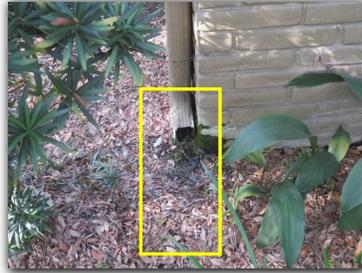
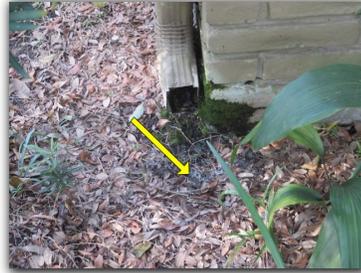
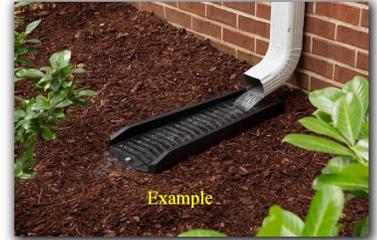
Splash Block was observed to be missing on the front of the property. Splash Block can be added to prevent soil erosion. Storm water should flow away from the structure at the points of discharge, at least 3 feet away from the foundation.

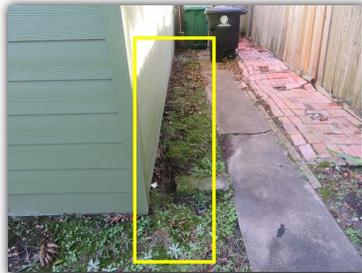
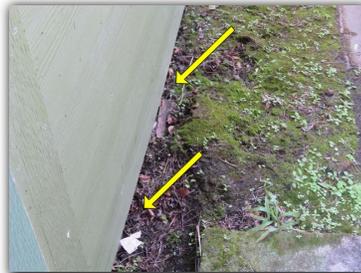
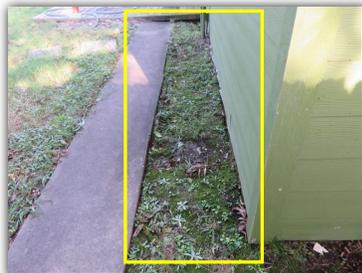
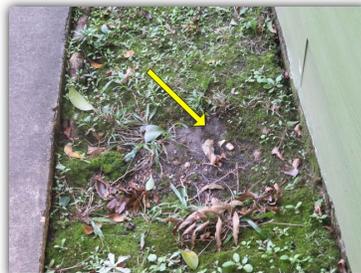
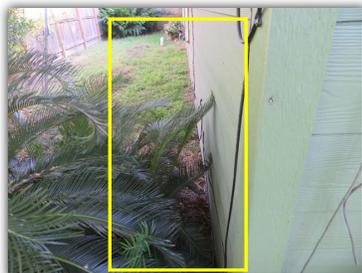
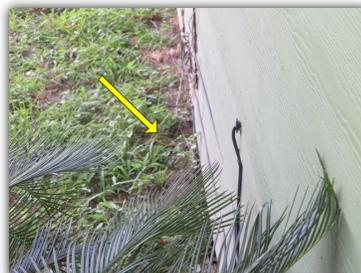
Areas of neutral and/or negative drainage that will route runoff from rain toward the foundation were observed on the property. The grading can be improved and/or French Drain installed to promote the flow of storm water away from the house. The ground should slope away from the house a minimum of 6 inches within the first 10 feet or to a swale if 10 feet is not available.

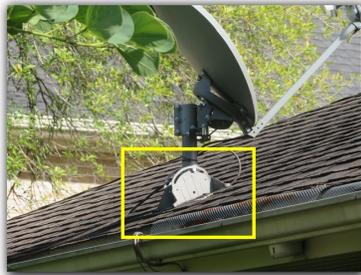
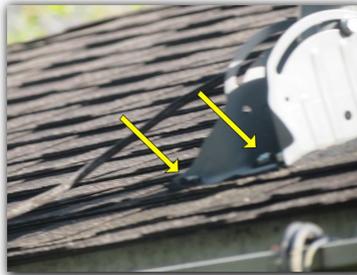
Dish mount fasteners were observed to be exposed on the roof and should be sealed to reduce risk the of water intrusion. All roof penetrations should be examined and sealed as needed.

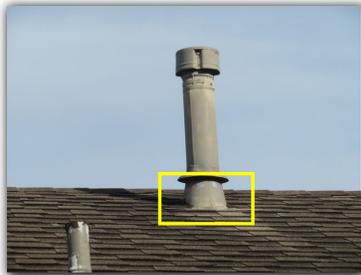
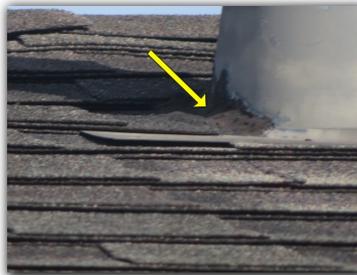
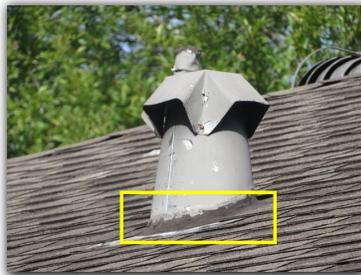
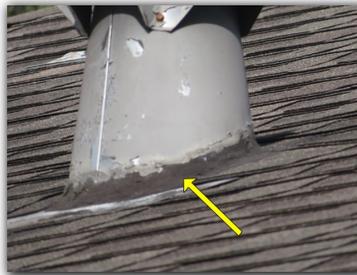
Evidence of prior repairs with sealant was observed on the roof vents. All repaired areas should be monitored on a continual basis and sealed as needed to reduce the risk of water intrusion.

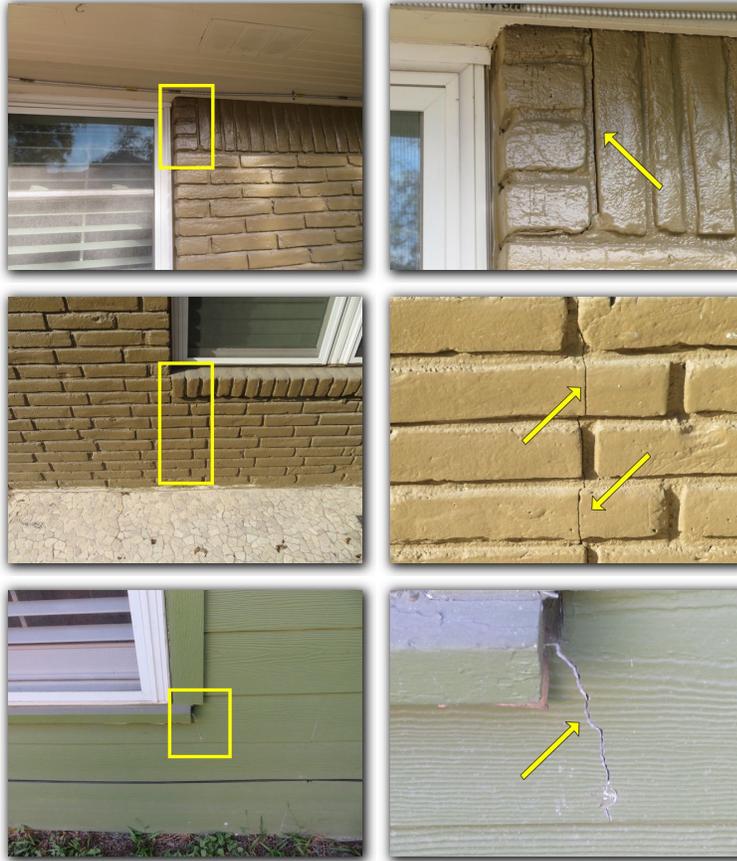
Typical cracks were observed on the walls of multiple rooms.

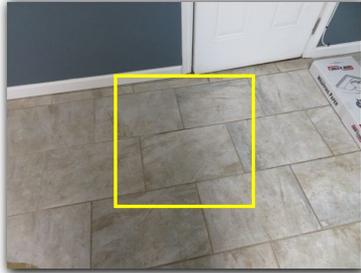
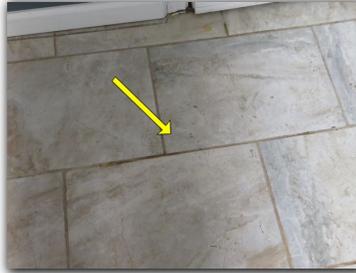
A tile was observed to be loose in the Foyer.

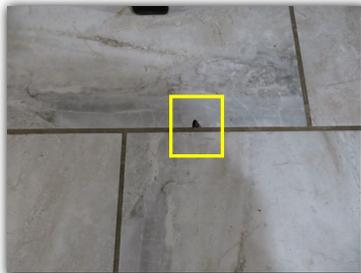
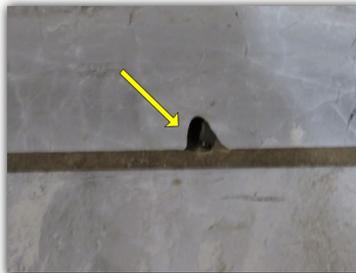
Damage was observed on the tile floor in the Kitchen.

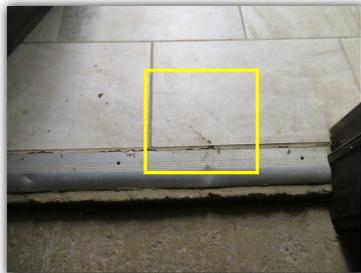
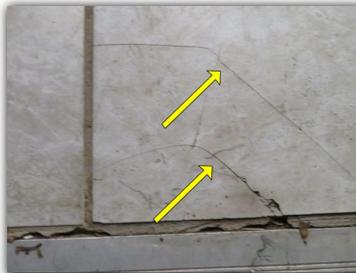
Cracks were observed on the tile floor in the Foyer.

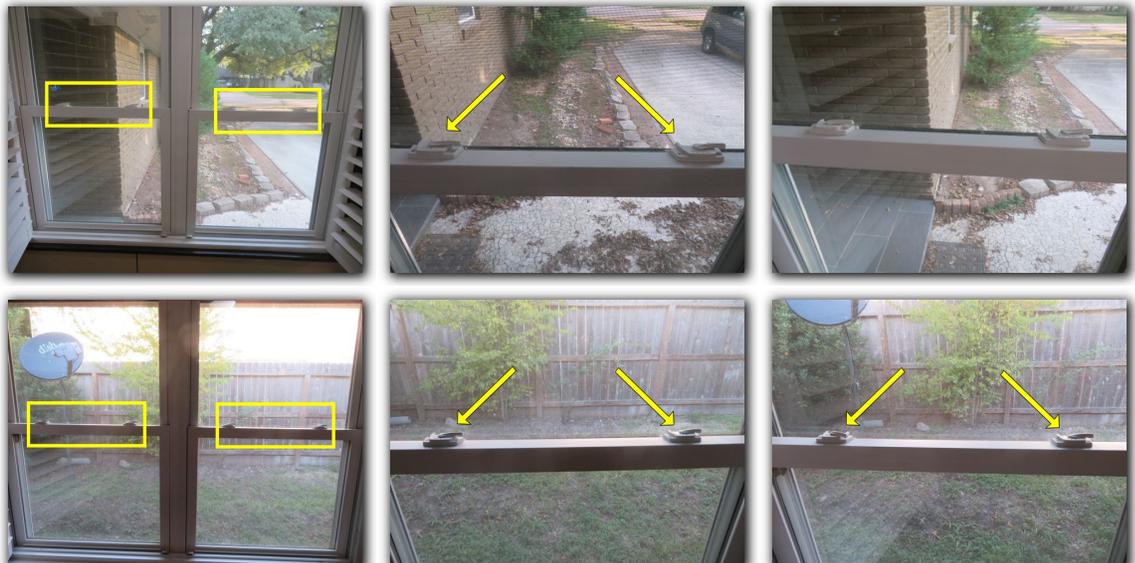
Windows did not latch or were difficult to latch when closed in multiple rooms. The window hardware should be adjusted for safety reasons and proper operation of the window.

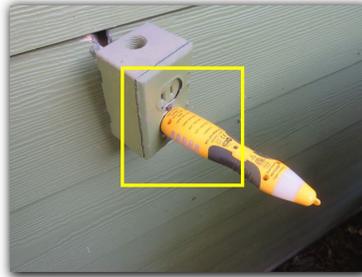
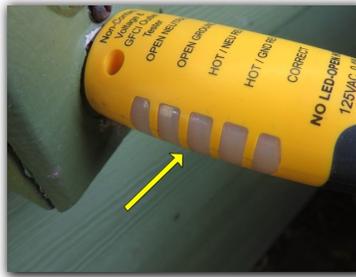
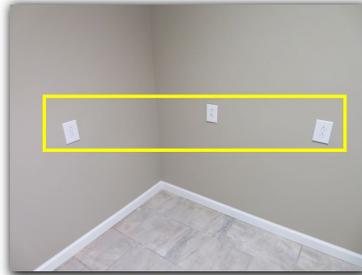
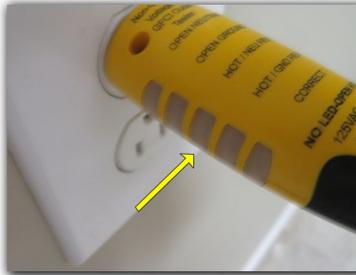
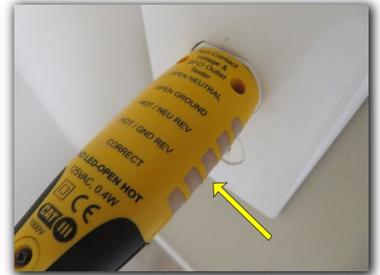
Multiple electrical receptacles/outlets were observed to be inoperative in the Exterior, and, Office. The circuit and/or outlet should be further evaluated, repaired and/or replaced as needed.

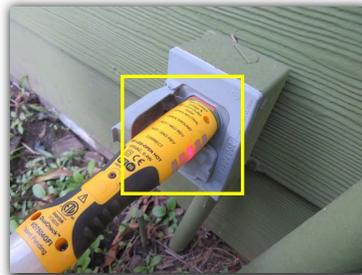
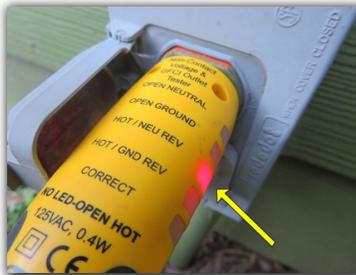
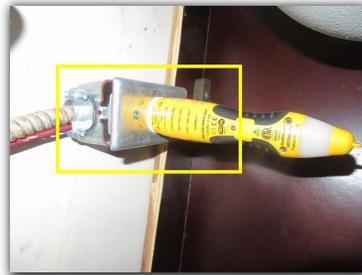
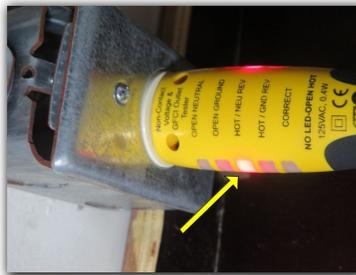
Reversed Polarity (hot and neutral conductors reversed) was observed in the electrical receptacle/outlet in the Exterior, and, Kitchen. This should be corrected for safety reasons.

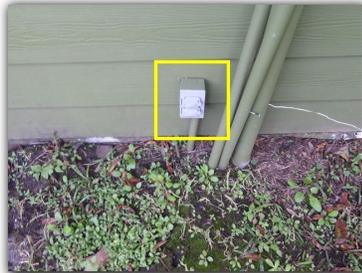
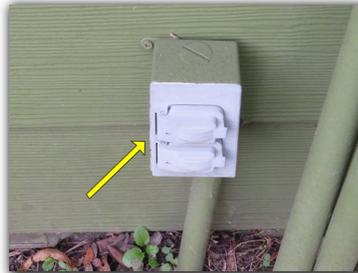
The outlets installed on the exterior were observed to be not compliant with the current electrical standards. Current electrical standards require for new construction and replacement outdoor outlet covers to be of the bubble cover type in all wet locations (being weatherproofed while outlet is in use). **This property predates the adoption of this standard; however, this should be corrected for safety reasons.**

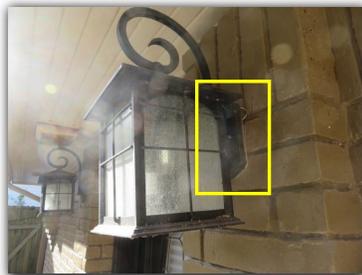
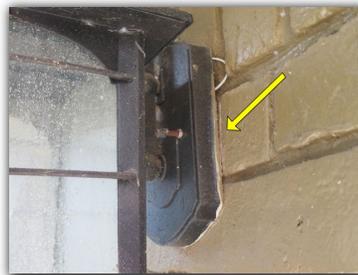
Light fixtures installed on the exterior walls were observed to be not caulked around the perimeter. Fixtures should be caulked where it contacts the exterior wall to reduce the risk of water intrusion.

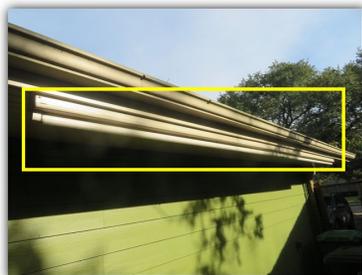
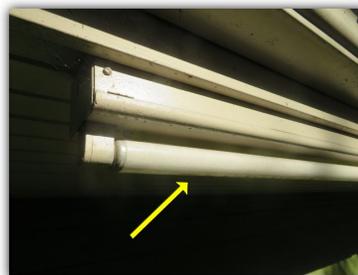
Multiple light fixtures installed on the soffit's in the exterior of the property were observed to be inoperative and/or missing the fluorescent lamps and light covers. This should be further evaluated by a qualified professional.

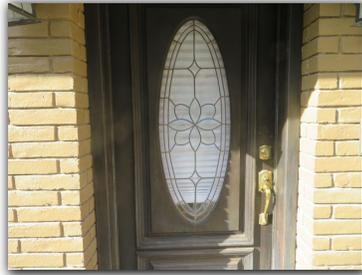
Doorbell was observed to be missing and can be installed.

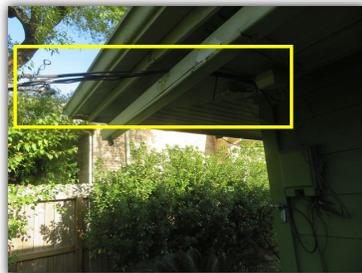
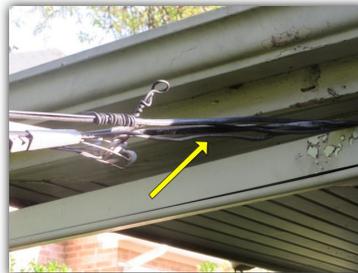
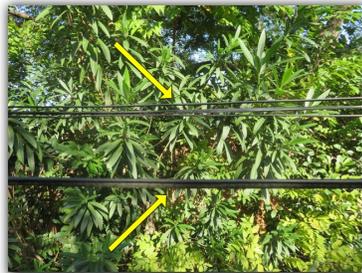
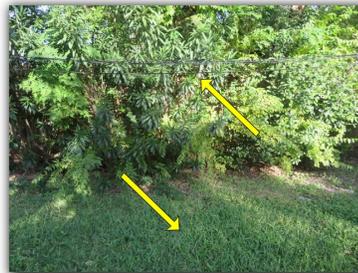
Multiple wires were observed in the back of the property having inadequate clearance from the ground. These wires should be further evaluated by a qualified professional to determine the purpose and safety.

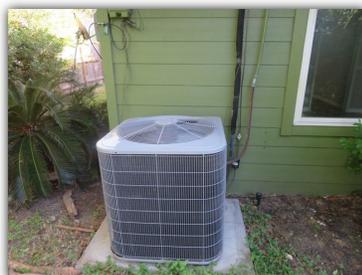
A receptacle was observed to be not installed for the AC compressor/condenser. Current building standards require that at least one 125 volt , 15 amp or 20 amp receptacle be installed within 25 feet of an HVAC unit that is located outside.

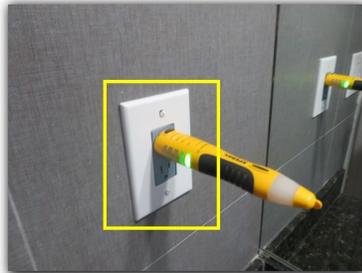
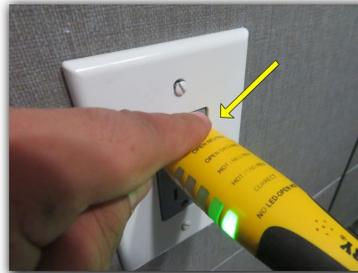
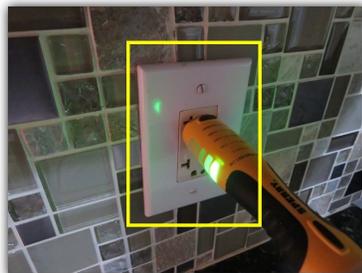
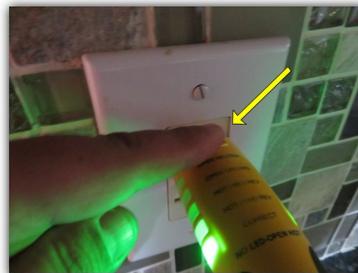
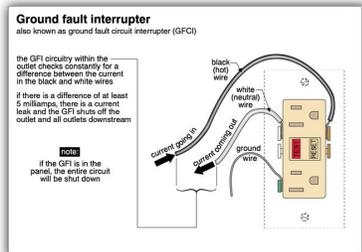
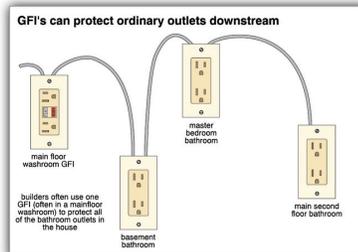
GFCI (Ground Fault Circuit Interrupter) protection was observed to be not installed to protect electrical circuits from ground faults. Current building standards require GFCI protection for 15 and 20 amp receptacles in kitchens, bathrooms, outdoor areas, unfinished basements and crawl spaces, garages, boathouses, laundry areas, and within 6' of sinks, bathtubs and shower stalls. GFCI protection is also required for certain appliances that have a history of being a shock hazard such as dishwashers and food waste disposers etc. GFCI devices can greatly reduce the risk of shock by immediately shutting off an electrical circuit when that circuit represents a shock hazard (i.e., a person comes in contact with a faulty appliance together with a grounded surface). GFCI devices can be installed as a circuit breaker in a panel or as a receptacle outlet. **This property predates the adoption of this standard; however, this should be corrected for safety reasons.**

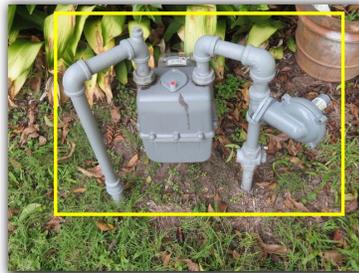
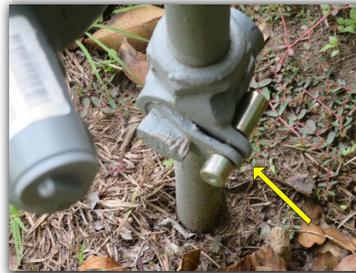
The heating equipment operation was not inspected because the gas supply to the property was turned off at the gas meter.

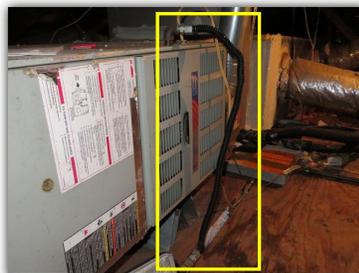
Sediment trap was observed to be not installed in the gas supply piping. The sediment trap serves as a collection chamber for sediment and moisture to reduce the risk of clogged gas valve(s) or burner(s). This should be corrected by a qualified professional for proper operation of the heating unit.

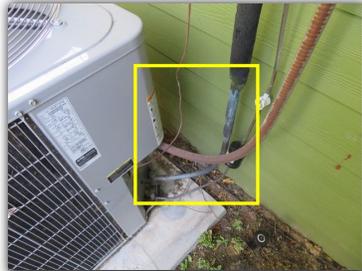
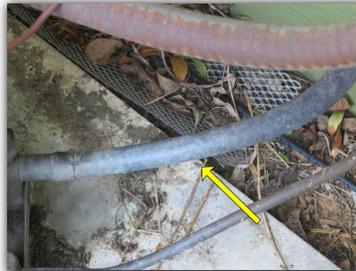
Insulation on the air-conditioning refrigerant (large, insulated) line was observed to be damaged at the compressor/condenser unit. It should be repaired and/or replaced by a qualified HVAC professional.

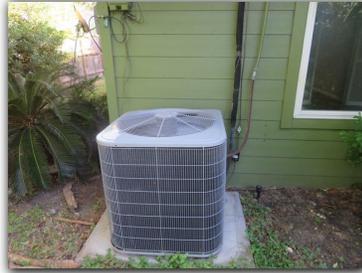
The compressor/condenser exterior service disconnect was observed to be not installed. Current building standards require a service disconnect should be installed that is readily accessible and within sight of the compressor/condenser unit.

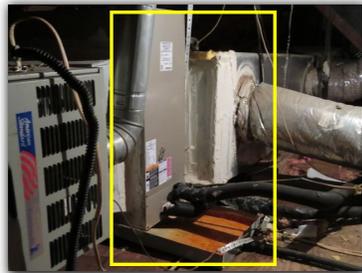
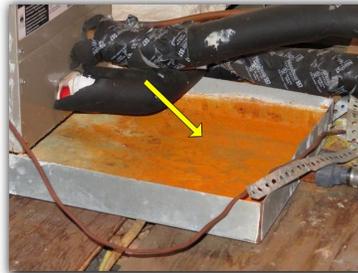
The secondary drain pan installed below the of the evaporator coil in the attic was observed to have rust stains. This area should be monitored for leaks. A new pan can be installed to reduce the risk or water intrusion.

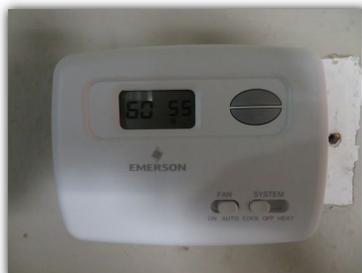
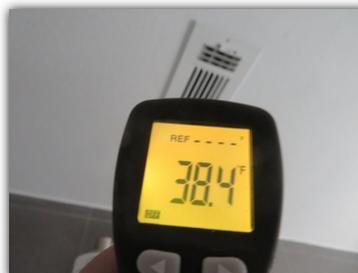
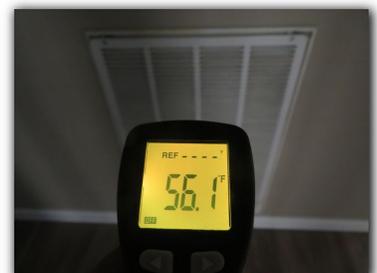
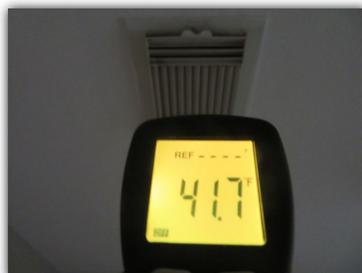
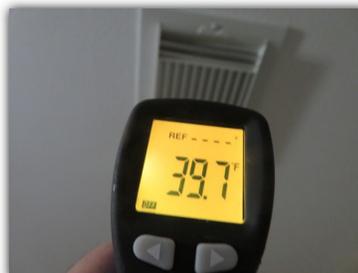
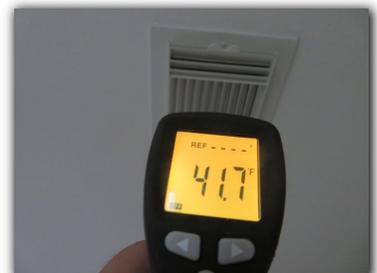
The cooling system was functional when tested and responded adequately to the thermostat. The difference in air temperature measured at supply and return registers was measured to be within the acceptable range of between 14 and 22 degrees F.

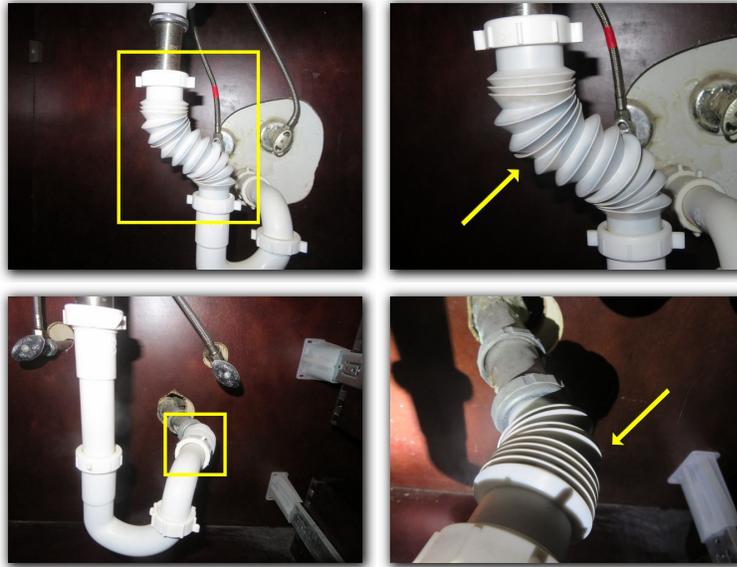
Flexible drain pipe was observed under the Master Bathroom, and, Guest Bathroom sink. It is not approved for installation by current plumbing standards, which require that any waste pipe fitting have a smooth interior surface that allows free flow of drain water and prevents waste buildup clogs.

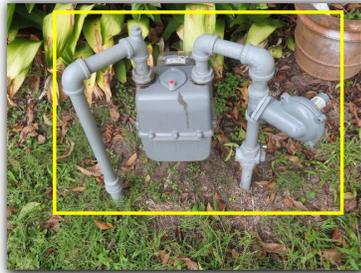
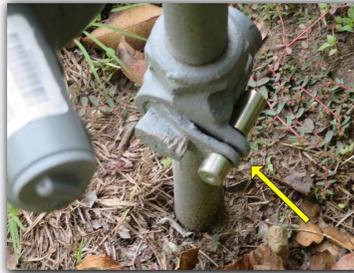
The water heater operation was not inspected because the gas supply to the property was turned off at the gas meter.

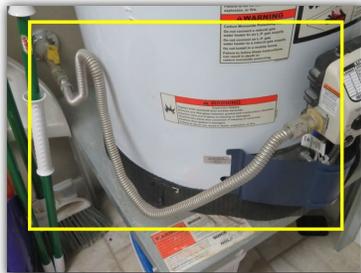
Sediment trap was observed to be not installed in the gas supply piping. The sediment trap serves as a collection chamber for sediment and moisture to reduce the risk of clogged gas valve(s) or burner(s). This should be corrected by a qualified professional for proper operation of the water heater.

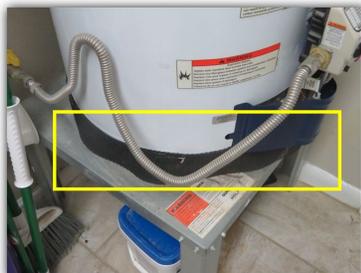
Drain pan and discharge drain pipe was observed to be not installed under the water heater. It collects water in the event the water heater leaks. This should be addressed by installation of a pan with a drain by a qualified plumber.

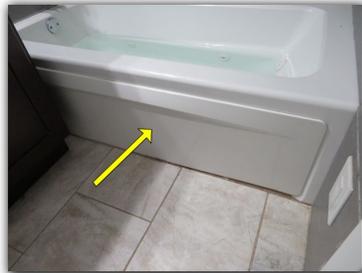
The access door for servicing the whirlpool was observed to be not installed. Current building standards require an access door large enough to remove and/or service the motor and/or pump shall be provided at the side or end of the whirlpool bathtub.

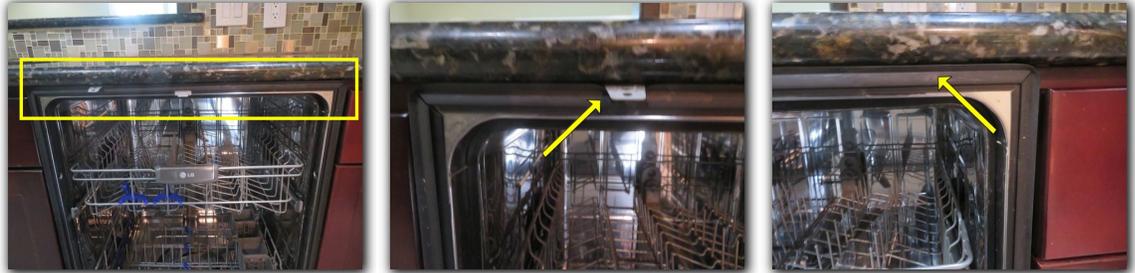
The dishwasher was observed to be not secured and properly mounted to the cabinet. The dishwasher should be level and fastened to the underside of the countertop using mounting brackets.

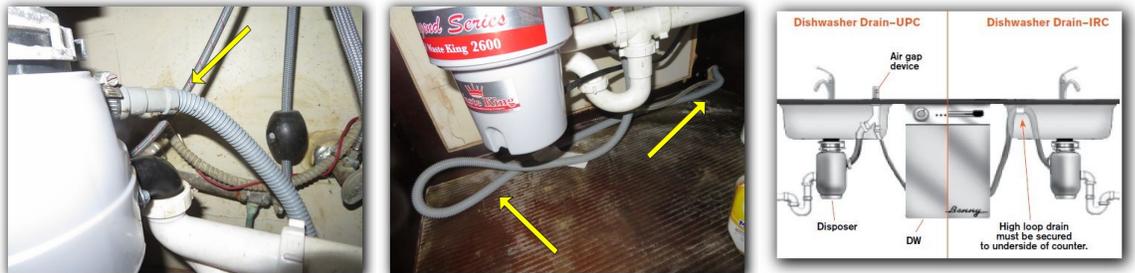
The dishwasher lacks an air gap device or a high loop. Air gaps are now standard equipment to assure a separation between supply and waste water. It is advised that one be installed or the waste pipe properly configured to prevent back flow of waste water into the dishwasher.

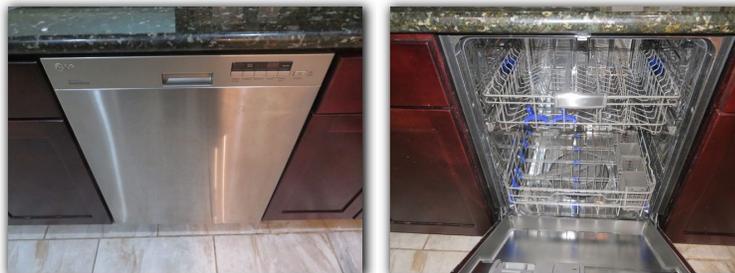
Additional dishwasher photos.

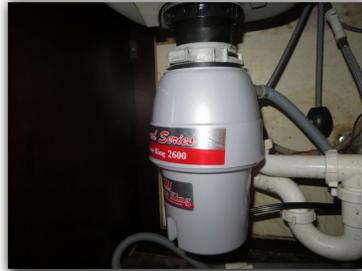
Additional food waste disposer pictures.

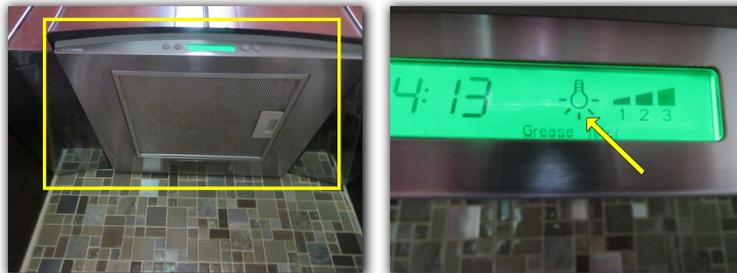
The range hood light was observed to be inoperative. This should be further evaluated, repaired and/or replaced for comfort reasons.

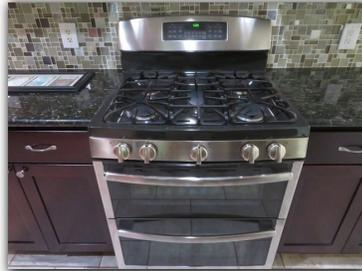
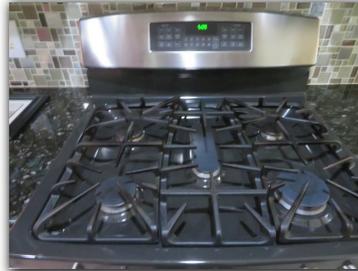
The Ranges, Cooktops and Ovens were not inspected because gas supply to the property was turned off.

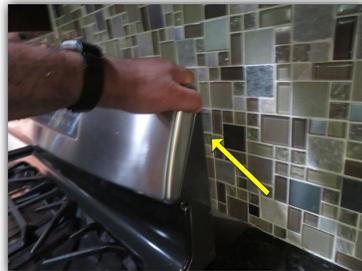
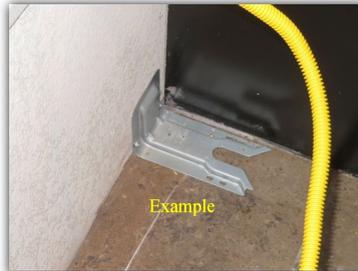
The cooking range was not secured to the wall or cabinet. An anti-tip bracket should be installed for safety reasons to avoid the cooking range from tipping over and causing injury.

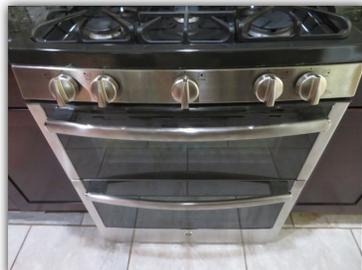
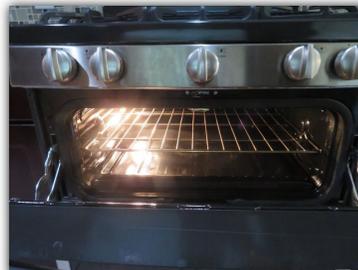
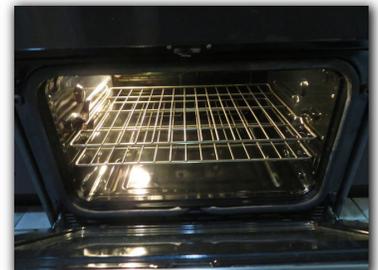
Additional range, cooktop and oven photos.
