# Axis Real Estate Inspections

## PROPERTY INSPECTION REPORT

**Concerning:** 1234 Happy Trail, Fun City, TX 77777  
(Address or Other Identification of Inspected Property)

**By:** Amandeep (Andy) Punia, Lic #22380 06/27/2017  
(Name and License Number of Inspector) (Date)

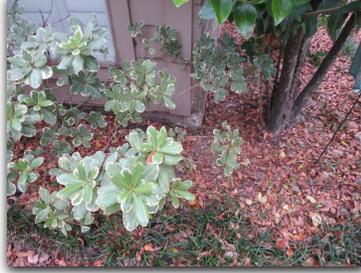
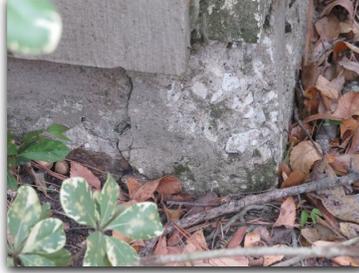
A corner pop was observed on the corner of the foundation. The rate of movement cannot be predicted during a one-time inspection. In the event the cracks and/or pops continue a structural specialist should be consulted to further evaluate this condition and the remedies available for correction.

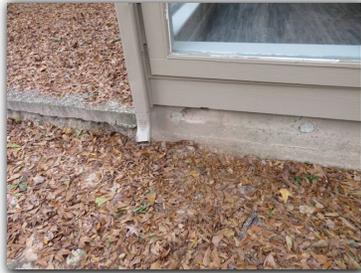
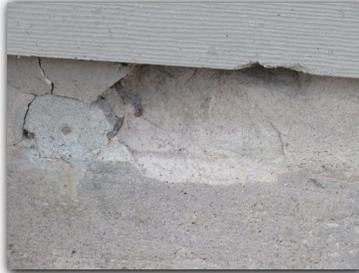
Spalling was observed on the foundation beam.

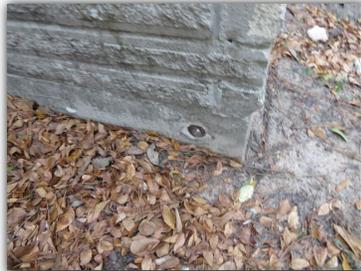
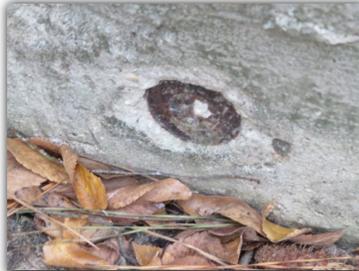
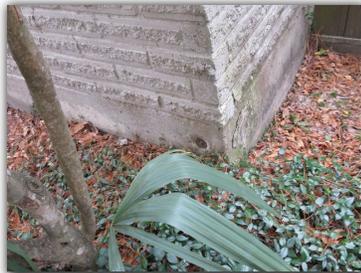
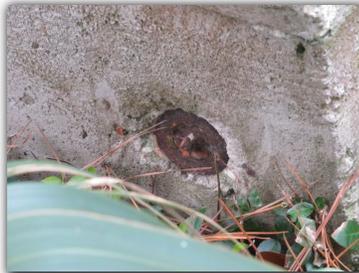
Post tension cable ends were observed to be exposed on the foundation beam. All exposed cable ends should be sealed to reduce the risk of corrosion and foundation damage.

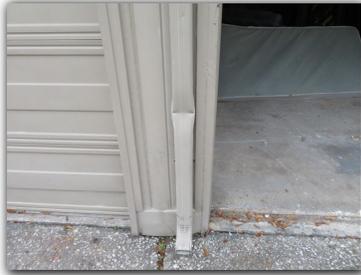
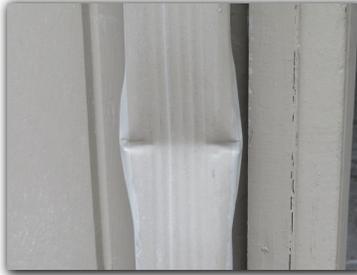
A downspout was observed to be damaged.

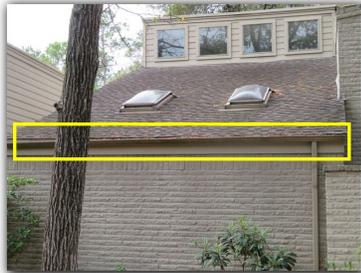
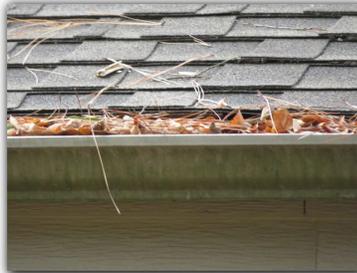
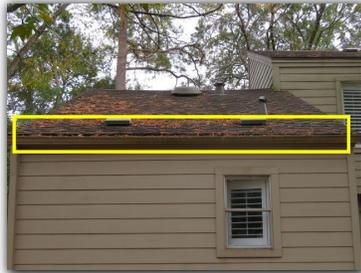
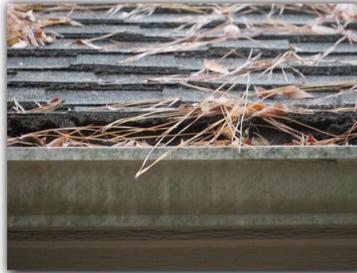
Debris was observed inside the gutters.. The debris should be cleared to allow for adequate drainage of rain water.

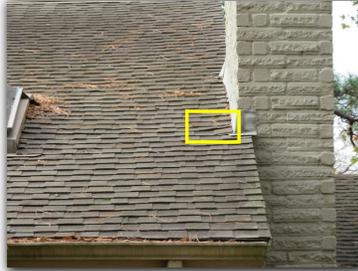
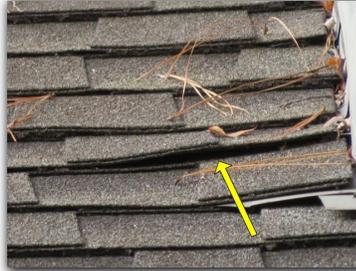
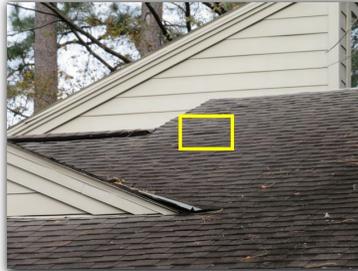
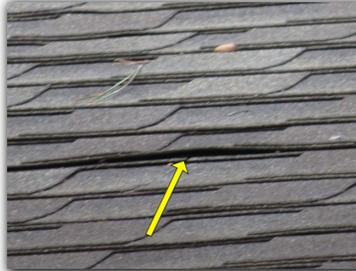
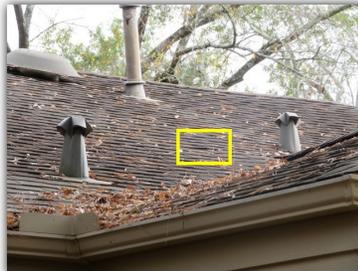
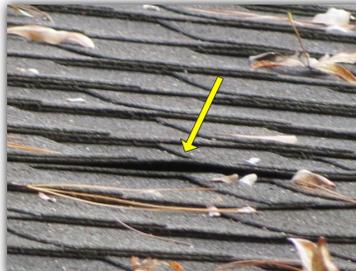
Multiple shingle uplifts were observed on the roof. All shingle uplifts and roof penetrations should be examined and sealed as necessary to reduce the risk of water intrusion.

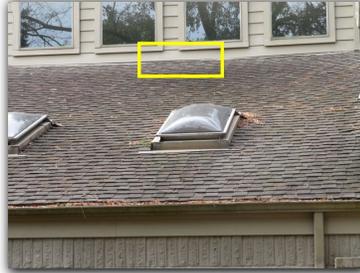
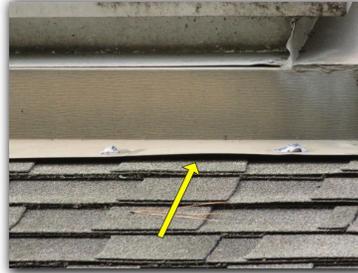
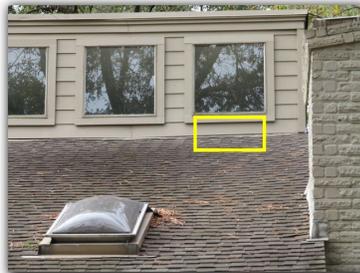
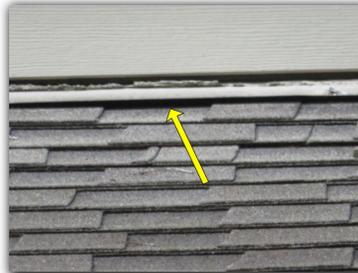
The wall flashing was observed to be loose with exposed nails. It should be secured and sealed to reduce the risk of water intrusion. All exposed flashing and roof penetrations should be examined and sealed as necessary.

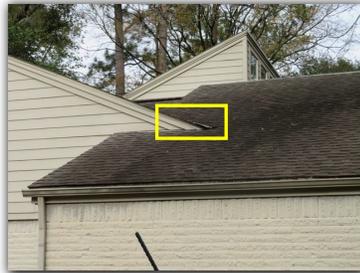
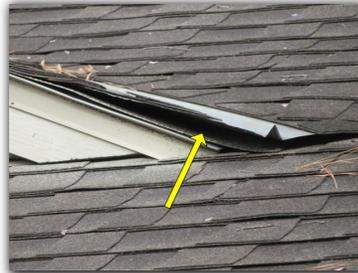
The valley flashing was observed to be loose. It should be secured and sealed to reduce the risk of water intrusion. All exposed flashing and roof penetrations should be examined and sealed as necessary.

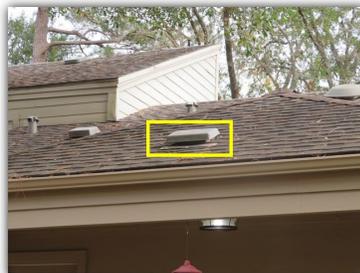
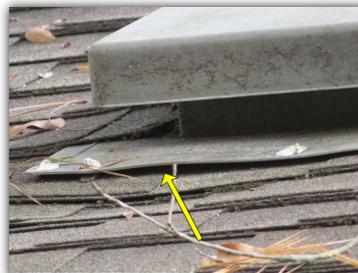
The vent flashing was observed to be loose and should be secured to reduce the risk of water intrusion.

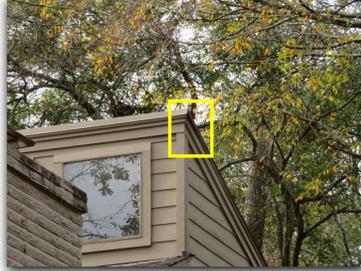
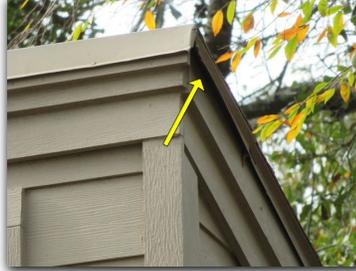
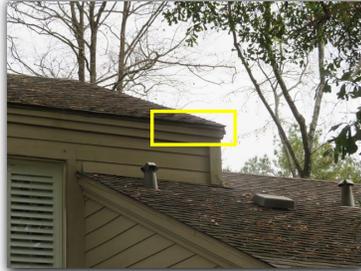
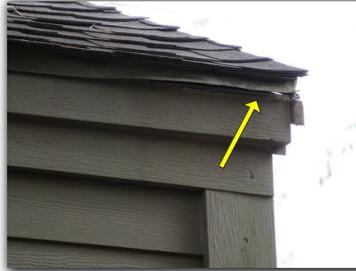
Drip edge flashing was observed to be loose and/or damaged. It should be re-secured and/or repaired to reduce the risk of water intrusion.

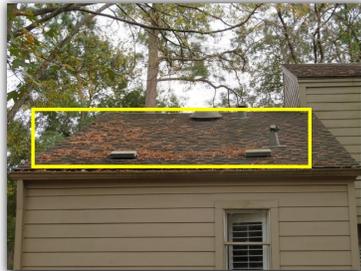
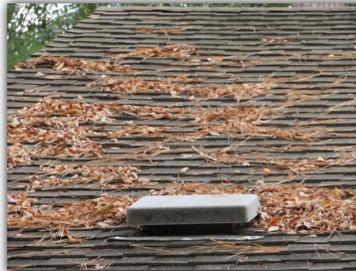
Debris was observed on the roof and can be removed to prevent future damage.

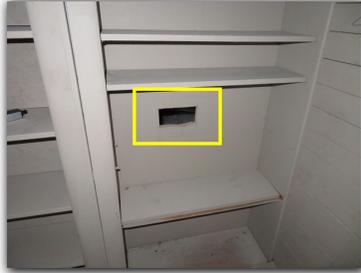
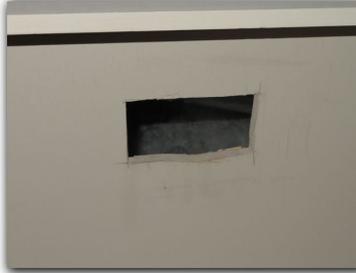
An opening was observed in the wall between the attic and the home. This can be sealed to increase the efficiency of heating and cooling system.

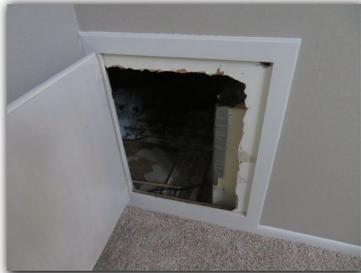
The attic access doors were observed to be not insulated. It can be weather stripped and/or insulation installed to increase the efficiency of the heating or cooling system.

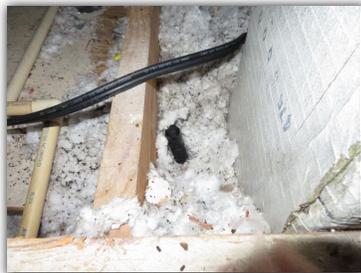
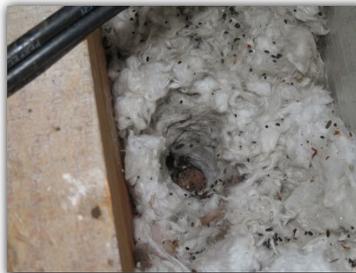
Insulation was observed to be Up to 4 inches thick on the attic floor. Current building standards recommend 13 - 14 inches insulation thickness for most southern climates. This can be improved or additional insulation can be installed as needed.

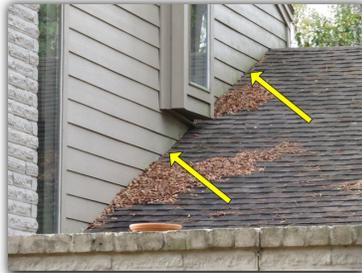
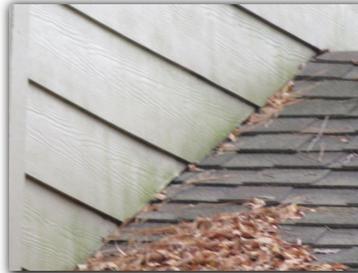
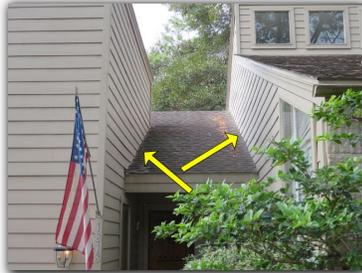
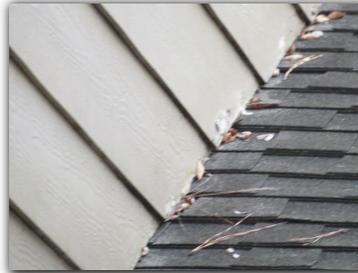
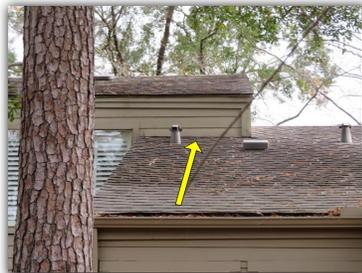
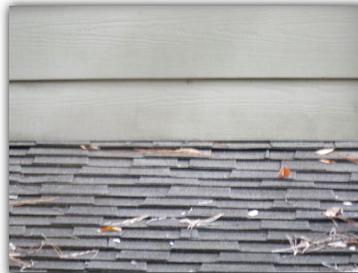
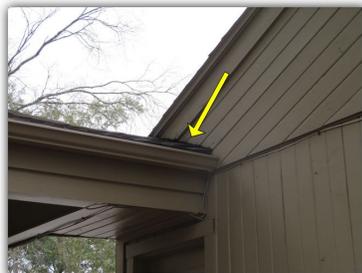
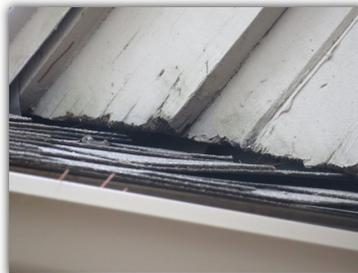
Inadequate clearance was observed between the wood siding and roof of the house. Current building standards recommend a minimum of 2 inches of clearance in the area where siding is in close proximity to the roof. This is a potential area for wood rot due to exposure to rain water.

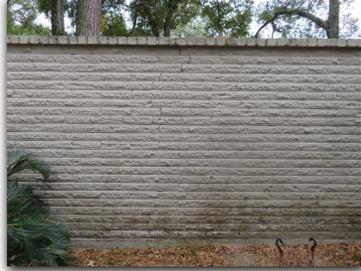
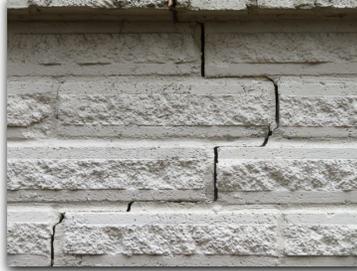
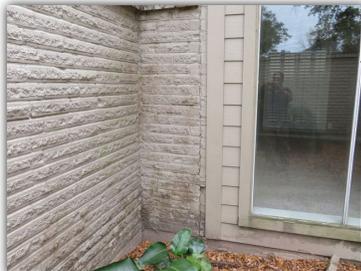
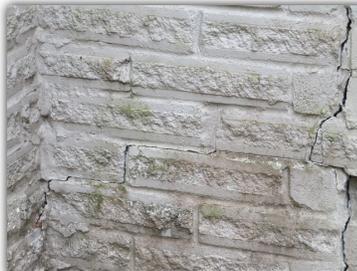
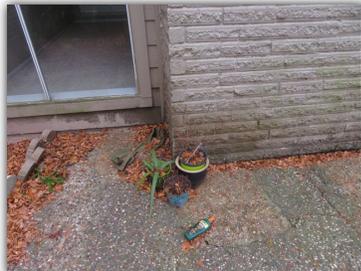
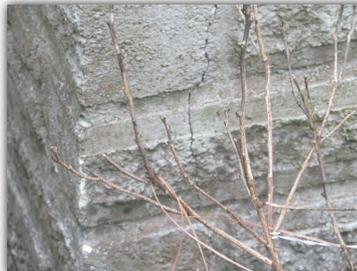
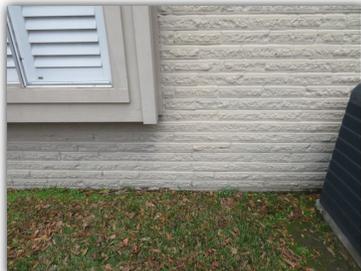
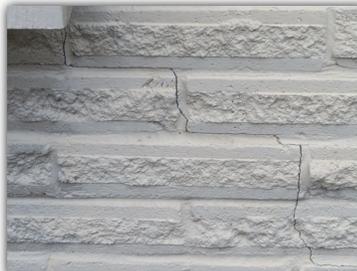
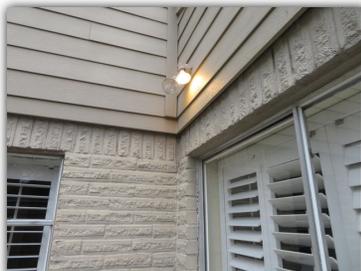
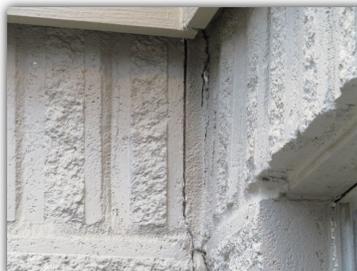
Typical cracks were observed on the exterior walls of the property. This area should be monitored. The rate of movement cannot be predicted during a one-time inspection. In the event the cracks continue a structural specialist should be consulted to further evaluate this condition and the remedies available for correction.

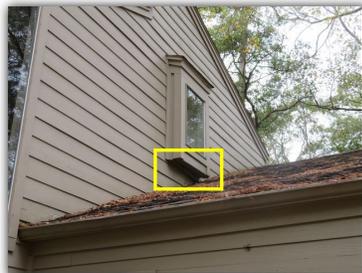
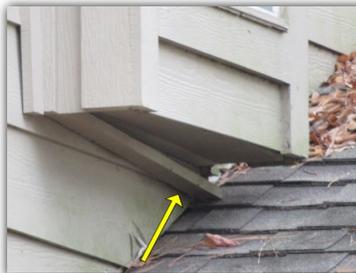
A trim board was observed to be loose on the right side of the property.

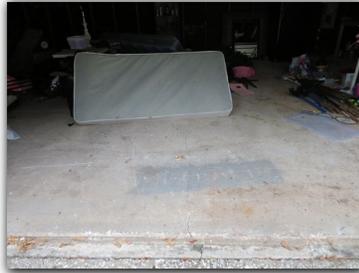
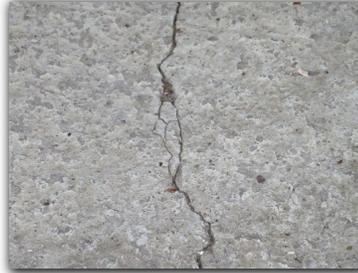
Typical cracks were observed in the Garage floor. This condition is very common and is not a structural concern.

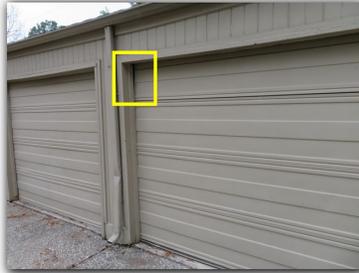
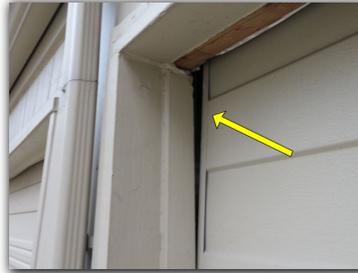
The roll up garage door was observed to be out-of-square in the door frame. This can be improved to establish a proper seal between the garage door and walls.

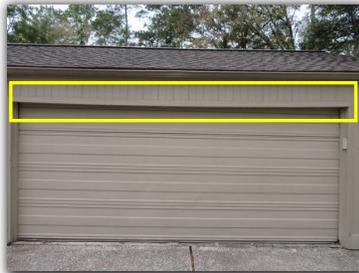
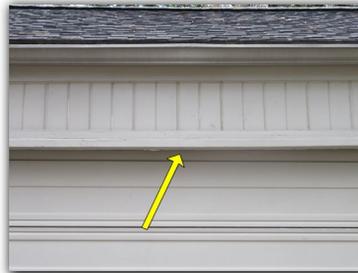
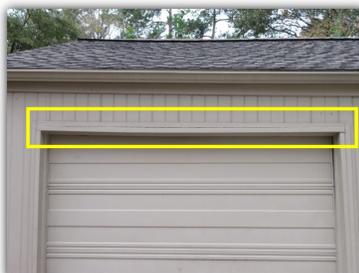
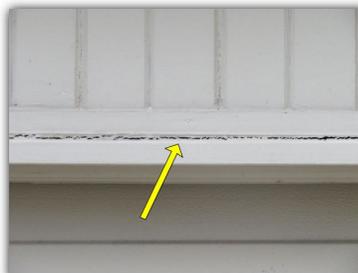
The roll-up garage door frame was observed to have a sag and separation.

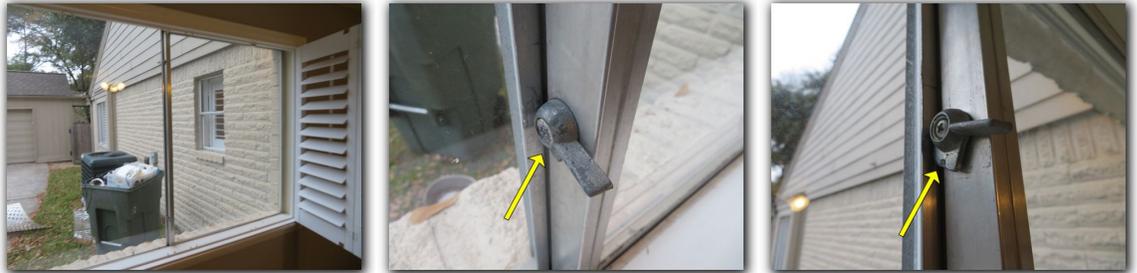
A window did not latch when closed in Bedroom 2. The window hardware should be adjusted for safety reasons and proper operation of the window.

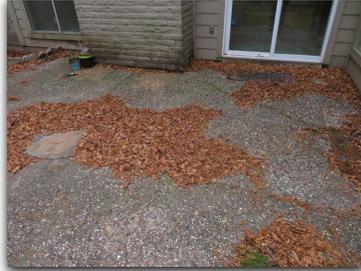
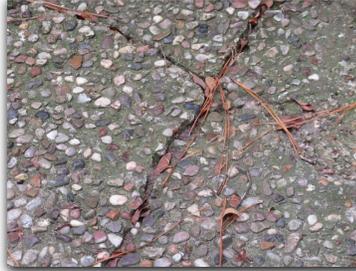
Cracks were observed in the patio floor.

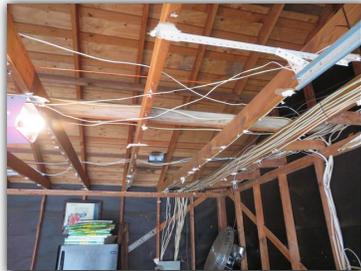
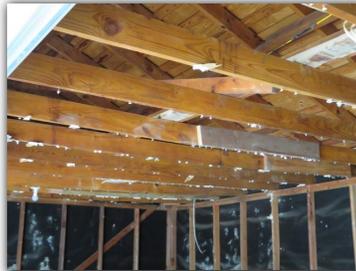
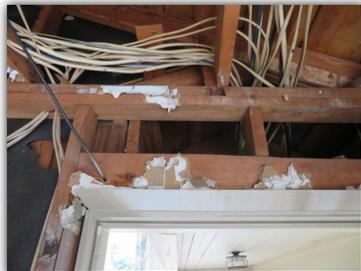
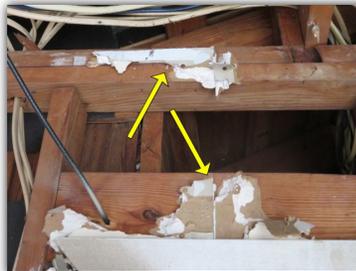
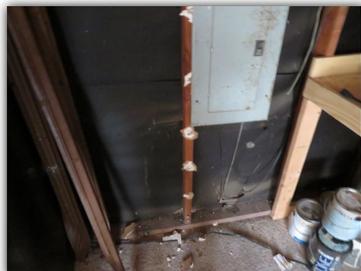
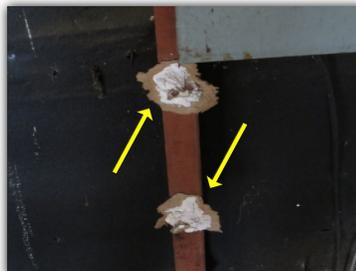
Incomplete ceiling and wall repairs were observed in the Garage.

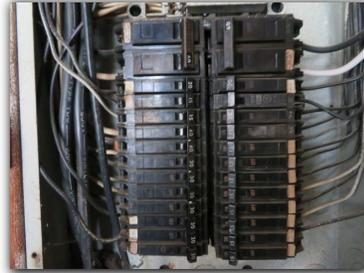
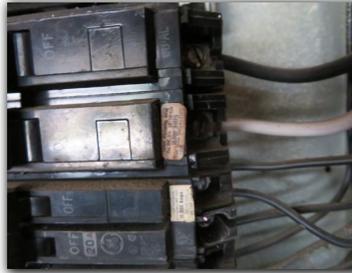
Multiple white (neutral) wires were observed to be used as a hot wires in the electrical panel. These wires should be marked with black or red colored tape for proper identification and safety reasons.

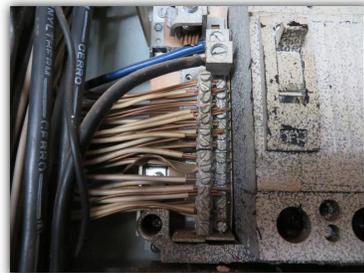
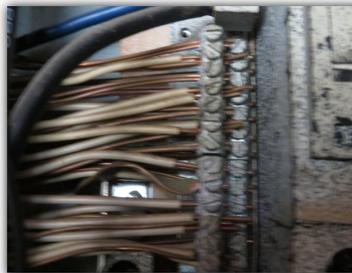
Neutral and Ground wires were observed to be double tapped under one lug. Current electrical standards require that neutral wires cannot be double tapped and a neutral and a ground wire cannot share one lug. This should be corrected for safety reasons.

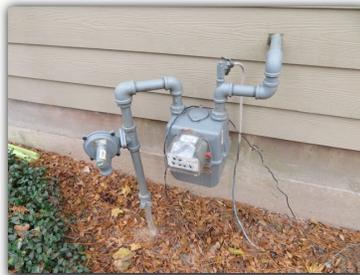
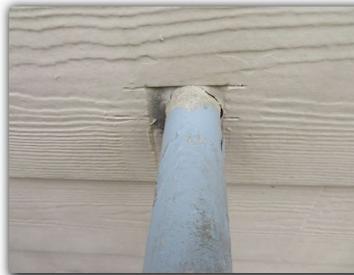
Gas and water pipes on the property were observed to be not bonded to the electrical system. Current building standards require that the gas and water pipes should be bonded to electrical system. This condition should be corrected by a qualified professional for safety reasons.

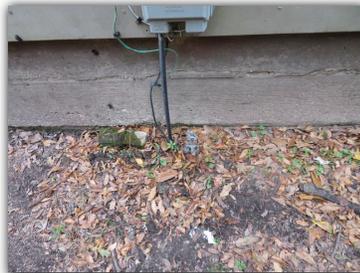
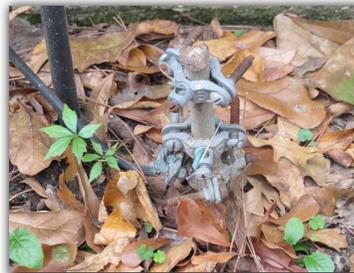
Only one grounding rod (grounding electrode ) was observed on the property. Current building standards require installation of two grounding electrodes. The presence of a proper grounding electrode system should be verified or a proper grounding electrode system should be installed for safety. **This house predates the adoption of this standard; however, this should be corrected for safety reasons.**

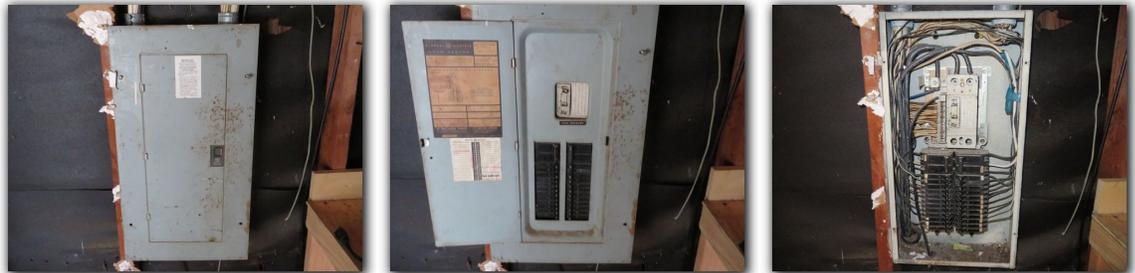
Additional service entrance and panel photos.

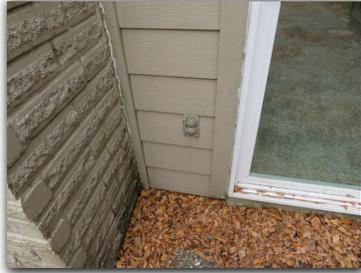
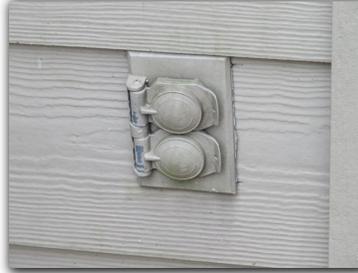
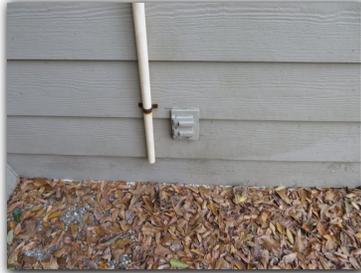
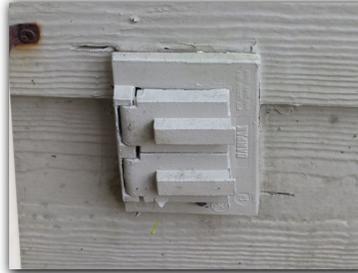
The outlets installed on the exterior were observed to be not compliant with the current electrical standards. Current electrical standards require for new construction and replacement outdoor outlet covers to be of the bubble cover type in all wet locations (being weatherproofed while outlet is in use). **This house predates the adoption of this standard; however, this should be corrected for safety reasons.**

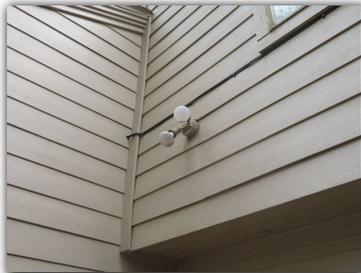
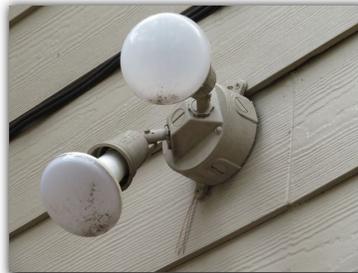
Light fixtures installed on the exterior walls were observed to be not caulked around the perimeter. Fixtures should be caulked where it contacts the exterior wall to reduce the risk of water intrusion.

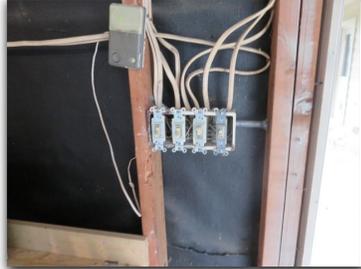
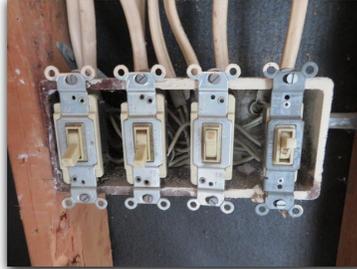
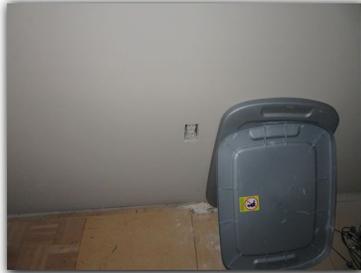
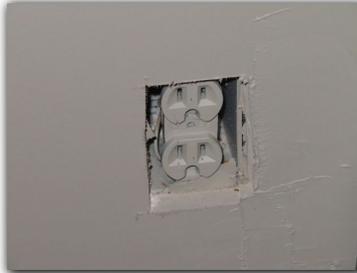
Cover plates were observed to be missing in Garage, and, Second Floor Bedroom Closet. All missing cover plates should be installed for safety reasons.

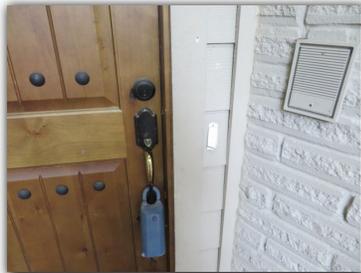
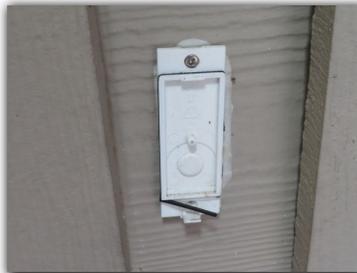
Doorbell was observed to be missing and can be installed.

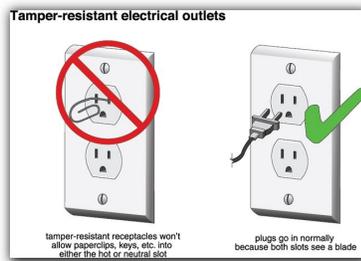
Tamper resistant receptacles were observed to be missing on the property. Current electrical standards require tamper resistant receptacles in new and renovated homes because it is the most effective way to prevent injuries associated with electrical receptacles, especially to children. **This property predates the adoption of this standard; however, this should be corrected for safety reasons.**

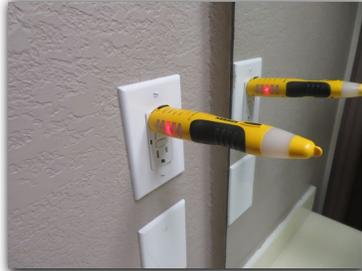
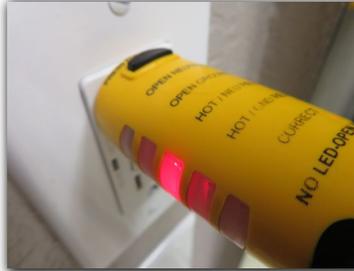
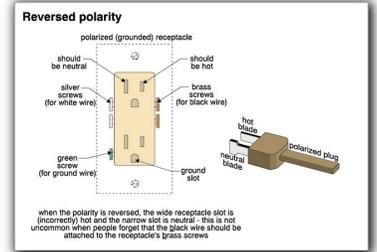
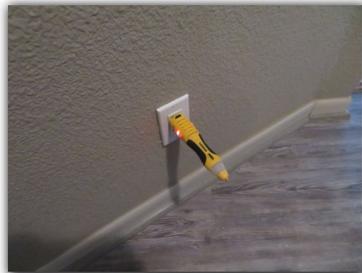
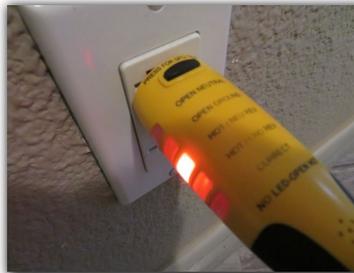
Reversed Polarity (hot and neutral conductors reversed) was observed in the electrical receptacle/outlet in the Foyer, and, Jack & Jill Bathroom. This should be corrected for safety reasons.

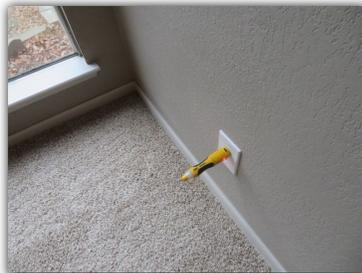
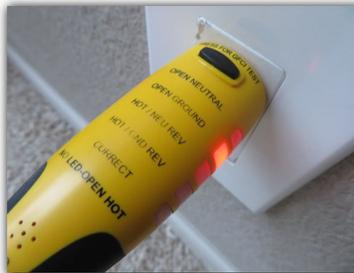
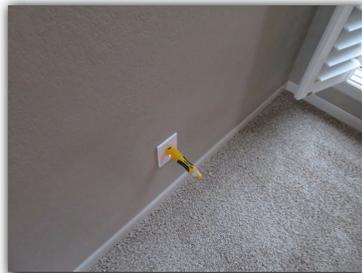
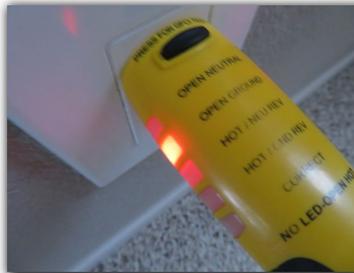
Several outlets were observed to have open ground in the Drawing Room. These outlets and the circuits should be evaluated and corrected by a qualified professional for safety reasons.

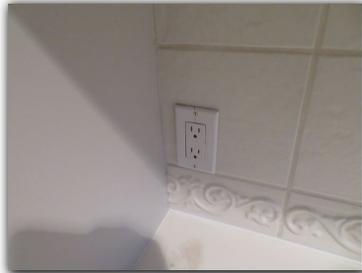
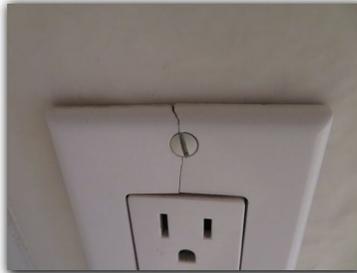
A cover plate was observed to be cracked in the Laundry Room.

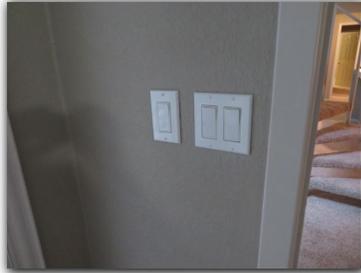
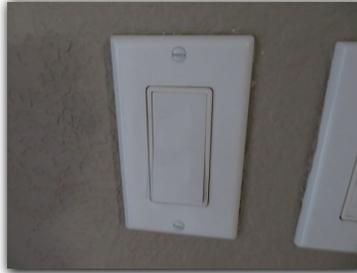
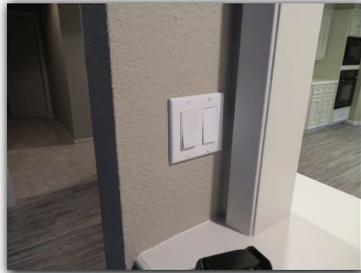
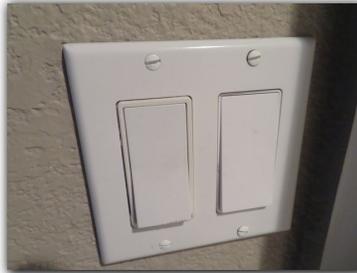
A mystery switch was observed in the Master Bedroom, Master Bathroom, and, Drawing Room. The switch function should be verified with the owner before closing.

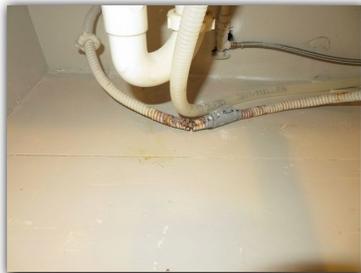
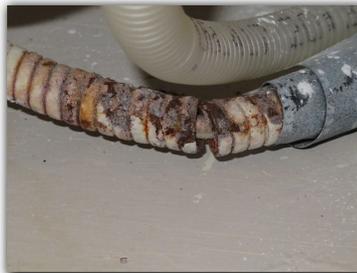
The conduit for the food waste disposer wire was observed to be rusted, cracked and/or damaged.

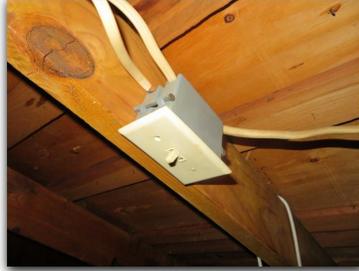
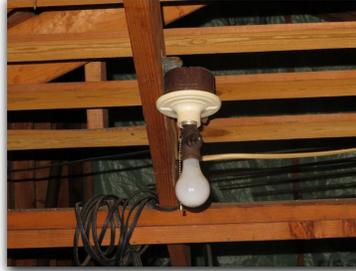
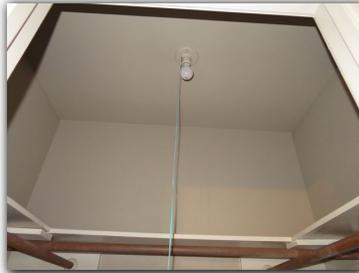
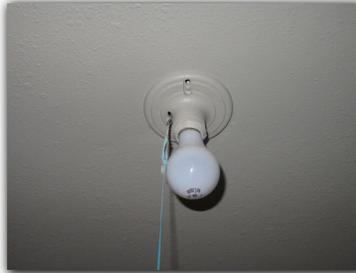
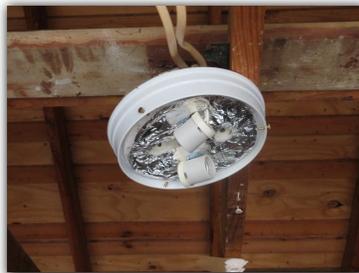
A light fixture was observed to be inoperative in the Attic, Bathroom 2 Closet, and, Garage. This should be further evaluated, repaired and all burned out light bulbs replaced.

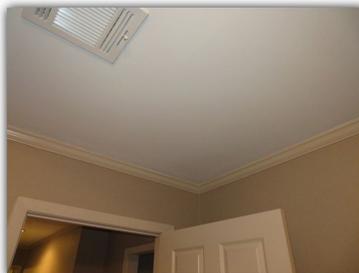
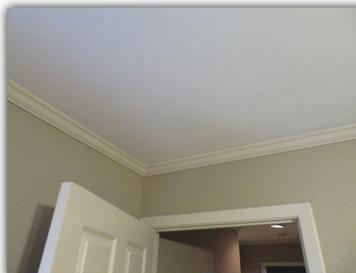
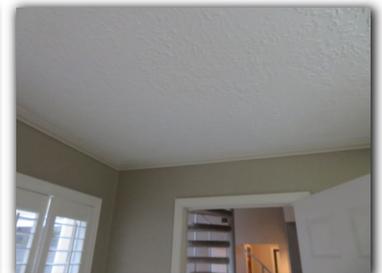
Smoke and Carbon Monoxide detector was observed to be missing in the Bedrooms.

Current building standards require:

- (a) a working smoke detector inside and outside each sleeping area, on every level, habitable attic, and basement
- (b) a working carbon monoxide detector installed in a central location outside each sleeping area and on every level

These items should be installed, repaired and/or replaced for safety reasons.

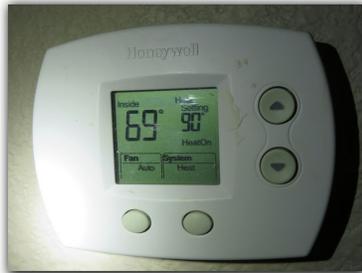
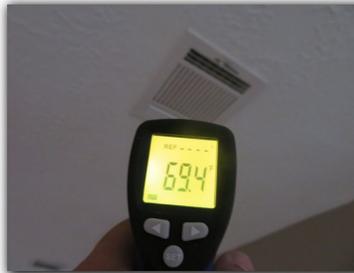
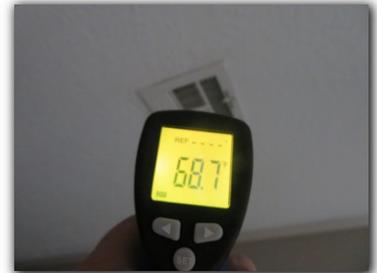
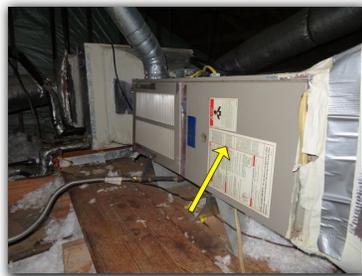
The furnace for the right side of the property was observed to be inoperative at the time of the inspection. This should be further evaluated, repaired and/or replaced as needed by qualified professional.

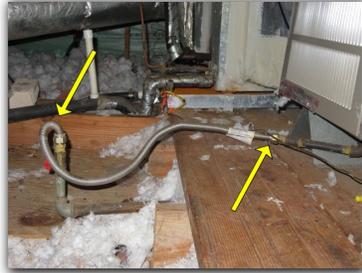
Sediment trap was observed to be not installed in the gas supply piping. The sediment trap serves as a collection chamber for sediment and moisture to reduce the risk of clogged gas valve(s) or burner(s). This should be corrected by a qualified professional for proper operation of the heating unit.

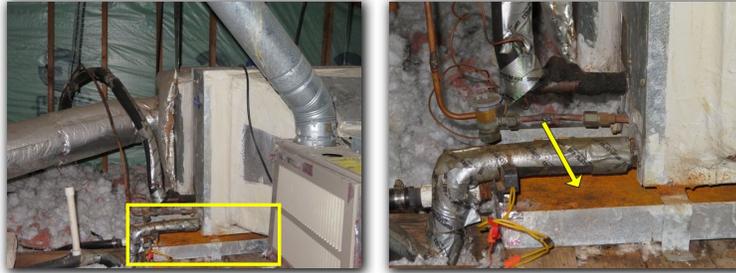
The secondary drain pan installed below the of the evaporator coil in the attic was observed to have rust stains.This area should be monitored for leaks. A new pan can be installed to reduce the risk or water intrusion.

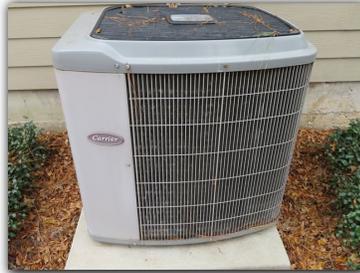
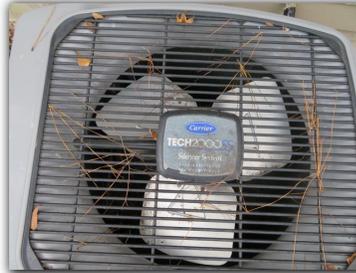
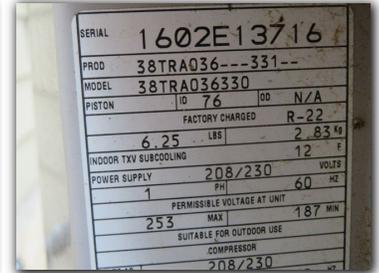
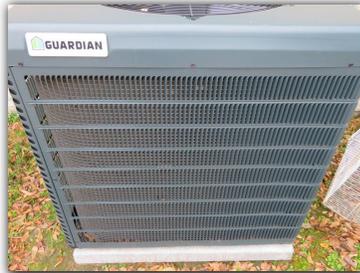
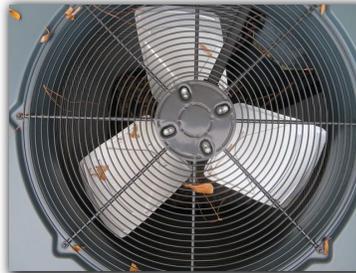
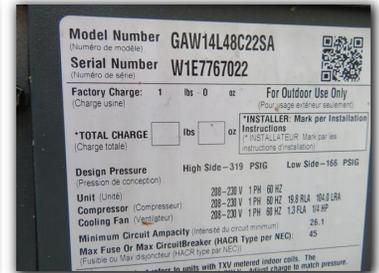
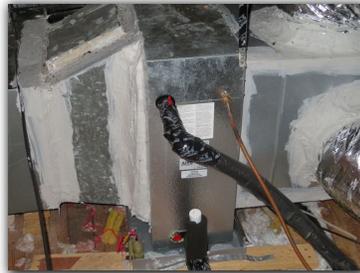
Additional cooling equipment photos.

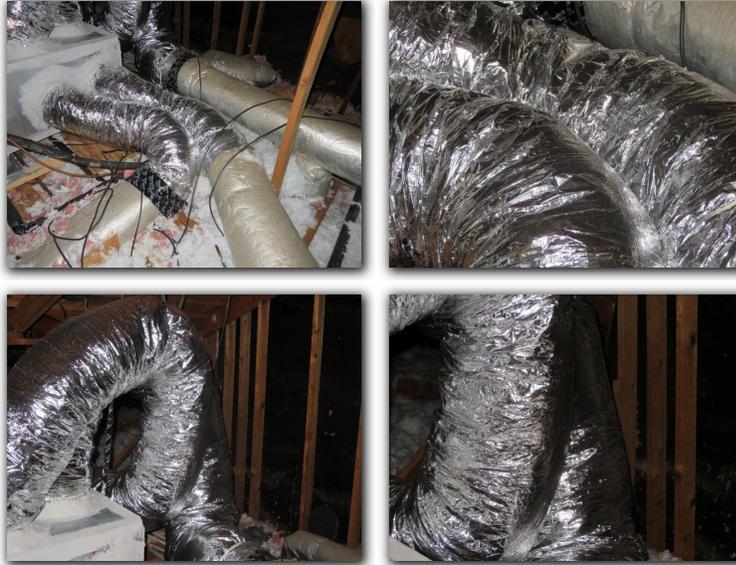
Supply air ductwork has ducts in contact with each other in the attic. Ideally there should be at least a 1-inch separation or a moisture barrier between the ducts to prevent damage from condensation and rot.

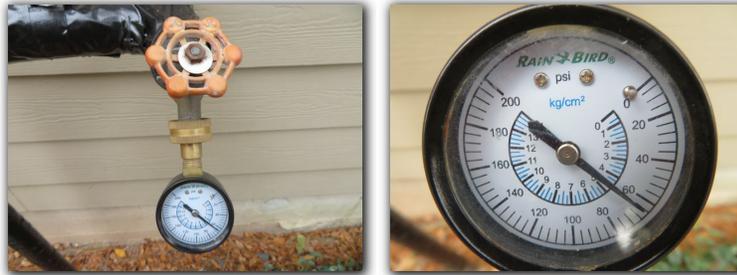
*Static water pressure reading:* 60 - 65 PSI

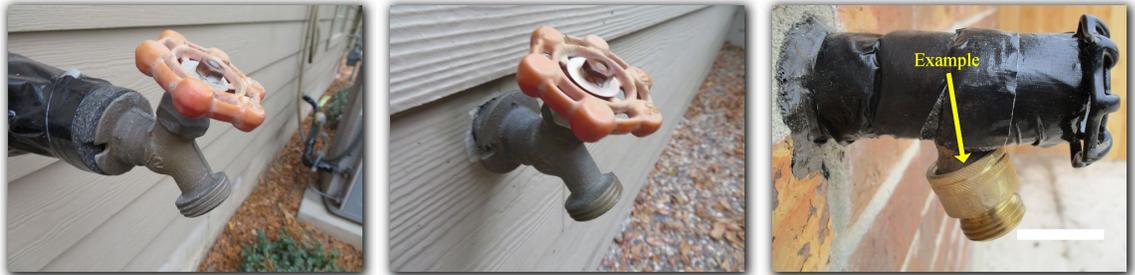
Anti-siphon device was missing on the hose bibs. It is recommended that an anti-siphon device be added to the hose bib(s) to prevent cross contamination of water system in the event of pressure drop in the main water supply.

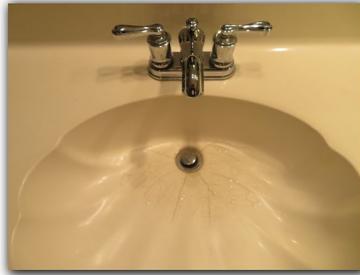
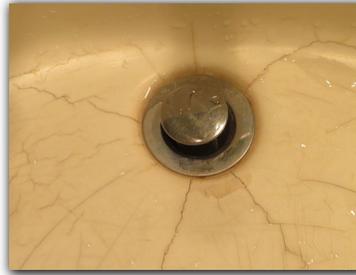
Water pressure/flow was observed to be low in Jack & Jill Bathroom sinks. This can be further evaluated.

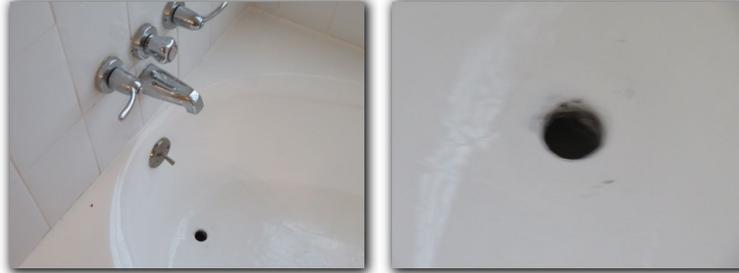
The drain stopper was observed to be missing in the Master Bathroom tub.

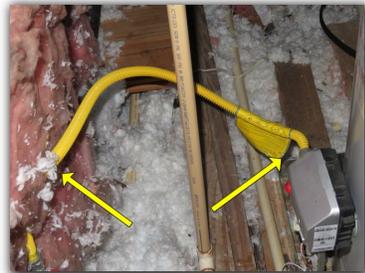
Sediment trap was observed to be not installed in the gas supply piping. The sediment trap serves as a collection chamber for sediment and moisture to reduce the risk of clogged gas valve(s) or burner(s). This should be corrected by a qualified professional for proper operation of the water heater.

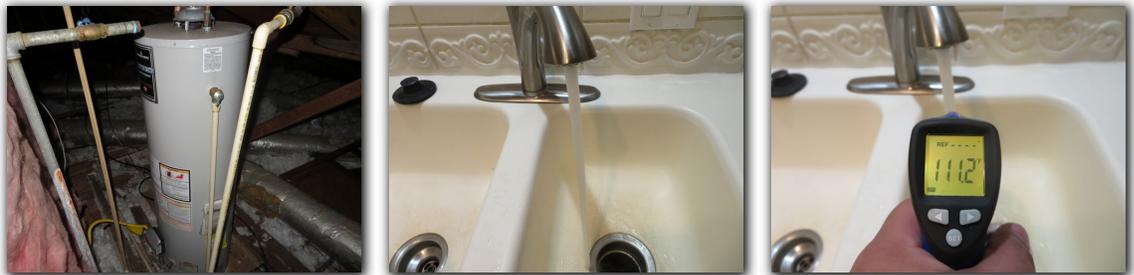
Additional water heater photos.

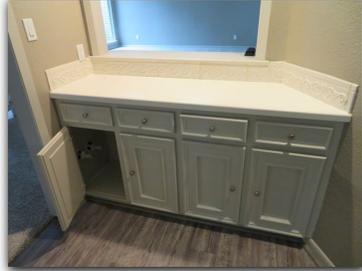
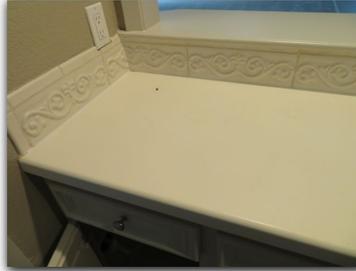
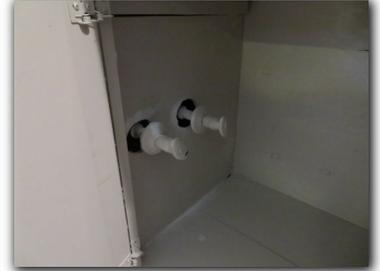
Piping was observed in the cabinet under the bar.

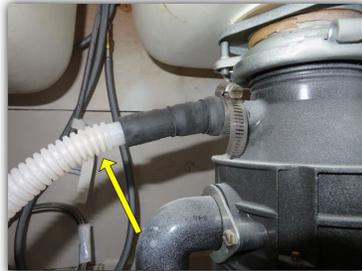
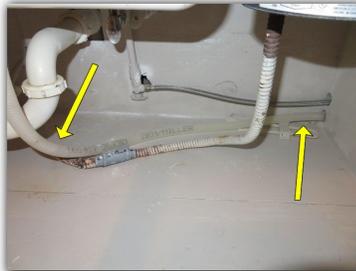
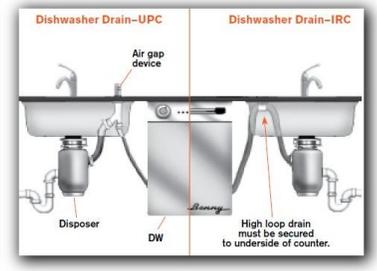
The dishwasher lacks an air gap device or a high loop. Air gaps are now standard equipment to assure a separation between supply and waste water. It is advised that one be installed or the waste pipe properly configured to prevent back flow of waste water into the dishwasher.

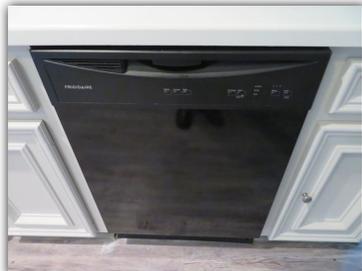
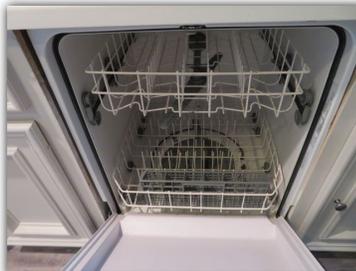
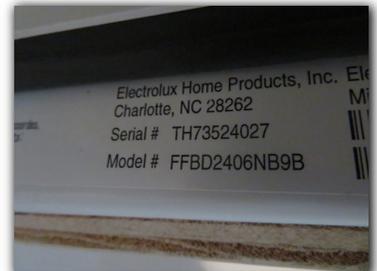
Additional dishwasher photos.

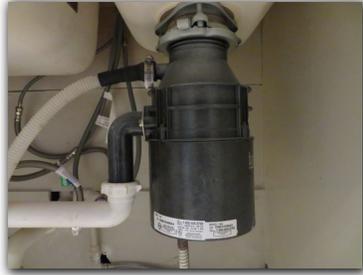
*Comments:* It is the opinion of the inspector that visible components of the food waste disposer appear to be in satisfactory condition and performing as intended on the day of the inspection.

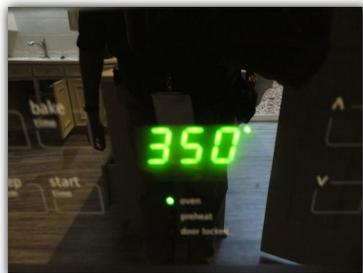
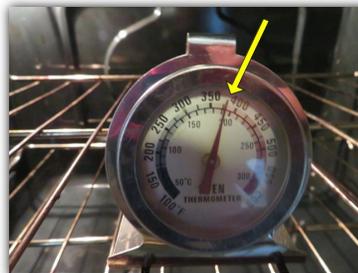
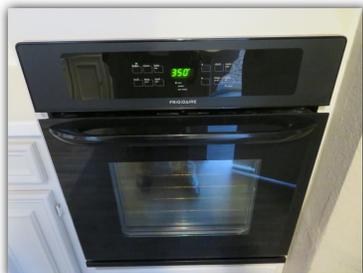
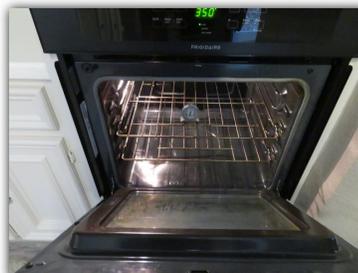
The thermostat for the oven was found to be inaccurate and should be recalibrated, repaired and/or replaced. The temperature was found to be 25 degrees greater than 350 degrees when tested.

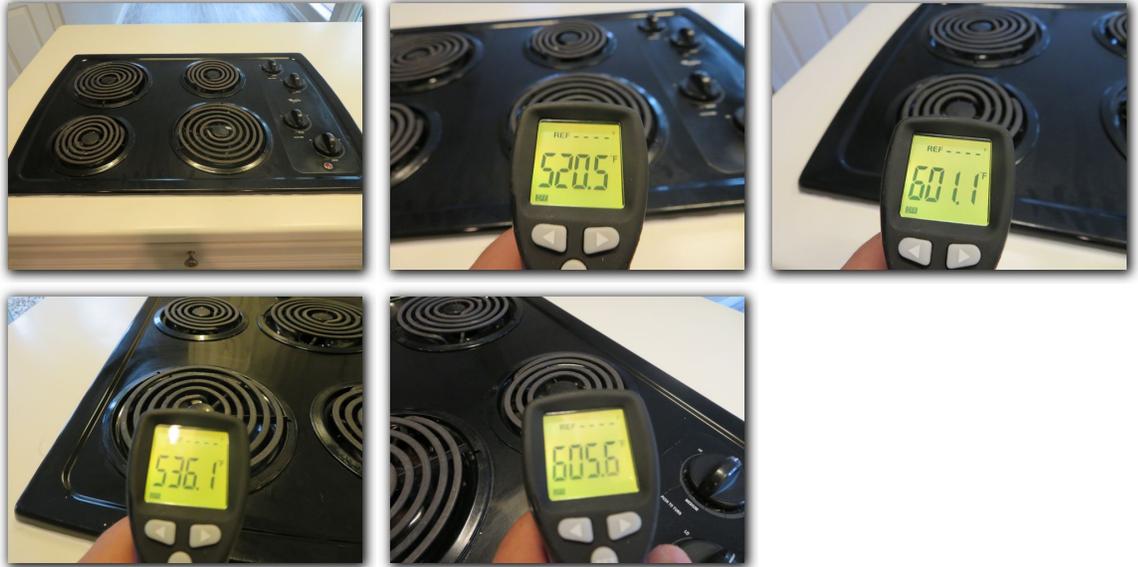
Additional range, cooktop and oven photos.

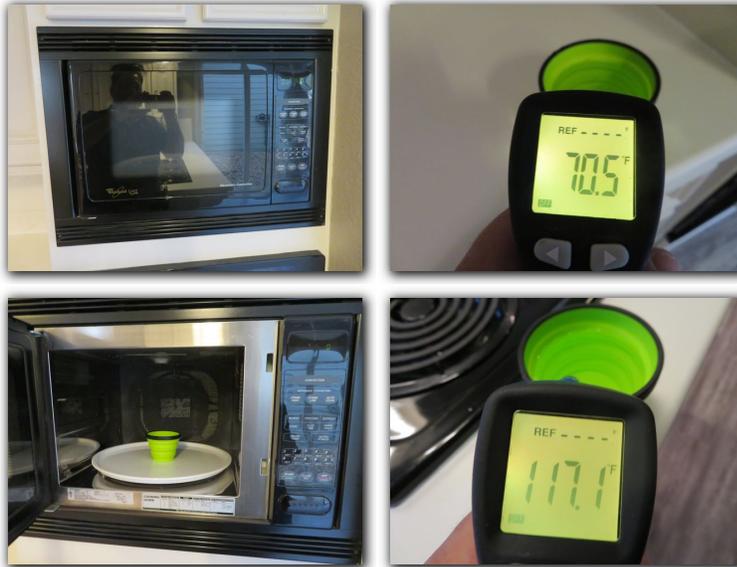
*Comments:* It is the opinion of the inspector that visible components of the microwave oven appear to be in satisfactory condition and performing as intended on the day of the inspection.

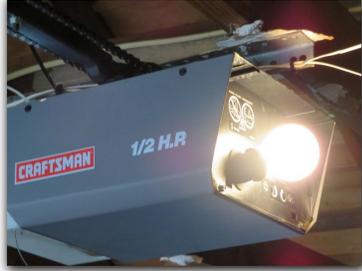
The garage door operator light cover was observed to be missing.

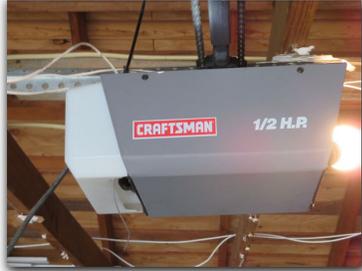
Additional garage door operator photos.
