## PROPERTY INSPECTION REPORT

**Prepared For:** Jack William  
(Name of Client)

**Concerning:** 1234 Happy Avenue, Fun City, TX 77777  
(Address or Other Identification of Inspected Property)

**By:** Amandeep (Andy) Punia, Lic #22380 04/27/2017  
(Name and License Number of Inspector) (Date)

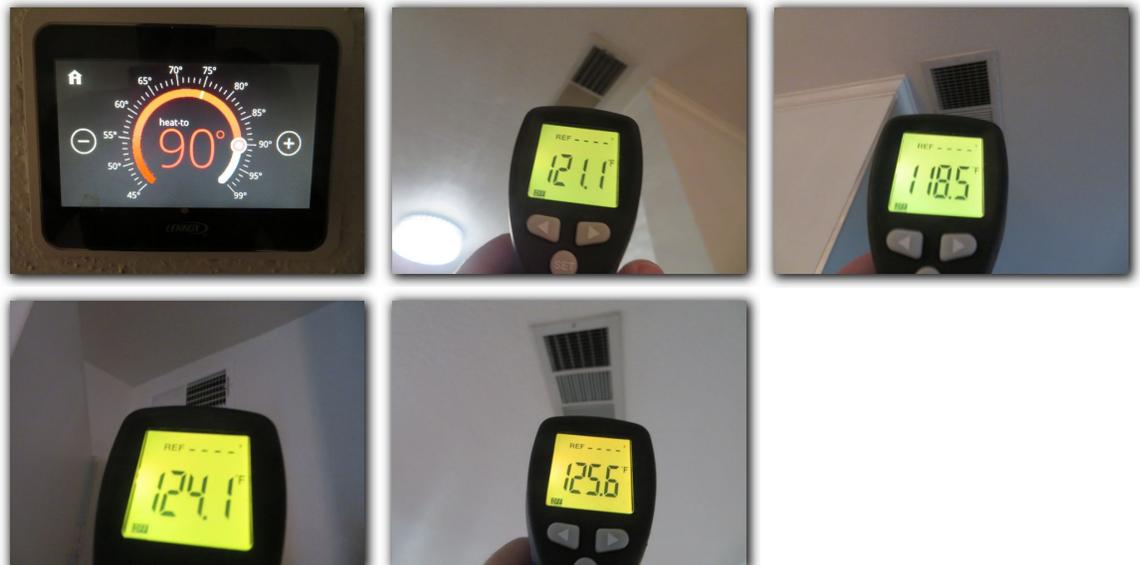
Comments: It is the opinion of the inspector that visible components of heating equipment appear to be in satisfactory condition and performing as intended on the day of the inspection.

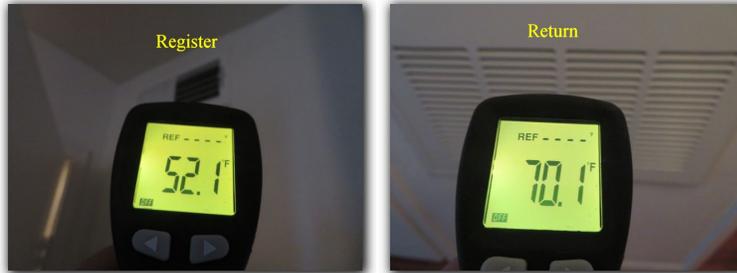
The air temperature differential measured at supply registers and return was observed to be within the acceptable range of between 14 and 22 degrees F when tested.

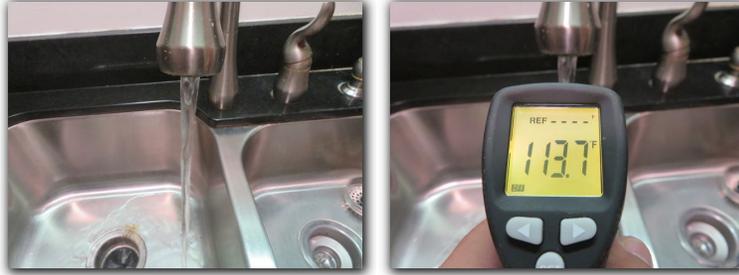
*Comments:* As per the realtor, the property is supplied by community boiler. The inspector was unable to locate the boiler.

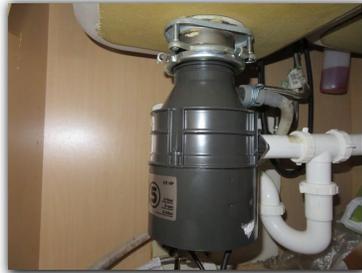
*Comments:* It is the opinion of the inspector that visible components of the food waste disposer appear to be in satisfactory condition and performing as intended on the day of the inspection.

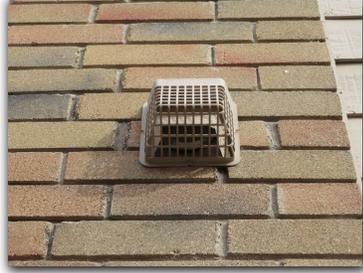
*Comments:* It is the opinion of the inspector that visible components of the dryer vents appear to be in satisfactory condition and performing as intended on the day of the inspection.
