# Axis Real Estate Inspections

## PROPERTY INSPECTION REPORT

Prepared For: Jane Smith

Concerning: 1234 Happy Court, Fun City, TX 77777

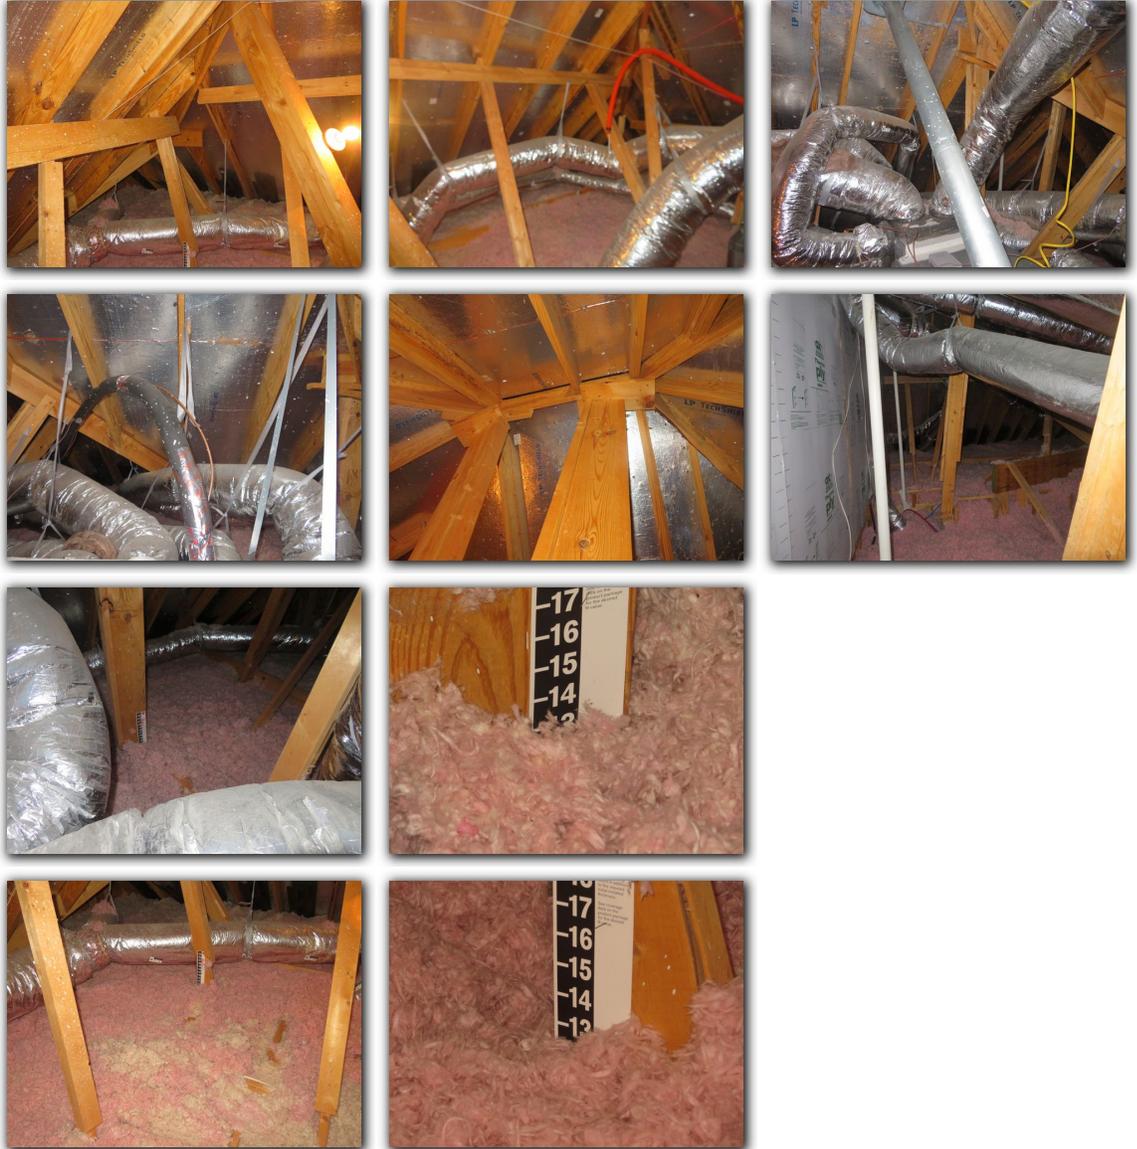
*Comments:* It is the opinion of the inspector that visible components of roof structure and attic appear to be in satisfactory condition and functioning as intended on the day of this inspection.

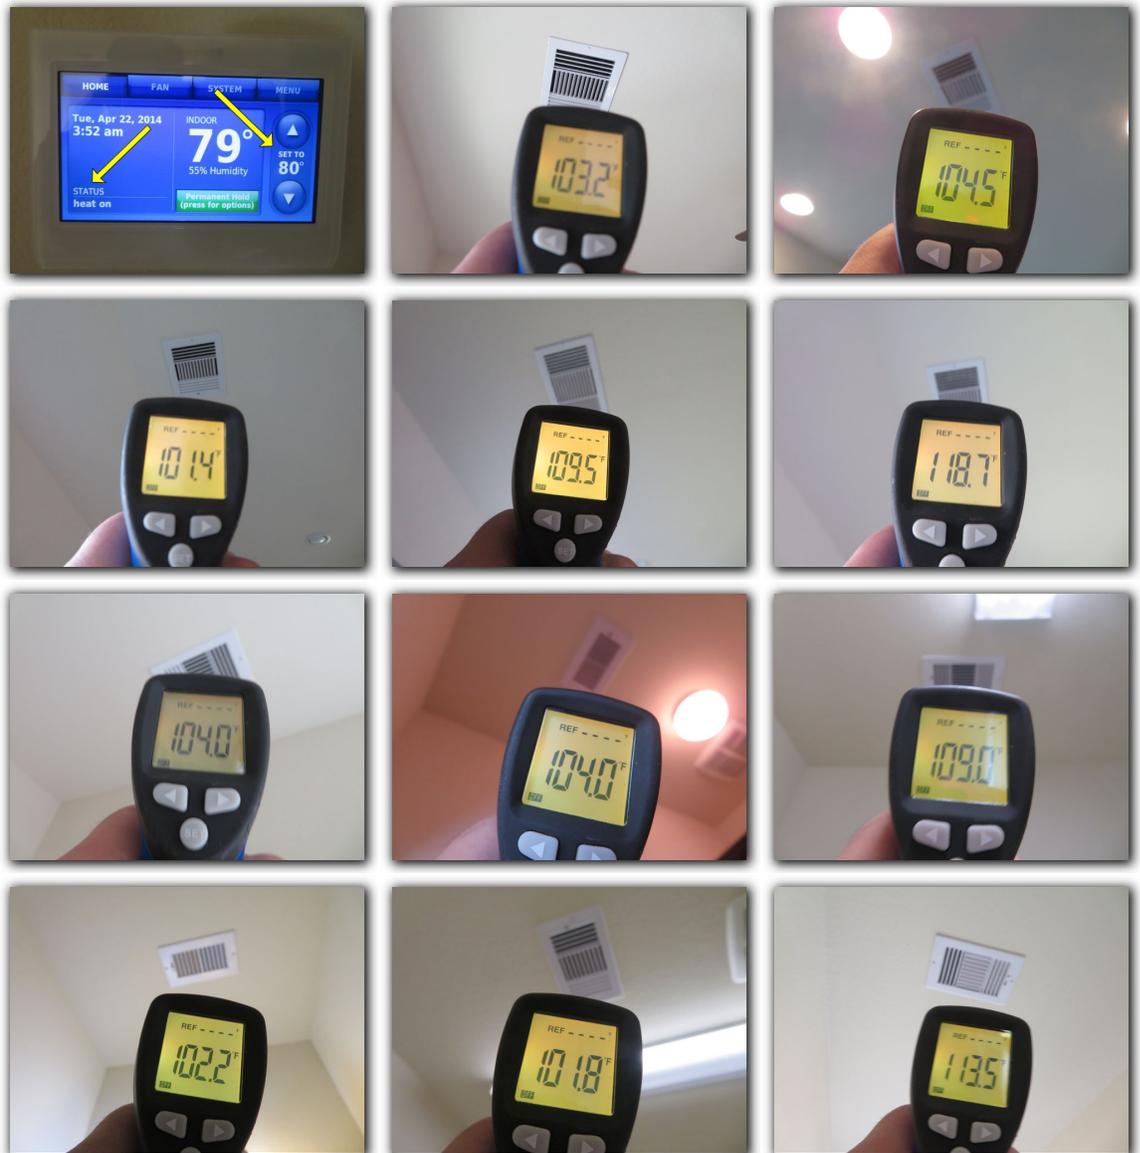
*Comments:* It is the opinion of the inspector that visible components of heating equipment appear to be in satisfactory condition and performing as intended on the day of the inspection.

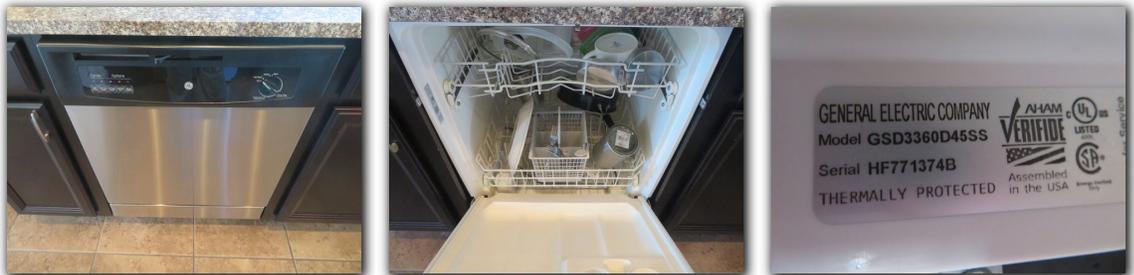
Comments: It is the opinion of the inspector that visible components of the dishwasher appear to be in satisfactory condition and performing as intended on the day of the inspection.

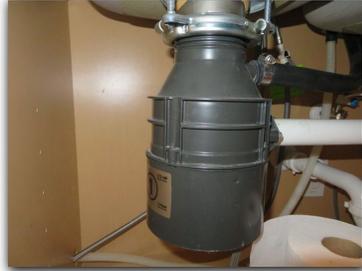
*Comments:* It is the opinion of the inspector that visible components of the food waste disposer appear to be in satisfactory condition and performing as intended on the day of the inspection.

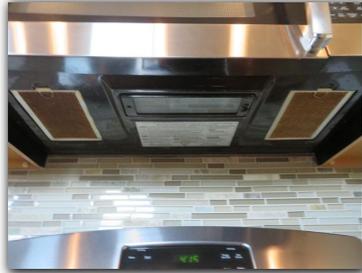
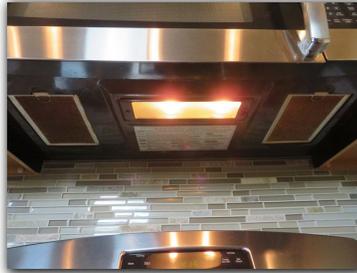
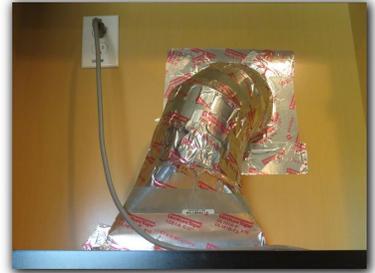
*Comments:* It is the opinion of the inspector that visible components of the range hood and exhaust systems appear to be in satisfactory condition and performing as intended on the day of the inspection.

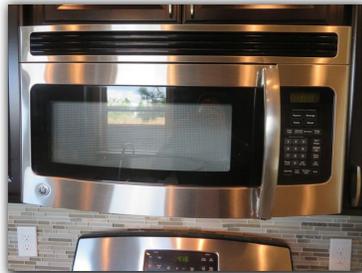
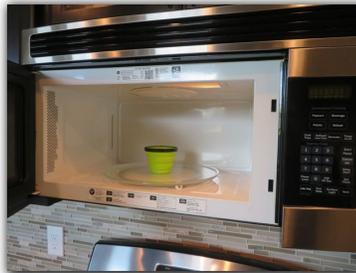
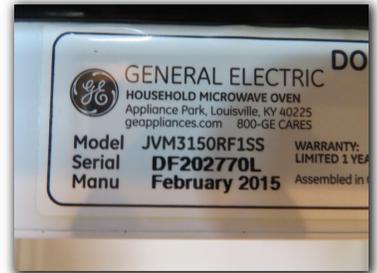
*Comments:* It is the opinion of the inspector that visible components of the microwave oven appear to be in satisfactory condition and performing as intended on the day of the inspection.
