## PROPERTY INSPECTION REPORT

Prepared For: John Smith

Concerning: 1234 Happy Lane, Fun City, TX 77777

By: Amandeep (Andy) Punia, Lic #22380 03/10/2017

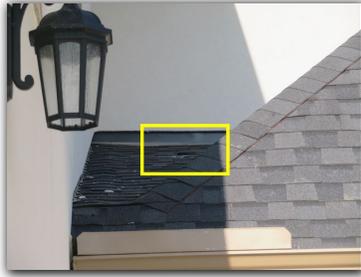
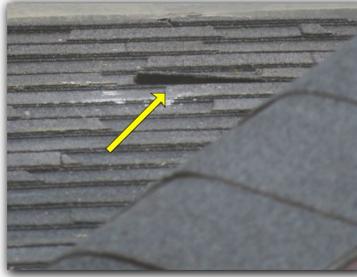
The wall flashing was observed to be loose on the left side of the property. It should be secured and sealed to reduce the risk of water intrusion. All exposed flashing and roof penetrations should be examined and sealed as necessary.

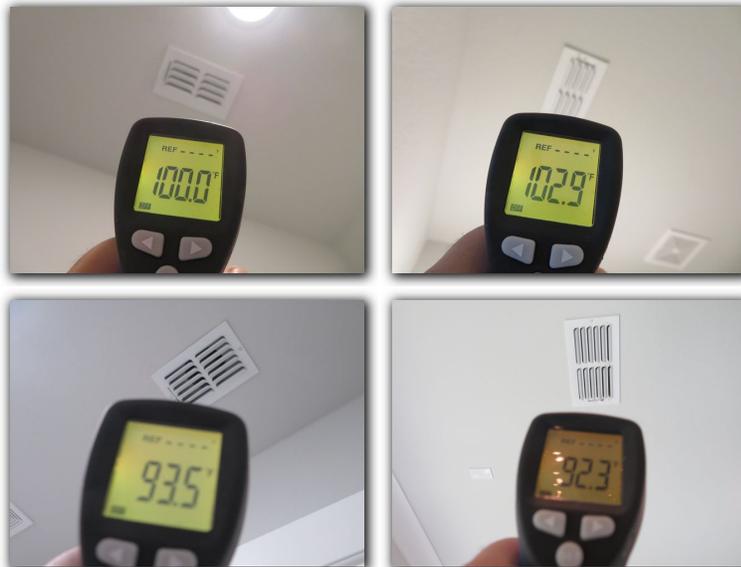
*Comments:* It is the opinion of the inspector that visible components of heating equipment appear to be in satisfactory condition and performing as intended on the day of the inspection.

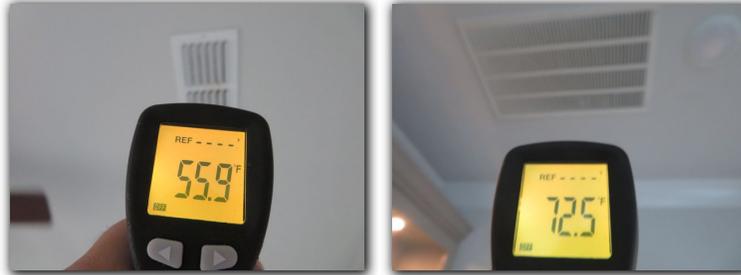
The cooling system was functional when tested and responded adequately to the thermostat on the second floor. The air temperature differential measured at supply registers and returns was measured to be within the acceptable range of between 14 and 22 degrees F.

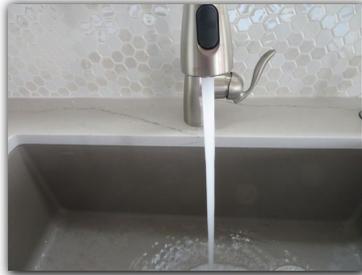
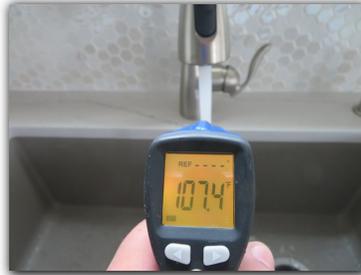
*Comments:* It is the opinion of the inspector that visible components of the water heating equipment appear to be in satisfactory condition and functioning as intended on the day of this inspection.

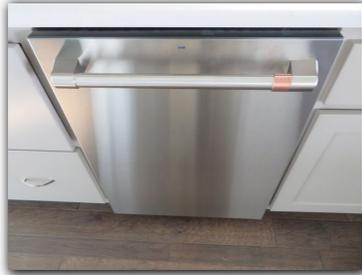
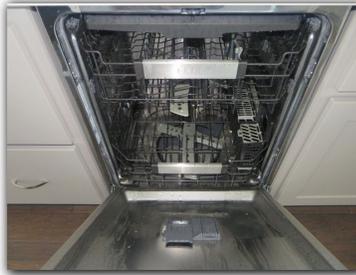
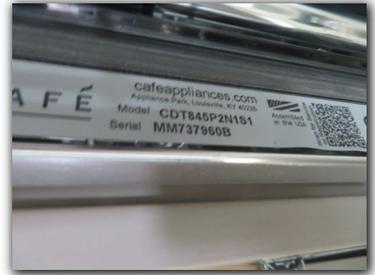
*Comments:* It is the opinion of the inspector that visible components of the dishwasher appear to be in satisfactory condition and performing as intended on the day of the inspection.

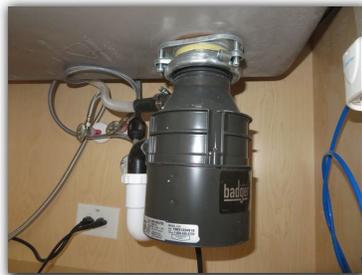
*Comments:* It is the opinion of the inspector that visible components of the food waste disposer appear to be in satisfactory condition and performing as intended on the day of the inspection.

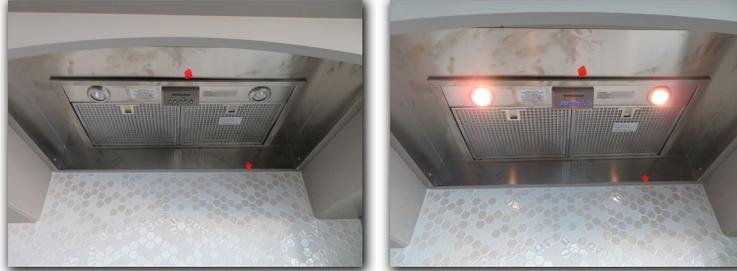
*Comments:* It is the opinion of the inspector that visible components of the range hood and exhaust systems appear to be in satisfactory condition and performing as intended on the day of the inspection.

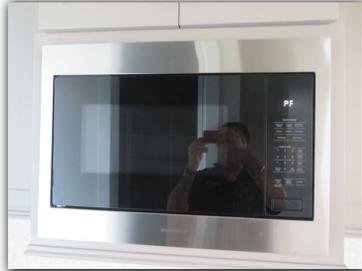
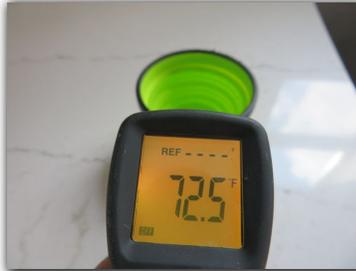
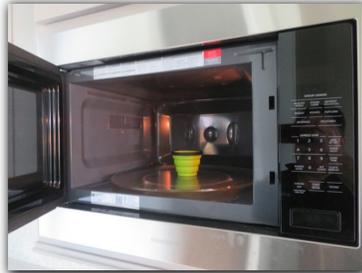
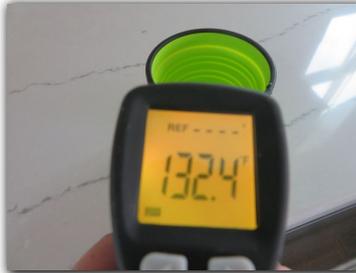
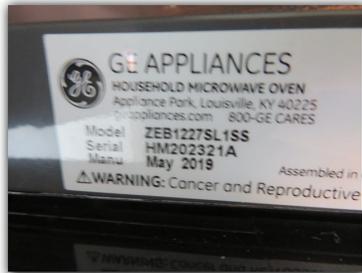
*Comments:* It is the opinion of the inspector that visible components of the microwave oven appear to be in satisfactory condition and performing as intended on the day of the inspection.

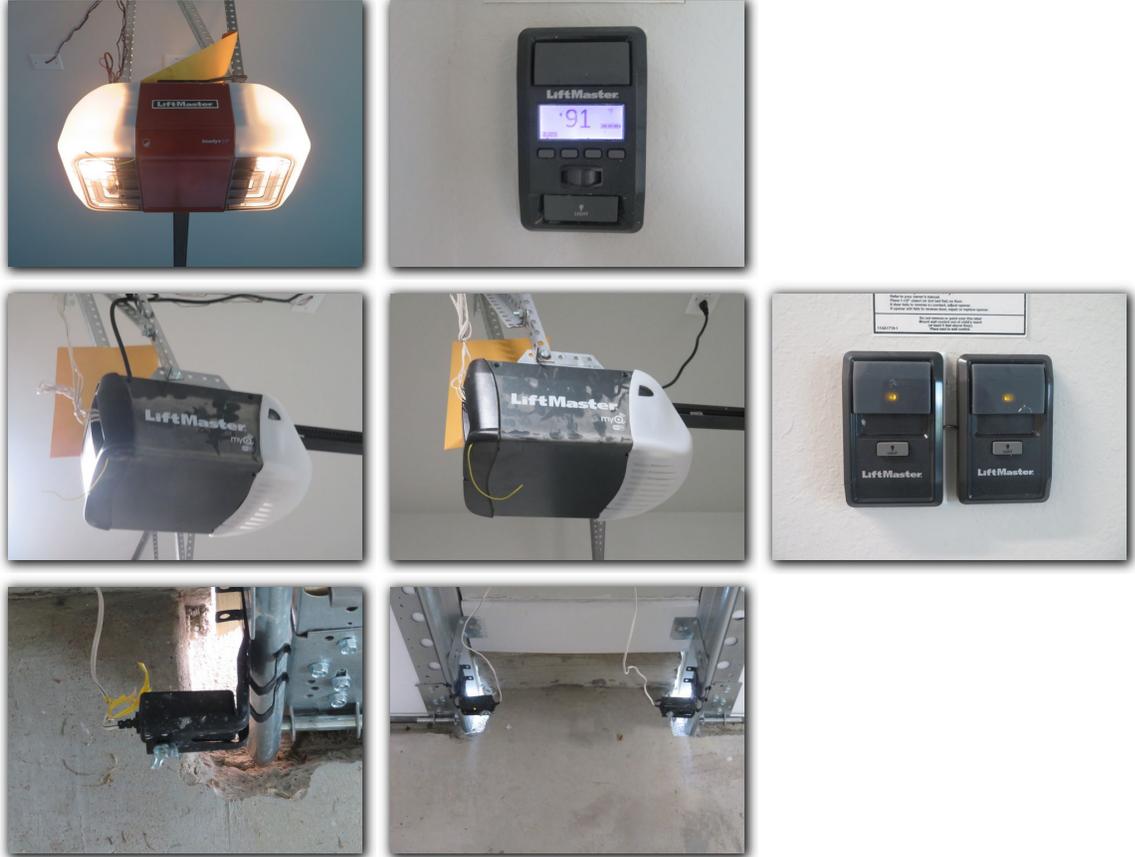
*Comments:* It is the opinion of the inspector that visible components of the garage door operator appear to be in satisfactory condition and performing as intended on the day of the inspection.
