Opportunities for Improvement Green River Panels August 2008

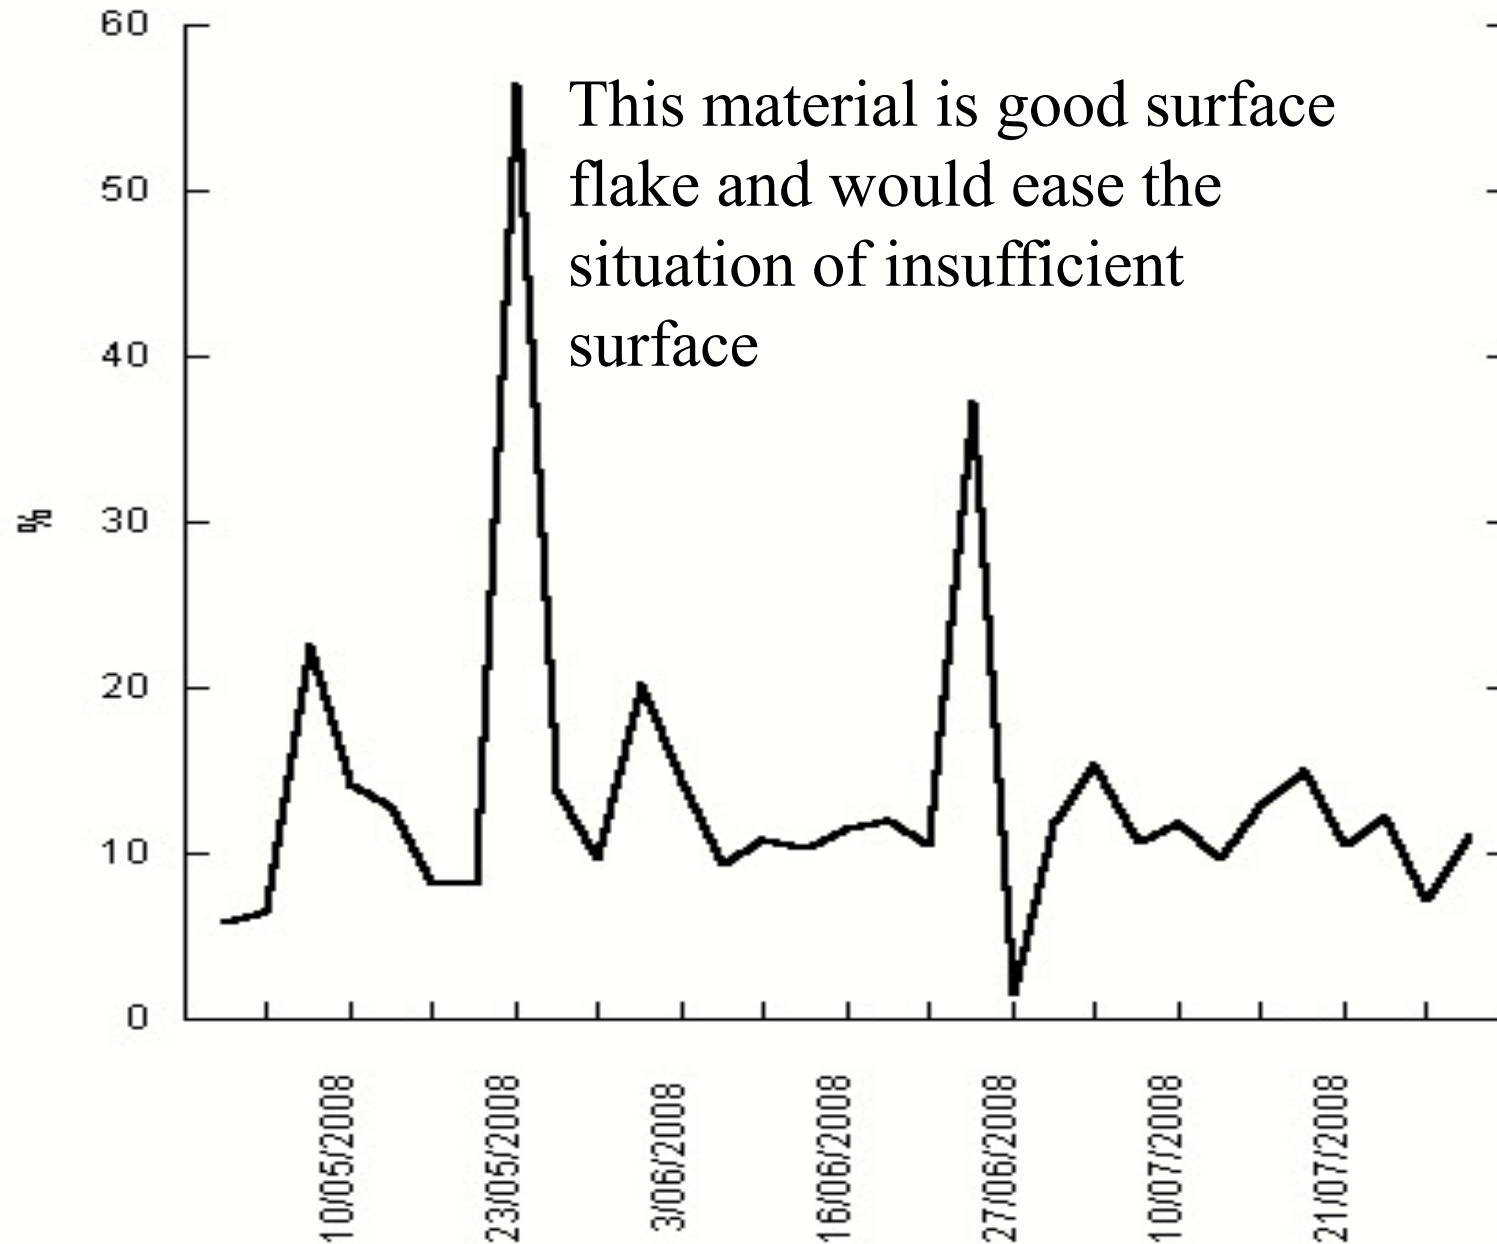
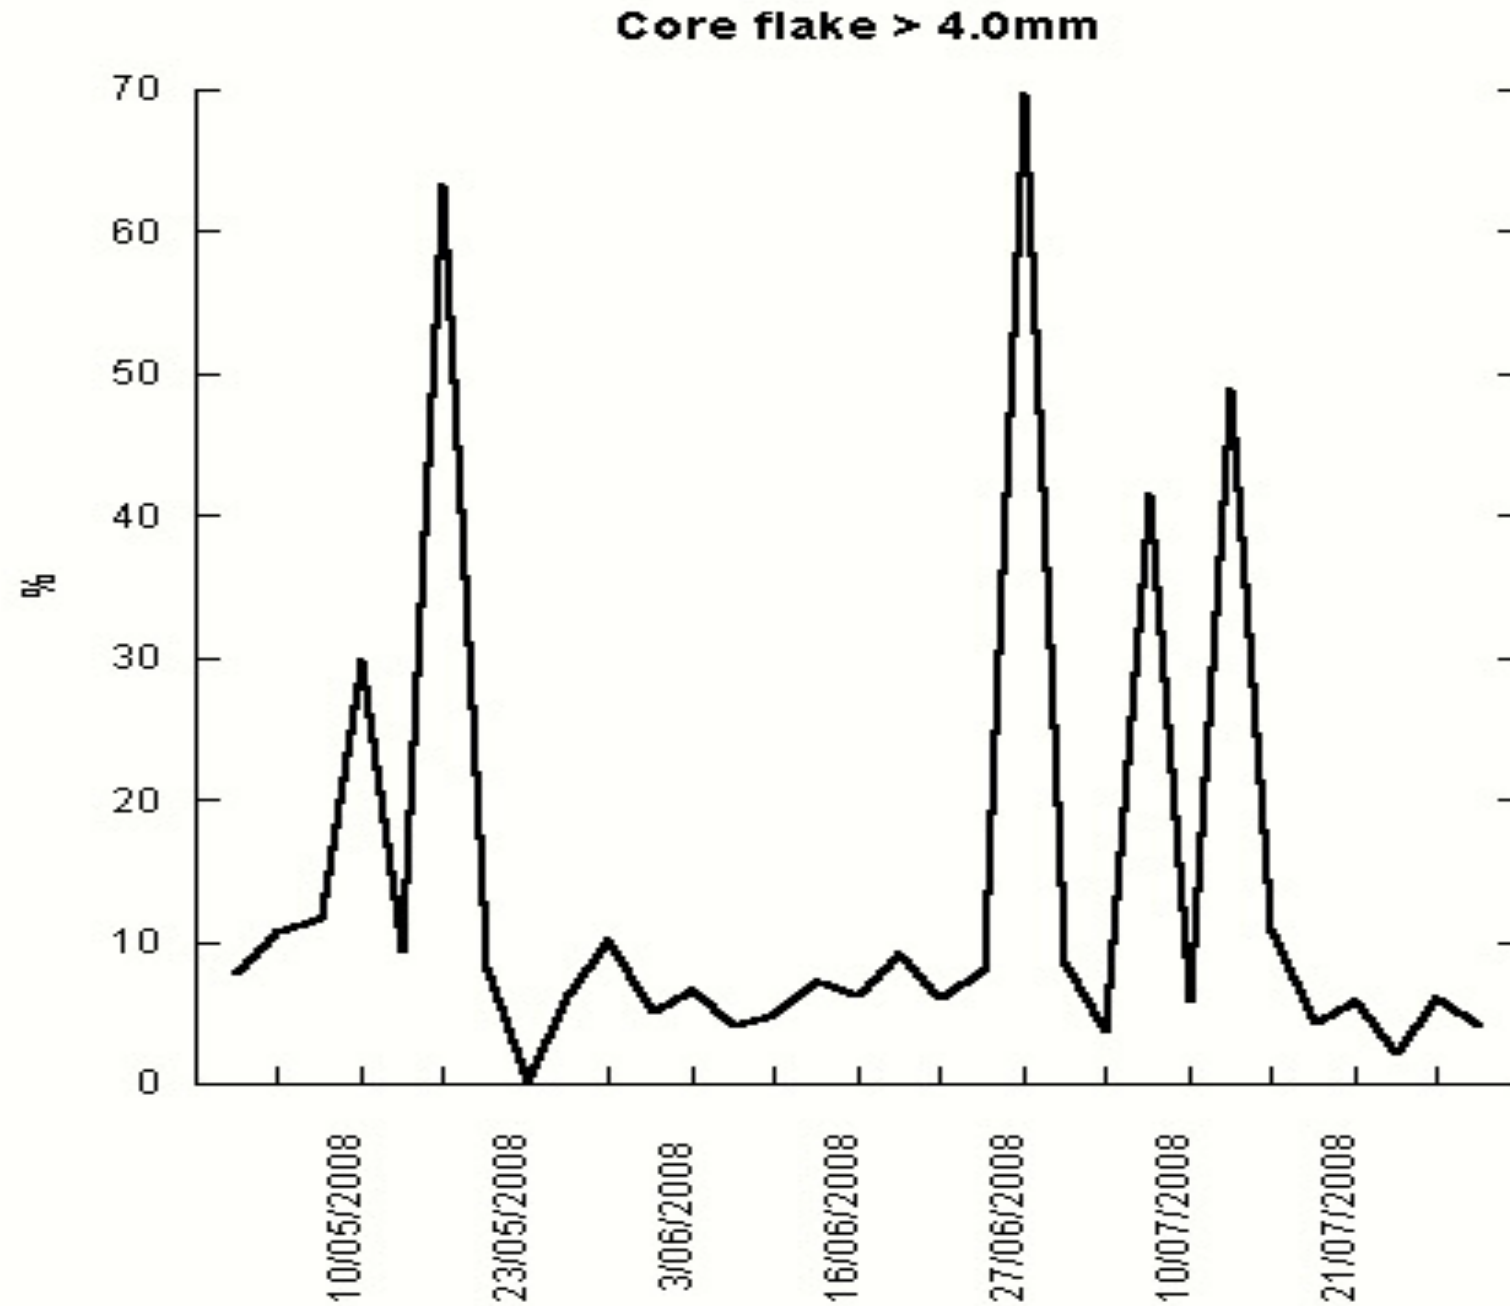
Core fines

- Flake quality at the blenders:
 - Ex flakers >4mm fraction can vary between 5% - 68% within 12 hrs.
 - Ex screens dust in surface can vary between 0 - 5%
 - Amount of surface flake in core fraction varies between 0-20%
 - This leads to excessive fines in core leading to excessive resin usage and low bending strength and lack of surface material.
 - This can also result in excessive dust in surface which causes dust and glue spots.

Difficult to maintain consistent core to surface flake ratio

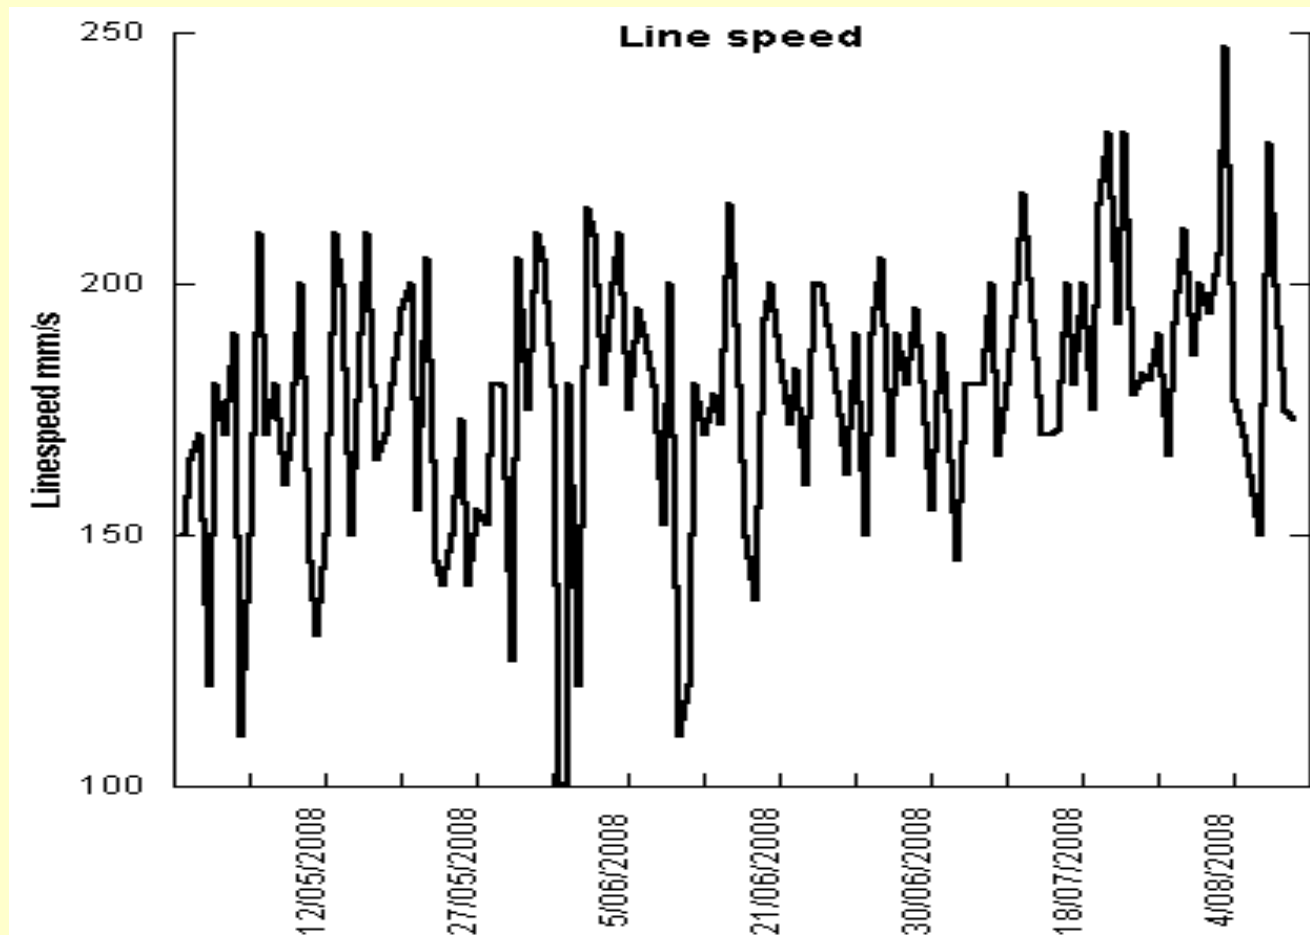
- Operating conditions and delegations of authority.
 - There needs to be consistent operating conditions i.e:
 - line speeds, resin loadings, temperatures etc.
