Report on Consultation Work for Rexcel C.V., Zitacuaro October 2007

Raymond J. Roberts

Abstract. This report details observations on the plant inspection carried out over three weeks in October 2007. It lists the major problems, and gives short and long term recommendations.

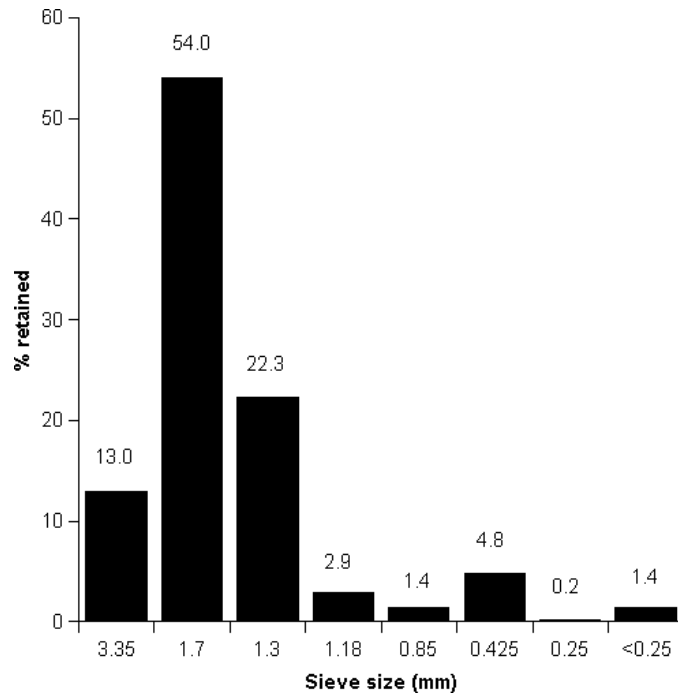
An examination of the screen analysis of the all the flake fractions showed that there was excessive fines in the core flake before blending (Figures 8), with 13% of flake below 1.3mm before blending. This small flake would be consuming a disproportionate amount of resin and affecting the physical properties of the board and shows there is considerable inefficiencies in the flake classification system. Surface flake before blending (Figure 9) has too much dusty material that should be removed (20%) (Figure 10). This dusty material also contains 90% of the grit.

Figure 8. Analysis of core flake before blending

7. There is too much fine material in the core flake. This results in the resin being unevenly distributed in the smaller flake at the expense of the larger flake which results in board of lower physical properties particularly bending strength. Figure 8 shows that 5% of the core flake is too small i.e. <0.85mm and approximately 1.5% is fine material that is even too small for surface flake.

8. There is too much large material in the core flake that sometimes shows through to the surface. This has a major impact on laminating. Figure 8 shows that 13% of core flake is >3.35mm which is significantly too much.

Regular sieve analysis should be done on surface and core flake, as well as regular surface grit tests.

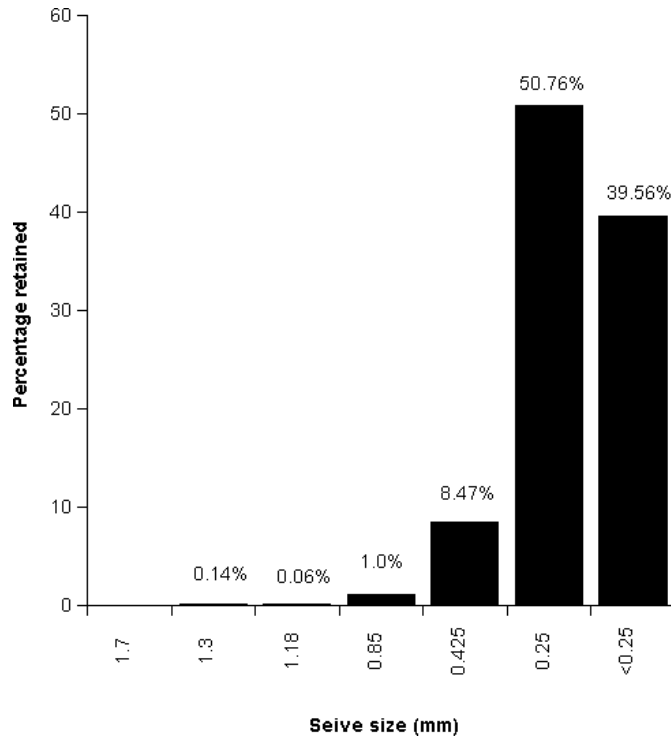
Figure 10. Analysis of surface fines before blending.

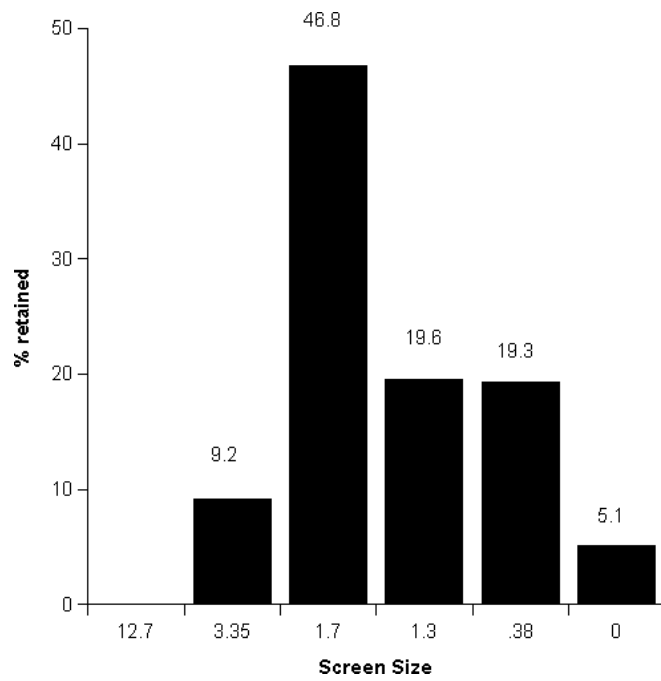
Analyses of core and surface flake after blending can be seen in Figures 11 & 12 and obviously show that there are too much fine material in the core flake and too much dust material in the surface flake after blending. This will be rectified with proper flake classification.

Figure 11. Analysis of core flake after blending

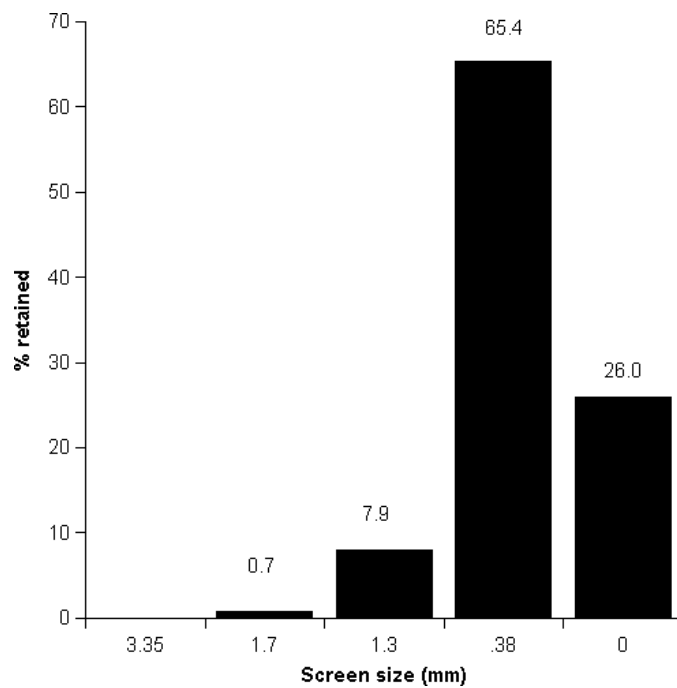
Figure 12. Analysis of surface flake after blending

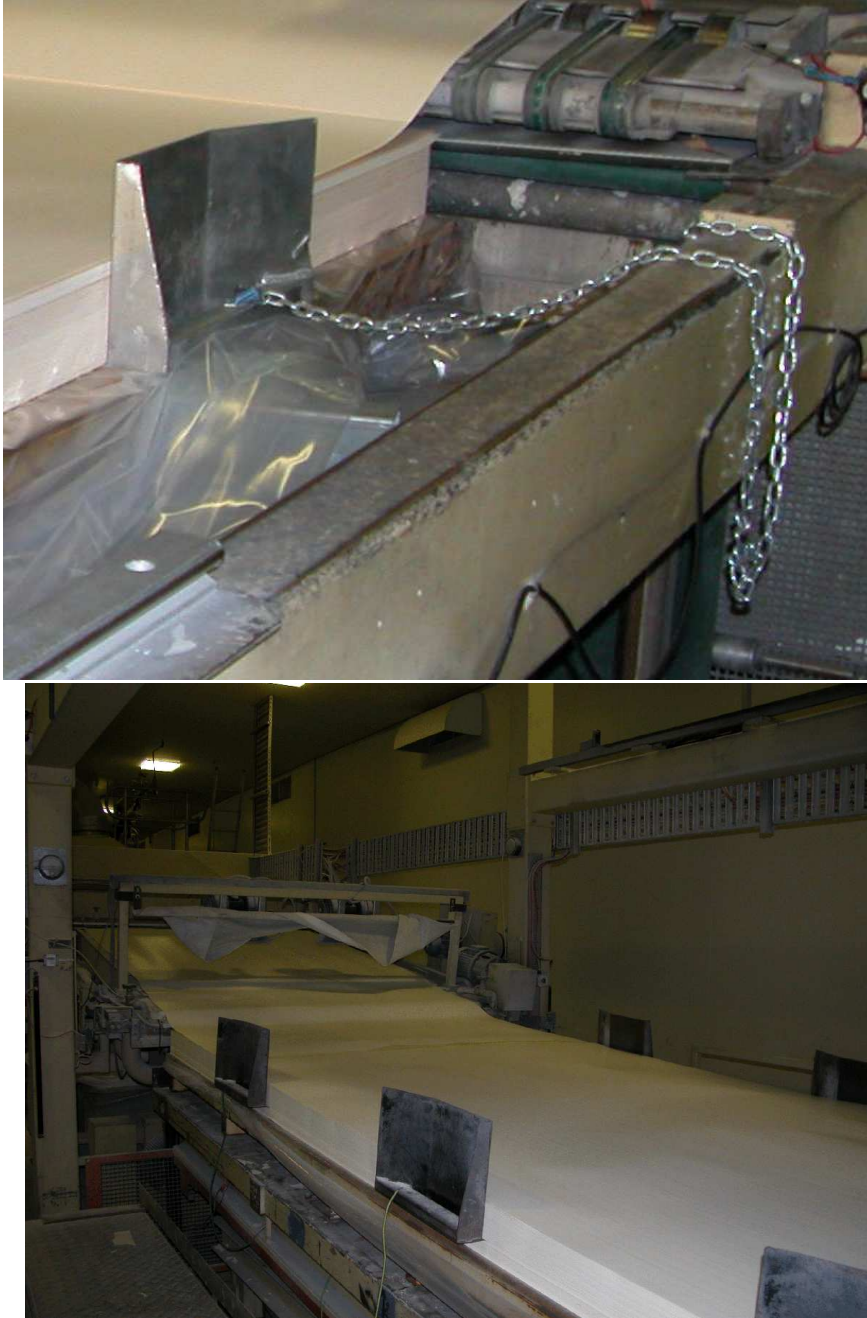
Figure 19. Images showing stops to improve stacking quality after the treater resulting in good stacking. This image is taken at the CHH Mt Gambier treater in Australia.

Stacking of the treated paper ex the treater was very poor, and would result in a large amount of paper chips occurring during lay-up. It is critically important that operators monitor stacking for the first 50mm of the stack to ensure a bookend finish on all edges of the pallet. If this is not achieved the whole pallet will exhibit poor stacking which will result in paper chips and torn paper lay-up. In fact paper chips caused by poor paper stacking are in the top five paper defects. Figure 18 clearly show the problem of poor stacking. The new Mt Gambier type of book end should be used which is fully earthed to the body of the treater (Figure 19). Another reason stacking ex the treater is so poor is that operators are using the internet rather than adjusting the stacking.

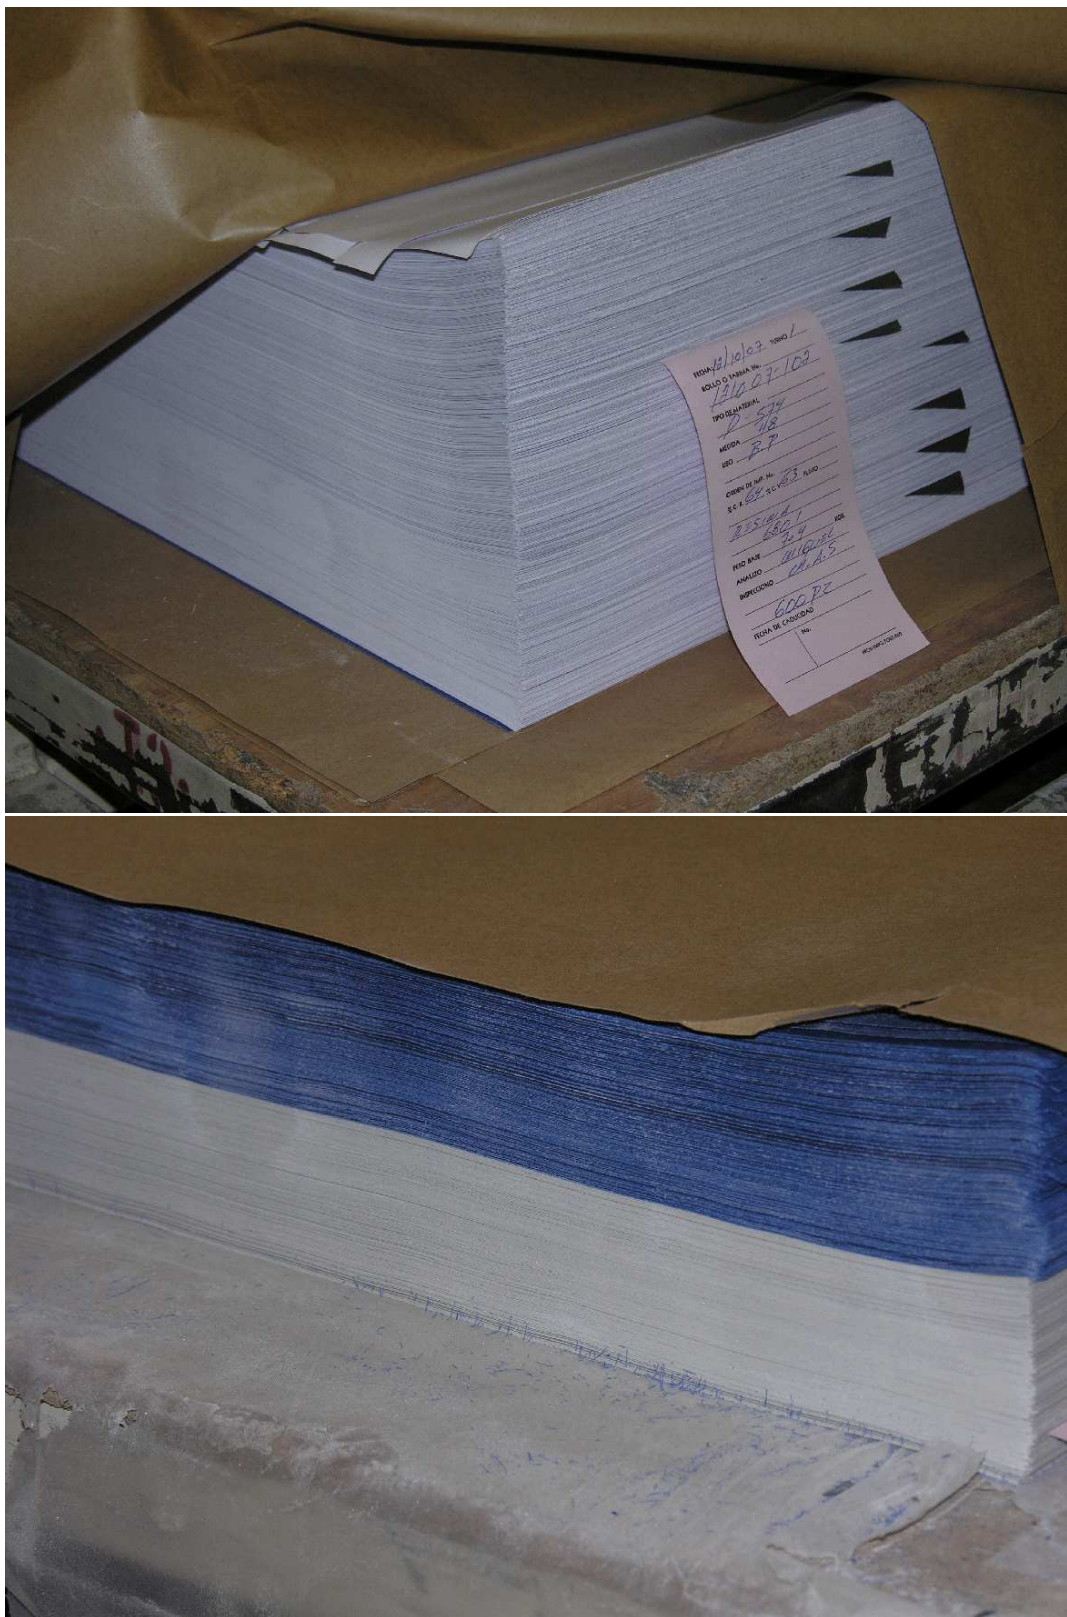
Figure 20. Examples of improved stacking at Rexcel Plant at Zitacuaro.
