# **Inspection Report**

18223 N 20th Dr Phoenix AZ 85023

**Sonic Property Inspections**

<b>Date:</b> 2/5/2019	<b>Time:</b> 03:00 PM	<b>Report ID:</b> 020519
Property: 18223 N 20th Dr Phoenix AZ 85023	<b>Customer:</b> Sample	<b>Real Estate Professional:</b> Robert Tolnai

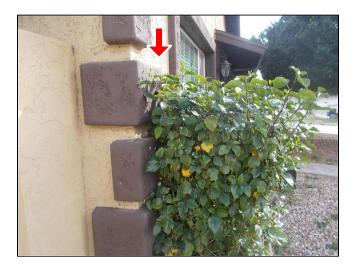
At time of inspection, one or more areas of the vegetation were observed to be against or close to the exterior walls. This should also be noted on your WDO (Termite) report. Irrigated vegetation against house walls is conducive to Subterranean Termites. Recommend removing or trimming the bushes

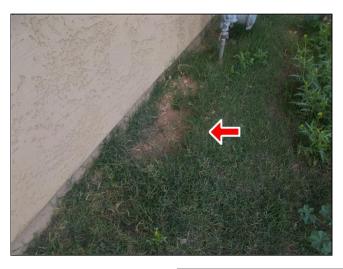
There is a negative slope at the several exterior areas and can cause or contribute to water intrusion or deterioration. Monitor the areas to determine if water is entering the structure. Have a qualified contractor or landscaper regrade the yard if needed.

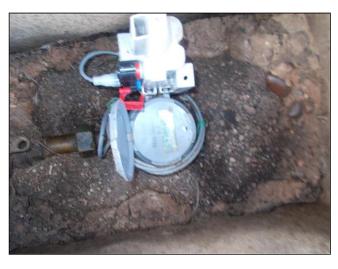
No defects were observed for the water supply piping to the main as identified in the Styles & Materials section. Water pressure recorded at the exterior main was (50 ) PSI. See Photo.

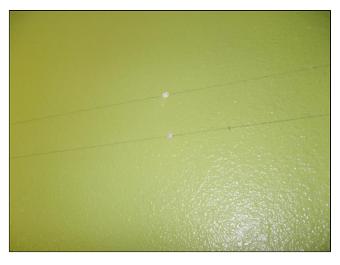
The walls or ceiling have minor cosmetic damage (scuffs, scrapes, nail holes etc) that you should view yourself and correct as desired.
