**RE: River Falls Hydroelectric Project, FERC Project No. 10489
Post-Flood Dam Safety Inspection and Repair Options**

Post-Flood Dam Safety Inspection and Repair Options Letter

Re: Post-Flood Dam Safety Inspection and Repair Options Letter for Powell Falls Dam (P-10489)

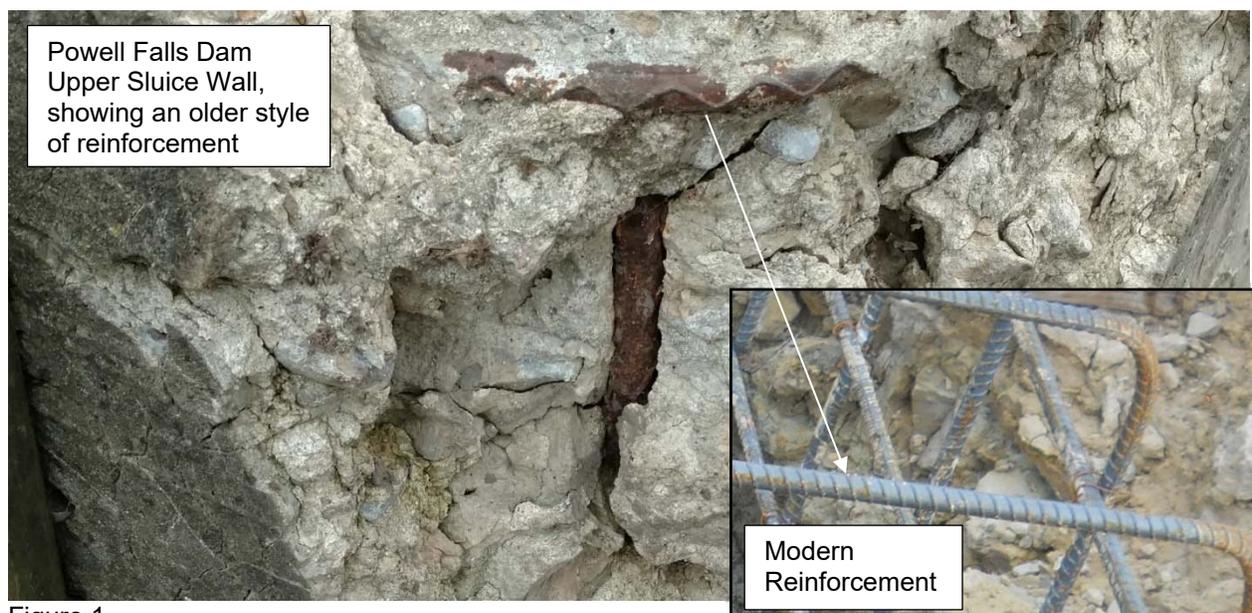
Figure 1

Powell Falls dam was not constructed all at once in the present-day form. Per the Initial Study Report (January 30, 2020), a wood-framed powerhouse was built at Powell Falls in 1903 with a timber spillway to retain water. A concrete powerhouse was constructed in 1946 - 1947. In 1964, a large flood destroyed the timber dam spillway. A concrete gravity dam was constructed in 1965 - 1966, and that project did not include replacement of the sluiceway walls or powerhouse foundation. Ayres' search of the available historic drawings and records could not confirm that the powerhouse foundation and sluiceway piers are original 1903 concrete, but Figure 1's reinforcement view indicates that the sluiceway wall concrete predates 1947 when ASTM A305 standardized¹ reinforcing deformity patterns.

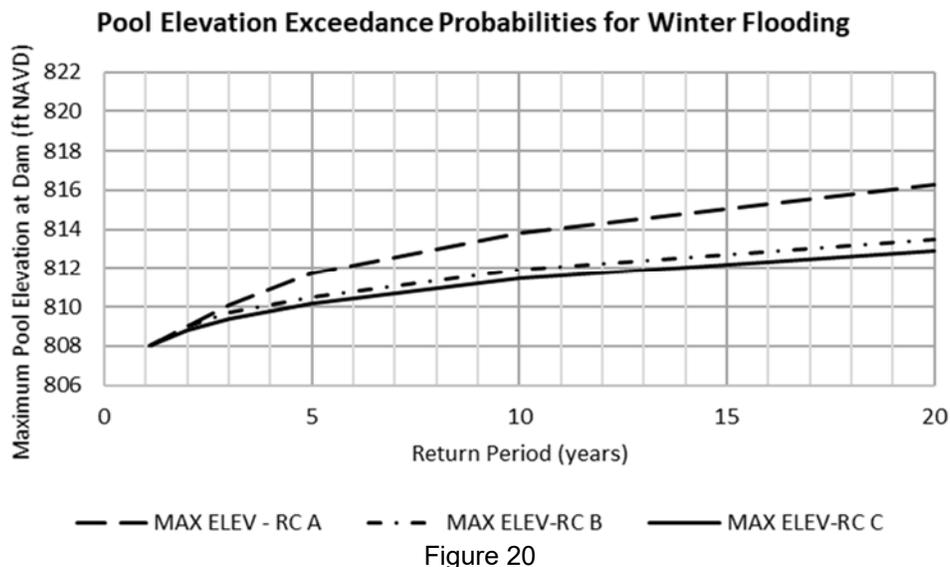
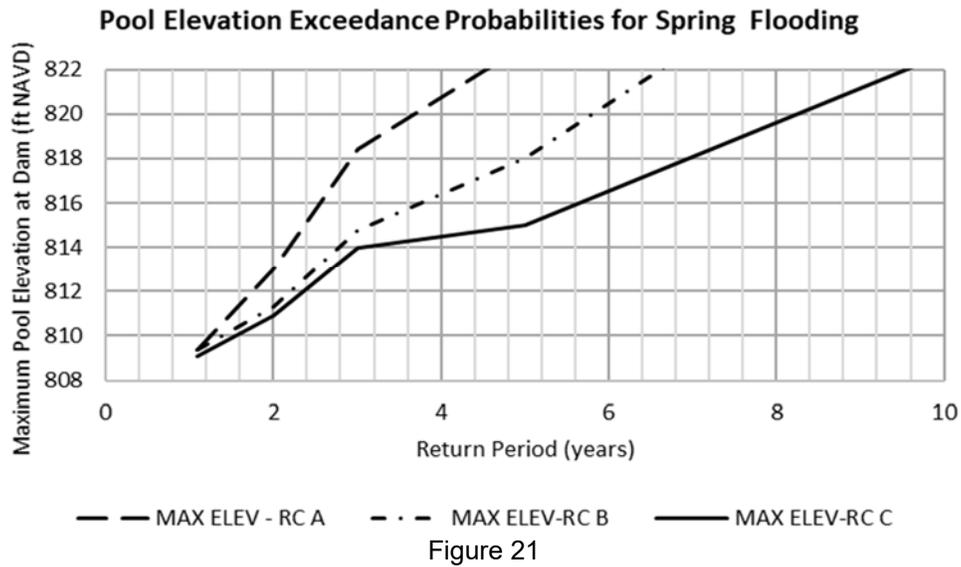
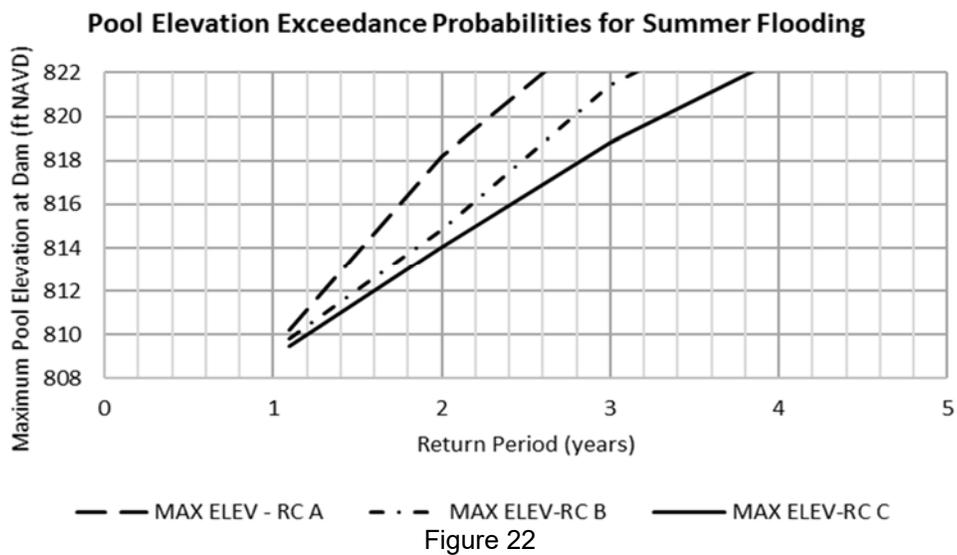
The hydrographs for each season and return period were routed through Lake Louise and Powell Falls Dam using the three discharge rating curves representing the range of alternatives for powerhouse/sluice modification. The reservoir elevation-storage curve was based on the bathymetry presented in the 2016 *Inter-Fluve Sediment Assessment Report*, but was modified to include Ayres' current understanding of the channel that has been incised upstream of the powerhouse. Figures 20 through 22 show the resulting seasonal stage-frequency curves for powerhouse/sluice modification scenarios A, B, and C above.

Table 1 summarizes the results shown in Figures 20 through 22 by listing the estimated exceedance probability of two threshold impoundment elevations for each season and discharge configuration considered. The impoundment elevations presented in Table 1 are (a) 822, just below the spillway crest elevation; and (b) 818, or a surface four feet below the spillway crest. This elevation was chosen for listing because it approximately represents the water surface elevation inundating most of the pre-drawdown lakebed, according to the bathymetry presented in the 2016 *Sediment Assessment Report*. Note that the exceedance probabilities listed are seasonal-annual and not overall annual. For example, with the sluice and turbine in their existing condition (Configuration A) there is a 38 percent chance that the dam will be overtopped in any given summer – and there is also a 22 percent chance that the dam will be overtopped in any given spring, including the same year in which a summer overtopping event occurs. Overall, the annual probability of overtopping is larger than either of the individual seasonal probabilities.
