# Repair Summary - Immediate Action

**Date:** 9/23/2025  
**Time:** 3:31:41 PM  
**Temperature:** Over 65  
**Weather:** Clear  
**Age Of Building:** Over 50 years  
**Building Type:** Single Family

**Client:** RAHB Investor Inspection  
**Real Estate Agent:** Steven Brockway  
**Attendance:**

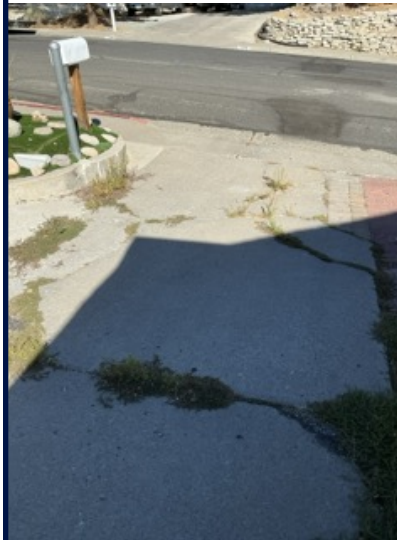
Exterior Picture: 2

Driveway is cracking in multiple areas.

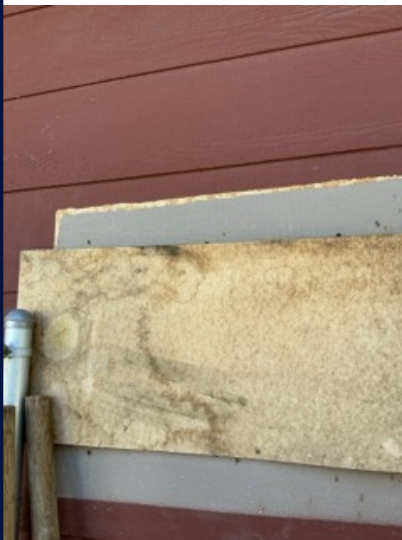
Exterior Picture: 16

Garage window is boarded up. I cannot see to inspect. --See Exterior Picture 16

Garage window is boarded up. I cannot see to inspect.

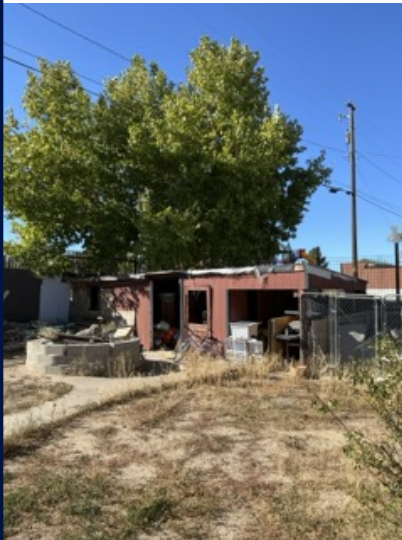
Exterior Picture:22

Outbuildings were not inspected. --See Exterior Picture 22

Outbuildings were not inspected.

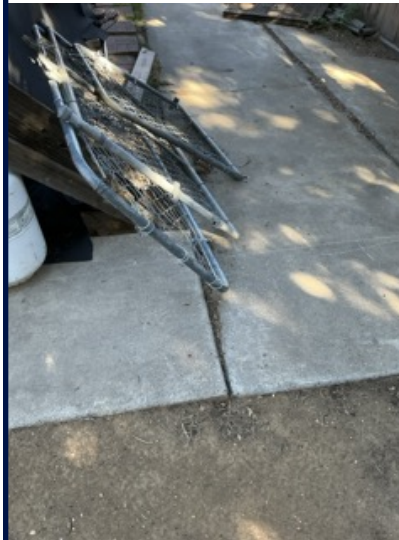
Exterior Picture:23

Concrete is lifting in some areas. --See Exterior Picture 23

Concrete is lifting in some areas.

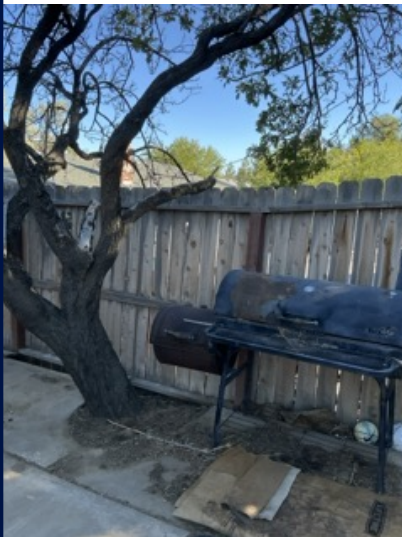
Exterior Picture:24

Fence is leaning. --See Exterior Picture 24

Fence is leaning.

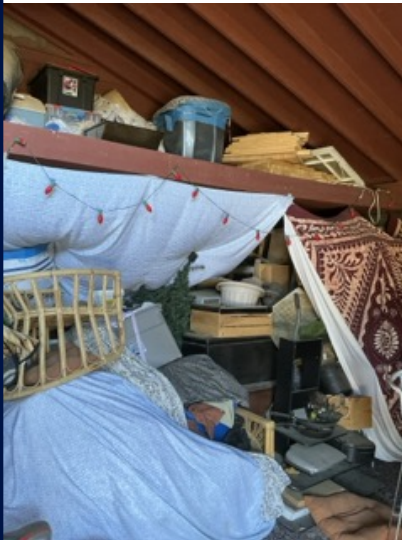
Exterior Picture:26

Cannot see multiple areas because of personal items. --See Exterior Picture 26

Cannot see multiple areas because of personal items.

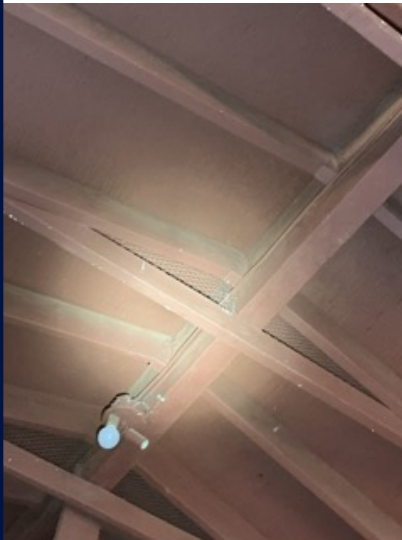
Exterior Picture:28

Electrical wiring under the back porch should be in conduit. --See Exterior Picture 28

Electrical wiring under the back porch should be in conduit.

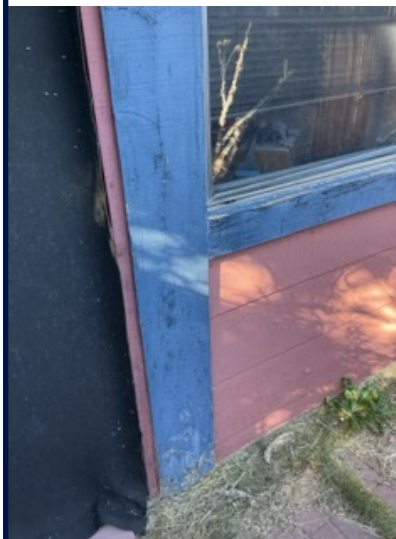
Exterior Picture:31

Paint is failing on the trim. Recommend prep and paint as needed to protect from damage. --See Exterior Picture 31

Paint is failing on the trim. Recommend prep and paint as needed to protect from damage.

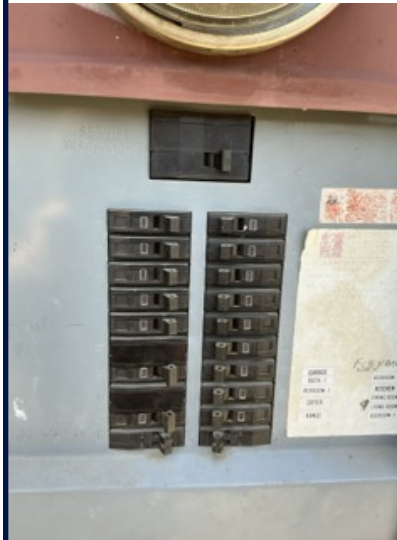
Exterior Picture:35

The electrical panel is not well marked. Recommend marking for safety. --See Exterior Picture 35

The electrical panel is not well marked. Recommend marking for safety.

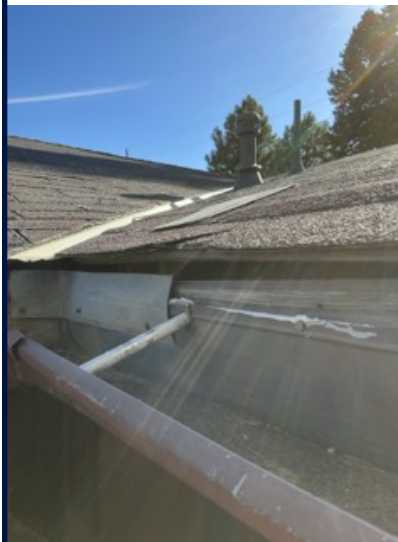
Exterior Picture:39

Roof sheeting is lifting over the garage. --See Exterior Picture 39

Roof sheathing is lifting over the garage.

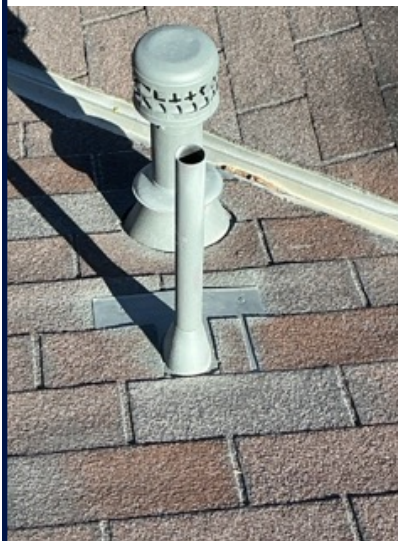
Exterior Picture:43

Some of the sealant on the roof vent penetrations is missing or damaged. Recommend repair. --See Exterior Picture 43

Some of the sealant on the roof vent penetrations is missing or damaged. Recommend repair.

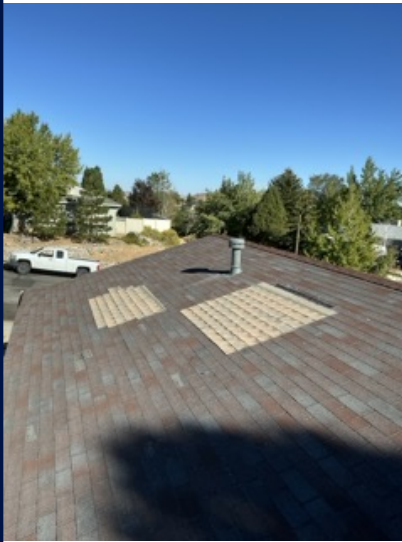
Exterior Picture:44

Roof has been patched in multiple areas. --See Exterior Picture 44

Roof has been patched in multiple areas.

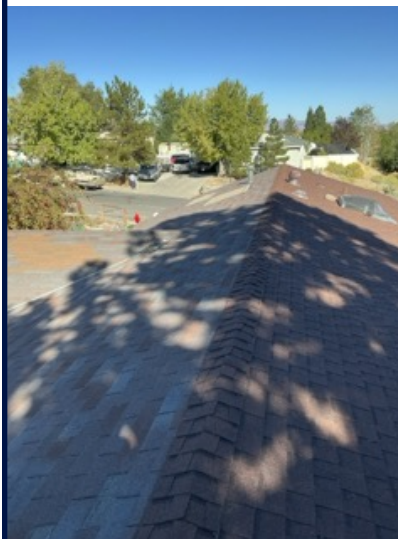
Exterior Picture:48

Roof flashing is lifting. --See Exterior Picture 48

Roof flashing is lifting.

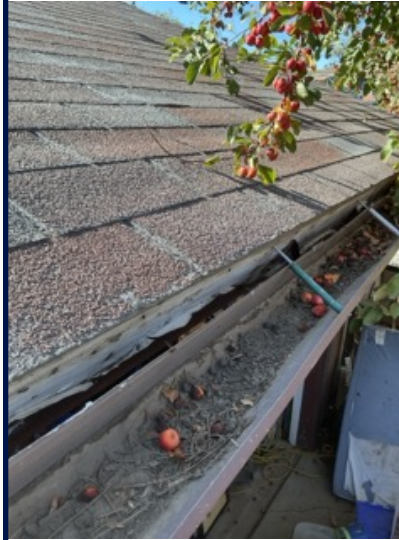
Exterior Picture:51

Gutter over the garage is pulling loose. This is a hazard.

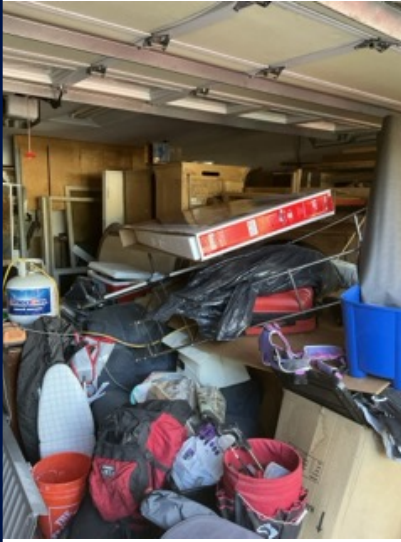
Interior Picture: 1

Not all areas could be seen to inspect. Personal items were in the way.

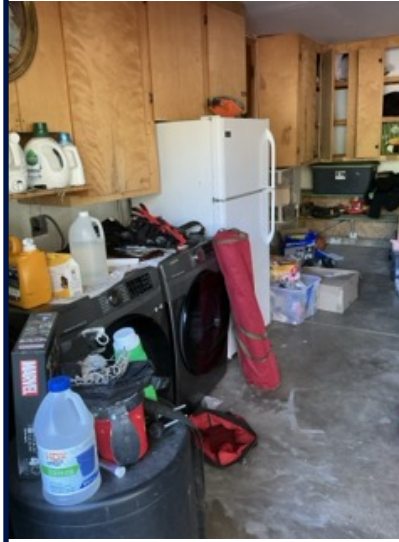
Interior Picture: 2

Not all areas could be seen to inspect. Personal items were in the way.

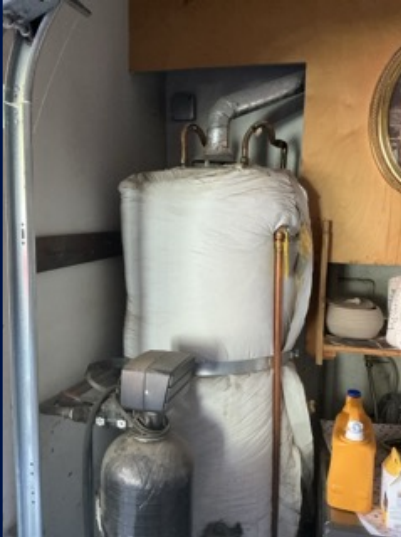
Interior Picture: 3

Water heater does not have a pan or expansion tank. . . . See Interior Picture 3

Water heater does not have a pan or expansion tank.

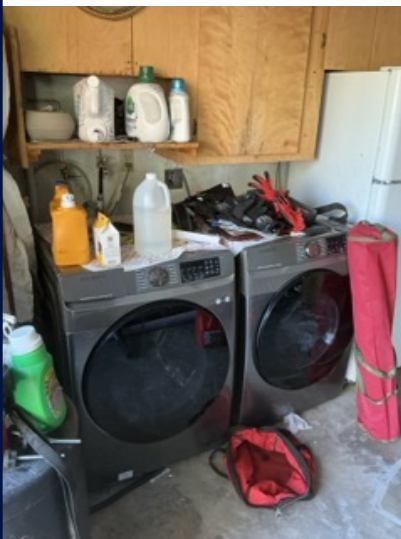
Interior Picture: 5

The washer and dryer were not inspected. . . . See Interior Picture 5

The washer and dryer were not inspected.

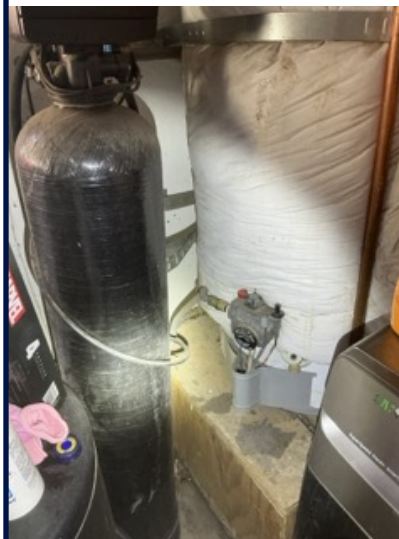
Interior Picture: 6

FYI, there is no debris trap on the gas line for the water heater. . . . See Interior Picture 6

FYI, there is no debris trap on the gas line for the water heater.

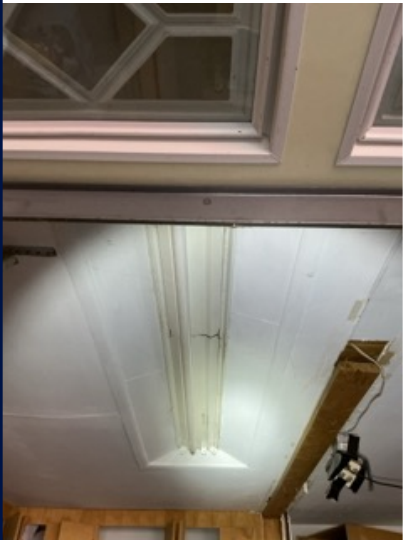
Interior Picture: 7

Multiple lights in the garage are missing. . . . See Interior Picture 7

Multiple lights in the garage are missing.

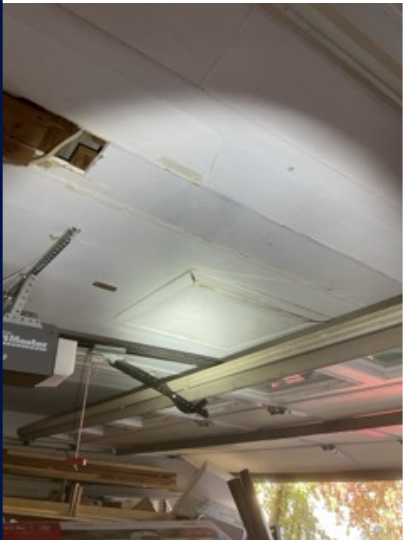
Interior Picture: 9

Could not access the attic access in the garage because of personal items. . . . See Interior Picture 9

Could not access the attic access in the garage because of personal items.

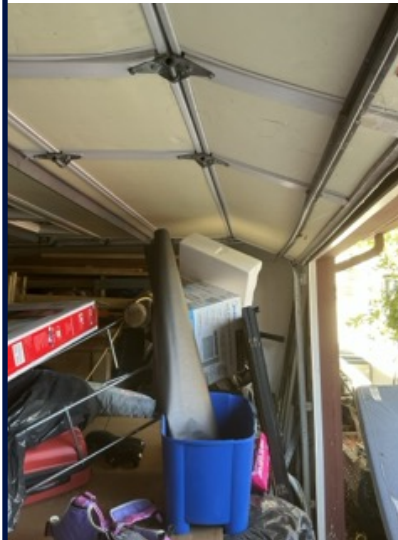
Interior Picture: 10

The owner was working in the garage and had items in the way. I did not test the garage door. . . . See Interior Picture 10

The owner was working in the garage and had items in the way. I did not test the garage door.

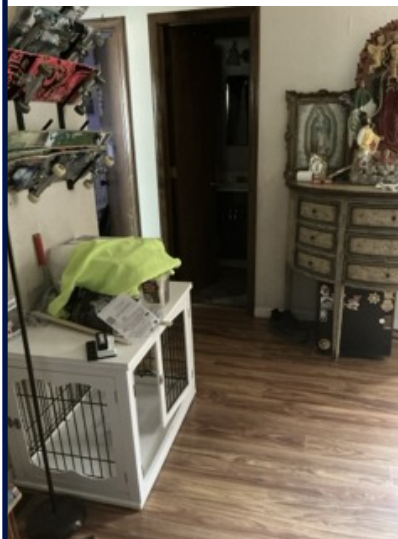
Interior Picture: 12

Not all areas could be seen to inspect. Personal items were in the way.

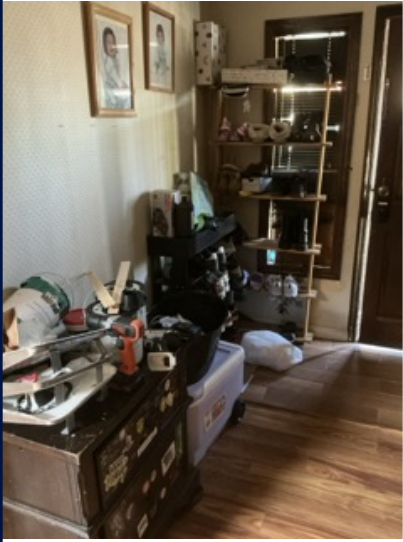
Interior Picture: 13

Not all areas could be seen to inspect. Personal items were in the way.

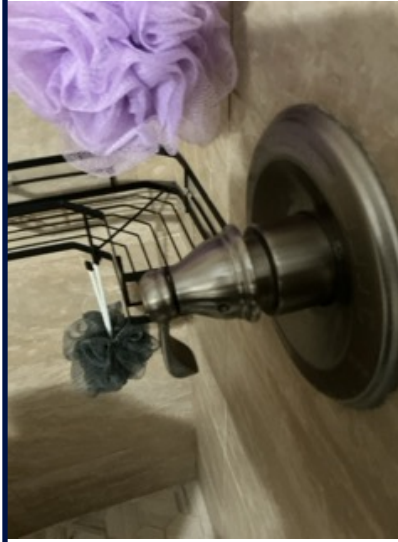
Interior Picture: 14

Hall shower handle spins in circles. It was not tested.

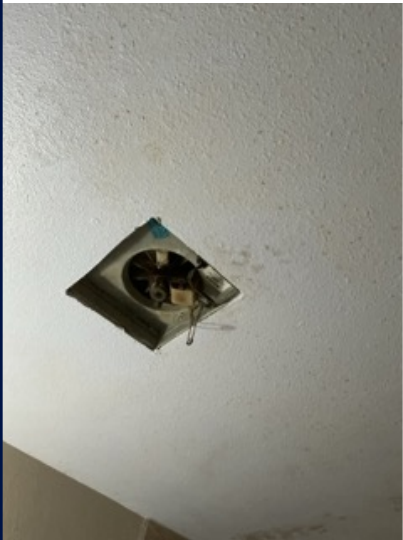
Interior Picture: 15

Hall bathroom ventilation fan is not working.

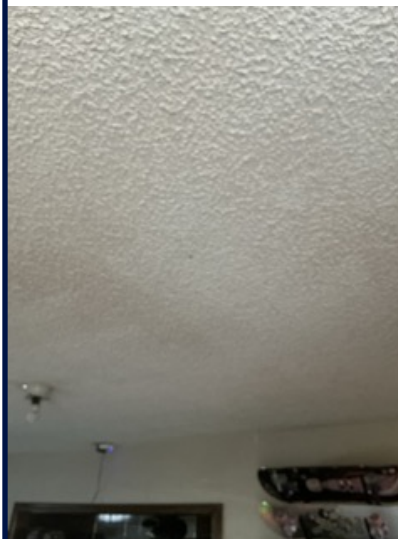
Interior Picture: 18

Because of the age of the home there may be lead/asbestos present. . . . See Interior Picture 18

Because of the age of the home there may be lead/asbestos present.

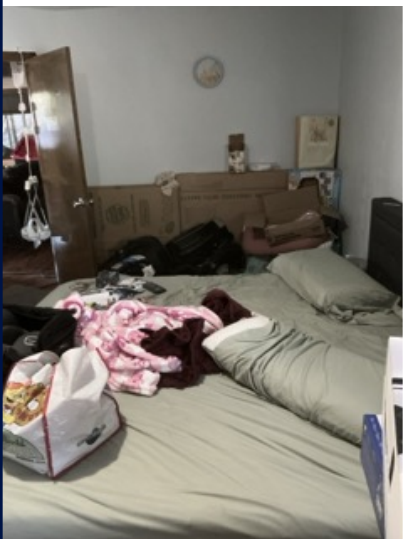
Interior Picture: 24

Not all areas could be seen to inspect. Personal items were in the way.

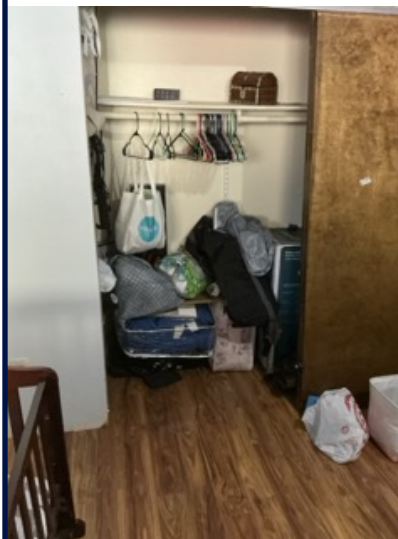
Interior Picture: 25

Not all areas could be seen to inspect. Personal items were in the way.

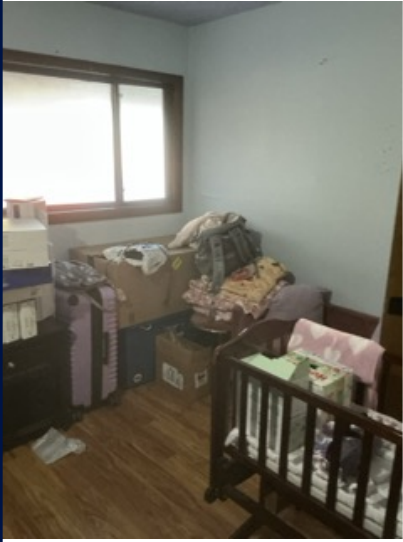
Interior Picture: 26

Not all areas could be seen to inspect. Personal items were in the way.

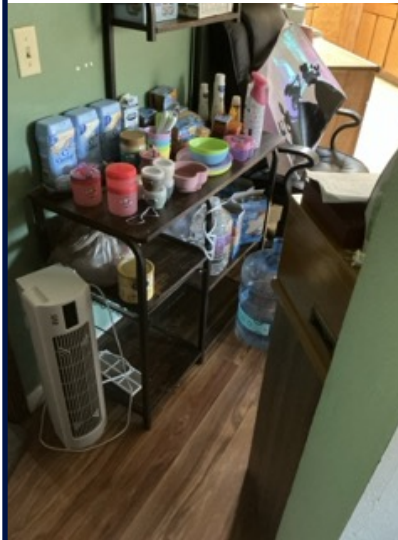
Interior Picture: 29

Not all areas could be seen to inspect. Personal items were in the way.

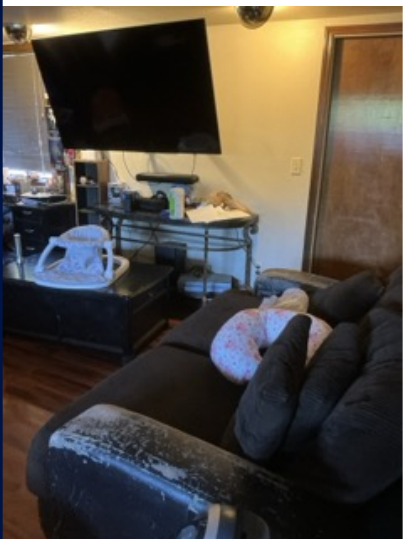
Interior Picture: 30

Not all areas could be seen to inspect. Personal items were in the way.

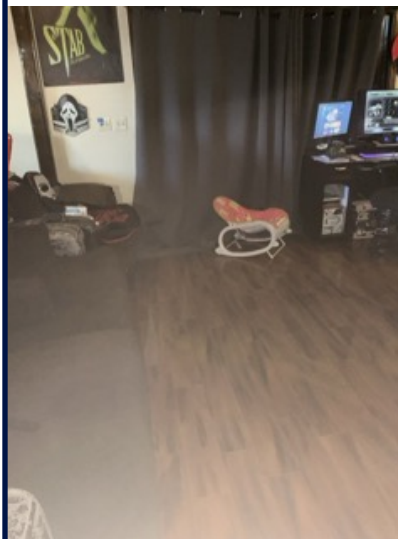
Interior Picture: 31

Not all areas could be seen to inspect. Personal items were in the way.

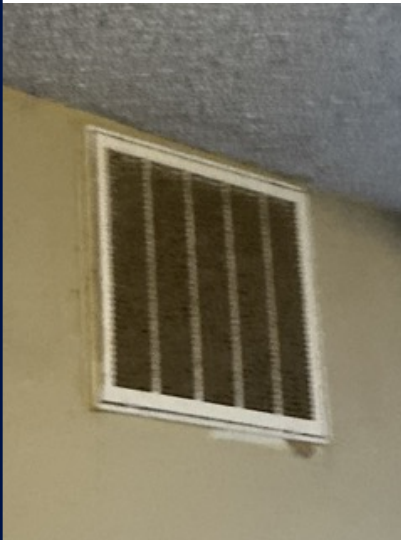
Interior Picture: 32

The furnace filters are very dirty. Recommend changing and servicing the unit. . . . See Interior Picture 32

The furnace filters are very dirty. Recommend changing and servicing the unit.

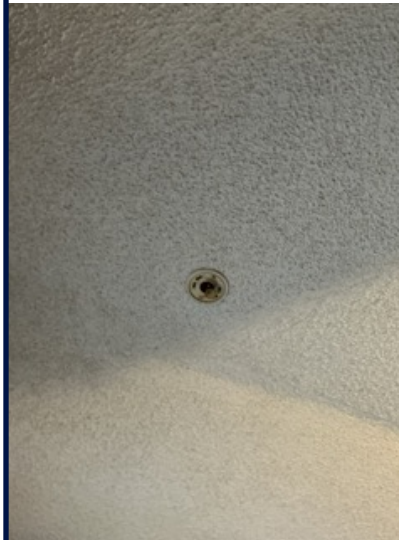
Interior Picture: 35

Smoke detectors were missing in some rooms. Recommend following the guidelines from the National Fire Protection Association. This is a safety issue. . . . See Interior Picture 35

Smoke detectors were missing in some rooms. Recommend following the guidelines from the National Fire Protection Association. This is a safety issue.

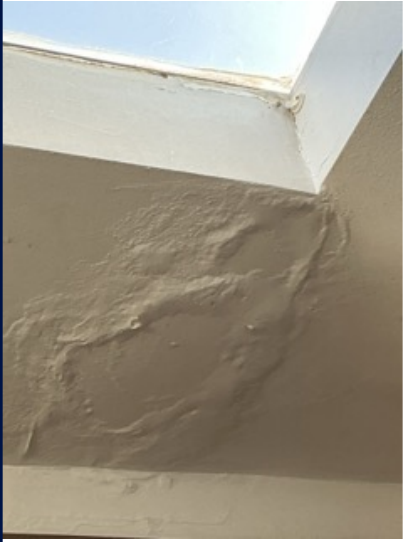
Interior Picture: 38

There is evidence of significant leaking around the skylight. There is damage to the drywall. . . . See Interior Picture 38

There is evidence of significant leaking around the skylight. There is damage to the drywall.

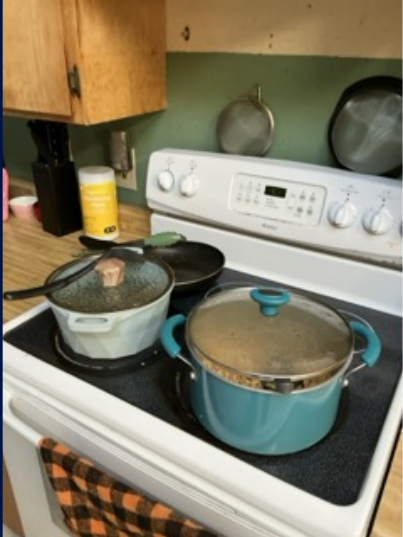
Interior Picture: 40

Stovetop was in use. It was not tested. . . . See Interior Picture 40

Stovetop was in use. It was not tested.

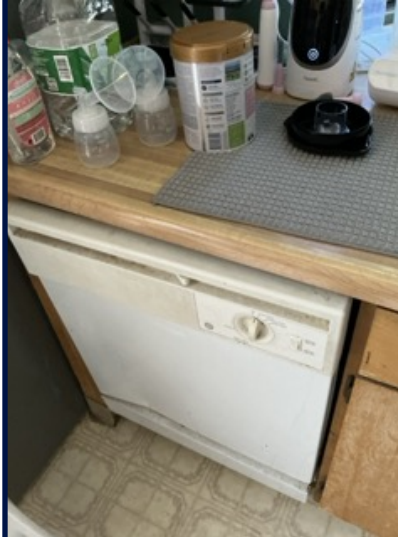
Interior Picture: 41

Dishwasher is not secured and was being used for storage. It was not tested. . . . See Interior Picture 41

Dishwasher is not secured and was being used for storage. It was not tested.

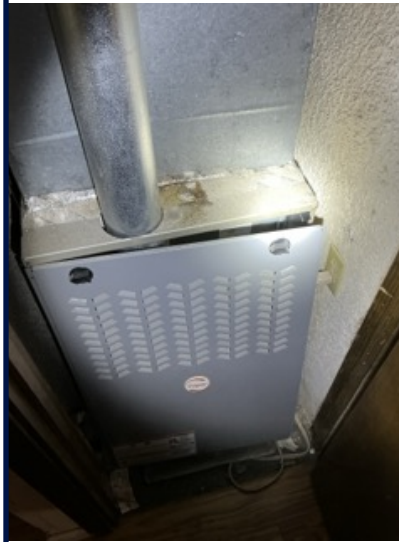
Interior Picture: 45

Furnace is an older unit and the cover was off. . . . See Interior Picture 45

Furnace is an older unit and the cover was off.

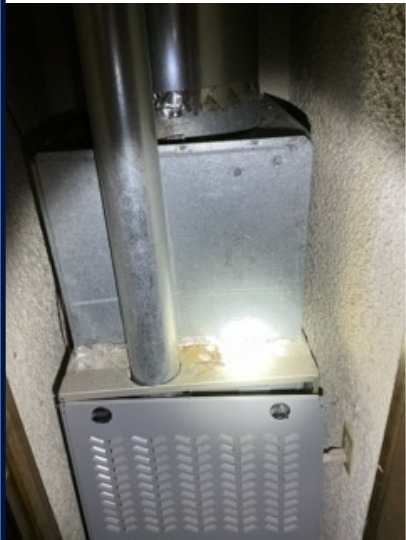
Interior Picture: 46

The closet for the furnace may need better ventilation. . . . See Interior Picture 46

The closet for the furnace may need better ventilation.

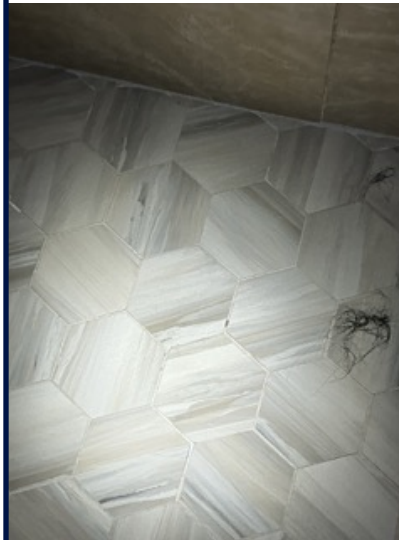
Interior Picture: 47

Small pieces of grout are missing inside the shower. Recommend correction. . . . See Interior Picture 47

Small pieces of grout are missing inside the shower. Recommend correction.

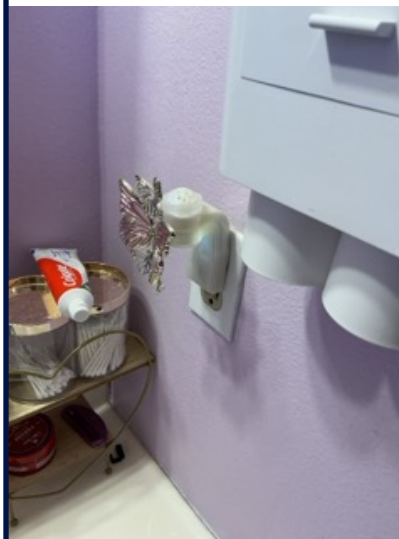
Interior Picture: 55

There are no GFCI's around some of the sinks. They may not have been required when the home was built but we recommend upgrading for safety. . . . See Interior Picture 55

There are no GFCI's around some of the sinks. They may not have been required when the home was built but we recommend upgrading for safety.

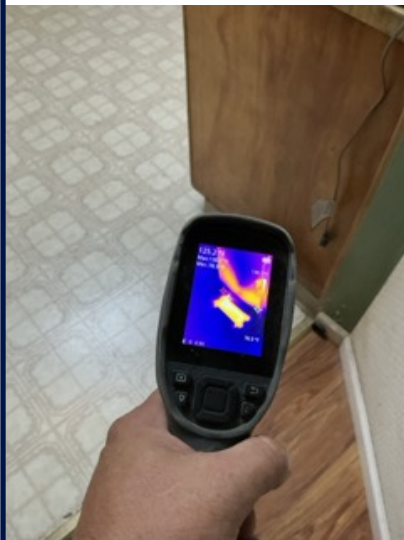
Interior Picture: 64

Furnace temperatures were within the normal range. However, the unit should be serviced every year. Recommend discussing last service with owner. . . . See Interior Picture 64

Furnace temperatures were within the normal range. However, the unit should be serviced every year. Recommend discussing last service with owner.
