FINAL FUNCTIONAL ASSESSMENT OF THE UPPER WABASH RIVER

Upper Wabash River Basin Commission

February 2019

Christopher B. Burke Engineering, LLC 115 West Washington Street, Suite 1368 South Indianapolis, Indiana 46204

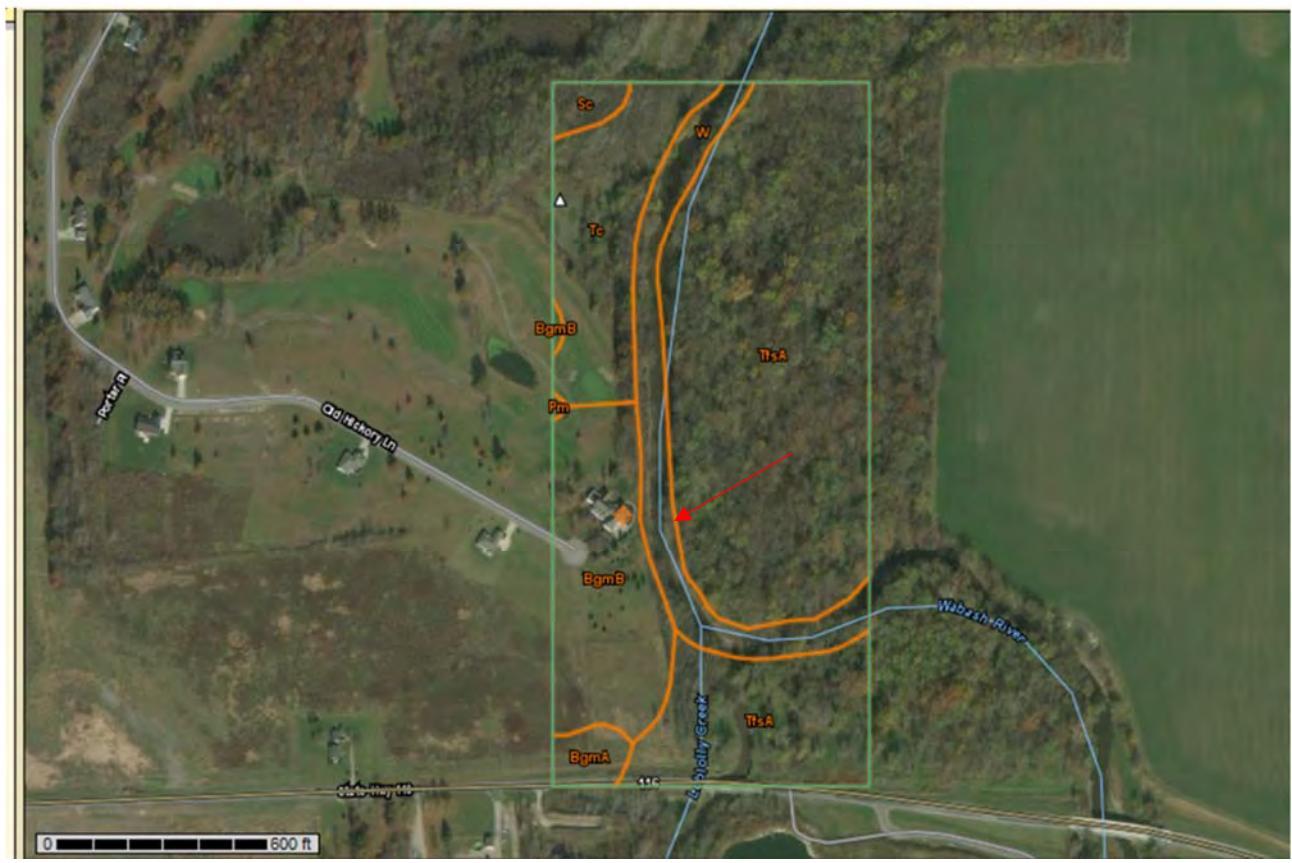
Bank Erosion Hazard Index (BEHI) = very high

This site has approximately 100-feet of the upper valley wall showing tension cracks and slab failure. No additional movement has been observed in the last 6 months. Slope failure is occurring above the left bank primarily in Blount silt loam soil. Note that the site is on the downstream portion of a meander (red arrow).

Figure 8: Detail showing soil map and soil types at UWR 1

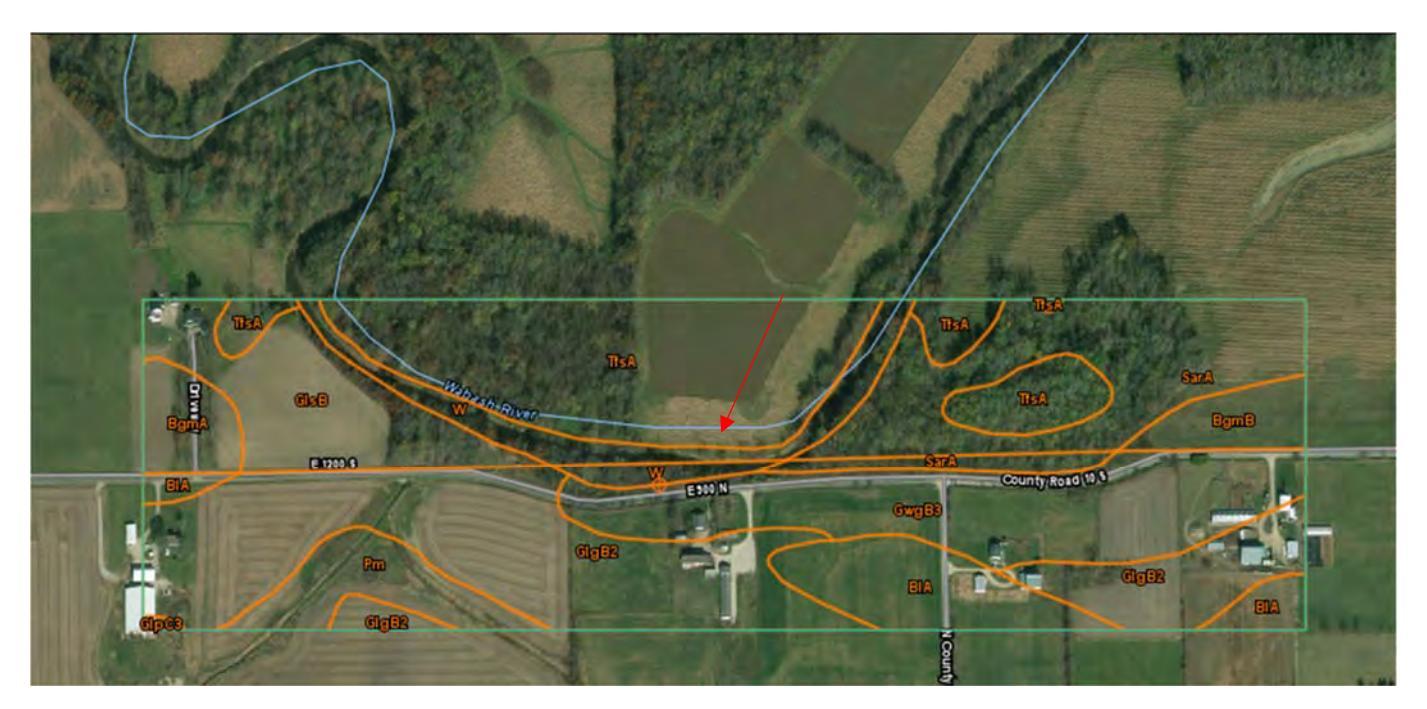
BEHI = high

Tension cracking and slab failure along the left upper valley wall are threatening E CR 1200 S approximately 2 miles east of SR 27. Slope failure has occurred along 500-feet of the upper valley wall (red arrow). Soil in that portion of the left bank is Glynwood-Mississinewa clay loam. Emergency repairs have been made at the site, but slope instability continues.

Figure 11: Detail showing soil map and soil types at UWR 2

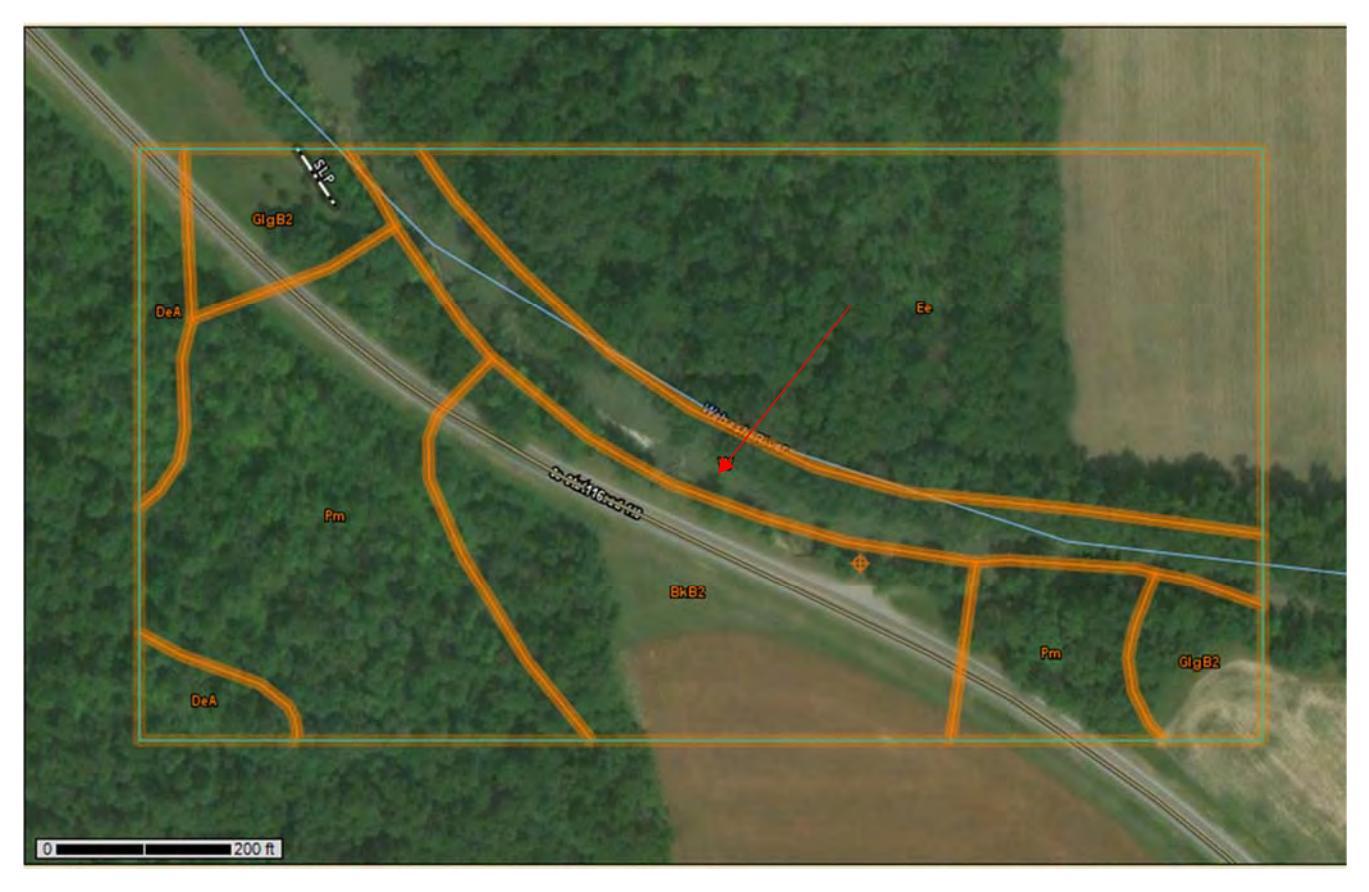
BEHI = extreme

Tension cracking and slab failure of the slope above the left bank. Slope failure is occurring in Blount and Del Rey silt and silty clay loam soils above the left bank. The visible slope failure extends for approximately 700 feet, but tree angle suggests that the failure area is expanding.

Figure 14: UWR 3 Site, south of Vera Cruz. Detail showing soil map and soil types. Web Soil Survey

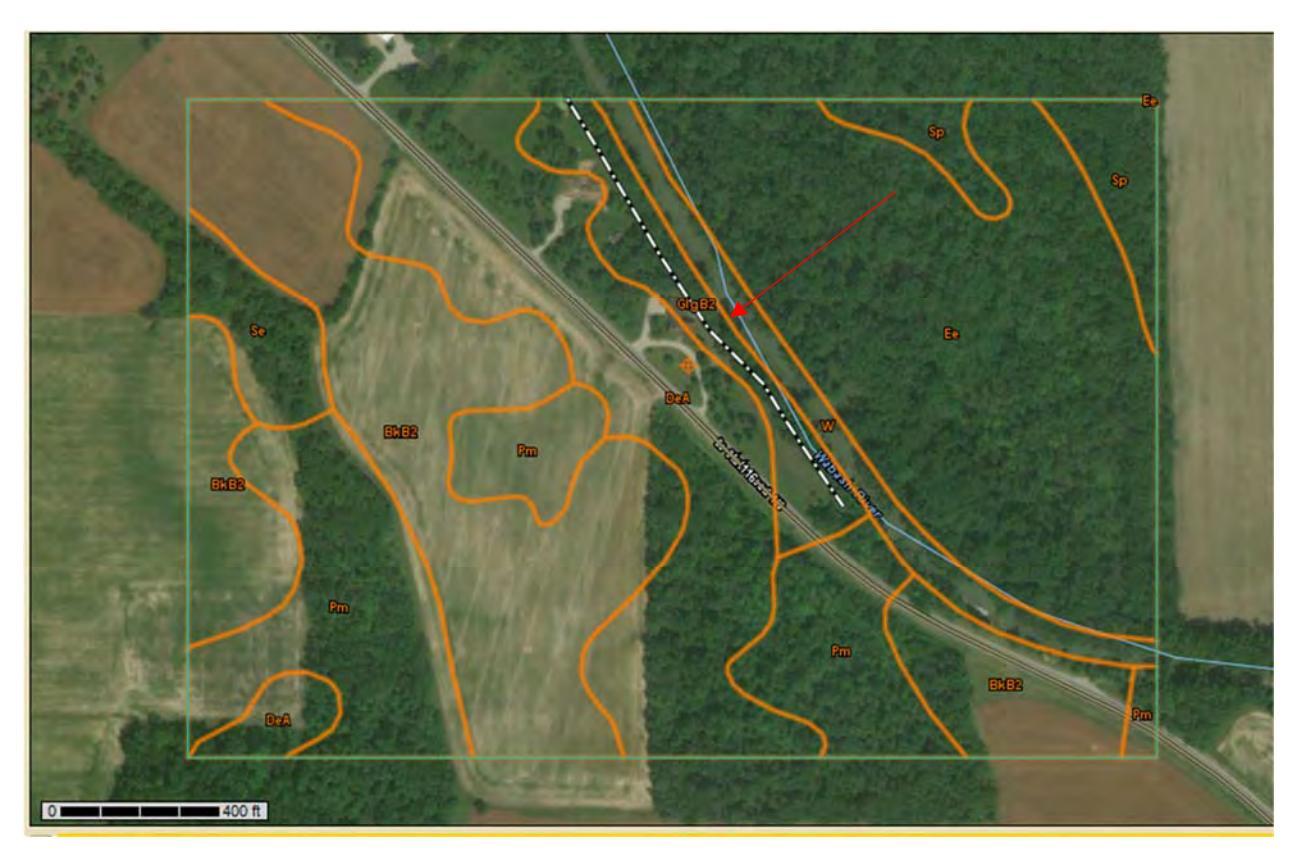
UWR 4, Near private homes south of Vera Cruz near SR116 (40.7058 - 85.0979) BEHI = extreme

Tension cracking and slab failure of upper valley wall above left bank of the Wabash River. Slope failure is occurring in the Glynwood silt loam soil above the left bank (red arrow). Note the dashed slope symbol on the soil map. The slope failure currently extends for about 500 feet, but it is expanding in both the upstream and downstream directions.

Figure 17: UWR4, South of Vera Cruz on SR 116. Detail showing soil map and soil types. Web Soil Survey

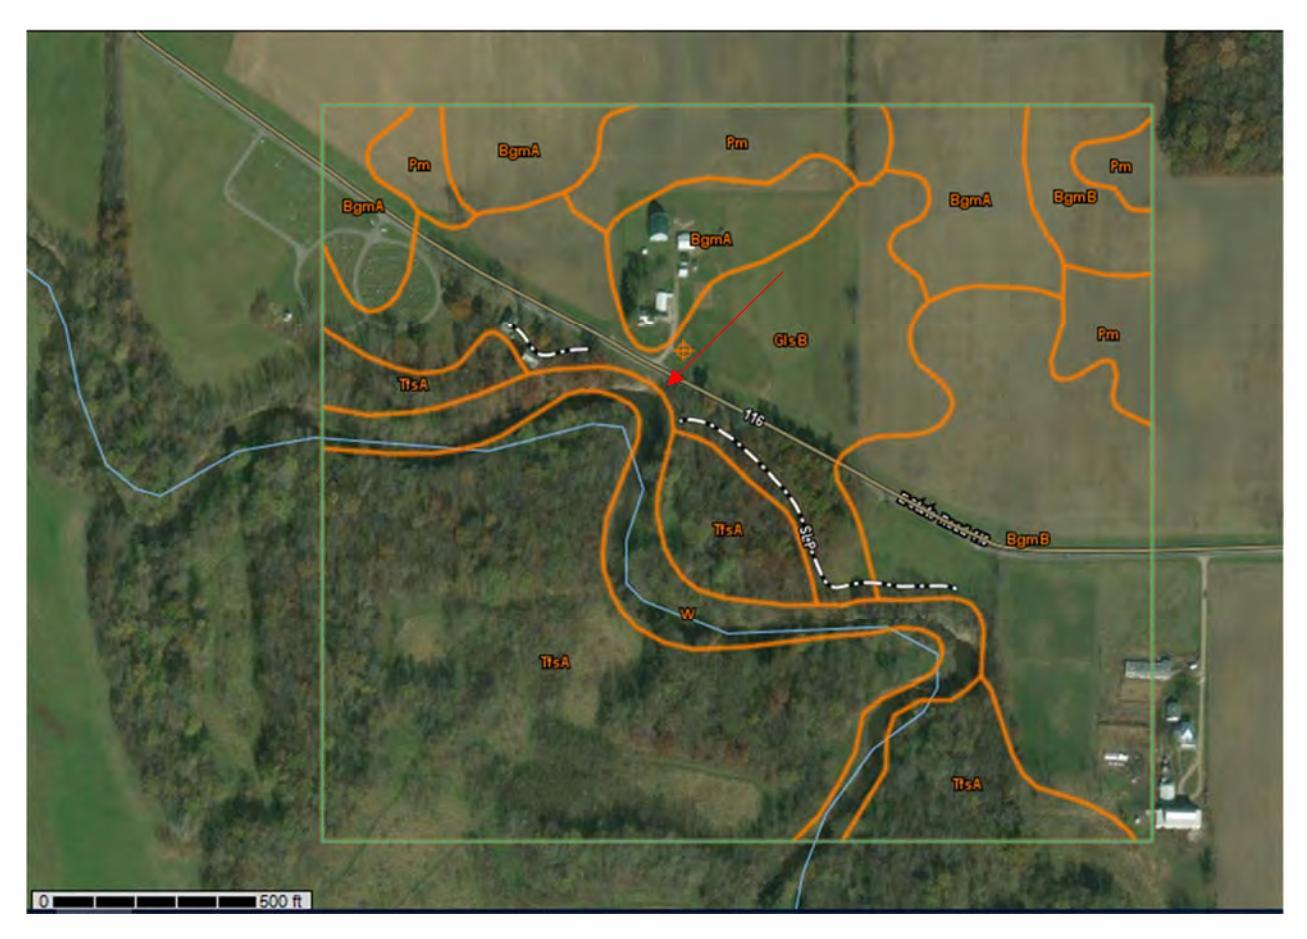
BEHI = extreme

Tension cracking and slab failure along the upper valley wall above the right bank of the Wabash River (red arrow). Slope failure is occurring in Glynwood silt loam. Slope failure extends for about 350 feet in the crest of a very tight meander

Figure 19: Site UWR 6 along SR116 south of Geneva. Detail showing soil map and soil types. Web Soil Survey

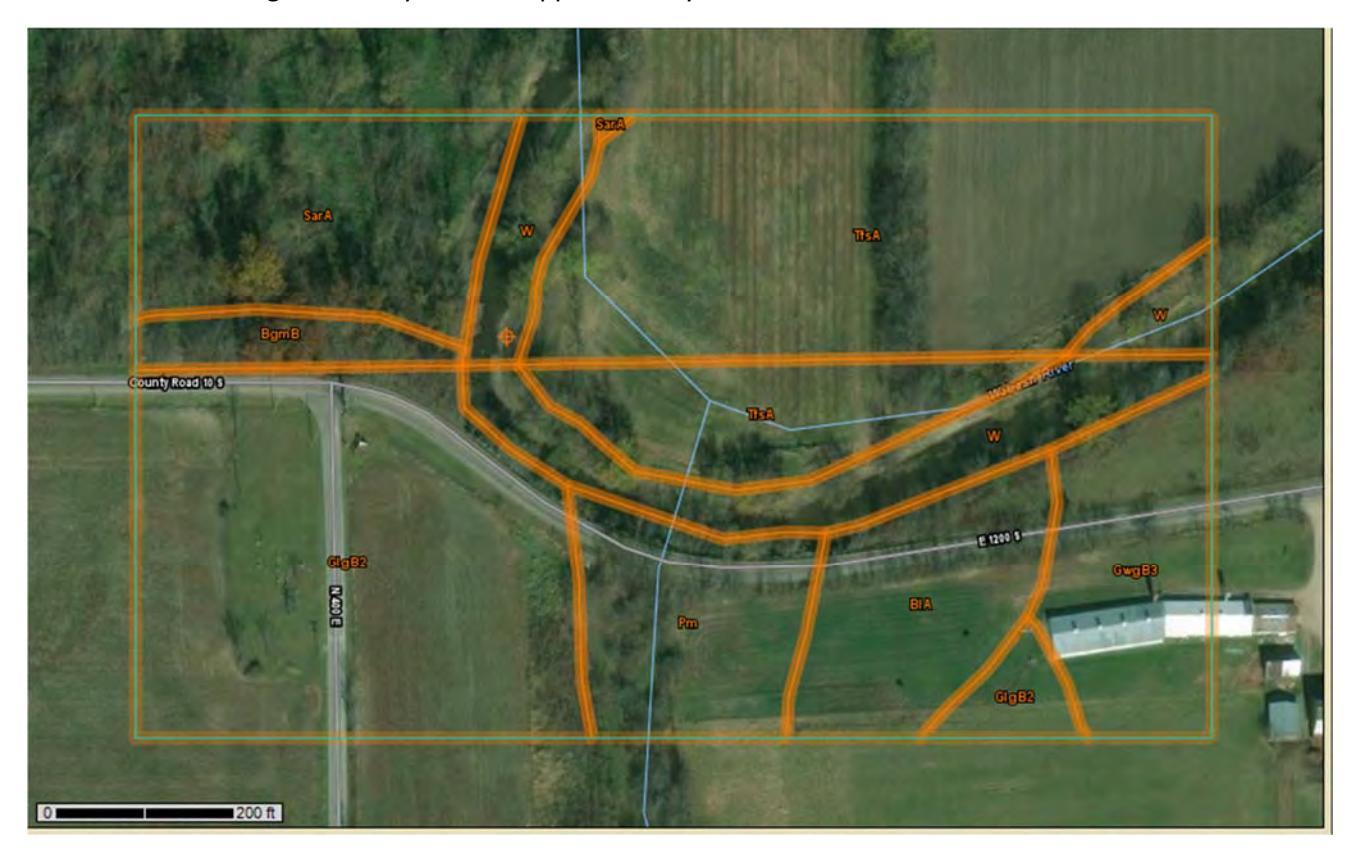
BEHI = extreme

Slope failure along the valley wall above the left bank. Failure is occurring in Pewamo silty clay loam soil. Failure is threatening the county road for approximately 800 feet.

Figure 22: Site UWR 7 along CR 1200 S, Jay County. Detail showing soil map and soil types. Web Soil Survey

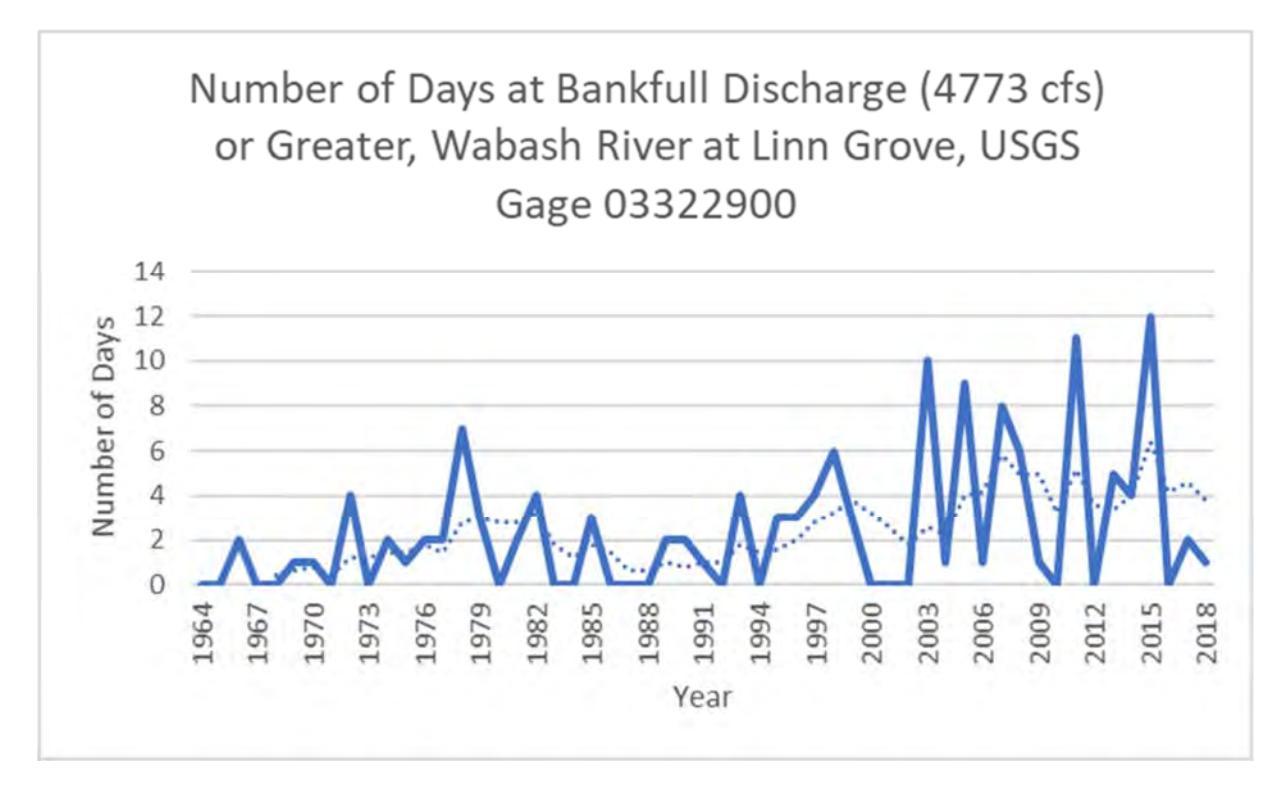
In the study area all the areas of concern have the channel moving very slowly against an upland valley wall and nonalluvial soil, usually resulting in tension cracking and slab failures. Analysis of air photographs combined with landowner observations suggest that the process is recent. An analysis of bankfull discharges in the study area indicates that the number of days that the Wabash River at Linn Grove is at bankfull stage has doubled since 2000 (Figure 24). The increase in days at bankfull stage is matched by a trend in increasing peak discharge which shows an increase in the average peak discharge

from 4000 cfs to 7000 cfs (Figure 25). Since at high flows the river is against the valley wall the upland soil is now saturated on average twice as long as it was just 18 years ago. Our working hypothesis is that more frequent saturation is the main driver of the slope instability. It is important to note in the preceding images of the areas of concern that the channel does not seem to be mobile. It is primarily the upper slope that is failing.

Figure 25: Number of Days at Bankfull Discharge (4773 cfs) or Greater, Wabash River at Linn Grove, USGS Gage 03322900

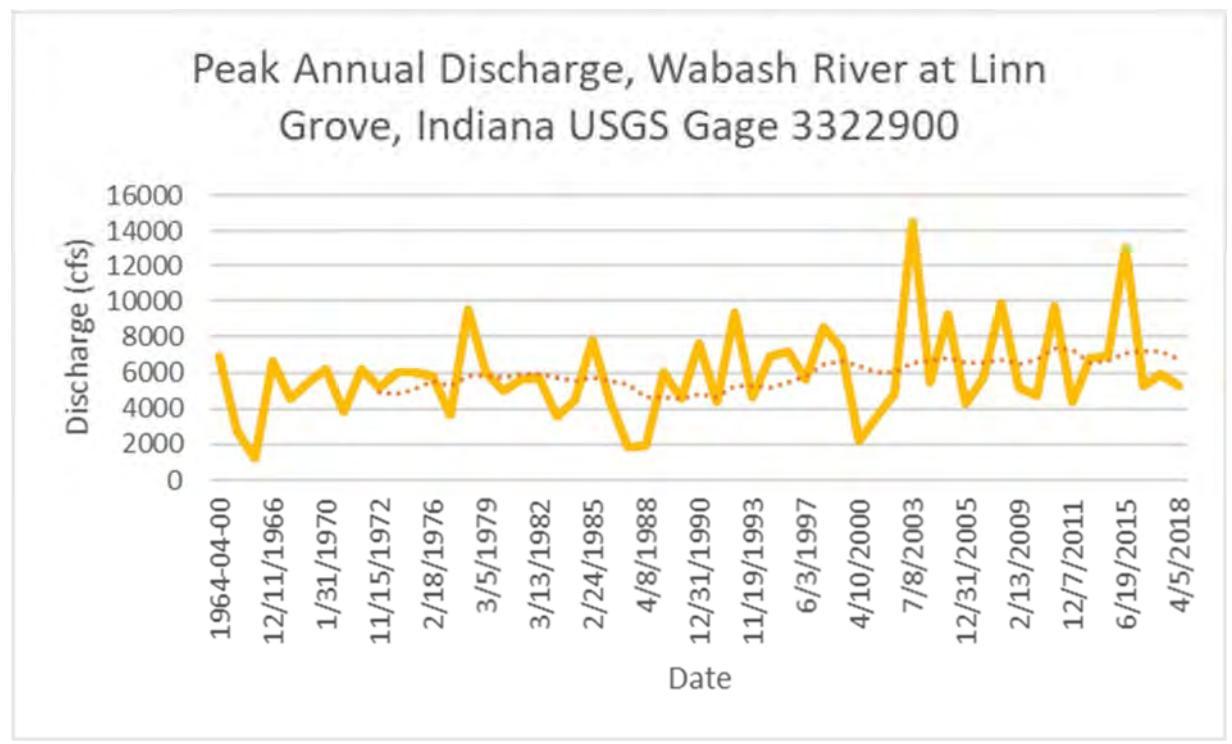
Figure 26: Peak Annual Discharge, Wabash River at Linn Grove, Indiana USGS Gage 3322900
