THERMAL IMAGE REPORT

Client	
Name	THE LANDMARK CONDOMINIUM
Site	20185 E COUNTRY CLUB DRIVE AVENTURA, FL 33180
Insp. Date	02/27/2024

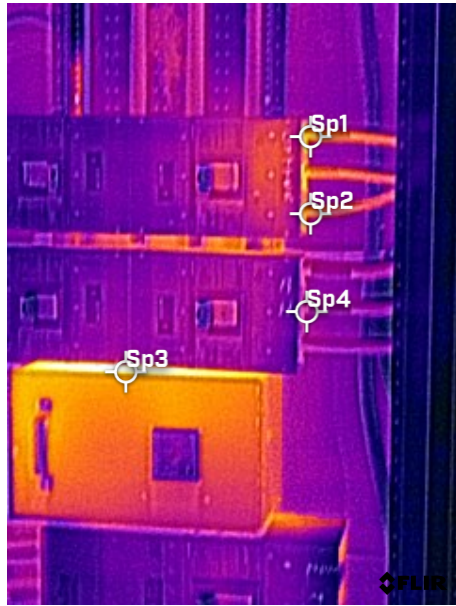
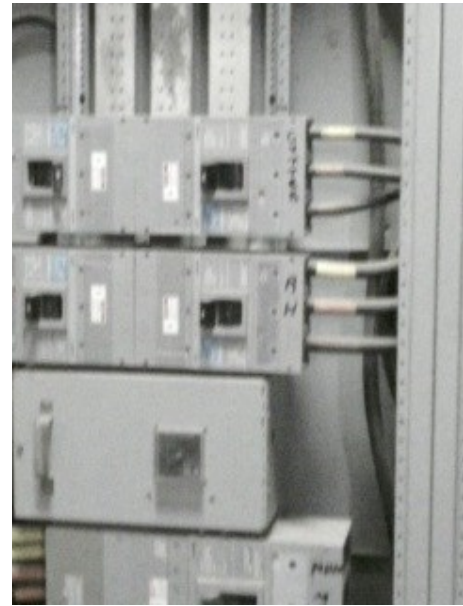
THE LANDMARK CONDOMINIUM	
Date	02/27/2024
Location	Main Electrical Room
Equipment	NDH Sec 1
Component	Switchboard
File name	FLIR0283.jpg
Condition	NORMAL

None.

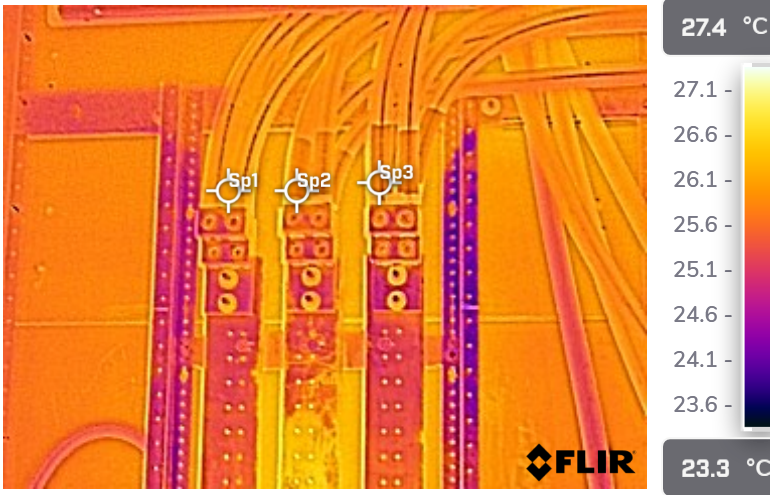
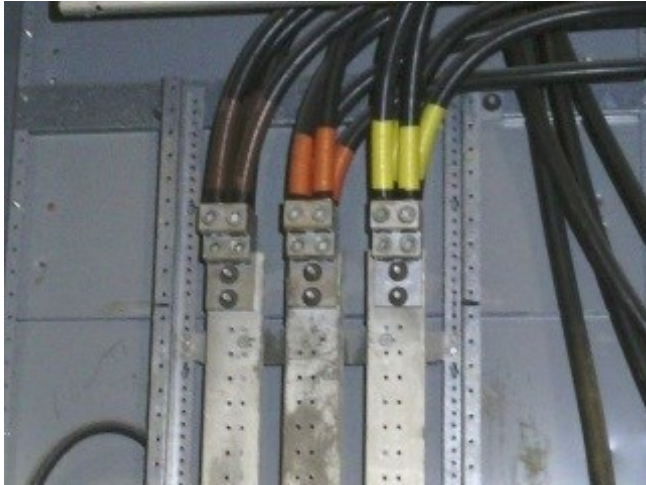
THE LANDMARK CONDOMINIUM	
Date	02/27/2024
Location	Main Electrical Room
Equipment	NDH Sec 1
Component	Switchboard BUS
File name	FLIR0289.jpg
Condition	NORMAL

None.

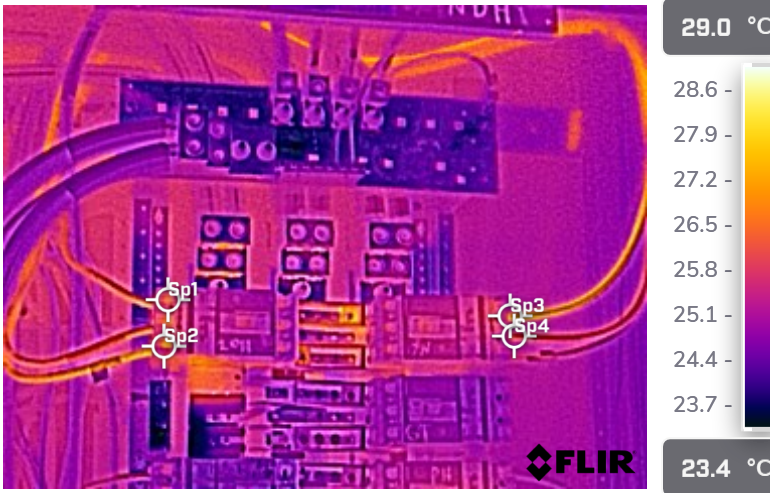
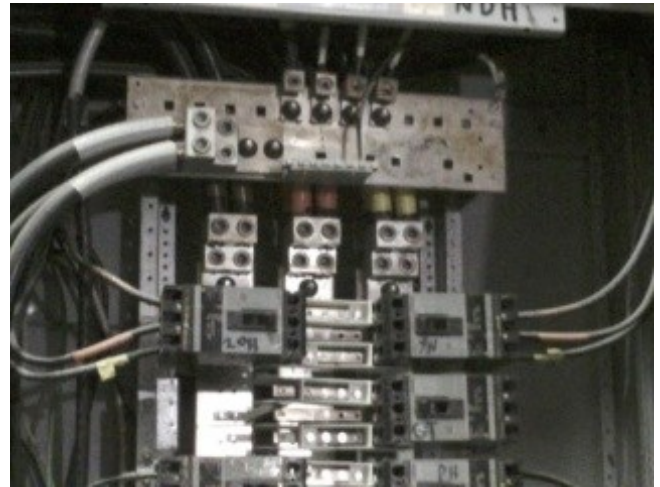
Date	02/27/2024
Location	Main Electrical Room
Equipment	NDH Sec 2
Component	Switchboard
File name	FLIR0295.jpg
Condition	NORMAL

None.

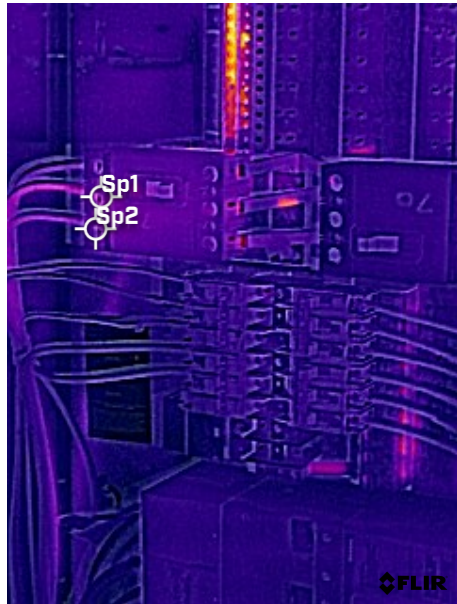
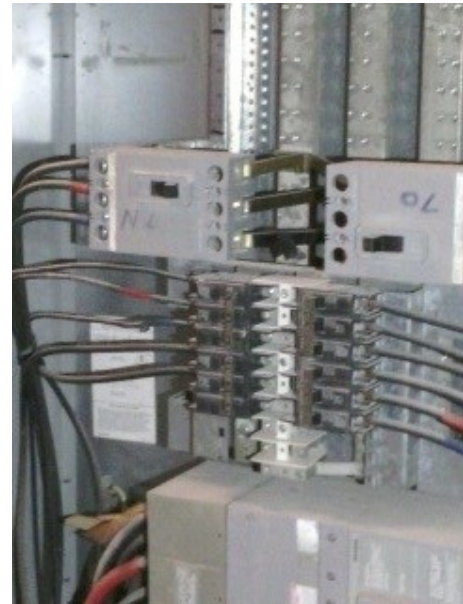
THE LANDMARK CONDOMINIUM	
Date	02/27/2024
Location	Main Electrical Room
Equipment	NDL
Component	Switchboard
File name	FLIR0321.jpg
Condition	NORMAL

None.

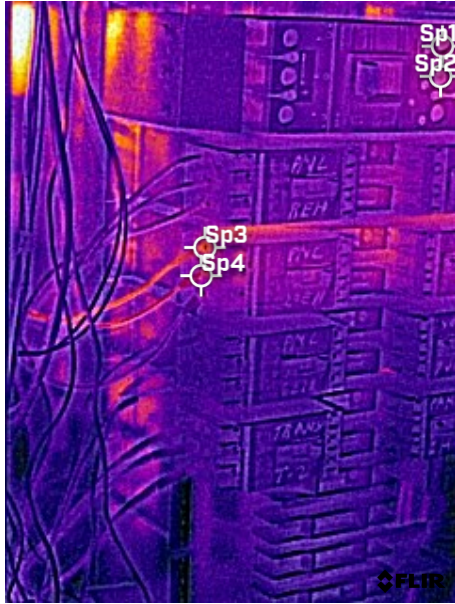
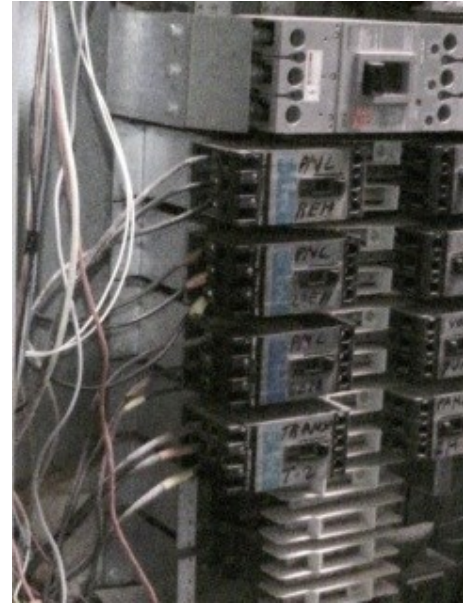
THE LANDMARK CONDOMINIUM	
Date	02/27/2024
Location	Main Electrical Room
Equipment	EDH
Component	Switchboard
File name	FLIR0337.jpg
Condition	NORMAL

None.

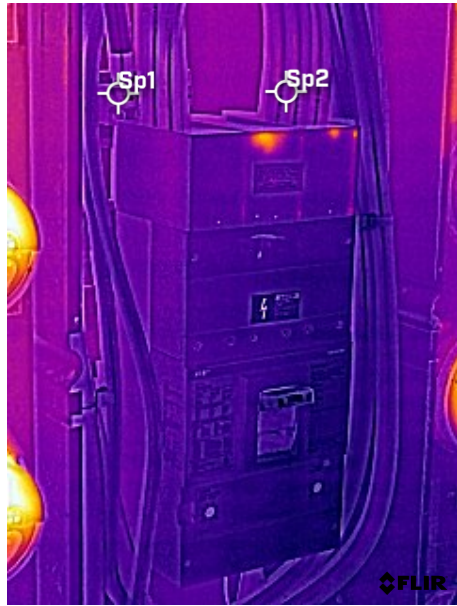
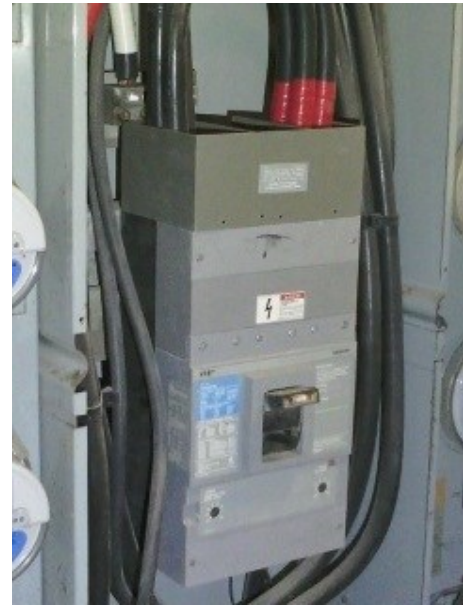
THE LANDMARK CONDOMINIUM	
Date	02/27/2024
Location	Main Electrical Room
Equipment	MC1
Component	Main Circuit Breaker
File name	FLIR0351.jpg
Condition	NORMAL

None.

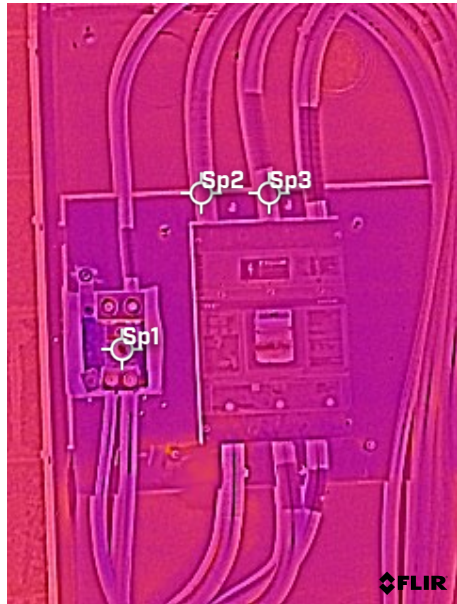
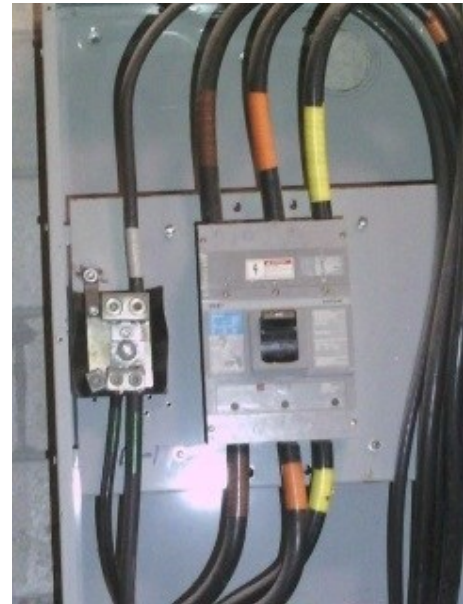
Date	02/27/2024
Location	Main Electrical Room
Equipment	M17
Component	Main Circuit Breaker
File name	FLIR0365.jpg
Condition	NORMAL

None.

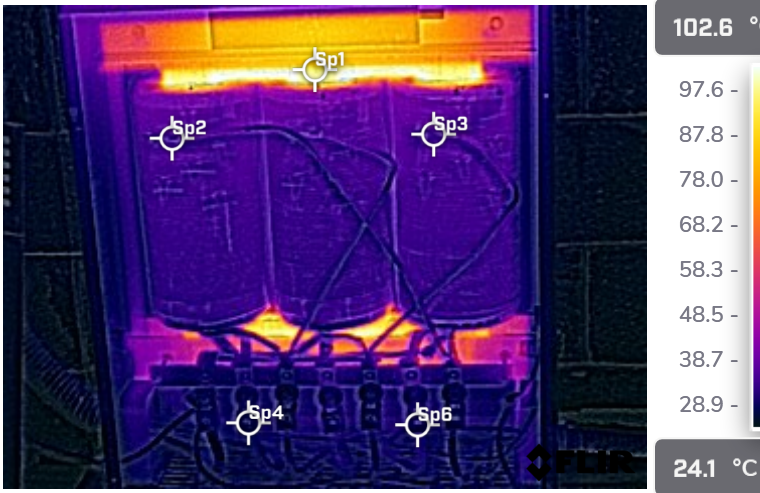
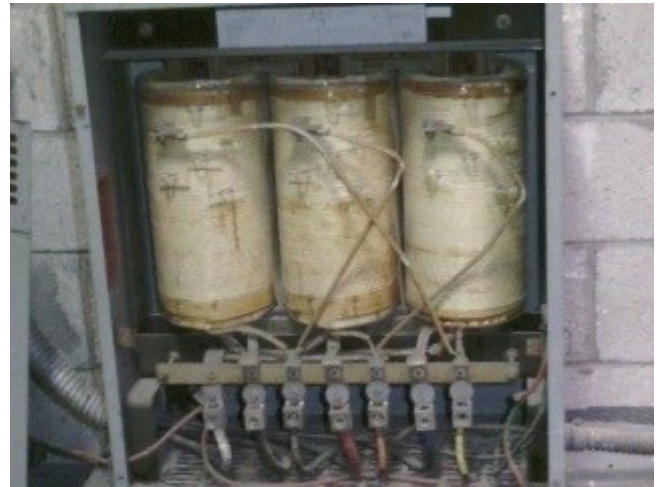
THE LANDMARK CONDOMINIUM	
Date	02/27/2024
Location	Main Electrical Room
Equipment	T2
Component	Transformer
File name	FLIR0379.jpg
Condition	NORMAL

None.

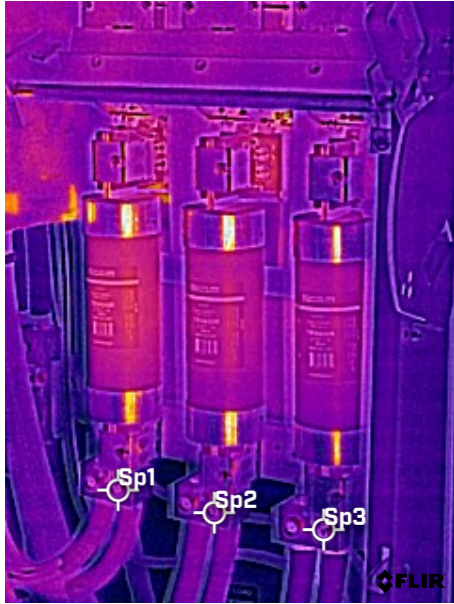
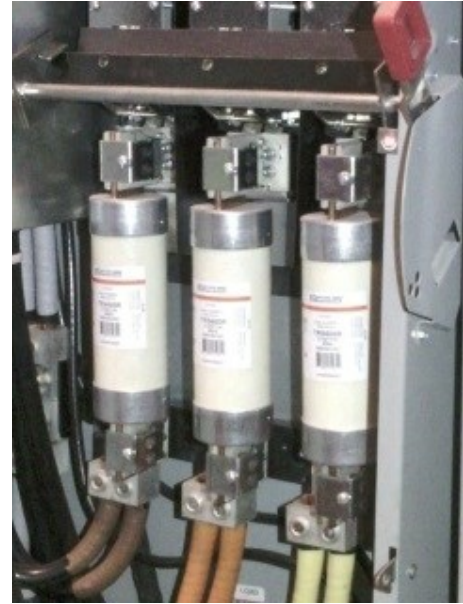
Date	02/27/2024
Location	Main Electrical Room
Equipment	Main 4
Component	Disconnect Switch
File name	FLIR0393.jpg
Condition	NORMAL

None.

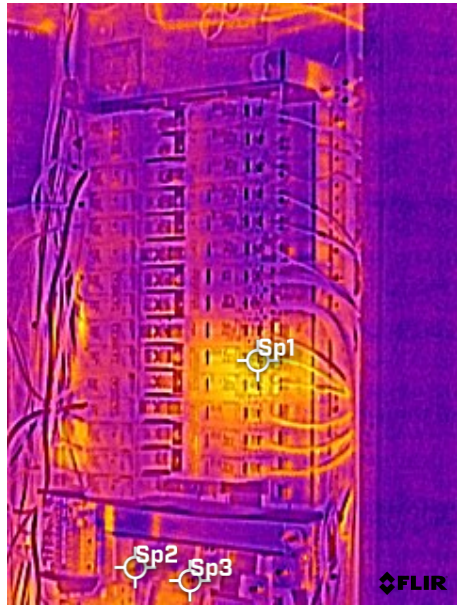
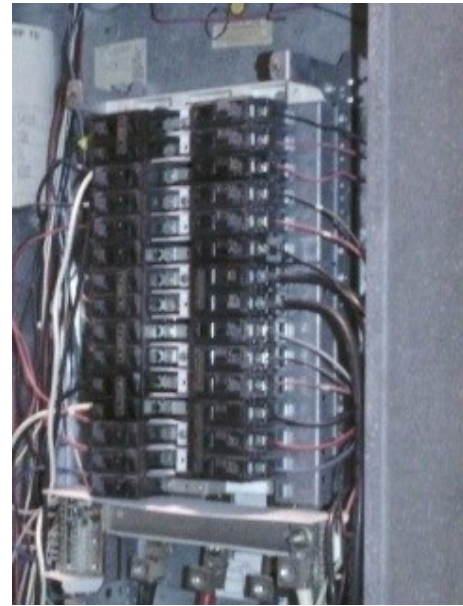
THE LANDMARK CONDOMINIUM	
Date	02/27/2024
Location	Main Electrical Room
Equipment	OL
Component	Panelboard
File name	FLIR0401.jpg
Condition	NORMAL

None.

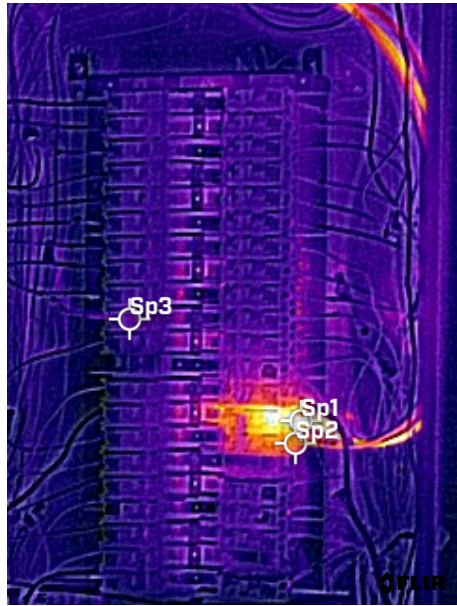
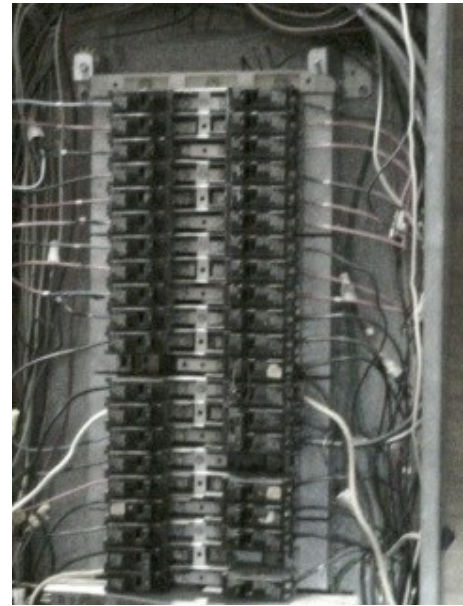
THE LANDMARK CONDOMINIUM	
Date	02/27/2024
Location	Main Electrical Room
Equipment	NL
Component	Panelboard
File name	FLIR0415.jpg
Condition	NORMAL

None.

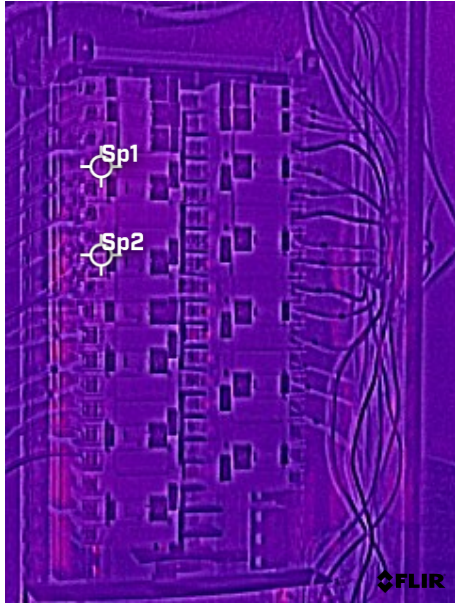
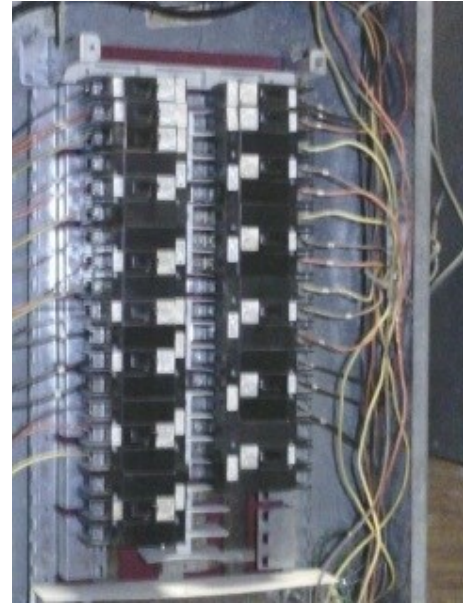
THE LANDMARK CONDOMINIUM	
Date	02/27/2024
Location	Main Electrical Room
Equipment	NO ID (NH)
Component	Panelboard
File name	FLIR0421.jpg
Condition	NORMAL

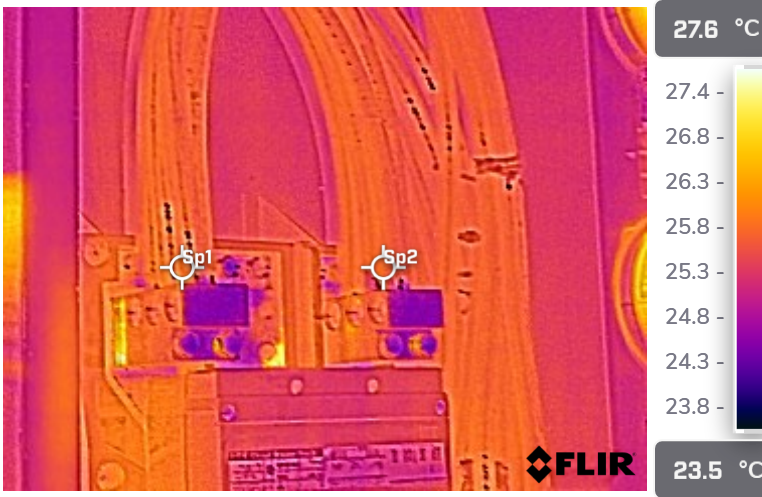
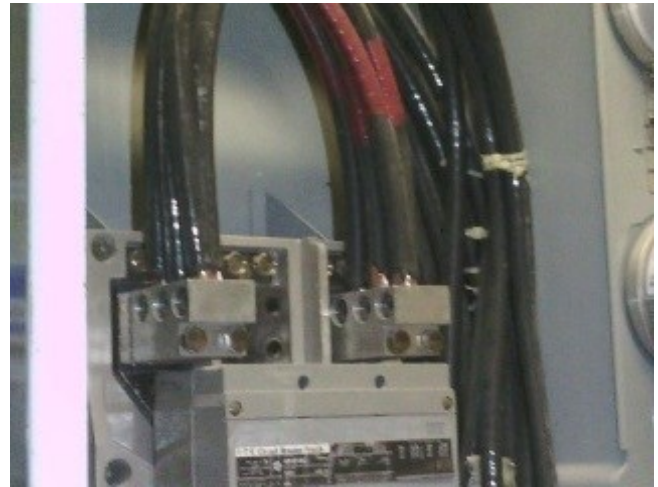
THE LANDMARK CONDOMINIUM	
Date	02/27/2024
Location	PH Meter Room
Equipment	NO ID
Component	Main Circuit Breaker
File name	FLIR0439.jpg
Condition	NORMAL

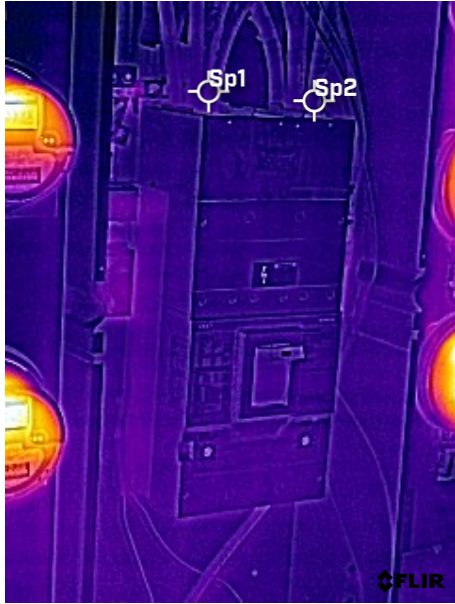
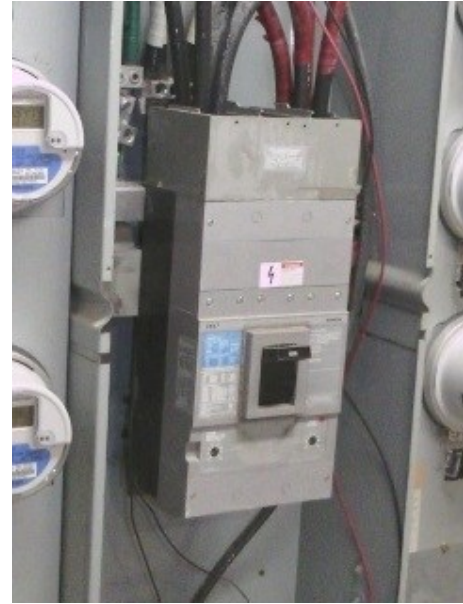
Date	02/27/2024
Location	Level 25 Meter Room
Equipment	NO ID
Component	Main Circuit Breaker
File name	FLIR0451.jpg
Condition	NORMAL

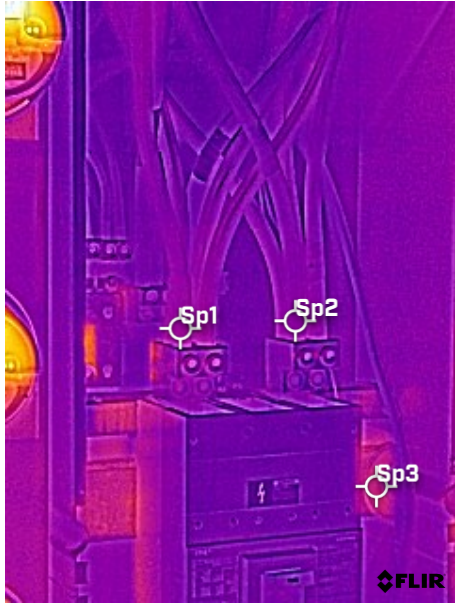
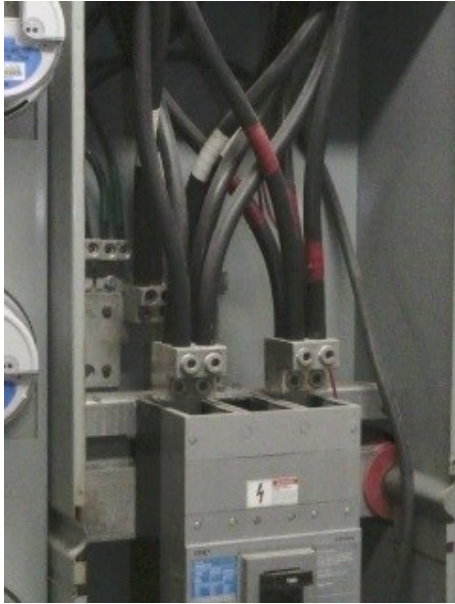
THE LANDMARK CONDOMINIUM	
Date	02/27/2024
Location	Level 22 Meter Room
Equipment	NO ID
Component	Main Circuit Breaker
File name	FLIR0467.jpg
Condition	NORMAL

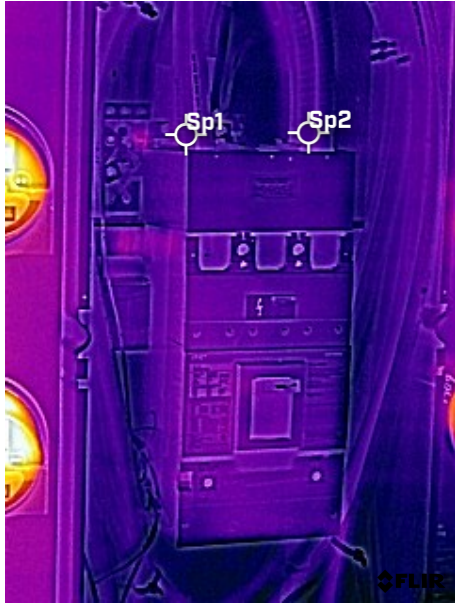
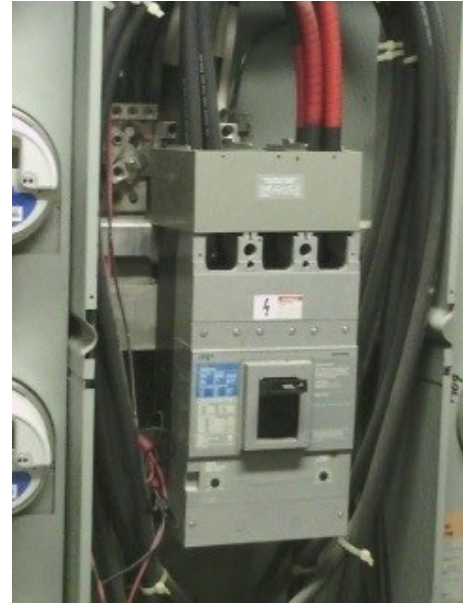
THE LANDMARK CONDOMINIUM	
Date	02/27/2024
Location	Level 20 Meter Room
Equipment	NO ID
Component	Main Circuit Breaker
File name	FLIR0475.jpg
Condition	NORMAL

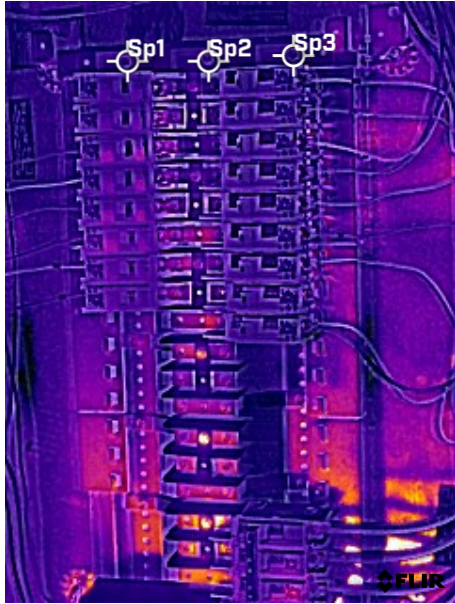
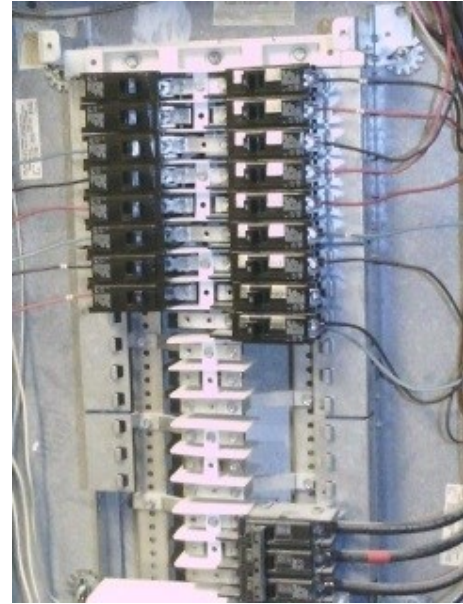
Date	02/27/2024
Location	Level 20 Meter Room
Equipment	20L
Component	Panelboard
File name	FLIR0485.jpg
Condition	NORMAL

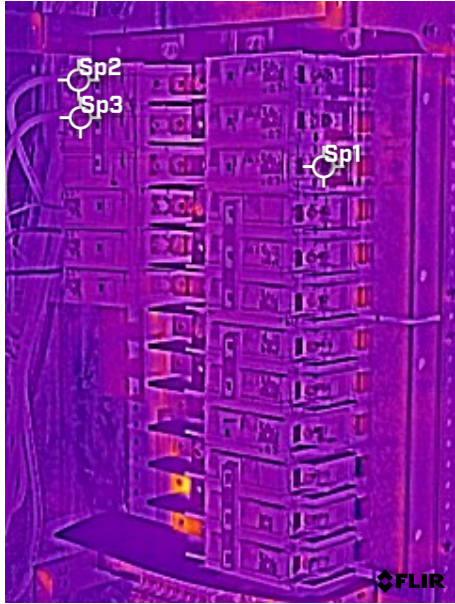
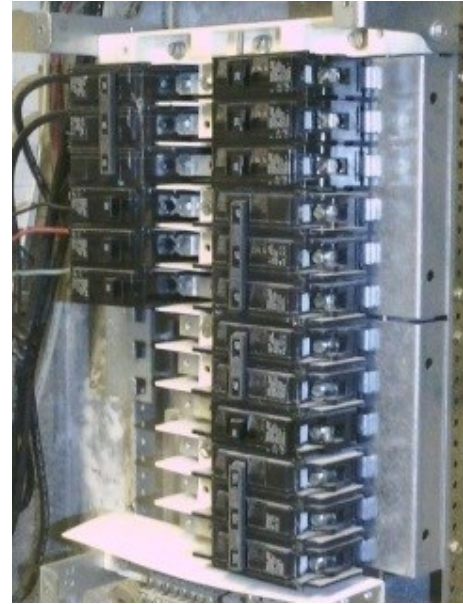
Date	02/27/2024
Location	Level 20 Meter Room
Equipment	20EL
Component	Panelboard
File name	FLIR0491.jpg
Condition	NORMAL

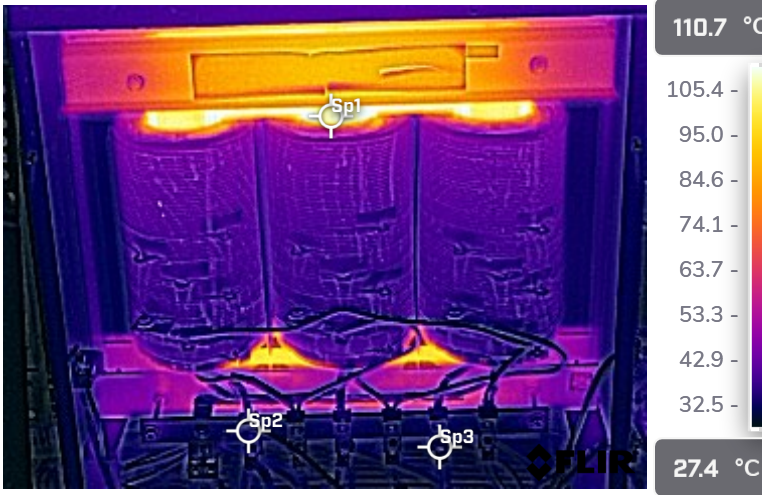
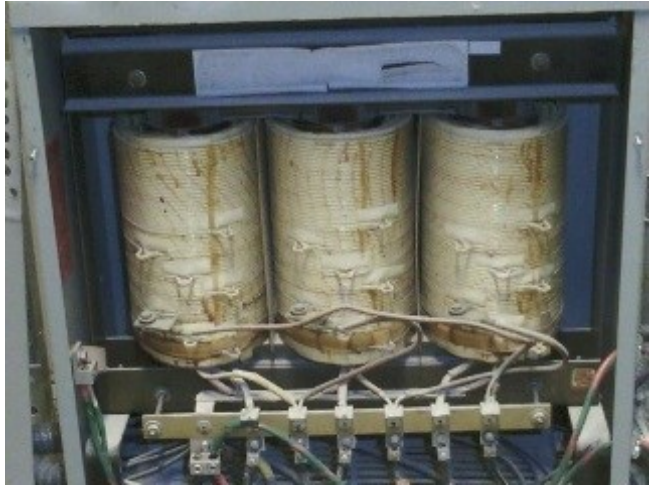
THE LANDMARK CONDOMINIUM	
Date	02/27/2024
Location	Level 20 Meter Room
Equipment	T6
Component	Transformer
File name	FLIR0495.jpg
Condition	NORMAL

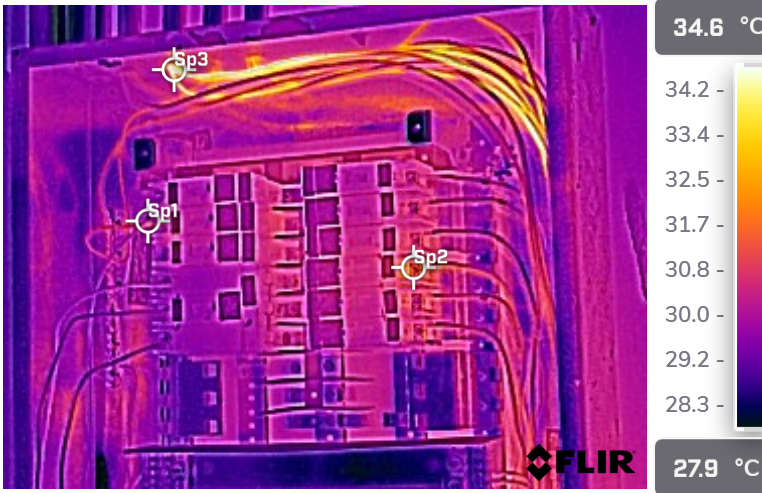
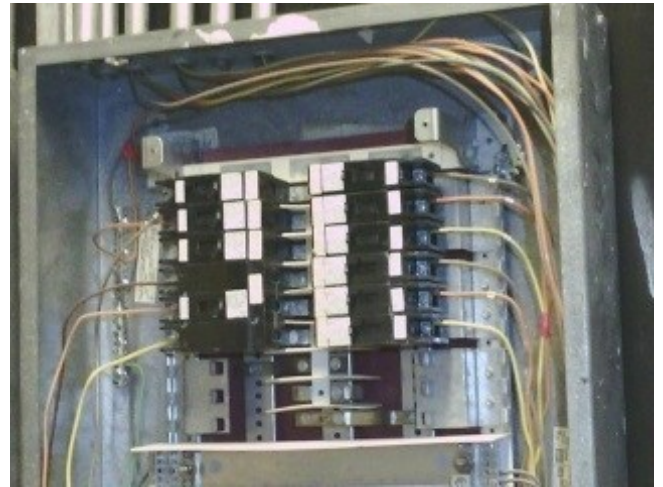
Date	02/27/2024
Location	Level 20 Meter Room
Equipment	EDH
Component	Panelboard
File name	FLIR0501.jpg
Condition	NORMAL

Sp1	29.9 °C
Sp2	31.2 °C
Sp3	36.0 °C

None.

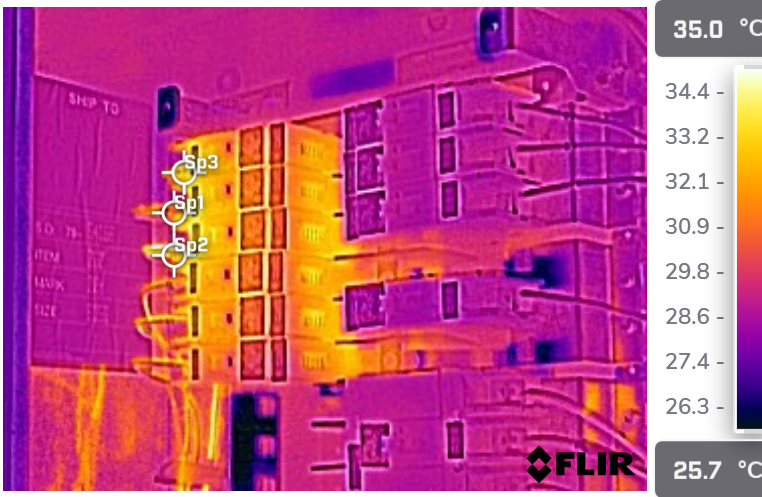
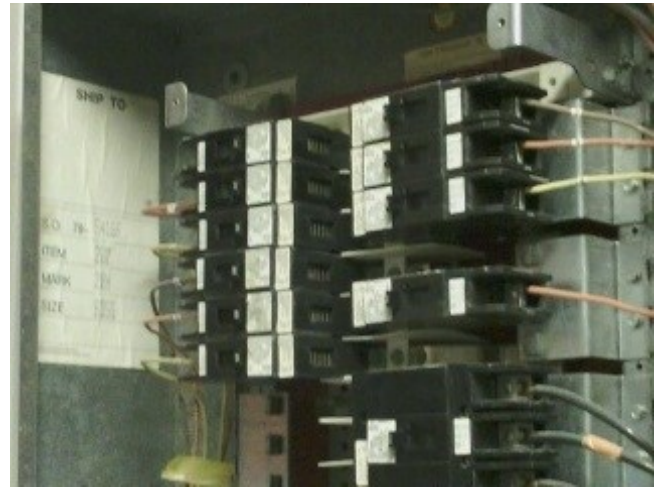
THE LANDMARK CONDOMINIUM	
Date	02/27/2024
Location	Level 20 Meter Room
Equipment	NDH
Component	Panelboard
File name	FLIR0511.jpg
Condition	NORMAL

Sp1	31.5 °C
Sp2	32.1 °C
Sp3	32.8 °C

None.

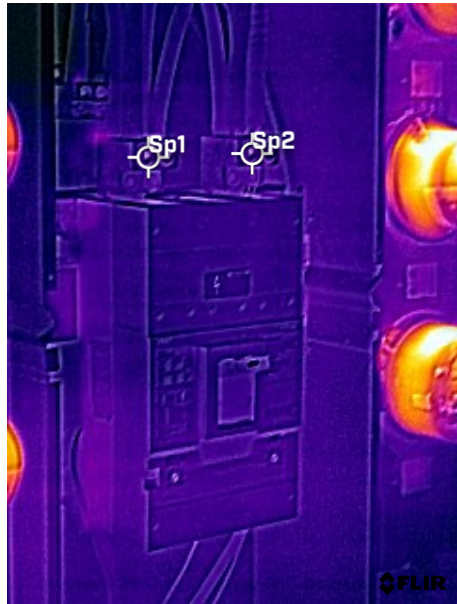
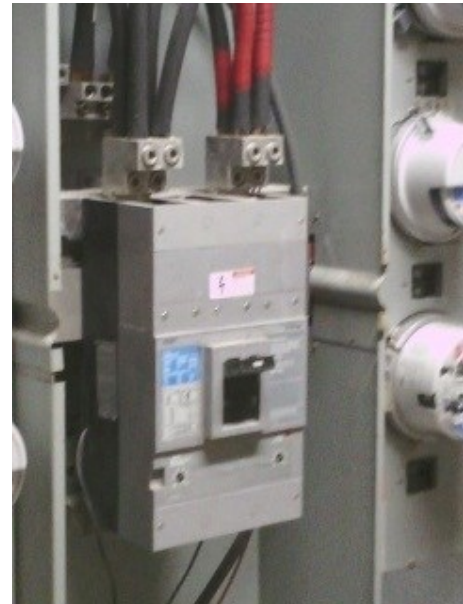
THE LANDMARK CONDOMINIUM	
Date	02/27/2024
Location	Level 18 Meter Room
Equipment	NO ID
Component	Main Circuit Breaker
File name	FLIR0517.jpg
Condition	NORMAL

Sp1	22.8 °C
Sp2	22.9 °C

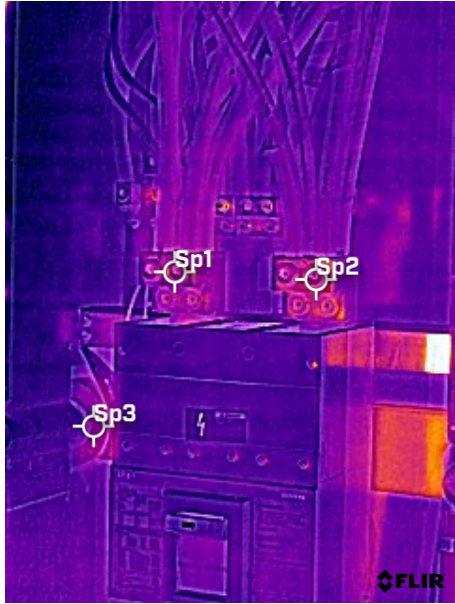
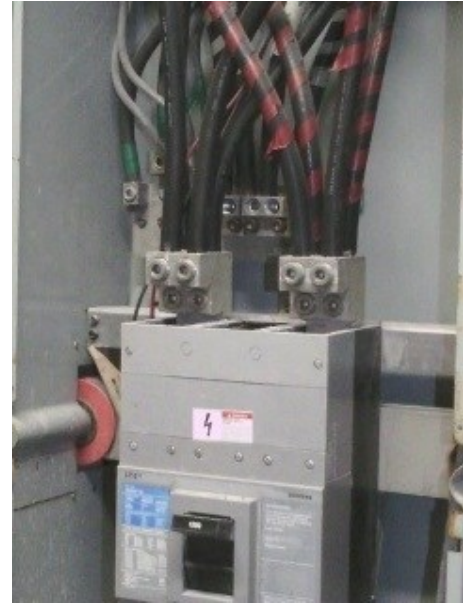
Date	02/27/2024
Location	Level 14 Meter Room
Equipment	NO ID
Component	Main Circuit Breaker
File name	FLIR0529.jpg
Condition	NORMAL

Sp1	23.5 °C
Sp2	23.5 °C
Sp3	23.3 °C

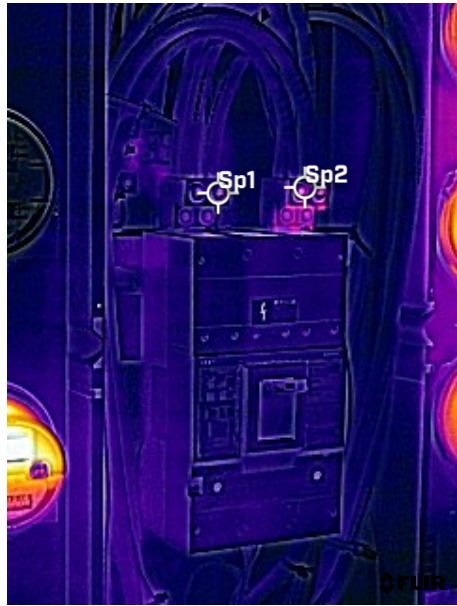
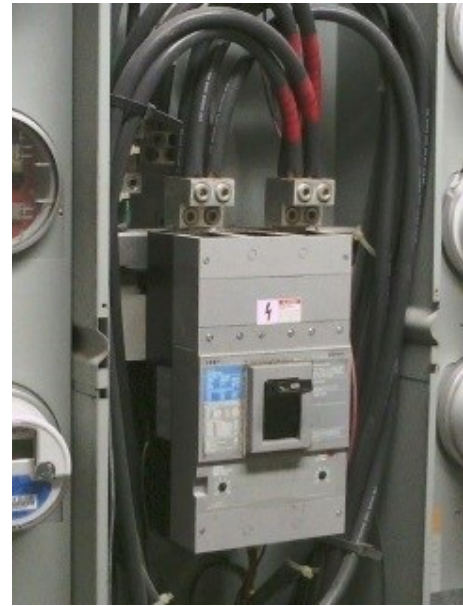
Date	02/27/2024
Location	Level 11 Meter Room
Equipment	NO ID
Component	Main Circuit Breaker
File name	FLIR0535.jpg
Condition	NORMAL

Sp1	27.1 °C
Sp2	27.6 °C

None.

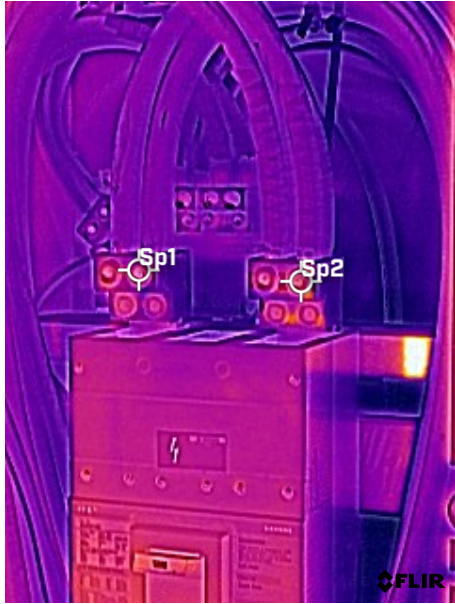
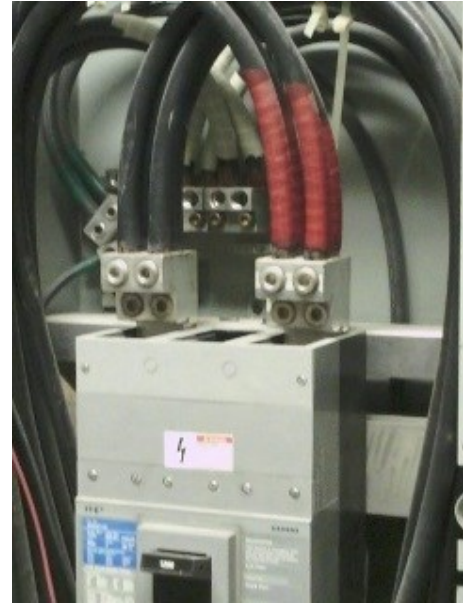
THE LANDMARK CONDOMINIUM	
Date	02/27/2024
Location	Level 7 Meter Room
Equipment	NO ID
Component	Main Circuit Breaker
File name	FLIR0555.jpg
Condition	NORMAL

Sp1	28.7 °C
Sp2	28.9 °C

None.

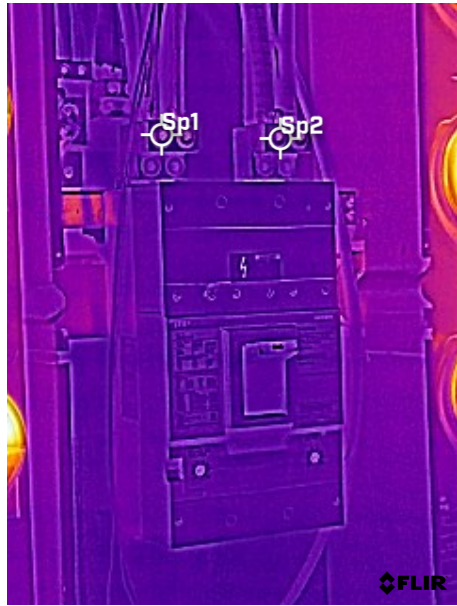
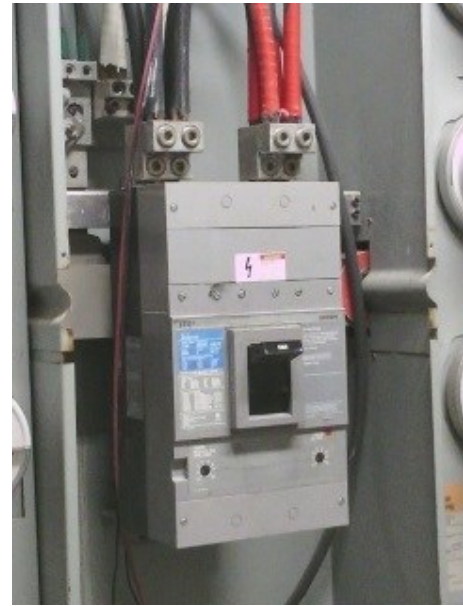
THE LANDMARK CONDOMINIUM	
Date	02/27/2024
Location	Level 9 Meter Room
Equipment	NO ID
Component	Main Circuit Breaker
File name	FLIR0545.jpg
Condition	NORMAL

Sp1	23.7 °C
Sp2	23.6 °C

None.

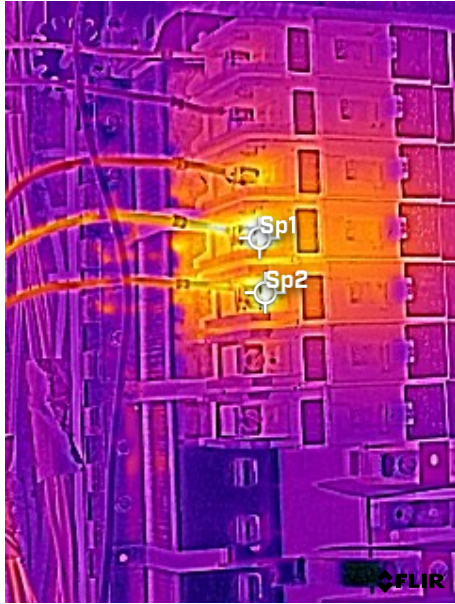
THE LANDMARK CONDOMINIUM	
Date	02/27/2024
Location	Level 7 Meter Room
Equipment	7H Panelboard
Component	Circuit breakers 7 & 9
File name	FLIR0569.jpg
Condition	POSSIBLE DEFICIENCY

Sp1	47.5 °C
Sp2	44.0 °C

1P Circuit breakers 7 & 9.
Abnormal temperature is observed in circuit breakers (load side).

- Remove conductors.
- Inspect conductors and circuit breakers.
- Clean the parts, and install conductors (apply torque according to manufacturer specifications).

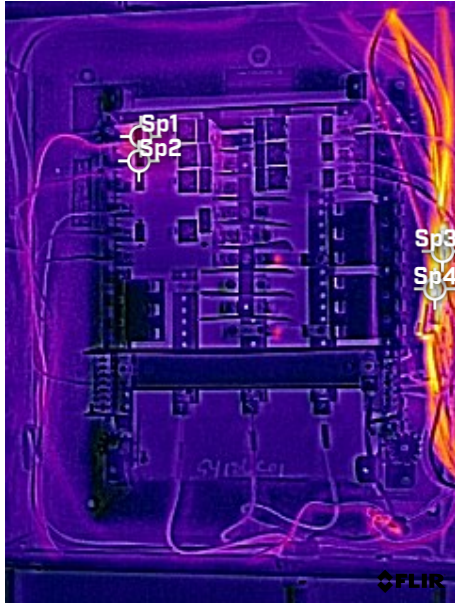
THE LANDMARK CONDOMINIUM	
Date	02/27/2024
Location	Level 7 Meter Room
Equipment	7EH Panelboard
Component	Wire splices
File name	FLIR0577.jpg
Condition	POSSIBLE DEFICIENCY

Sp1	32.2 °C
Sp2	31.7 °C
Sp3	48.3 °C
Sp4	40.7 °C

Possible deficiency in wire splices.

- Remove splices and inspect wires.
- Use proper wire nut.
- Perform splicing according to wirenut specification.

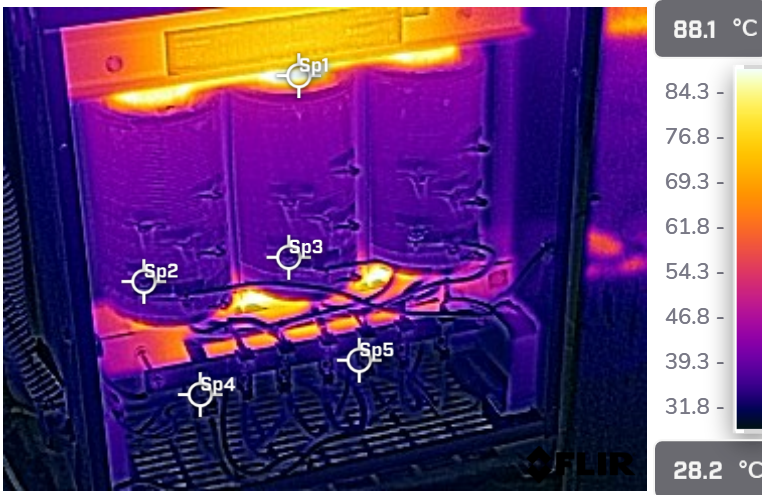
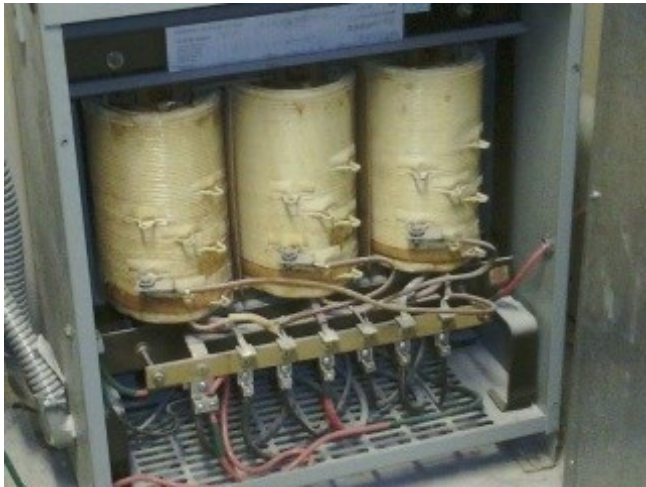
THE LANDMARK CONDOMINIUM	
Date	02/27/2024
Location	Level 7 Meter Room
Equipment	T5
Component	Transformer
File name	FLIR0579.jpg
Condition	NORMAL

Sp1	89.7 °C
Sp2	36.0 °C
Sp3	36.5 °C
Sp4	31.4 °C
Sp5	32.6 °C

None.

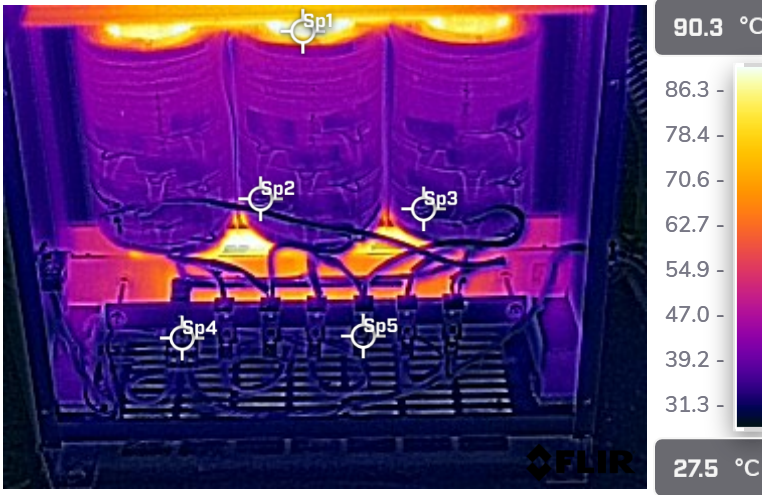
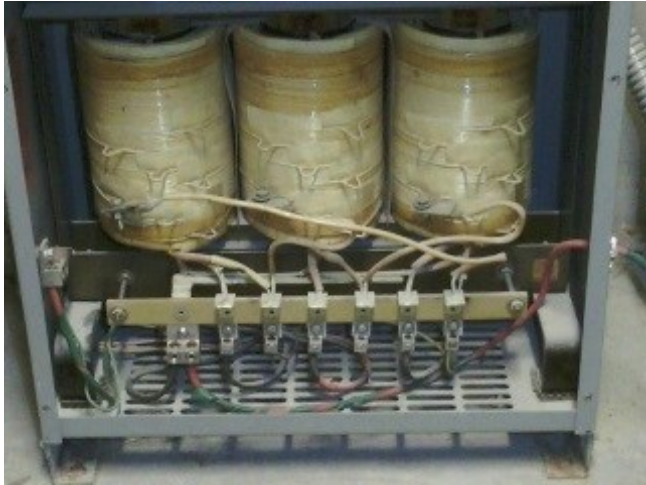
THE LANDMARK CONDOMINIUM	
Date	02/27/2024
Location	Level 7 Meter Room
Equipment	T4
Component	15KVA Transformer
File name	FLIR0585.jpg
Condition	NORMAL

Sp1	89.9 °C
Sp2	36.4 °C
Sp3	34.3 °C
Sp4	31.9 °C
Sp5	31.0 °C

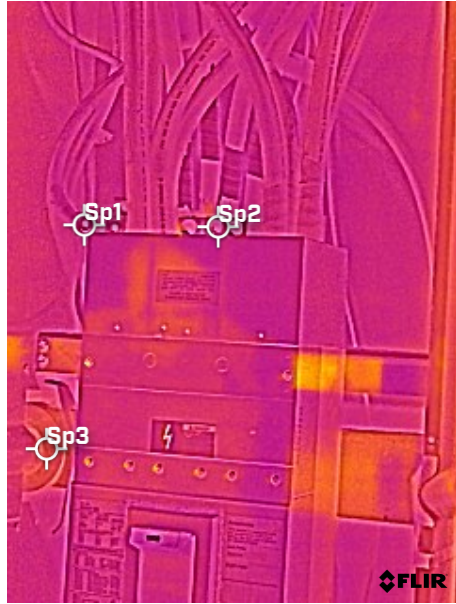
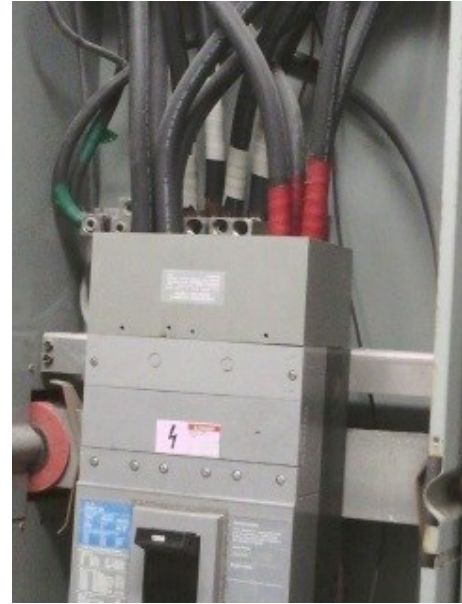
Date	02/27/2024
Location	Level 5 Meter Room
Equipment	NO ID
Component	Main Circuit Breaker
File name	FLIR0591.jpg
Condition	NORMAL

Sp1	23.5 °C
Sp2	23.5 °C
Sp3	23.9 °C

None.

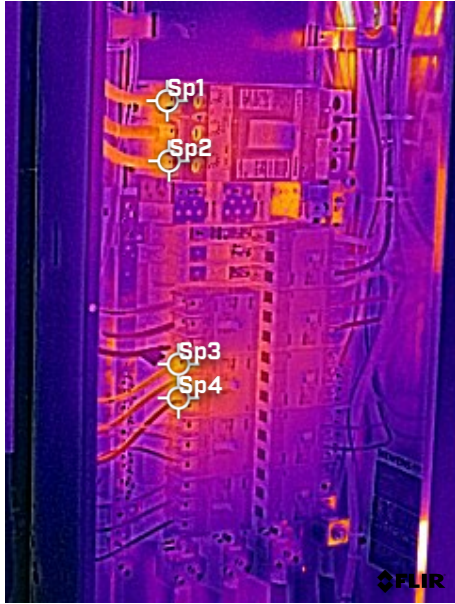
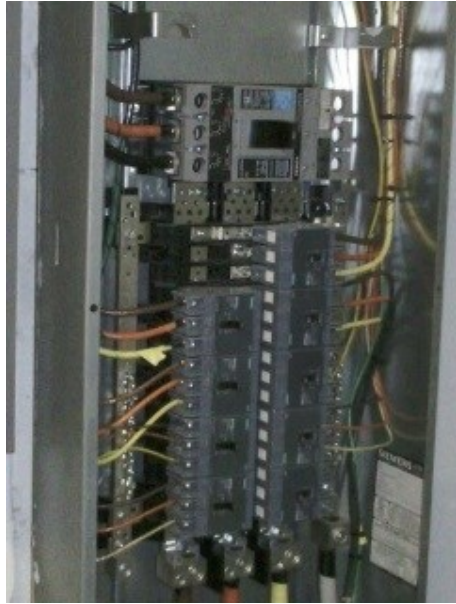
THE LANDMARK CONDOMINIUM	
Date	02/27/2024
Location	Roof Electrical Room
Equipment	NO ID
Component	400A Panelboard
File name	FLIR0605.jpg
Condition	NORMAL

Sp1	29.9 °C
Sp2	29.8 °C
Sp3	30.6 °C
Sp4	30.2 °C

None.

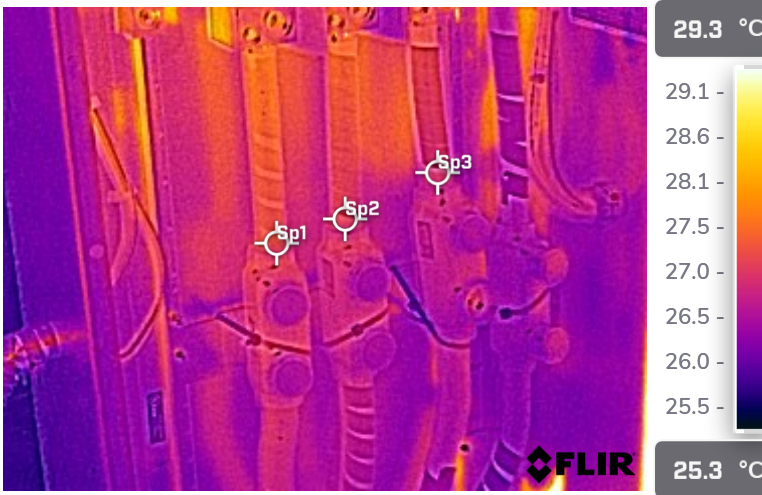
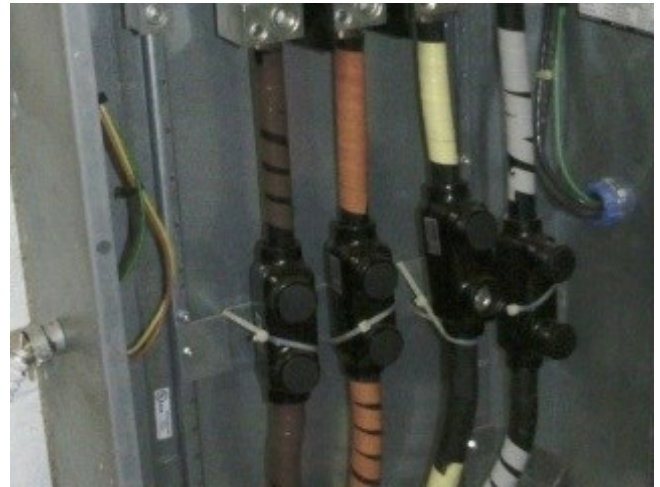
THE LANDMARK CONDOMINIUM	
Date	02/27/2024
Location	Roof Electrical Room
Equipment	NO ID Panelboard
Component	Conductors
File name	FLIR0613.jpg
Condition	NORMAL

Sp1	27.3 °C
Sp2	27.1 °C
Sp3	27.0 °C
