City of Aventura

MINIMUM INSPECTION PROCEDURAL GUIDELINES FOR BUILDING ELECTRICAL RECERTIFICATION

a. Name on Title: THE LANDMARK CONDO

b. Building Street Address: 20185 E COUNTRY CLUB DRIVE, AVENTURA, FL 33180

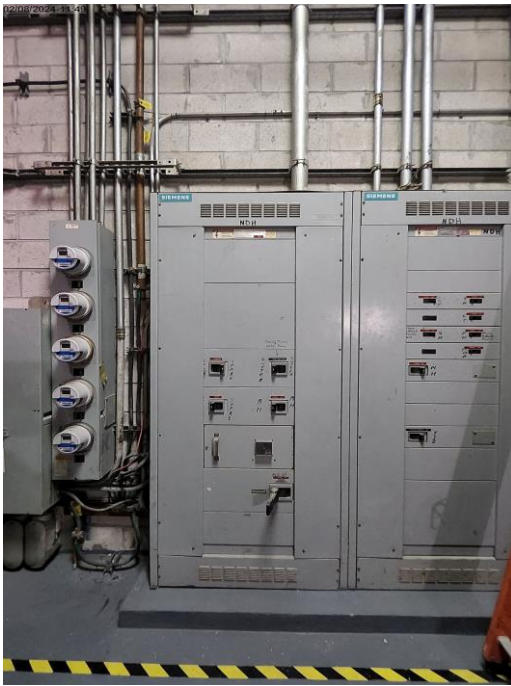
Photo # 1. Item 3.1. Electrical Room. NDH. Missing proper panel Identification - X of Y. All service equipment must be identified

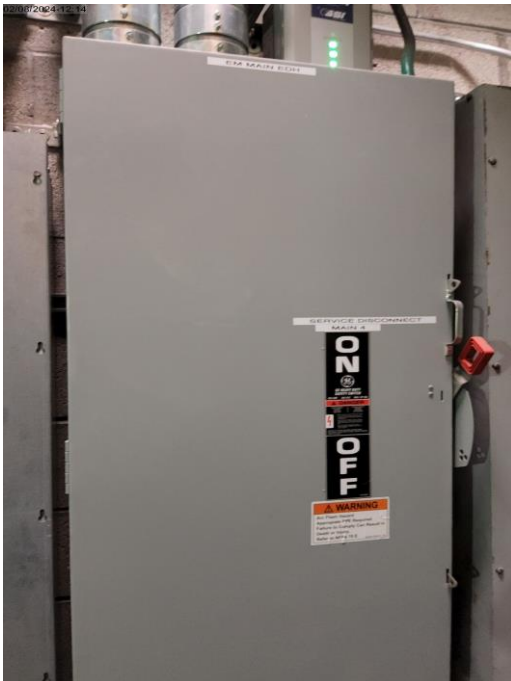
Photo # 3. Item 3.3. Electrical Room. EM Main #4. Disconnect Switch. All service equipment must be identified

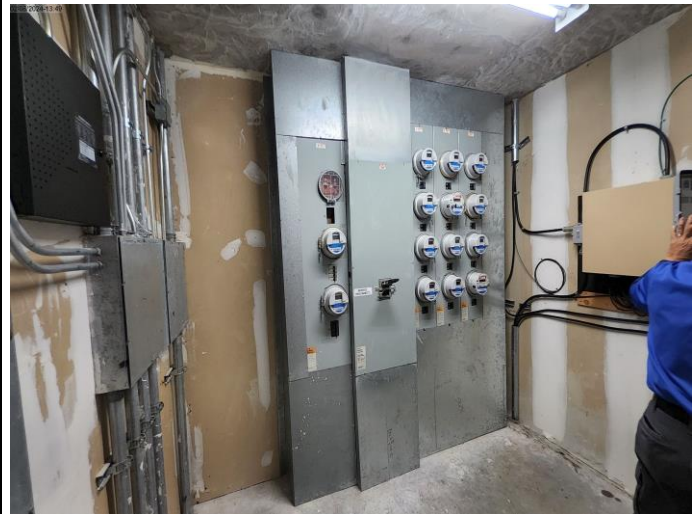
Photo # 12. Item 5.9. Level 5. Meter Electrical Room.

9. Clearances:	Good (<input checked="" type="radio"/>)	Fair ()	Needs Correction ()
Comments: None. Level 5. Meter Electrical Room. See Annex "A", photo #12.

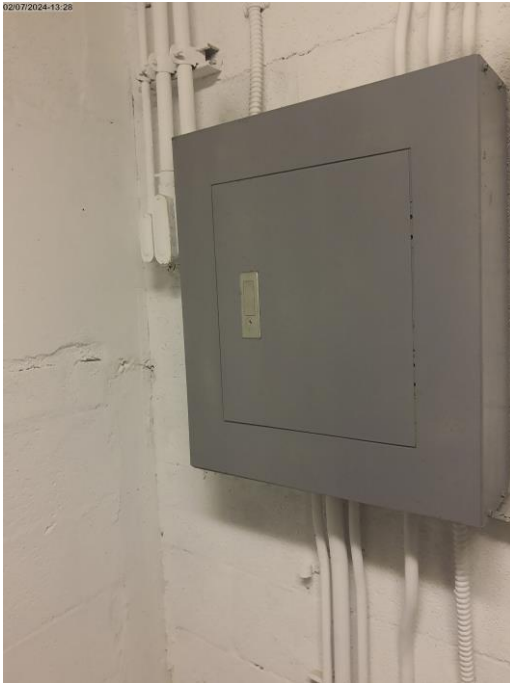
Photo # 13. Item 7.1.a. Level Roof. Mechanical Room. Panelboard No ID. Missing panel Identification.

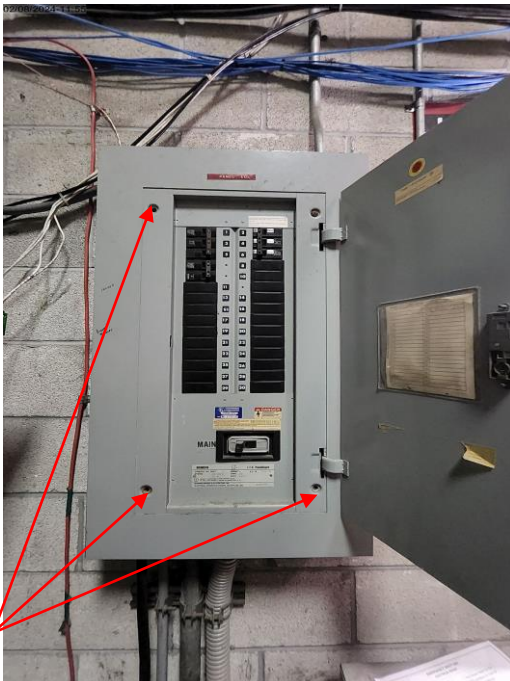
Photo # 15. Item 7.2. Level 1. Main Electrical Room. Panel EDL. Missing screws.

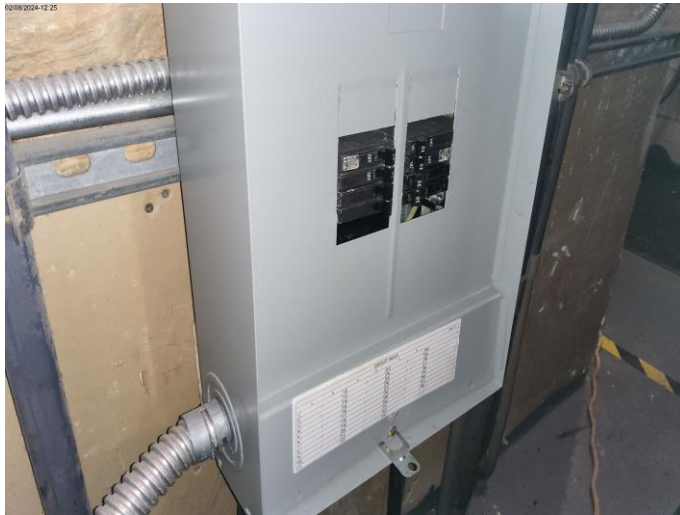
Photo # 25. Item 7.8.b. Level 1. Main Electrical Room. Panel No ID. Missing proper circuit identification and opening in circuit space.

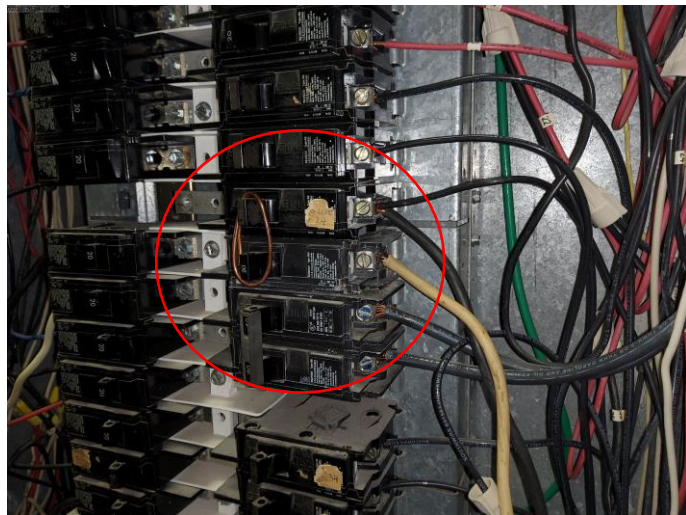
Photo # 29. Item 7.9.c. Level 1. Main Electrical Room. Panel NL. Double tapping in circuit breaker CB#24 and no proper Handle Tie.

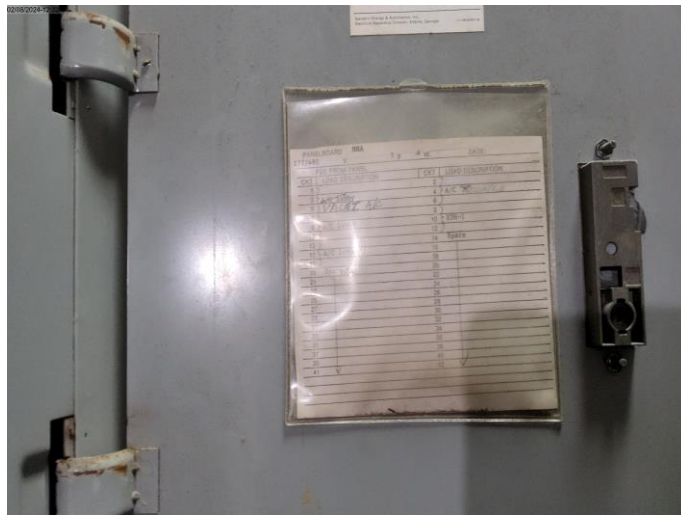
Photo # 30. Item 7.10.a. Level 1. Main Electrical Room. Panel NHA. Missing proper circuit identification.

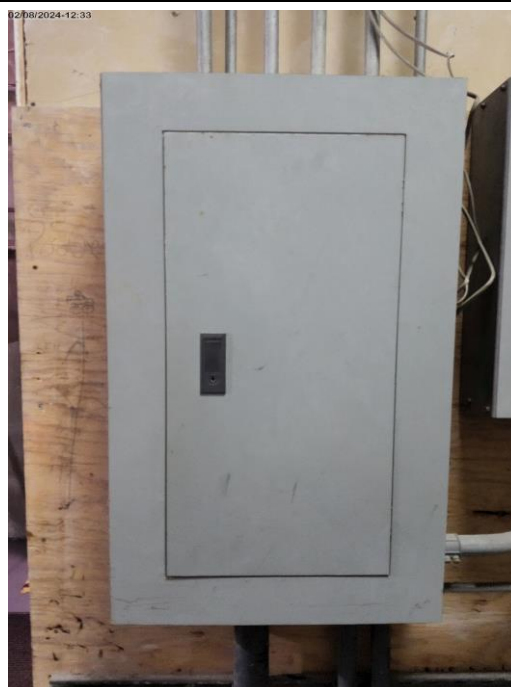
Photo # 32. Item 7.11.a. Panel NH. Main Electrical Room. Missing panel Identification.

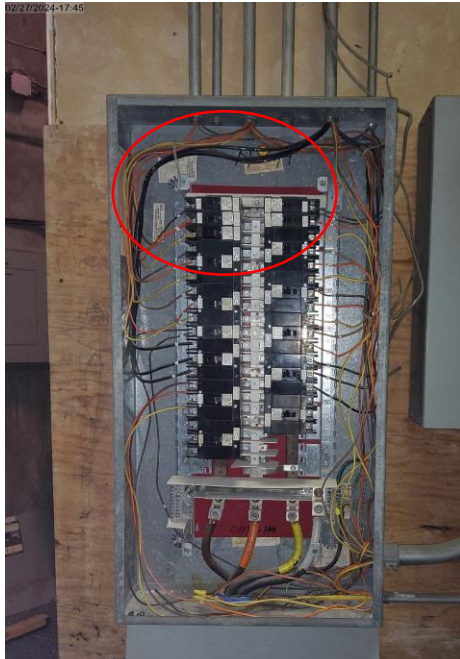
Photo # 35. Item 7.11.c. Level 1. Main Electrical Room. Panel NL. Double tapping in circuit breaker CB#2 and CB#3.

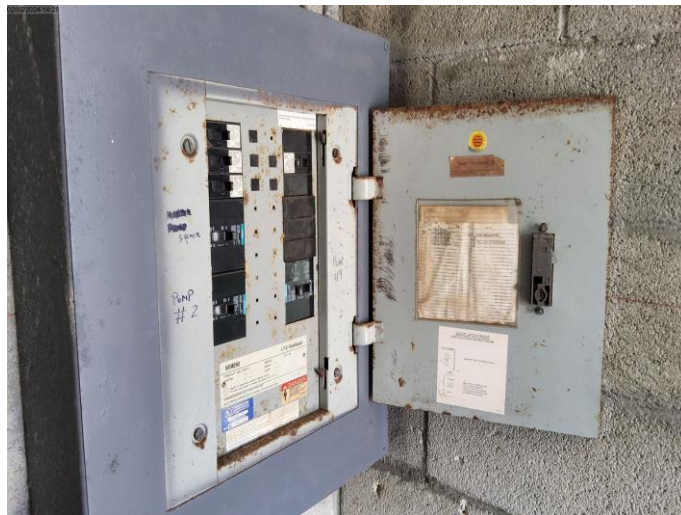
Photo # 42. Item 7.14.b. Pool. Electrical Room. Panel PHE. Missing proper circuit identification.

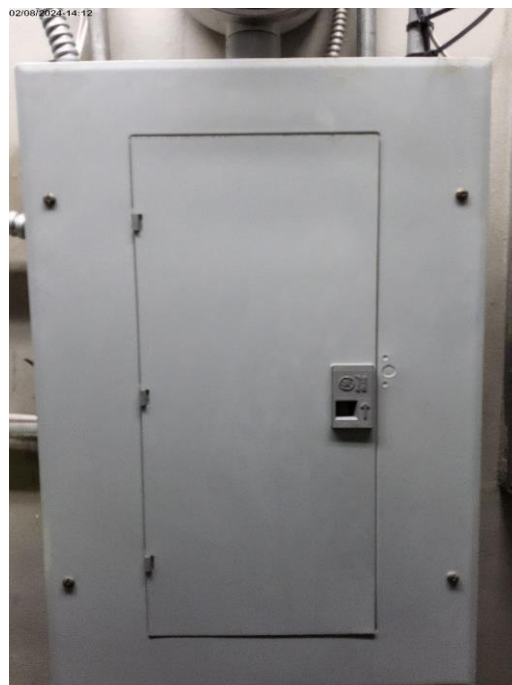
Photo # 46. Item 7.17.a. Generator Room. Panel No ID. Missing panel Identification.

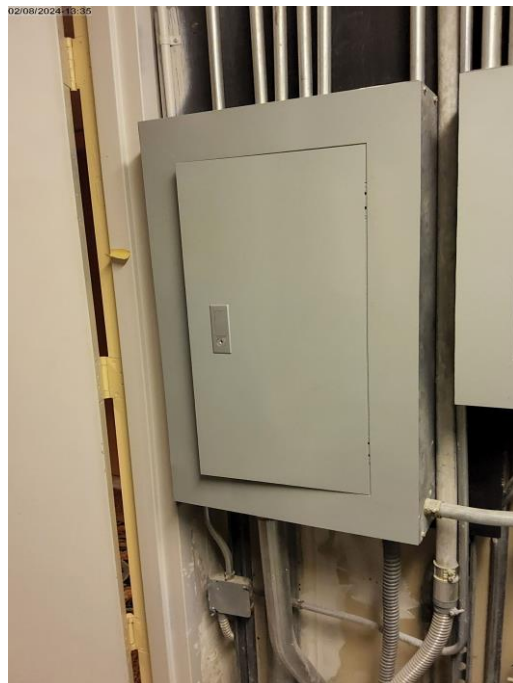
Photo # 50. Item 7.19.a. Level 20. Meter Room. Panelboard 20H. Missing panel Identification.

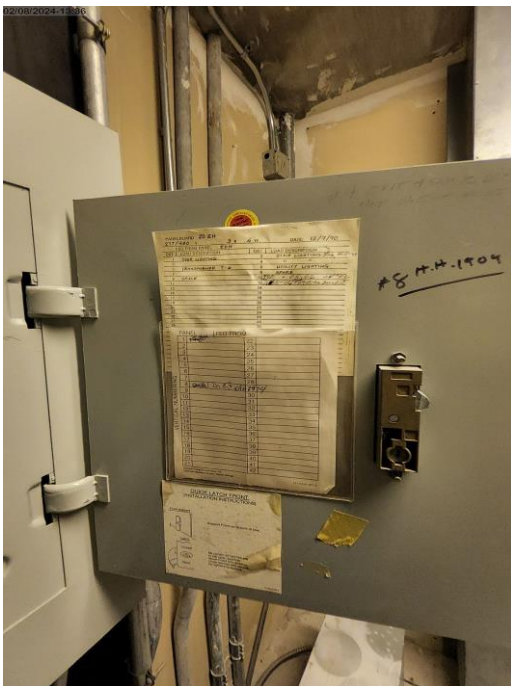
20. Panel #:	20EH	Location:	Level 20. Meter Room
		Good ()	Needs Repair (<input checked="" type="radio"/>)
Comments:	Size: 100 AMPS	Volt: 480	Phases: 3 Type: MLO
Repairs are required as follows:			
a. Missing panel Identification. See Annex "A", photo #52.			
b. Missing proper circuit identification and missing screws. See Annex "A", photo #53.

Photo # 53. Item 7.20.b. Level 20. Meter Room. Panelboard 20EH. Missing proper circuit identification and missing screws.

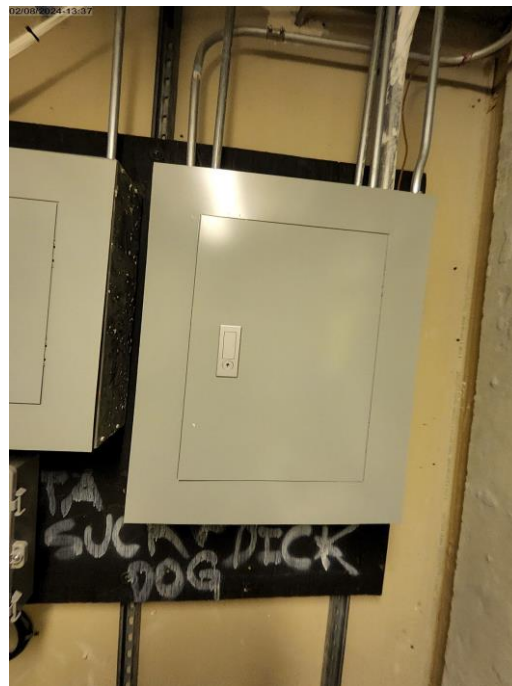
21. Panel #:	20L	Location:	Level 20. Meter Room
		Good ()	Needs Repair (<input checked="" type="radio"/>)
Comments:	Size: 100 AMPS	Volt: 208	Phases: 3 Type: MCB
Repairs are required as follows:			
a. Missing panel Identification. See Annex "A", photo #54.			
b. Missing proper circuit identification and missing screws. See Annex "A", photo #55.

Photo # 54. Item 7.21.a. Level 20. Meter Room. Panelboard 20L. Missing panel Identification.

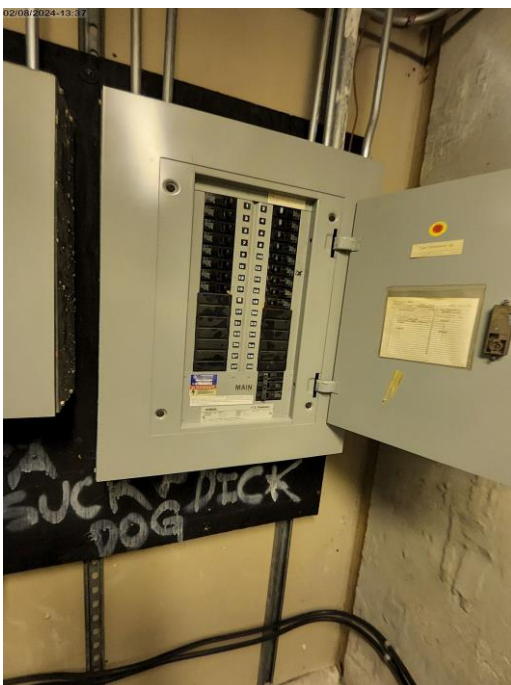
Photo # 55. Item 7.21.b. Level 20. Meter Room. Panelboard 20L. Missing proper circuit identification and missing screws.

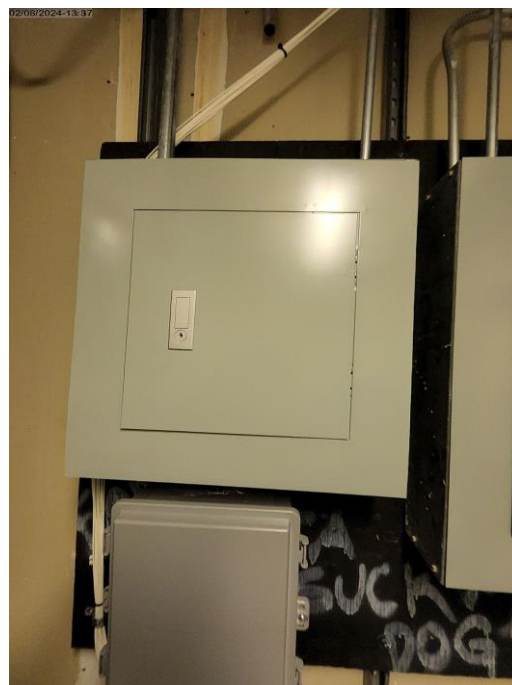
22. Panel #:	20EL	Location:	Level 20. Meter Room
		Good ()	Needs Repair (<input checked="" type="radio"/>)
Comments:	Size: 100 AMPS	Volt: 208	Phases: 3 Type: MCB
Repairs are required as follows:			
a. Missing panel Identification. See Annex "A", photo #56.			
b. Missing proper circuit identification. See Annex "A", photo #57.

Photo # 56. Item 7.22.a. Level 20. Meter Room. Panelboard 20EL. Missing panel Identification.

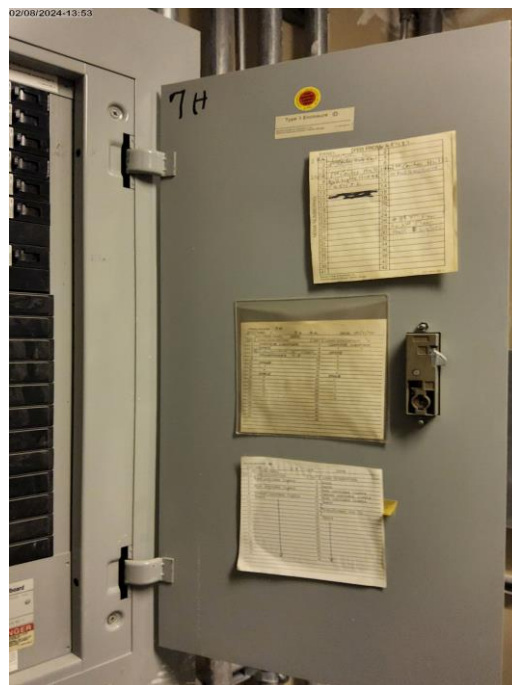
23. Panel #:	7H	Location:	Level 7. Meter Room
		Good ()	Needs Repair (<input checked="" type="radio"/>)
Comments:	Size: 100 AMPS	Volt: 480	Phases: 3 Type: MLO
Repairs are required as follows:			
Missing proper circuit identification and missing screws. See Annex "A", photo #58.

Photo # 58. Item 7.23. Level 7. Meter Room. Panelboard 7H. Missing proper circuit identification and missing screws.

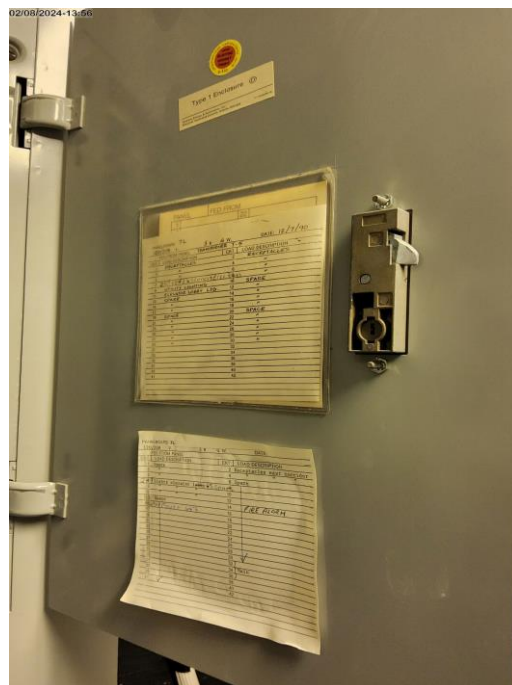
25. Panel #:	7L	Location:	Level 7. Meter Room
		Good ()	Needs Repair (<input checked="" type="radio"/>)
Comments:	Size: 100 AMPS	Volt: 208	Phases: 3 Type: MCB
Repairs are required as follows:			
Missing proper circuit identification. See Annex "A", photo #60.

Photo # 60. Item 7.25. Level 7. Meter Room. Panelboard 7L. Missing proper circuit identification.

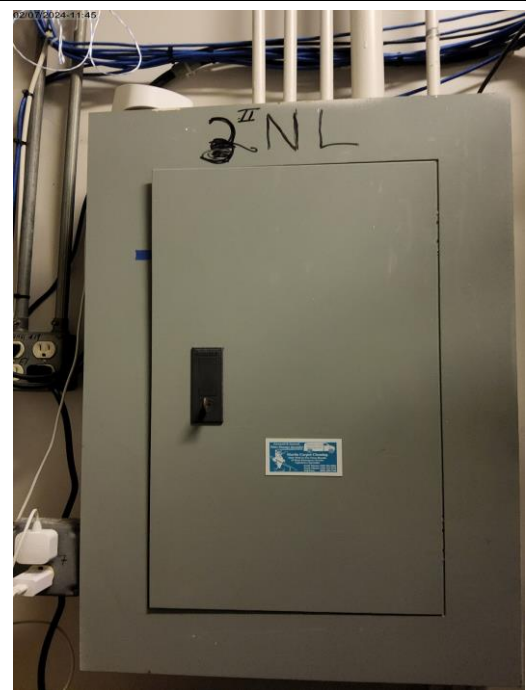
Photo # 62. Item 7.27. Level 2. Electrical Room. Panelboard 2NL.

27. Panel #:	2NL	Location: Level 2. Electrical Room			
		Good	(<input checked="" type="radio"/>)	Needs Repair	()
Comments:	Size: 225 AMPS	Volt: 208	Phases: 3	Type: MLO	
See Annex "A", photo #62.

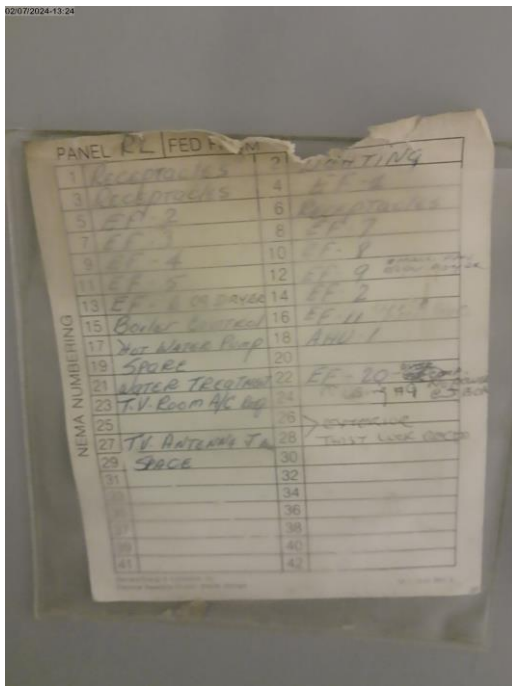
28. Panel #:	RL	Location: Level Roof.			
		Good	()	Needs Repair	(<input checked="" type="radio"/>)
Comments:	Size: 100 AMPS	Volt: 208	Phases: 3	Type: MCB	
Repairs are required as follows: a. Missing panel Identification. See Annex "A", photo #63. b. Missing screws. See Annex "A", photo #64. c. Missing proper circuit identification. See Annex "A", photo #65. d. Opening in circuit space. See Annex "A", photo #66.

Photo # 65. Item 7.28.c. Level Roof. Mechanical Room. Panelboard RL. Missing proper circuit identification.

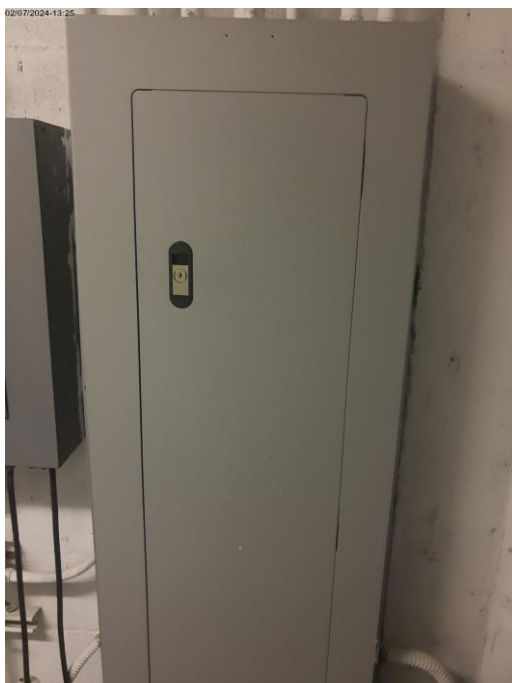
29. Panel #:	No ID	Location: Level Roof.			
		Good	()	Needs Repair	(<input checked="" type="radio"/>)
Comments:	Size: 400 AMPS	Volt: 480	Phases: 3	Type: MLO	
Repairs are required as follows: a. Missing panel Identification. See Annex "A", photo #67. b. Missing proper circuit identification. See Annex "A", photo #68.

Photo # 67. Item 7.29.a. Level Roof. Mechanical Room. Panelboard No ID. Missing panel Identification.

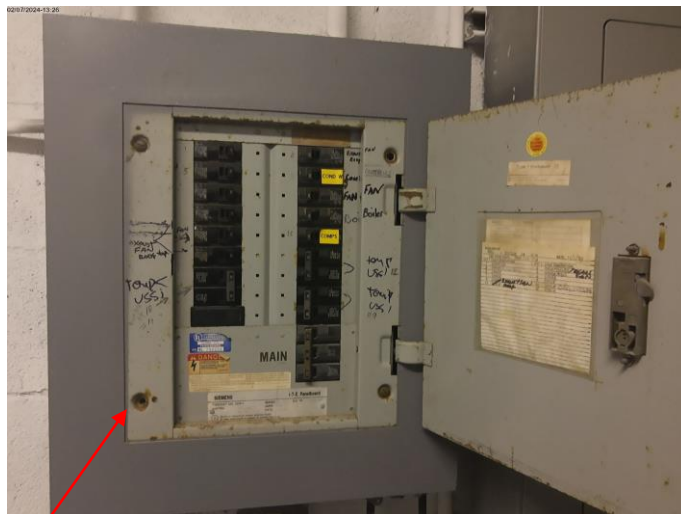
30. Panel #:	REL	Location: Level Roof.			
		Good	()	Needs Repair	(<input checked="" type="radio"/>)
Comments:	Size: 100 AMPS	Volt: 208	Phases: 3	Type: MCB	
Repairs are required as follows: a. Missing panel Identification. See Annex "A", photo #69. b. Missing proper circuit identification and missing screws. See Annex "A", photo #70.

Photo # 70. Item 7.30.b. Level Roof. Mechanical Room. Panelboard REL. Missing proper circuit identification and missing screws.

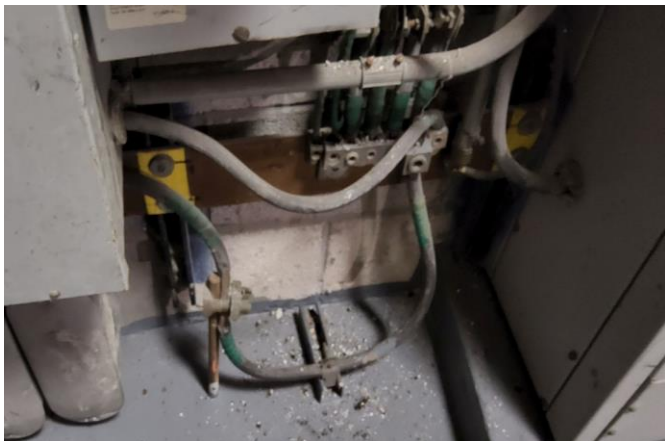
Good	(<input checked="" type="radio"/>)	Needs Repair	()
Comments: Ground Service. See Annex "A", photo #71.

Photo # 71. Item 9. Level G. Main Electrical Room. Ground service

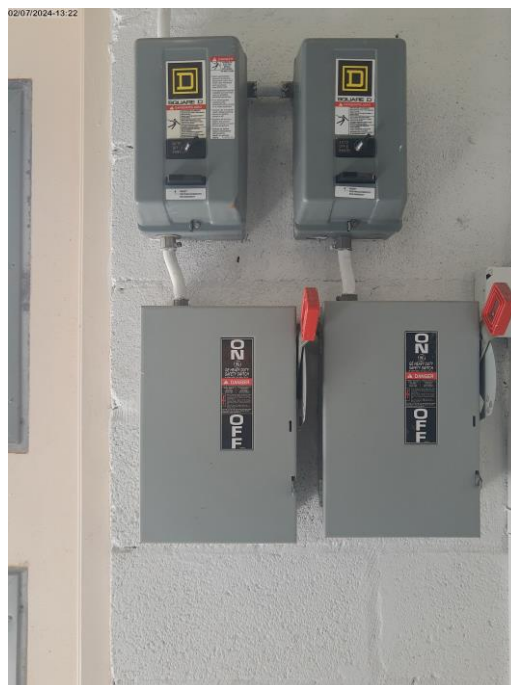
Good (<input type="radio"/>)	Needs Repair (<input checked="" type="radio"/>)
Comments: Repairs are required as follows: a. Roof. Enclosed Circuit breaker not marked to identify the load it serves. See Annex "A", photo #72. b. Roof. Enclosed Circuit breaker not marked to identify the load it serves. See Annex "A", photo #73. c. Main Electrical Room. Enclosed disconnect switch not marked to identify the load and missing screws. See Annex "A", photo #74.

Photo # 72. Item 12.a. Roof. Enclosed Circuit breaker not marked to identify the load.

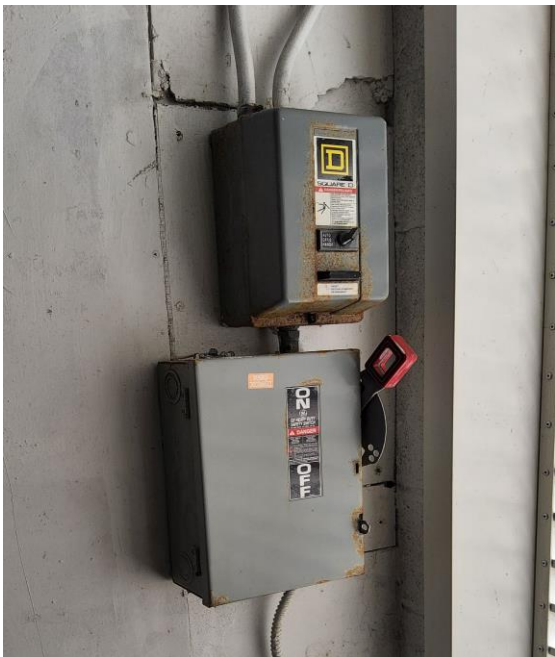
Photo # 73. Item 12.b. Roof. Enclosed Circuit breaker not marked to identify the load.

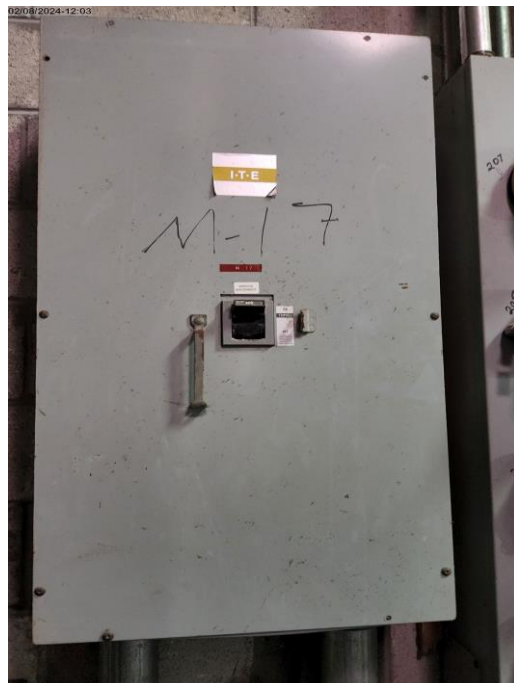
Photo # 74. Item 12.c. Level 1. Main Electrical Room. Enclosed disconnect switch M17 not marked to identify the load and missing screws.

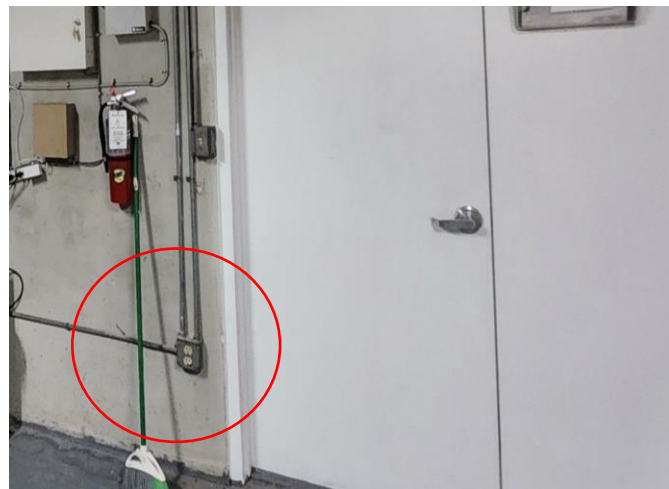
Photo # 76. Item 17.b. Generator Room. Missing GFCI protection for receptacles.

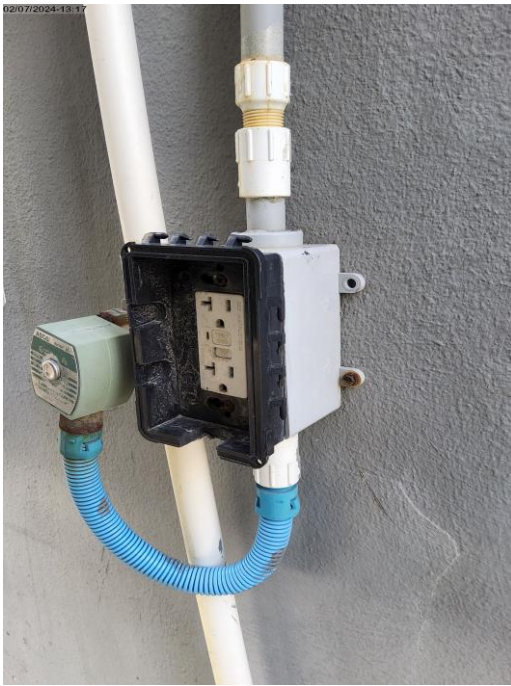
Photo # 81. Item 17.g. Roof. Missing cover weatherproof for receptacle box.

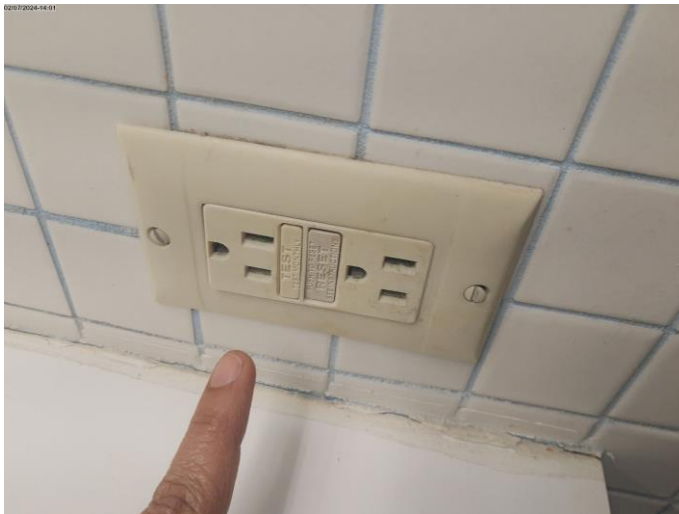
Photo # 83. Item 17.h. Level 2. Women Restroom. Missing GFCI protection for receptacles- test fail.

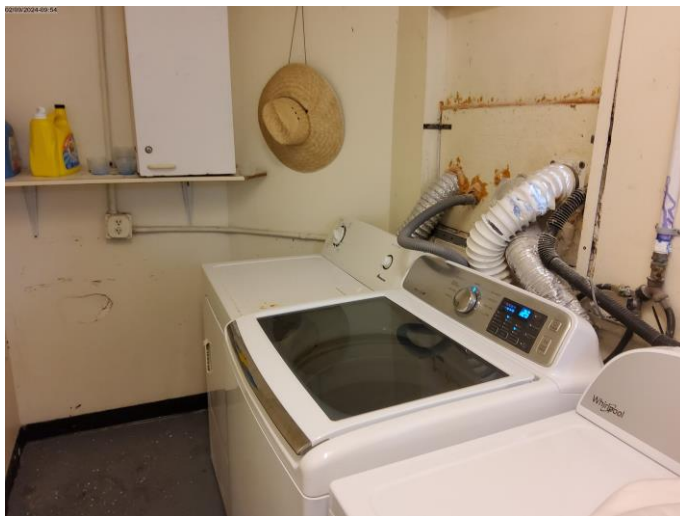
Photo # 87. Item 17.l. Laundry Room. Missing GFCI protection for receptacles.

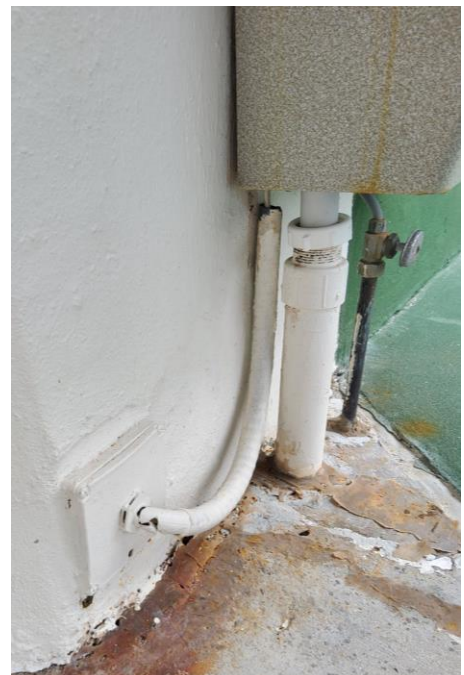
Photo # 88. Item 17.m. Drinking fountain. Flexible detached and broken connector.

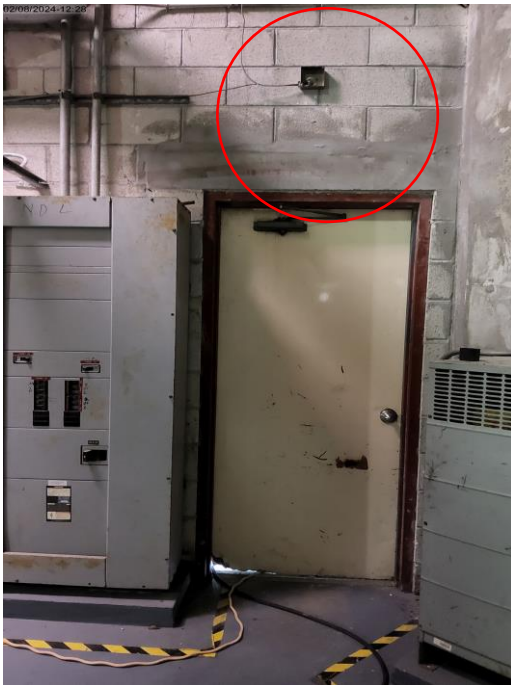
Good ()	Needs Repair (●)	N/A ()
Comments: Repairs are required as follows: Missing Exit sign. Main Electrical room. See Annex "A", photo #93, photo #94.

Photo # 93. Item 22.a. Main Electrical Room. Missing exit sign.

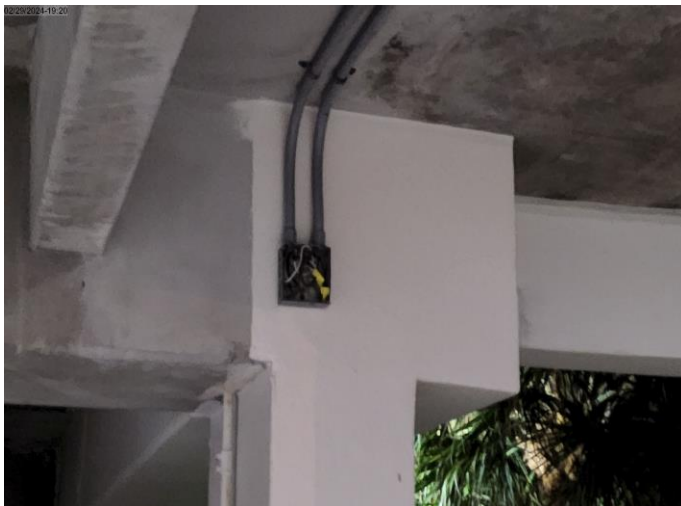
Good ()	Requires Additional Illumination (●)	N/A ()
Comments: None. Level C. Cover parking garage. Missing cover in Junction Box. See Annex A, photo #95.

Photo # 95. Item 24. Level C. Cover parking garage. Missing cover in Junction Box.

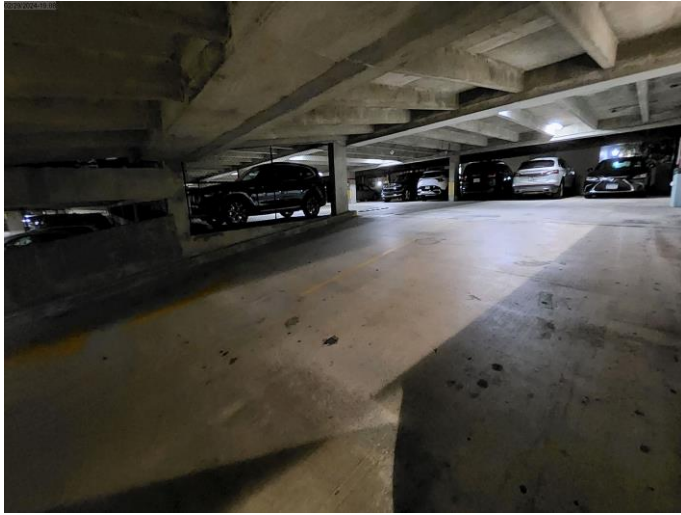
Good ()	Requires Additional Illumination (●)	N/A ()
Comments: Repairs are required as follows: a. Level A. Cover parking garage. Missing proper illumination - fc = 0.3. See Annex A, photo #96. b. Ramp Level A and B. Cover parking garage. Missing proper illumination - fc = 0.71. See Annex A, photo #97. c. Level B. Cover parking garage. Missing proper illumination - fc = 0.89. See Annex A, photo #98. d. Level C. Missing exit sign. See Annex A, photo #99.

Photo # 97. Item 25.b. Ramp Level A and B. Cover parking garage. Missing proper illumination -fc = 0.71.

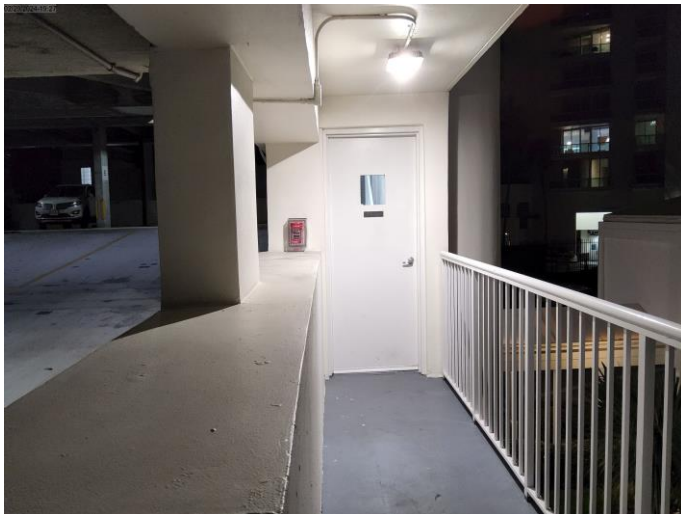
Photo # 99. Item 25.d. Level C. Missing exit sign.

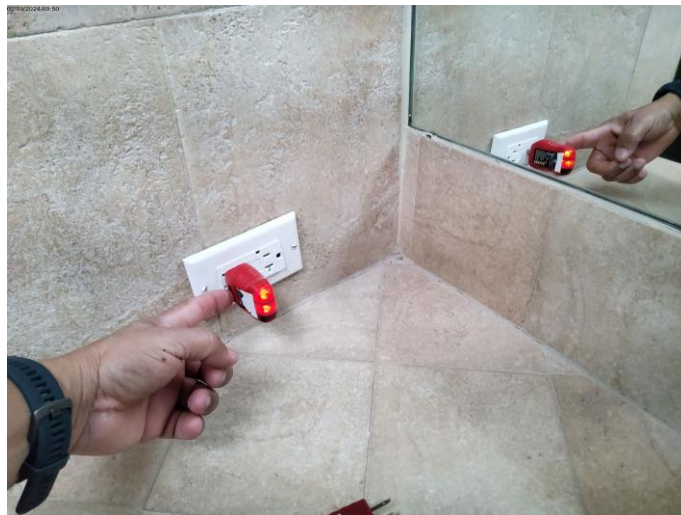
Good ()	Needs Repair (●)	N/A ()
Comments: Repairs are required as follows: a. Swimming Pool. Pool equipotential bonding: Failed test. See Annex "A", photo #100. b. Jacuzzi. Pool equipotential bonding: Failed test. See Annex "A", photo #101. c. Pool. Men's restroom. Missing GFCI protection for receptacles- test fail. See Annex "A", photo #102. d. Pump Pool Room. Missing GFCI protection for receptacles. See Annex "A", photo #103. e. Pool Pump room. Missing GFCI protection for receptacles. See Annex "A", photo #104. f. Pool - Electrical Room. Transformer 30 KVA. Double tapping in neutral. See Annex "A", photo #105.

Photo # 102. Item 26.c. Pool. Men's restroom. Missing GFCI protection for receptacles- test fail.

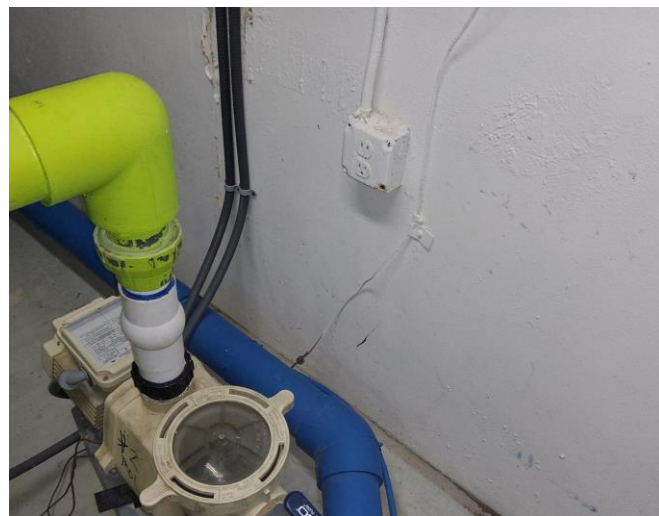
Photo # 104. Item 26.e. Pool Pump Room. Missing GFCI protection for receptacles.

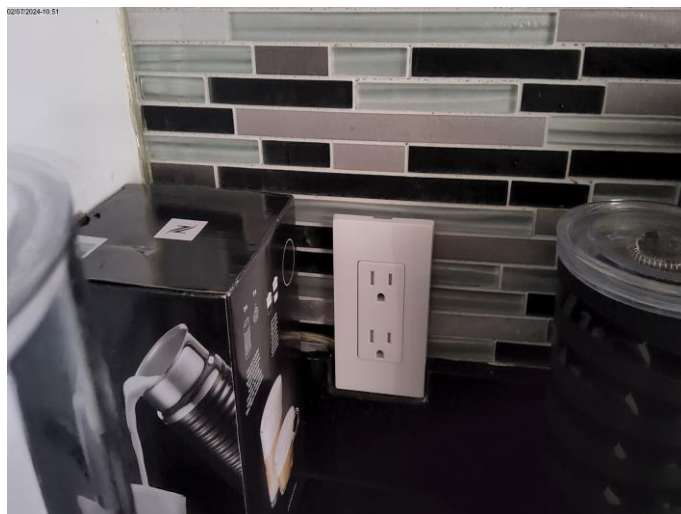
1. Missing GFCI protection for receptacles in the kitchen. See Annex “A”, photo #106, photo #107, and photo #108.
2. Missing GFCI protection for receptacles in the bathroom. See Annex “A”, photo #109, and photo #110.

Photo # 106. Item 28.1. Missing GFCI protection for receptacles in the kitchen.

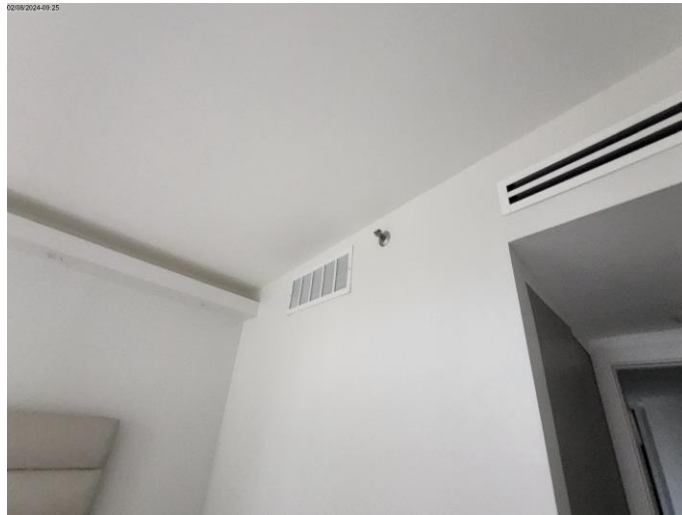
3. Missing GFCI protection for receptacles in the balcony. See Annex “A”, photos #111, and photo #112.
4. Missing smoke alarm inside the sleeping rooms. See Annex “A”, photos #113, and photo #114.

Photo # 113. Item 28.4. Missing smoke alarm inside the sleeping rooms.

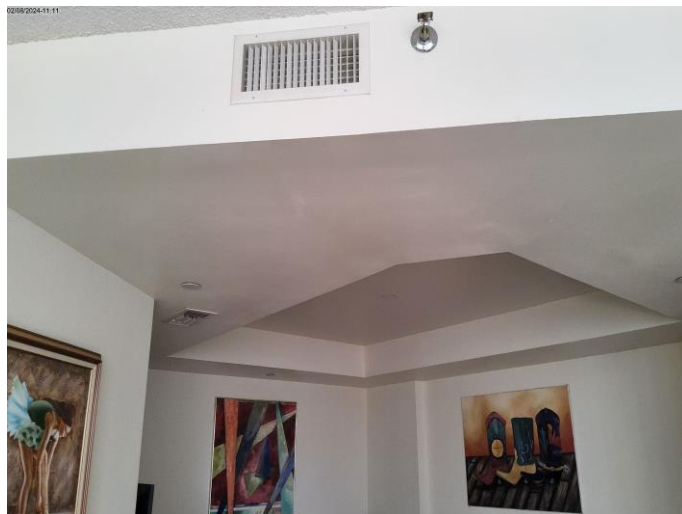
5. Missing smoke alarm outside the sleeping rooms. See Annex “A”, photos #115.
6. Electrical panel: working space clearance violation. See Annex “A”, photo #116.

Photo # 115. Item 28.5. Missing smoke alarm outside the sleeping rooms.

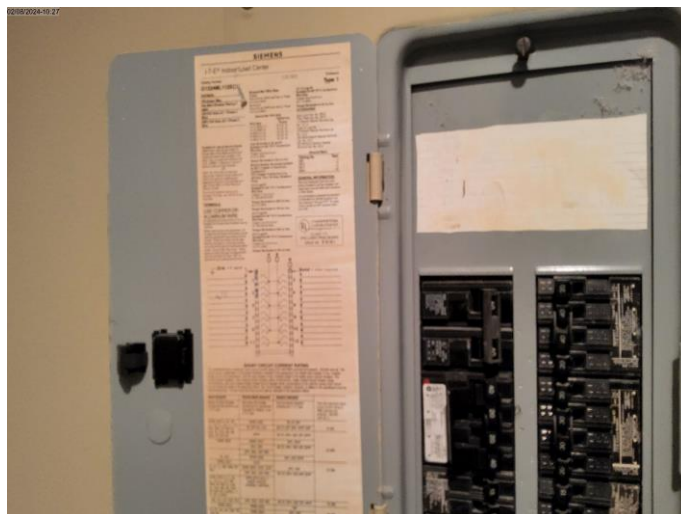
7. Electrical panel: missing or incomplete proper circuit directory. See Annex “A”, photos #117, and photo #118.
8. Electrical panel: opening in circuit spaces. See Annex “A”, photo #119.

Photo # 118. Item 28.7. Electrical panel missing or incomplete proper circuit directory.

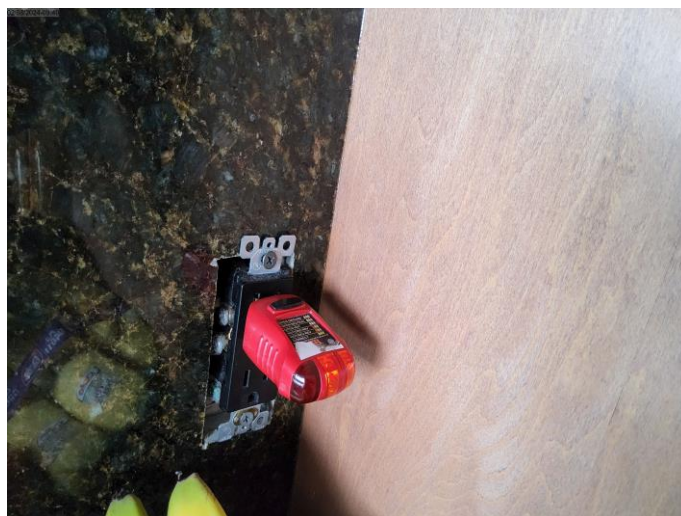
9. Missing GFCI protection and cover for receptacles in the Kitchen. See Annex “A”, photo #120, and photo #121.
10. Missing GFCI protection in the Laundry. See Annex “A”, photo #122.

Photo # 120. Item 28.9. Missing GFCI protection and cover for receptacles in the Kitchen.
