# Inspection report for the property at 101 Stubbs Avenue, Monroe, LA 71201

This report is prepared exclusively for **Glynis Davis**  
Inspected On: **2023-10-27**

Michael Burroughs , LA  
State License #LHI 10044,  
ASHI 202398

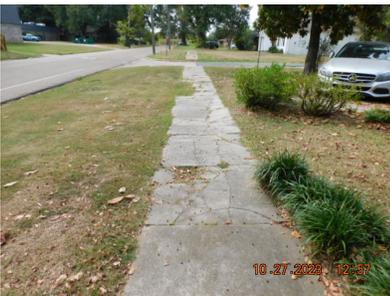
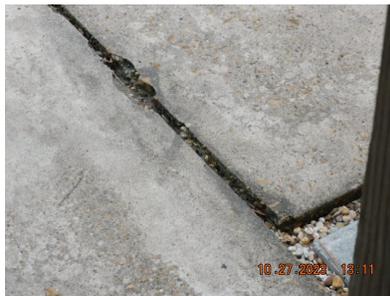
**🔧 (G-2) Review:** Portions of the walkway flatwork around the home are settling creating trip hazards. Hire a qualified general contractor to further investigate and repair to eliminate all trip hazards and ensure a reliable walking surface.

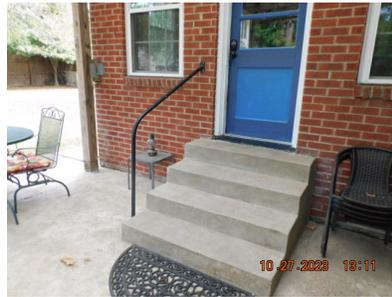
**🔍 (G-7) Review:**

Exterior steps installation questionable. Refer to line 0280 of the Uniform Building Inspection Report Binder.

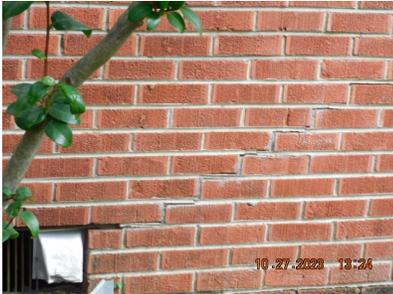
**🔧 (ED-3) Review:** Masonry siding cracked possibly indicating foundation movement or defect. These cracks may only be a masonry issue and not foundational as the foundation is a pier and beam system.

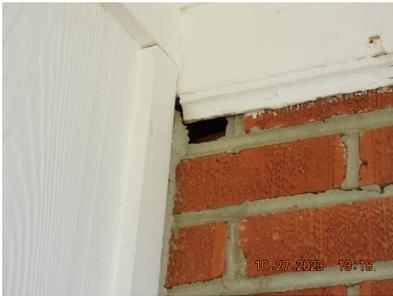
**🔧 (ED-4) Review:** Masonry siding mortar joints missing or damaged in numerous locations.

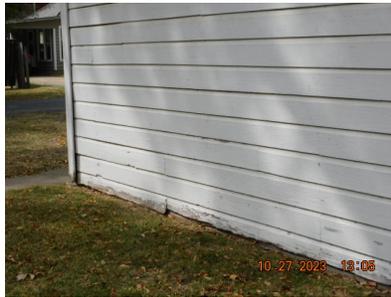
**🔗 (G1-3) Review:** Wood siding in contact with earth and damaged. Refer to line 0800 of the Uniform Building Inspection Report Binder.

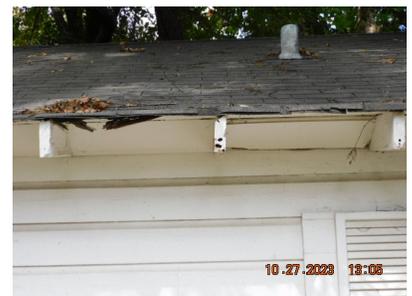
**🔗 (G1-4) Review:**  
Detached garage roof appear to be near the end of life. Refer to line 1020 of the Uniform Building Inspection Report Binder.

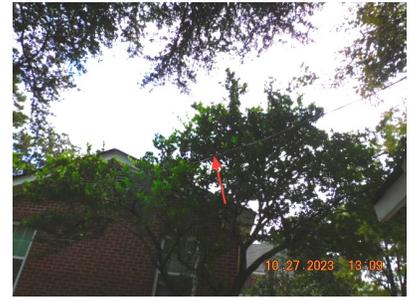
**🔧 (ES-3) Review:**

Electrical service passes through trees

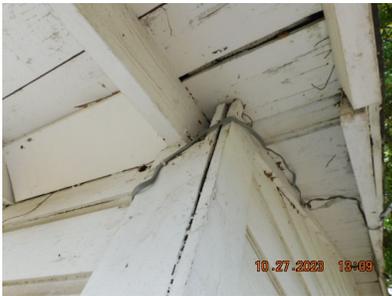
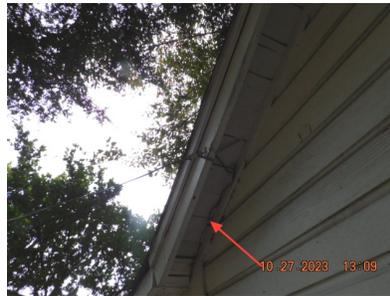
🔧 (EDFW-2) Review: Nonmetallic sheathed cable installed on the exterior of the buildings. Refer to line 5440 of the Uniform Building Inspection Report Binder.

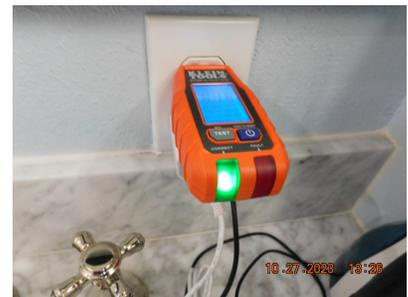
### ⚡ (EDFW-7) Review:

Outlets near water do not appear to be GFCI protected.

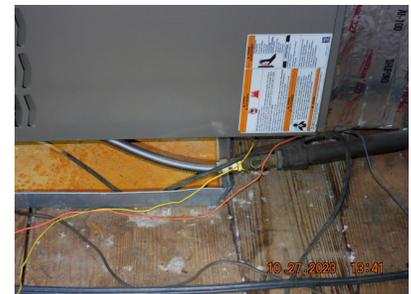
🏠 (HCFV-1) Improve:

Flex gas line enters the heating - this piping should be hard pipe to prevent the metal cabinet from rubbing on the thin wall flex gas line. Refer to line 4300 of the Uniform Building Inspection Report Binder.

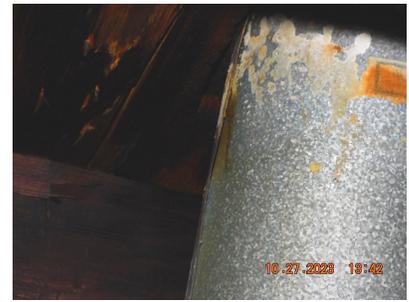
🔧 (HCFV-2) Review:

Heater exhaust flue too close to combustibles. Refer to line 2150 and 9670 of the Uniform Building Inspection Report Binder.

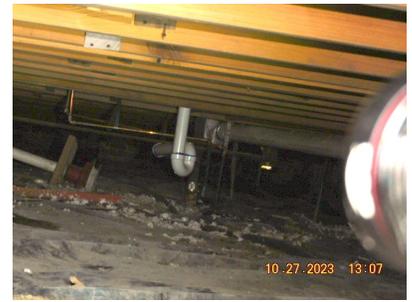
### 🔧 (P-3) Review:

Copper water lines under the home are not insulated. Refer to line 4440 of the Uniform Building Inspection Report Binder.

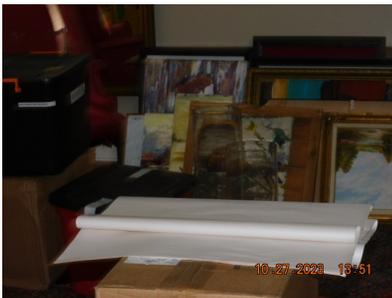
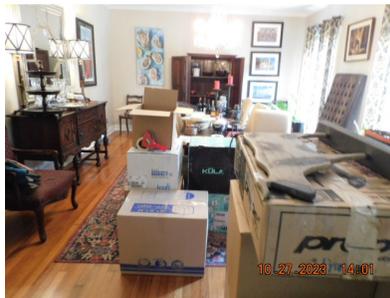
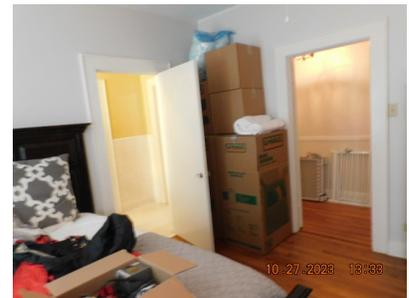
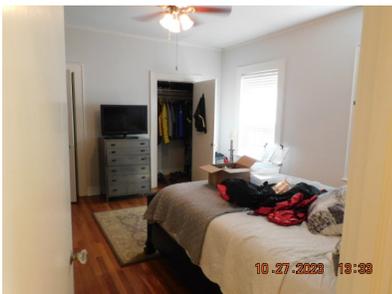
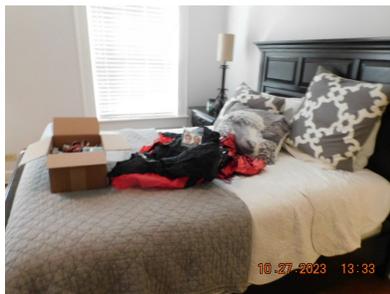
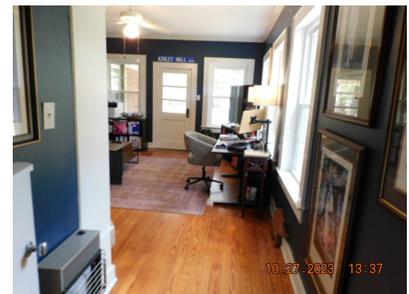
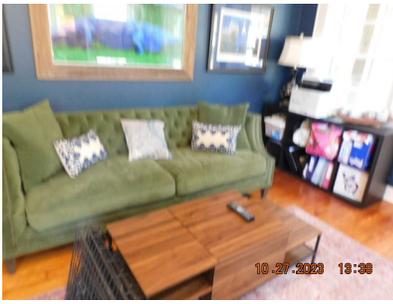
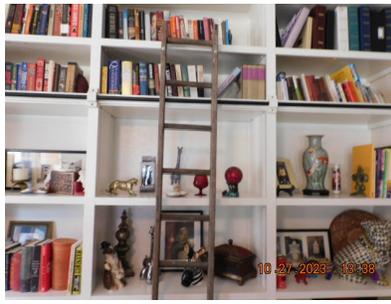
**(I-1) (no modifier):** Access impaired in numerous location by home owners possessions.

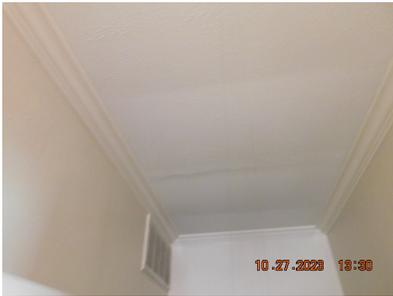
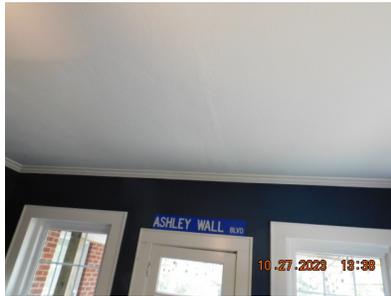
📍 **(I-2) Note:** Sags and patches noted in sheetrock in numerous locations.

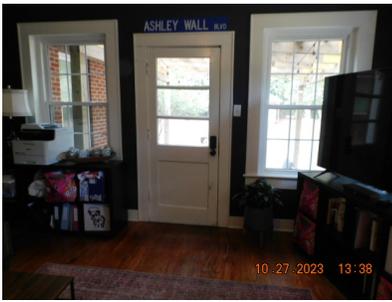
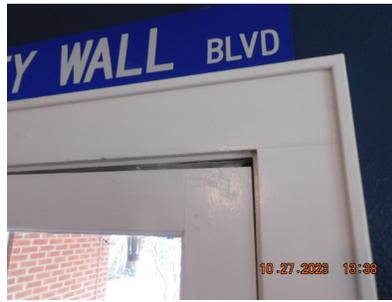
🔧 **(I-3) Review:** Doors appear to be out of square and dragging on jambs. Refer to line 7300 & 7310 of the Uniform Building Inspection Report Binder.

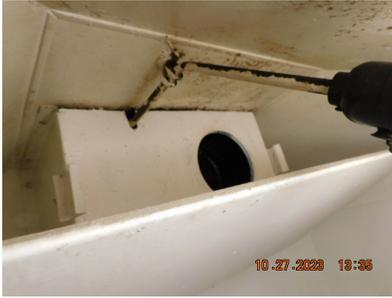
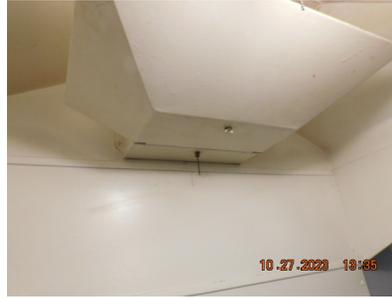
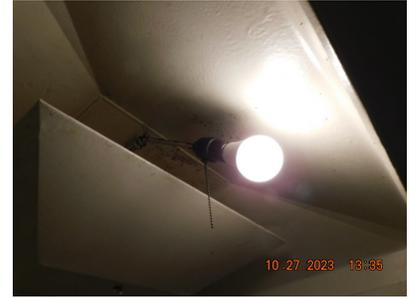
**🔧 (K-2) Review:** Exhaust fan appears to need service and cleaning. Refer to line 8100 of the Uniform Building Inspection Report Binder.

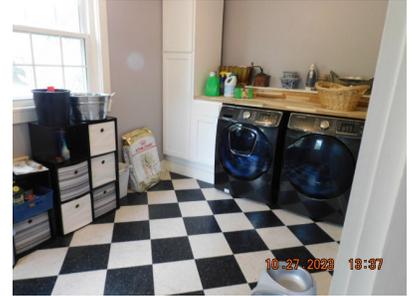
Apparently, the washer and dryer appliances may not be included in this sale.

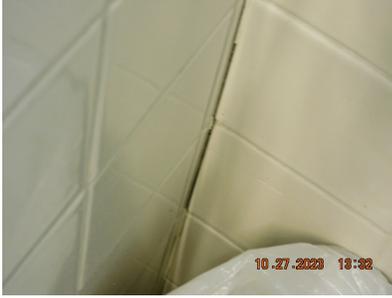
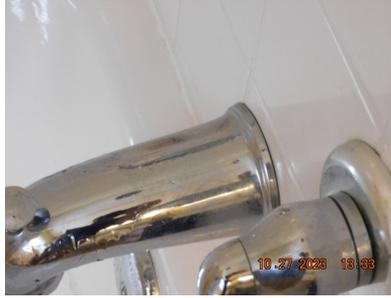
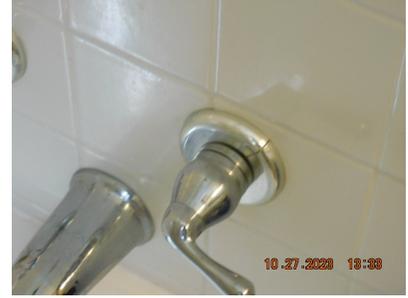
**🔧 (B-4) Review:** Caulking and sealing of the shower walls at wall joints, tub joints and plumbing fixtures in bathrooms.

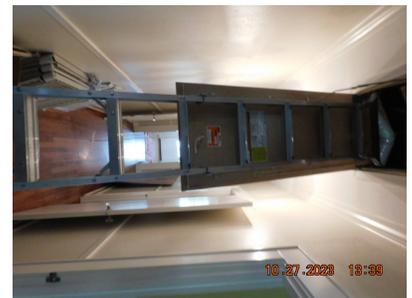
**🌿 (A-1) Efficiency:**  
Attic access not insulated.

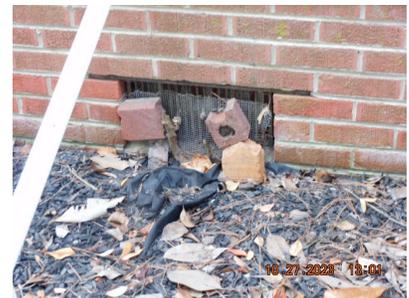
### (CS-4) Monitor:

Crawlspace venting questionable at the time of the inspection. Refer to line 9430 & 9440 of the Uniform Building Inspection Report Binder.
