Inspection report for the property at
3212 White Street, Monroe, LA 7120

This report is prepared exclusively for **Elvrin Worthey**
Inspected On: **2023-10-17**

QED Service
318-376-0482

Michael Burroughs , LA State License #LHI
10044, ASHI 202398

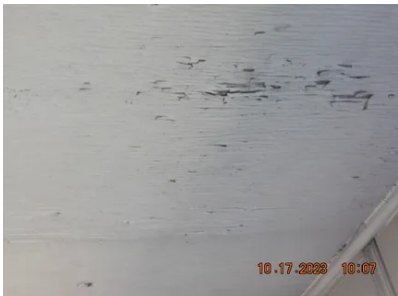
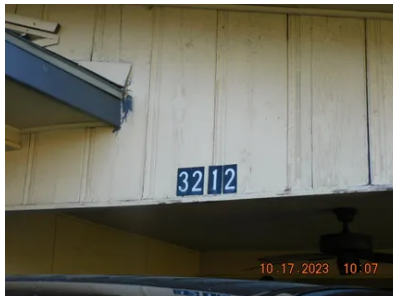
🔑 (ED-1) Review: Paint peeling in numerous locations around the home. Refer to line 1900 of the Uniform Building Inspection Report Binder.

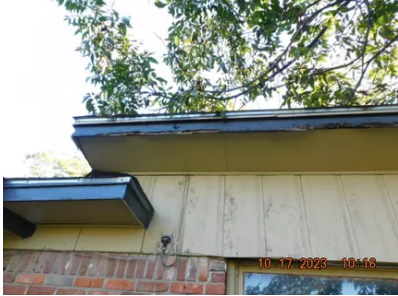
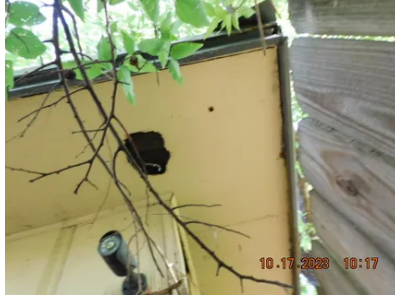
🔑 (ED-2) Review: Siding damaged or loose in numerous locations.

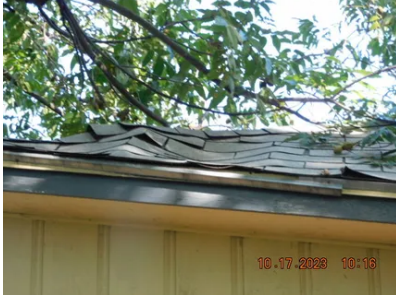
**(RCG-1) Review:** /Roof damaged and needs review in numerous locations.

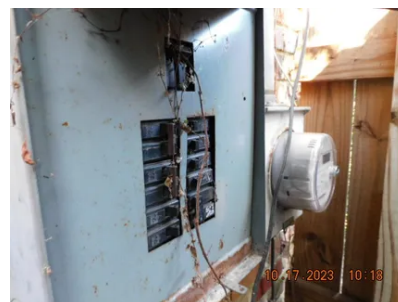
Panel not labeled and is full.

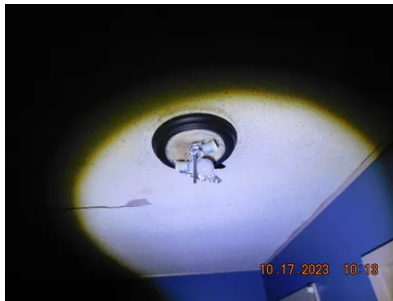
🔍 (EDFW-2) Review: Light fixtures damaged in various locations. Photo is only examples. Refer to line 5650 of the Uniform Building Inspection Report Binder.

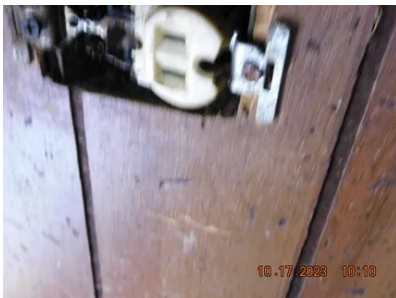
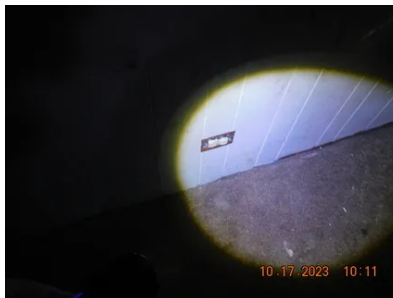
🔍 (EDFW-3) Review: Electrical outlets damaged in various locations and missing covers. Refers to lines 5650 & 5640 of the Uniform Building Inspection Report Binder.

🔍 (EDFW-4) Review: The missing cover plates to electric receptacles, switches and junction boxes should be installed to cover all access to wiring at switches and receptacles. Where switches, receptacles or junction boxes are positioned below wall or ceiling or cabinet finishes, an extension ring may be needed. Refer to 5640 of the Uniform Building Inspection Report Binder.

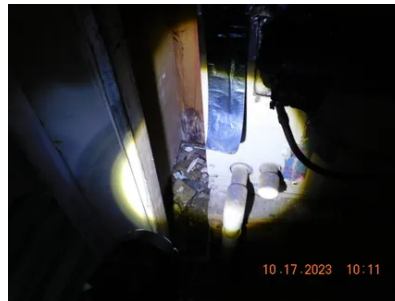
🔍 (HCFV-3) Review: Suspect Mold observed in heating unit closet. No testing was done by inspector to confirm the present of actual mold. Testing is recommend. Refer to line 2850 of the Uniform Building Inspection Report Binder.

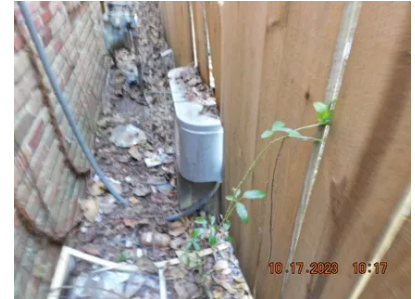
No access to condenser unit.

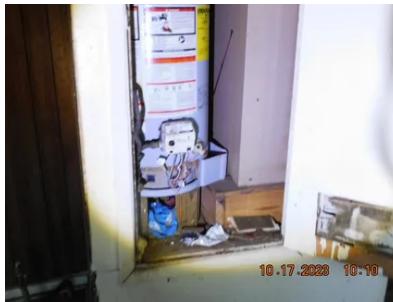
🔧 **(P-8) Review:** The discharge tube for the water heater relief valve is installed too high off the ground and into a sink. Discharge tubes should always terminate by pointing toward the ground to eliminate a scald hazard and should be no more than 6" off the ground. Ideally, the discharge tube terminates to an exterior or unfinished location or above a drain, though this is not always possible. The drain should also slope to drain to prevent water pooling inside the discharge tube and should be visible so it can be monitored. The end of the tube should not be threaded to prevent accidental capping of this important discharge. have this further investigated and repaired as recommended by a qualified plumber.

I recommend having this relief valve discharge tube further investigated and repaired as recommended by a licensed plumber.

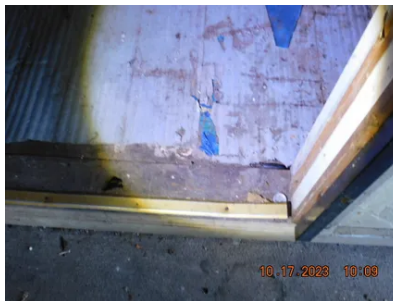
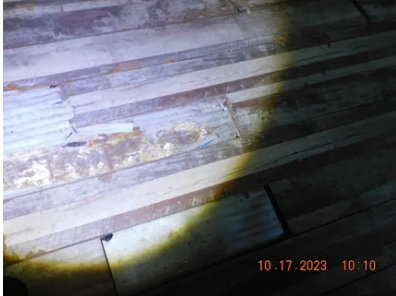
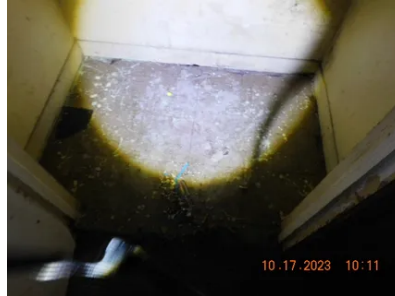
🔑 **(I-1) Review:** Interior flooring damaged and missing in numerous locations in the home. Refer to line 7200 & 7250 of the Uniform Building Inspection Report Binder.

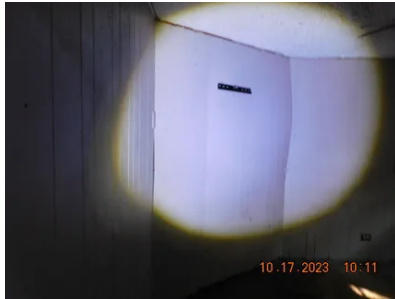
(I-5) Review: Wall paneling damaged in numerous locations in the home. Refer to line 7060 of the Uniform Building Inspection Report Binder.

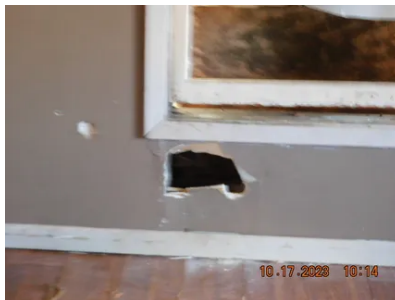
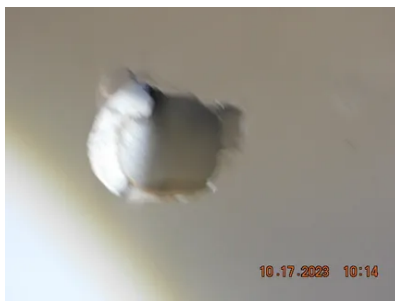
(I-6) Review: Interior walls damaged in numerous locations. Refer to line 7040 of the Uniform Building Inspection Report Binder.

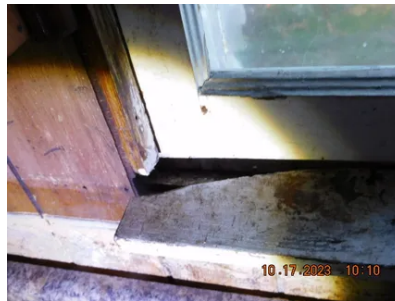
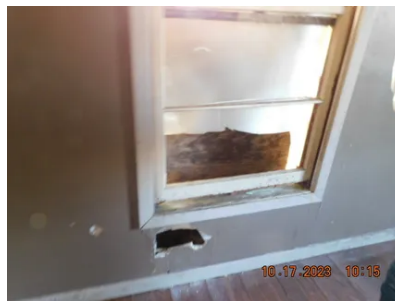
⚠️ **I-10 Interior:** All of the windows in this home are old windows that require maintenance and repair. You need to decide how you want to approach the windows in this home as they are generally older and do not comply with modern standards for safety glass and energy efficiency. Repairs can be made on an as needed basis and efficiency can be added with storm windows and curtains. Existing windows that have character are often worth preserving and restoring, where windows that are in worse condition and have less character may be good candidates for replacement. The windows are in poor condition for age and type.

- *Some windows in the home are not operating* and may be painted shut.
- *Glazing is missing from some of the windows* - this is used to secure the window pane to the wood frame of the window
- *Many of the windows are single pane glass* - these older windows do not comply with modern energy efficiency standards
- **Windows are showing signs of leakage and moisture control problems.**
- *Loose window hardware* was noted
- *Missing window hardware* was noted
- *Cracked panes of glass were noted* - glass replacement is needed in these windows.
- *Gaps were noted in windows* that can allow excessive air into the house.

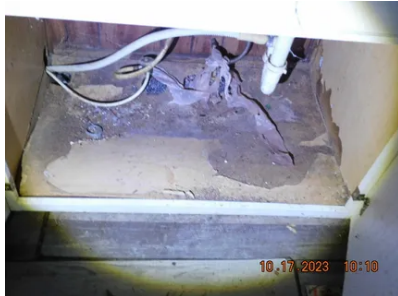
🔧 (K-1) Review: Tune-up repairs are needed to the kitchen cabinets. Repair as desired. Examples of observations noted during inspection include:

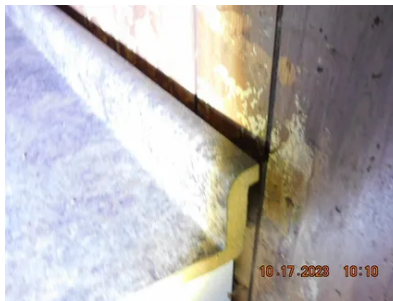
🔧 (K-2) Review: Cabinet countertop damaged and not secured. Refer to line 8810 of the Uniform Building Inspection Report Binder.

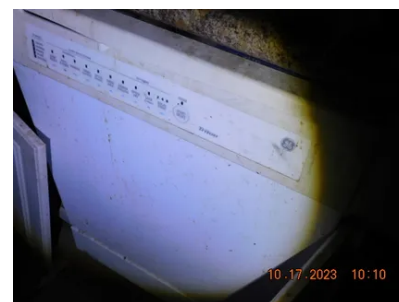
Dishwasher not functional at the time of the inspection. Refer to line 8340 of the Uniform Building Inspection Report Binder.

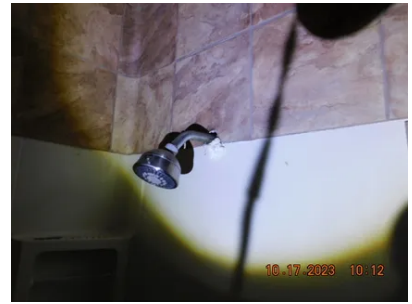
Caulking and seal shower arm at wall connection. Refer to line 6760 of the Uniform Building Inspection Report Binder.

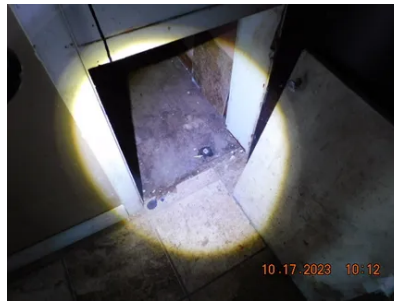
🔍 (B-6) Review: Suspected Mold like substance noted in bathroom. No testing done by inspector at the time of the inspection. Refer to line 7015 of the Uniform Building Inspection Report Binder.

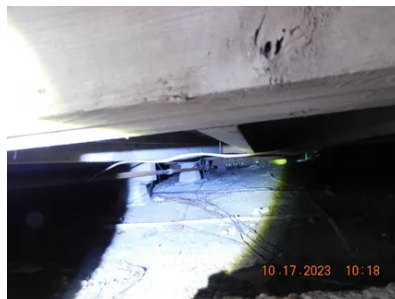
🔧 (CS-2) Review: No vapor barrier has been installed on the soils of this crawl space to contain the moisture in the ground. This is a conducive pest condition and can lead to high moisture conditions. Install a 6 mil. black plastic vapor barrier to cover all exposed earth.
