The Uniform Building Inspection Report™ Condensed

Commercial - Retail:
Pier One Building, Monroe, LA

Inspection Date:
5/15/2021, 9:00:00 AM

Report Number:
052021A

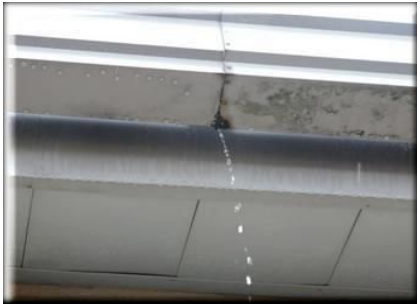
Photo: 1280.04 (1)

[R] [P] [N] [M] 1280.04: Gutter appears to leak.
Monitor the situation on a regular basis. Corrections by a qualified licensed contractor, if and when necessary, are recommended. Discretion advised. The significance of the finding is uncertain. Further study by a qualified licensed contractor is advised. Correction or modification decreases the probability of continued and excessive deterioration. It is recommended that the finding be reviewed, and corrected as needed, by a qualified licensed contractor before purchasing the property.
See Photo(s) 1280.04.

[R] [P] [N] 1280.04: Gutter appears to leak.
Discretion advised. The significance of the finding is uncertain. Further study by a qualified licensed contractor is advised. Correction or modification decreases the probability of continued and excessive deterioration. It is recommended that the finding be reviewed, and corrected as needed, by a qualified licensed contractor before purchasing the property.
See Photo(s) 1280.04.

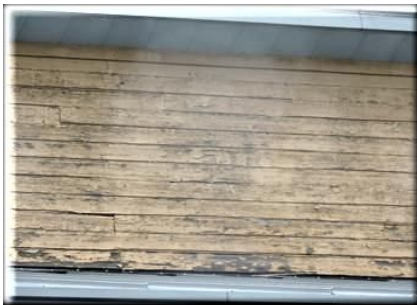
Photo: 1310 (2)

[U] [P] [N] [M] [C] [A] 1310: Siding cracked / holed / gapped / damaged / weathered / stained.
Maintenance, alteration or repair could be expected to improve component appearance and may decrease deterioration. Caution is advised. The finding could be, or could become, hazardous under certain circumstances. The opinion of a qualified licensed contractor is recommended. Monitor the situation on a regular basis. Corrections by a qualified licensed contractor, if and when necessary, are recommended. Discretion advised. The significance of the finding is uncertain. Further study by a qualified licensed contractor is advised. Correction or modification decreases the probability of continued and excessive deterioration. Modification or addition is generally considered an upgrade which should improve safety or efficiency. The opinion of a qualified licensed contractor is recommended.
See Photo(s) 1310.

[U] [R] [P] [N] [M] 1310: Siding cracked / holed / gapped / damaged / weathered / stained.
