# The Uniform Building Inspection Report™ Condensed

**Single Family Residence:**  
368 Bella court, Frierson, LA

**Inspection Date:**  
10/6/2021, 9:00:00 AM

**Report Number:**  
100521L

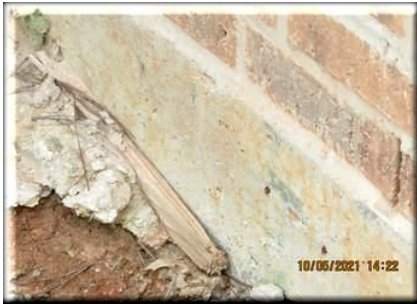
Photo: 0960 (2)

[U] [P] [N] 0960: Finding not covered in the narratives. Construction debris near foundation with may rot or cause possible termites. Discretion advised. The significance of the finding is uncertain. Further study by a qualified licensed contractor is advised. Correction or modification decreases the probability of continued and excessive deterioration. Modification or addition is generally considered an upgrade which should improve safety or efficiency. The opinion of a qualified licensed contractor is recommended. See Photo(s) 0960.

termites. Monitor the situation on a regular basis. Corrections by a qualified licensed contractor, if and when necessary, are recommended. Discretion advised. The significance of the finding is uncertain. Further study by a qualified licensed contractor is advised. Correction or modification decreases the probability of continued and excessive deterioration.  
See Photo(s) 0960.

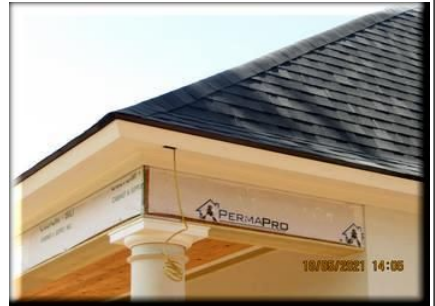
Photo: 9710.03 (1)

[U] [R] [P] [N] [E] 9710.03: Insulation incomplete.  
Repair, alteration or replacement usually improves the efficiency of the component or system. Discretion advised. The significance of the finding is uncertain. Further study by a qualified licensed contractor is advised. Correction or modification decreases the probability of continued and excessive deterioration. It is recommended that the finding be reviewed, and corrected as needed, by a qualified licensed contractor before purchasing the property. Modification or addition is generally considered an upgrade which should improve safety or efficiency. The opinion of a qualified licensed contractor is recommended.  
See Photo(s) 9710.03.

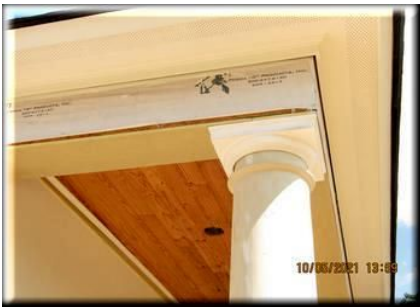
Photo: 9750.20 (1)

[U] [R] [P] [N] 9750.20: Moisture barrier not installed.  
Discretion advised. The significance of the finding is uncertain. Further study by a qualified licensed contractor is advised. Correction or modification decreases the probability of continued and excessive deterioration. It is recommended that the finding be reviewed, and corrected as needed, by a qualified licensed contractor before purchasing the property. Modification or addition is generally considered an upgrade which should improve safety or efficiency. The opinion of a qualified licensed contractor is recommended.  
Installation not complete and sealed.  
See Photo(s) 9750.20.

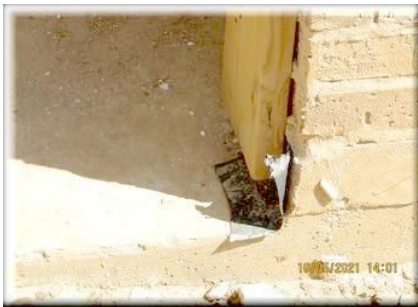
Photo: 9750.21 (1)

[U] [P] [N] 9750.21: Moisture barrier faulty or otherwise amiss.  
Discretion advised. The significance of the finding is uncertain. Further study by a qualified licensed contractor is advised. Correction or modification decreases the probability of continued and excessive deterioration. Modification or addition is generally considered an upgrade which should improve safety or efficiency. The opinion of a qualified licensed contractor is recommended.  
See Photo(s) 9750.21.

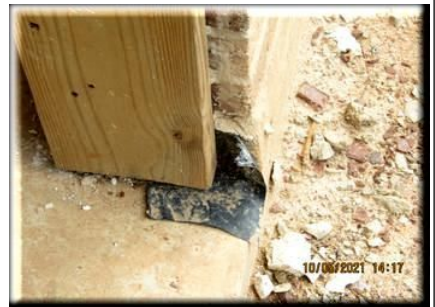
Photo: 9750.21 (2)

[R] [P] [N] 9750.21: Moisture barrier faulty or otherwise amiss.

Discretion advised. The significance of the finding is uncertain.  
Further study by a qualified licensed contractor is advised.  
Correction or modification decreases the probability of continued and excessive deterioration. It is recommended that the finding be reviewed, and corrected as needed, by a qualified licensed contractor before purchasing the property.  
See Photo(s) 9750.21.
