# The Uniform Building Inspection Report™ Condensed

## Single Family Residence:

7310 Camelback Drive, Shreveport, LA 71105

20220113B

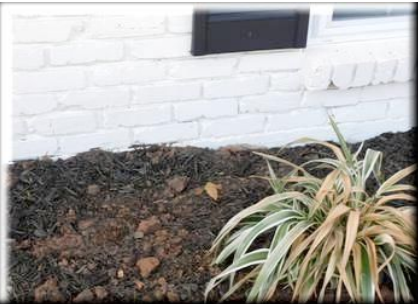
Photo: 0800.02 (1)

[M] [N] 0800.02: Earth separation from building inadequate. Discretion advised. The significance of the finding is uncertain. Further study by a qualified licensed contractor is advised. Monitor the situation on a regular basis. Corrections by a qualified licensed contractor, if and when necessary, are recommended. See Photo(s) 0800.02.

[P] [N] 0800.02: Earth separation from building inadequate. Discretion advised. The significance of the finding is uncertain. Further study by a qualified licensed contractor is advised. Correction or modification decreases the probability of continued and excessive deterioration. See Photo(s) 0800.02.

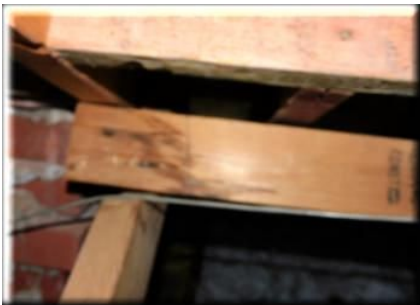
Photo: 9150.02 (1)

[R] [P] [N] [M] 9150.02: Slab deterioration noted.

Monitor the situation on a regular basis. Corrections by a qualified licensed contractor, if and when necessary, are recommended.

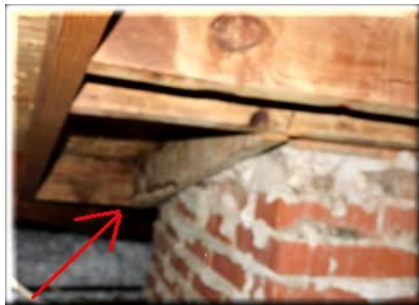
Photo: 9650 (1)

[M] 9650: Roof leak evidence noted (stained wood).

Although stains were noted at several locations there is no way to determine whether there are ongoing roof leaks. It appears that the roof needs minimal repairs and that the stains are old.

Monitor the situation on a regular basis. Corrections by a qualified licensed contractor, if and when necessary, are recommended.

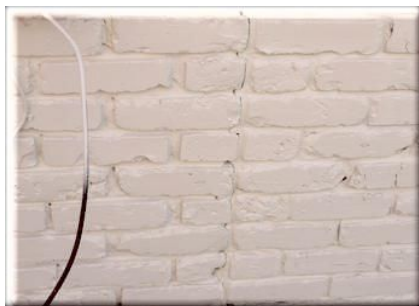
Photo: 9800 (1)

[U] [R] [P] [N] 9800: Review by qualified licensed contractor or engineer advised.  
Discretion advised. The significance of the finding is uncertain. Further study by a qualified licensed contractor is advised. Correction or modification decreases the probability of continued and excessive deterioration. It is recommended that the finding be reviewed, and corrected as needed, by a qualified licensed contractor before purchasing the property. Modification or addition is generally considered an upgrade which should improve safety or efficiency. The opinion of a qualified licensed contractor is recommended.  
See Photo(s) 9800.
