SMD CONSTRUCTION CO., INC.

Inspection No.: 202211010

Inspection Date's: 11/06/2022 & 11/10/2022

Address: 1111 Anywhere Lane, Anywhere, CA

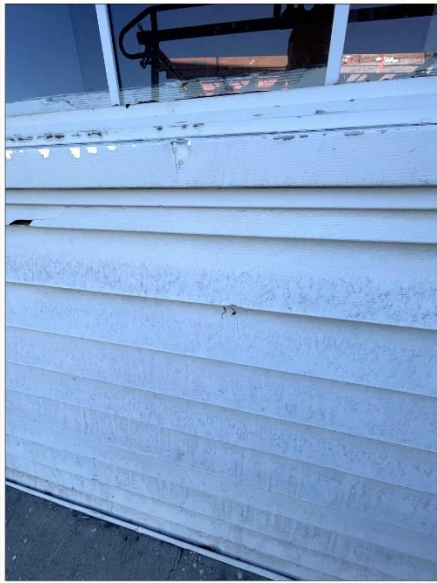
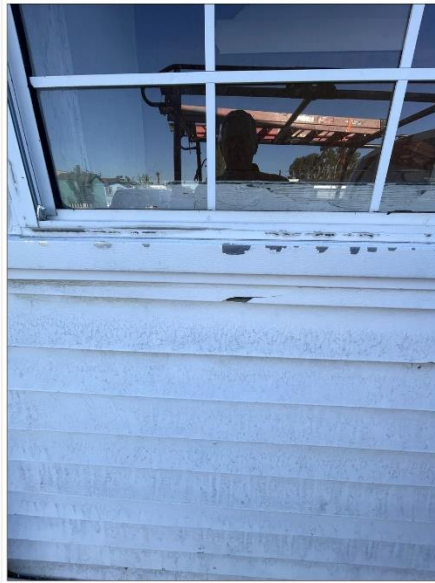
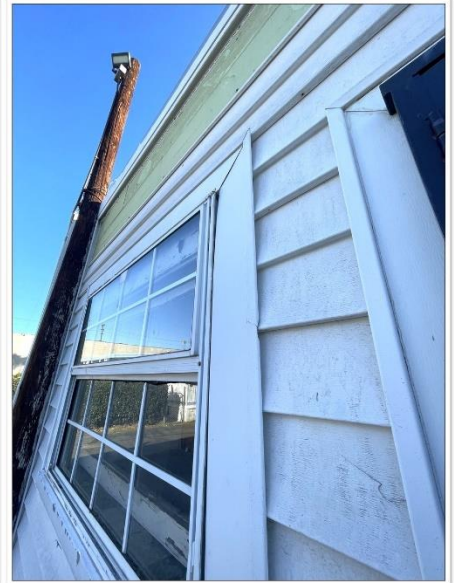
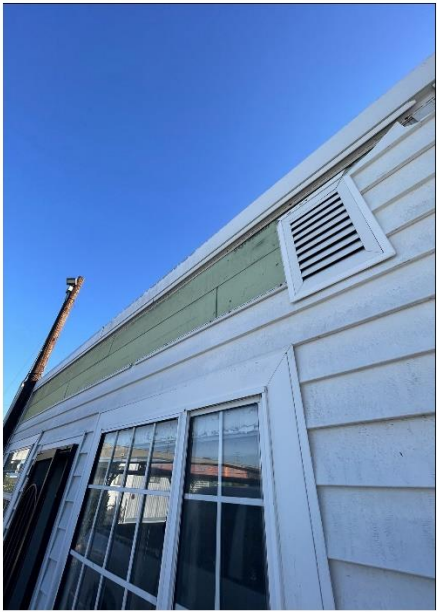
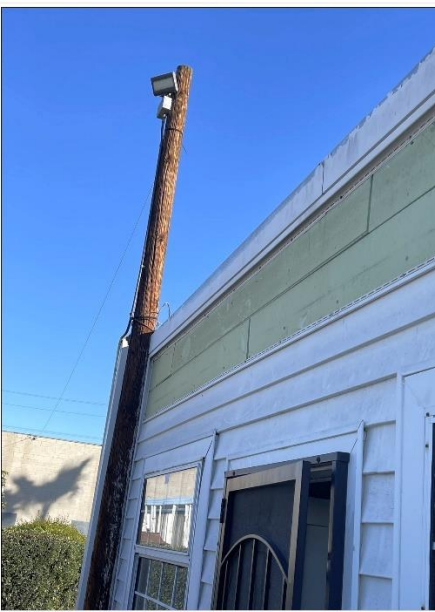
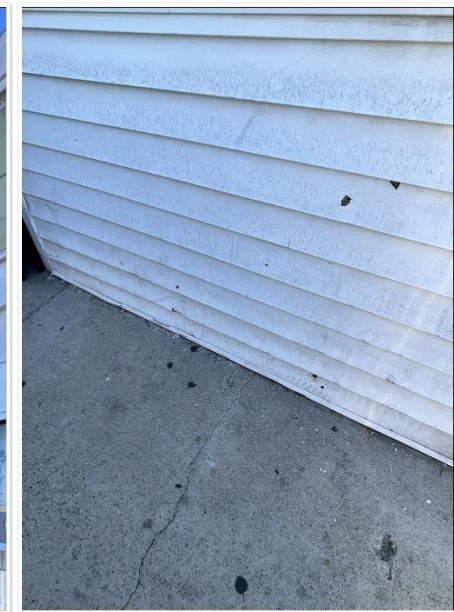
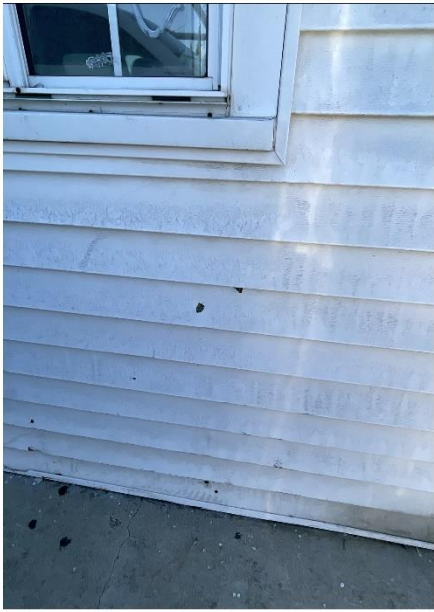
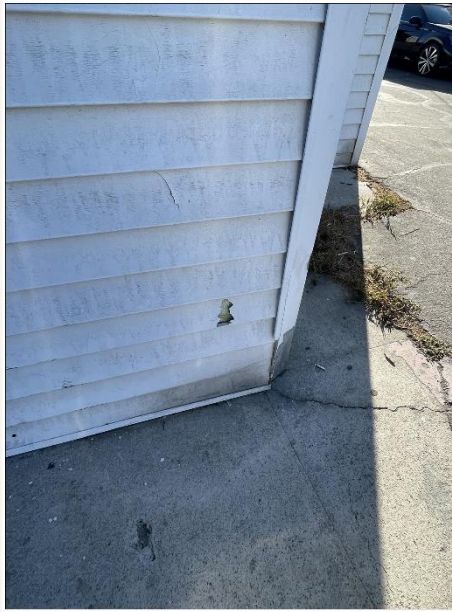
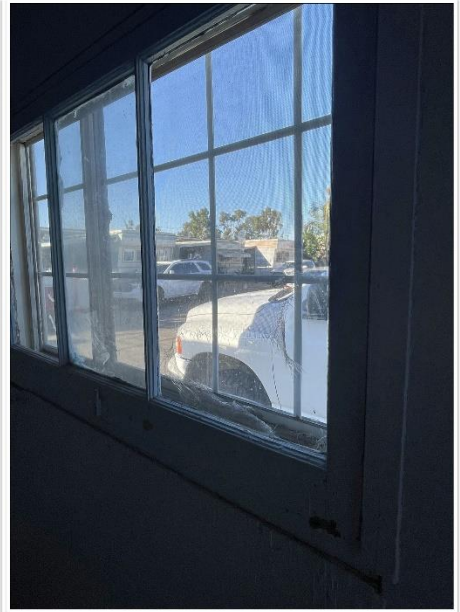
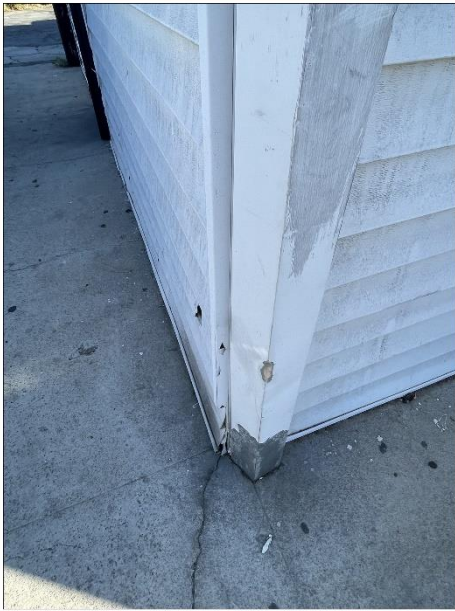
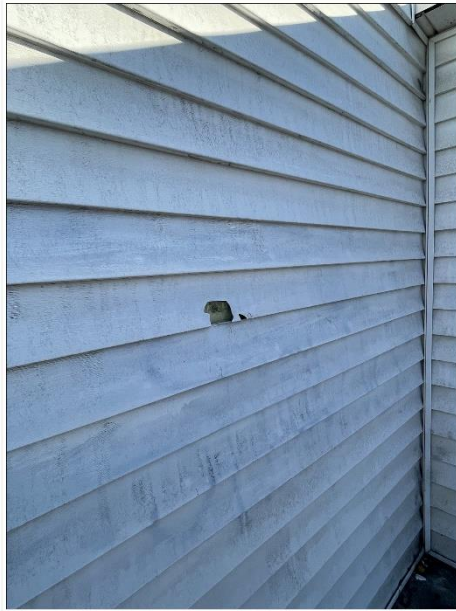
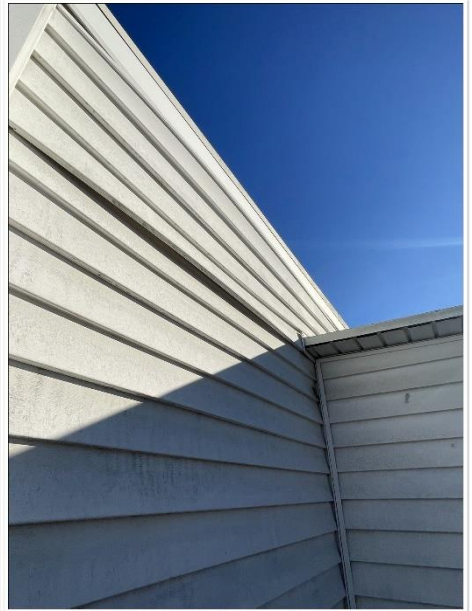
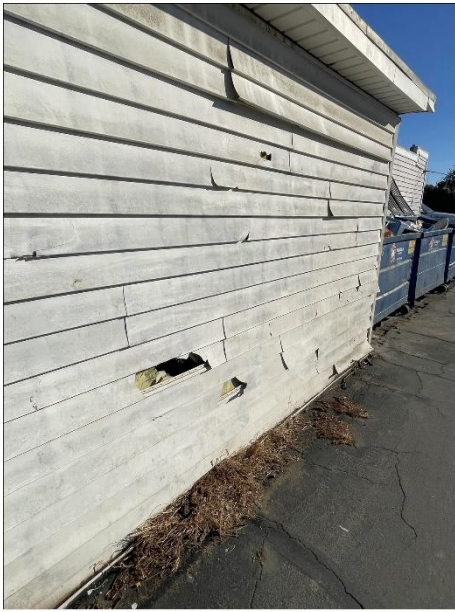
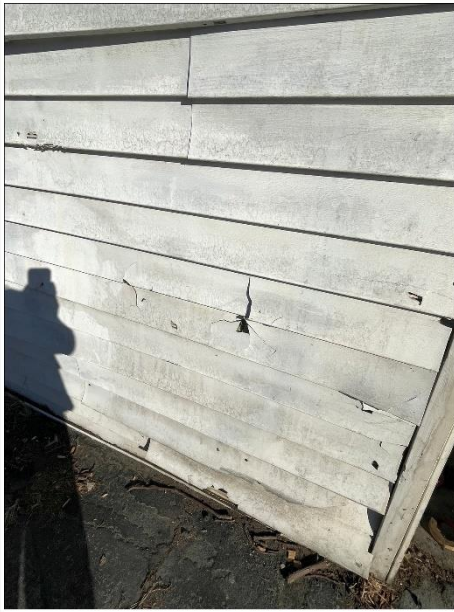
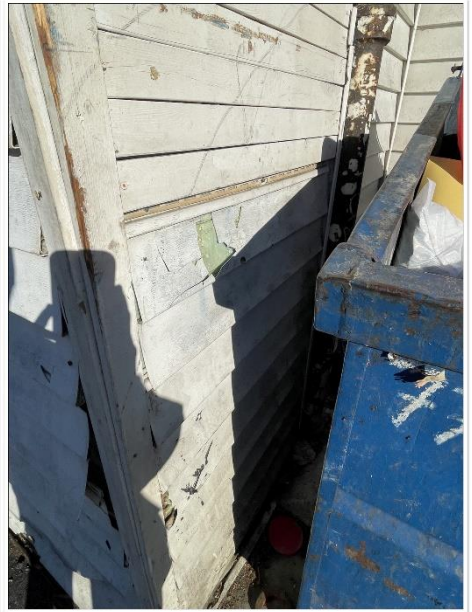
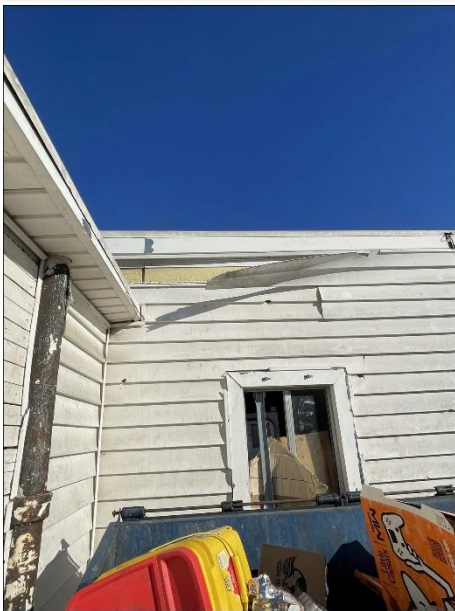
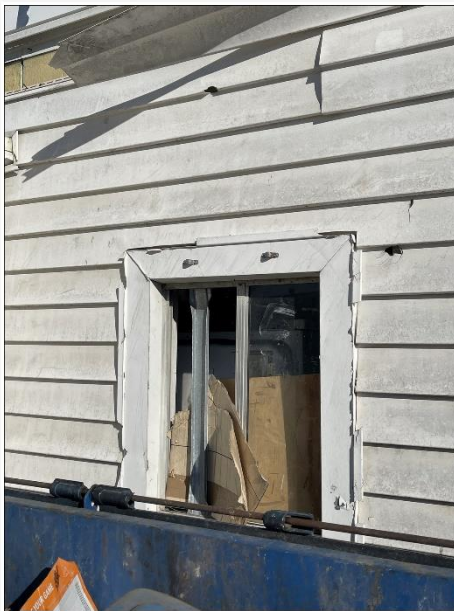
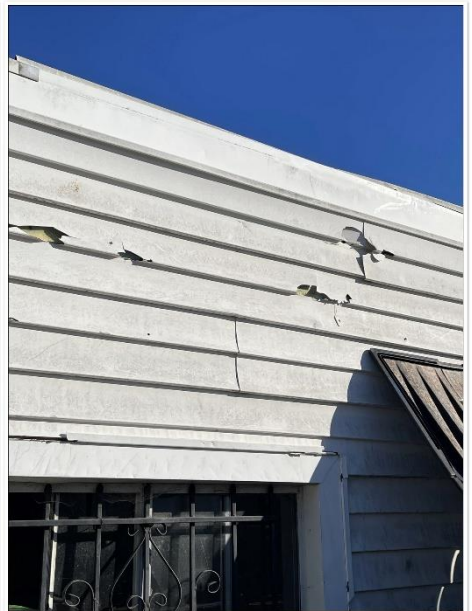
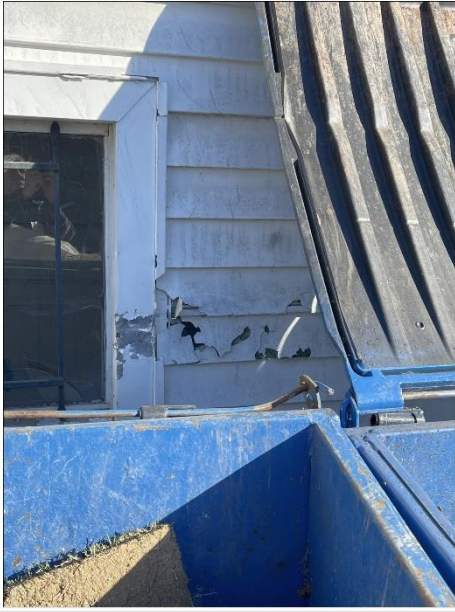
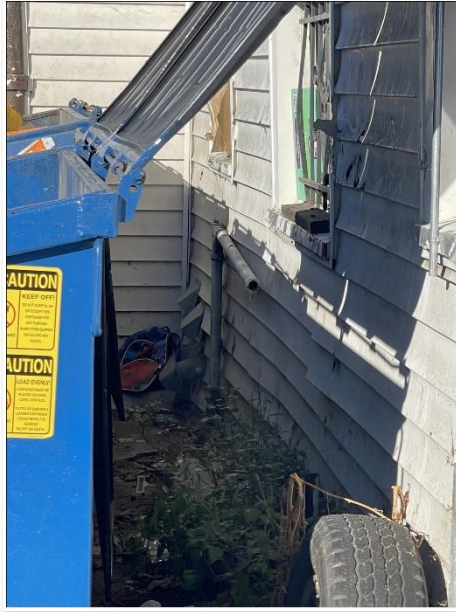
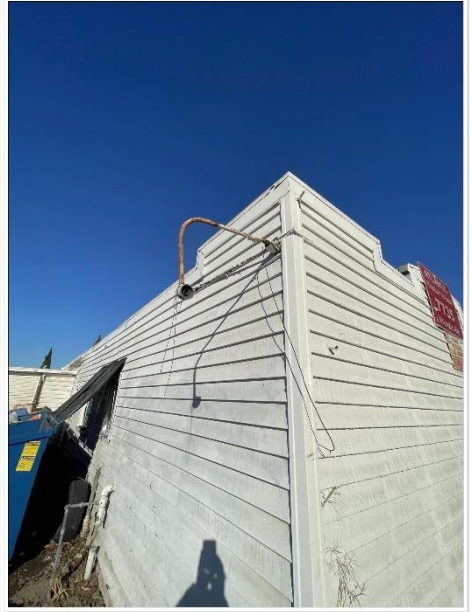
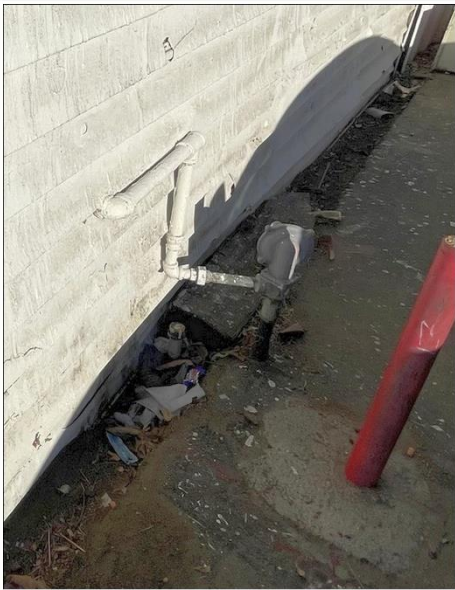
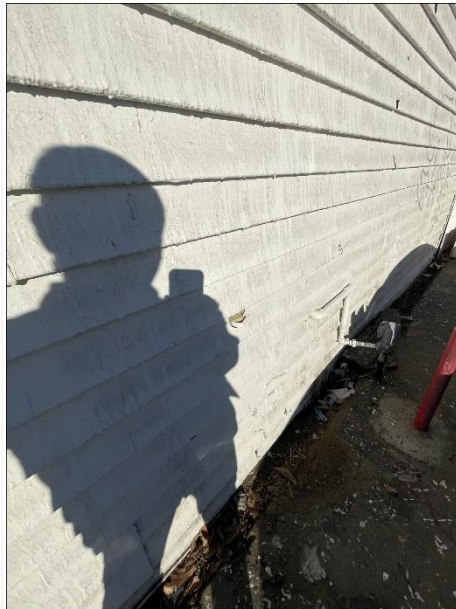
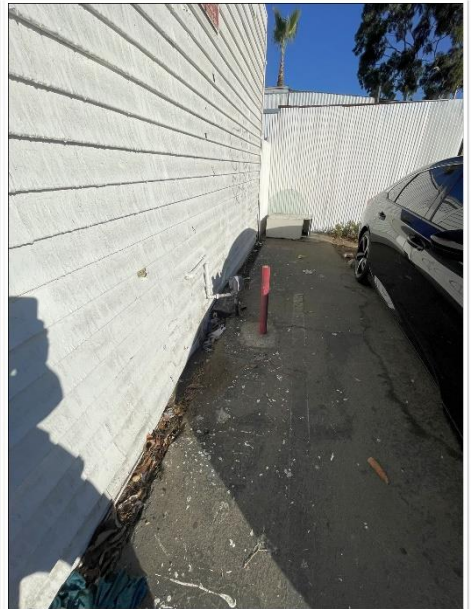
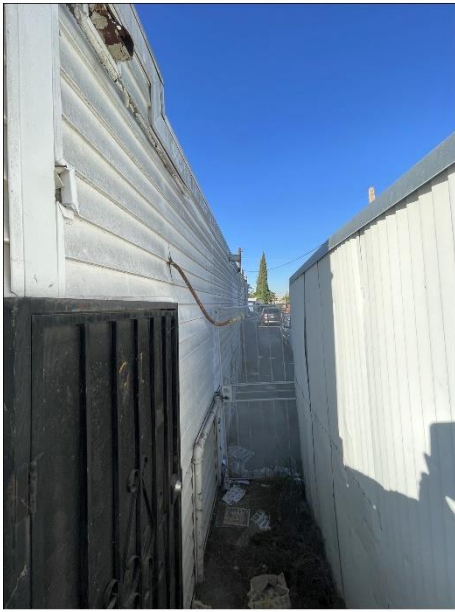
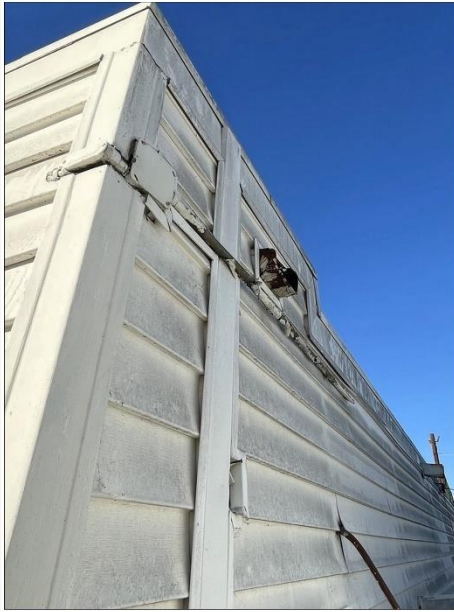
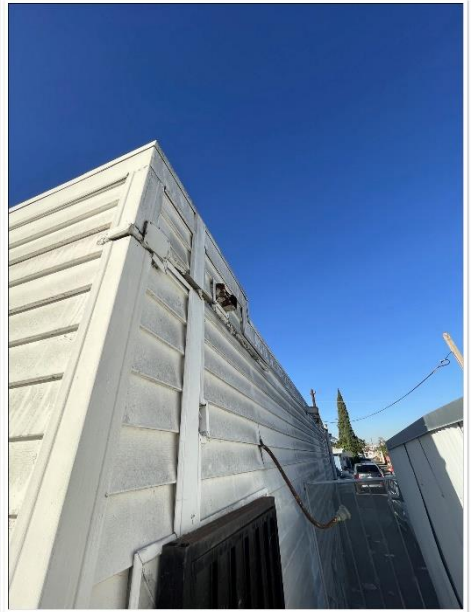
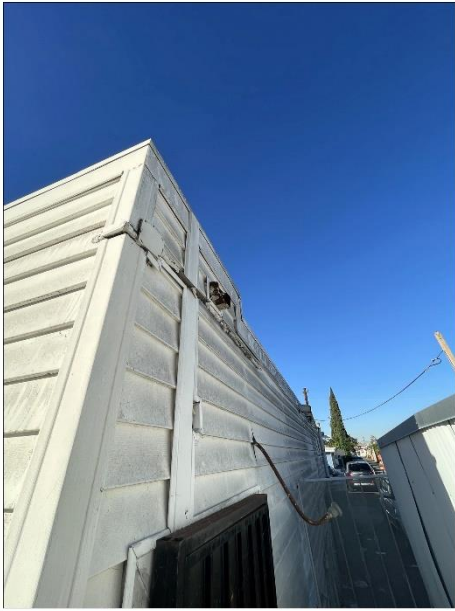
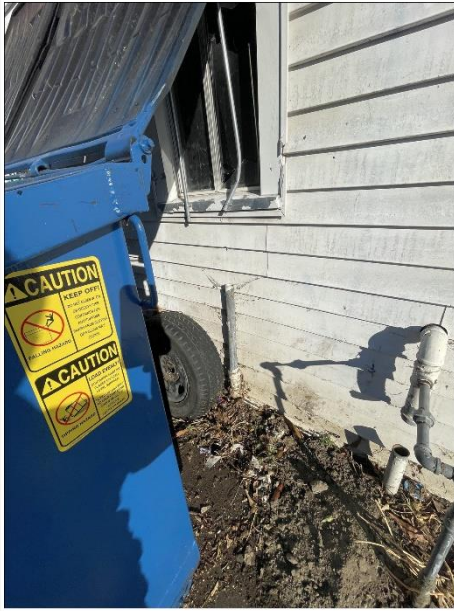
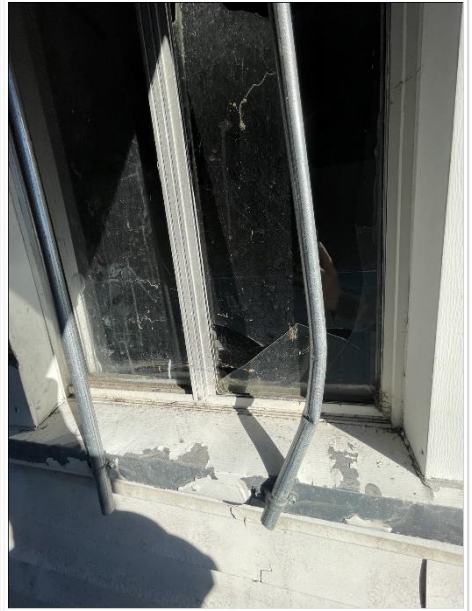
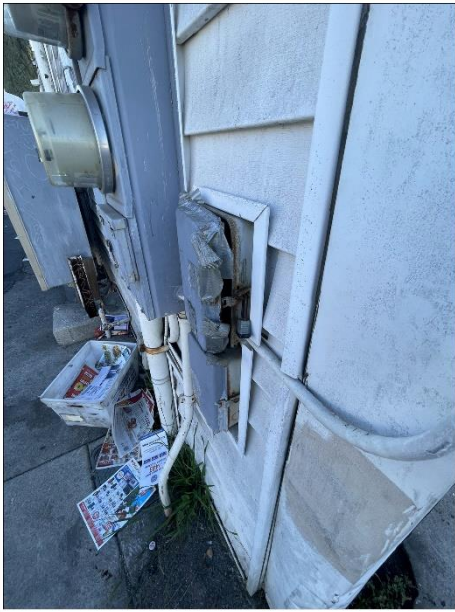
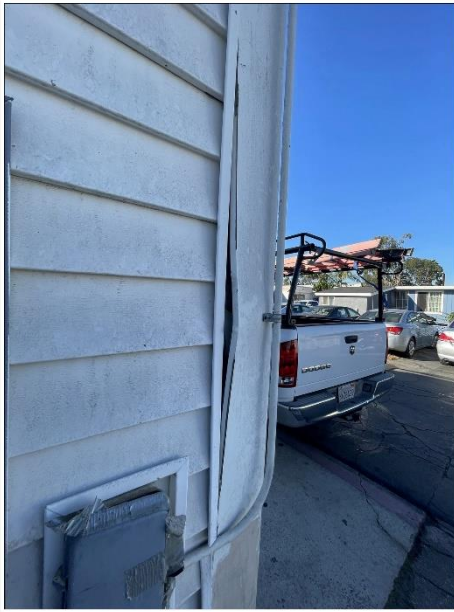
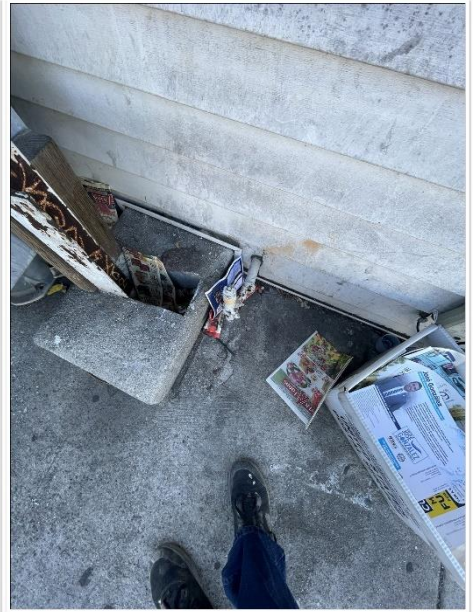
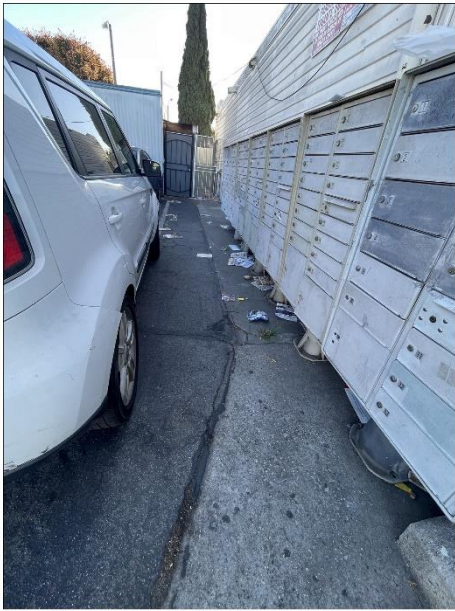
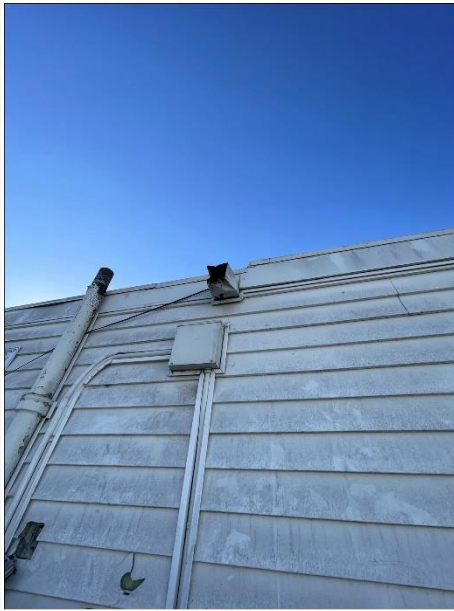
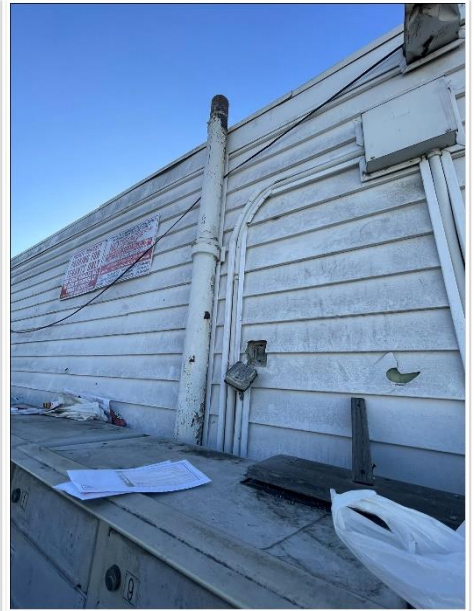
THIS LAUNDRY ROOM HAS EXTENSIVE DAMAGE TO THE EXTERIOR AND INTERIOR AS NOTED IN ABOVE REPORT AS YOU CAN VISUALLY SEE IN ATTACHED COPIES OF PICTURES. ALL DAMAGES TO THIS UNIT ARE REPAIRABLE; AS PER OWNER HE HAS AGREED TO MAKE REPAIRS AS NEEDED.
