PROPERTY INSPECTION REPORT FORM

John & Jane Doe <i>Name of Client</i>	02/10/2026 <i>Date of Inspection</i>
1234 Sample Street, Dallas, TX 75000 <i>Address of Inspected Property</i>	
Jay Wilkinson <i>Name of Inspector</i>	TREC #20338 <i>TREC License #20338</i>
<i>Name of Sponsor (if applicable)</i>	<i>TREC License #</i>

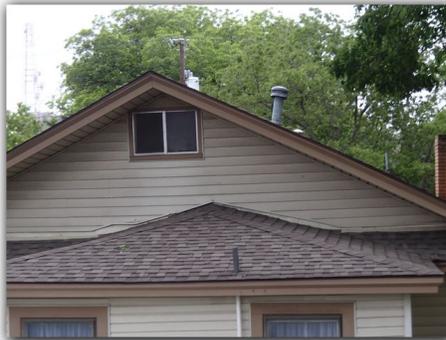
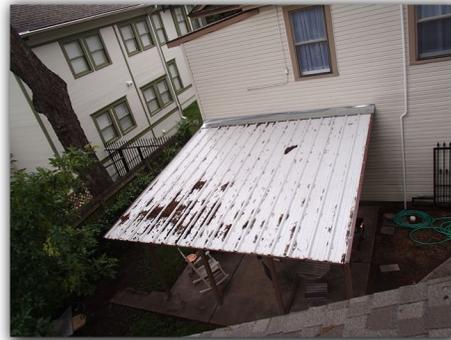
Roof views:

In my opinion, the roof is functioning as intended and shows average wear for age. All components were found to be in satisfactory condition on the day of the inspection except as noted below:

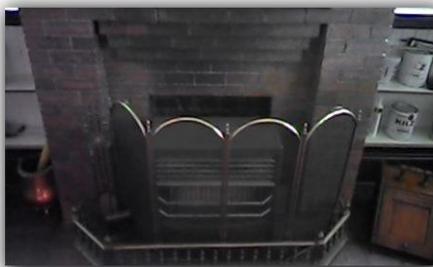
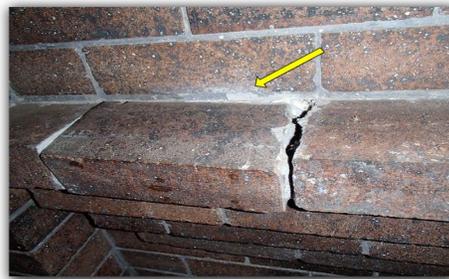
Type and location: Decorative fireplace only, in the living room

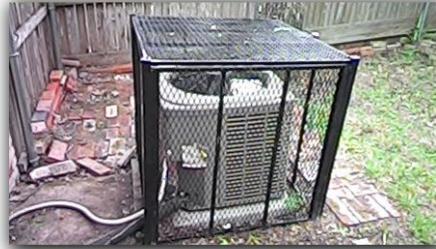
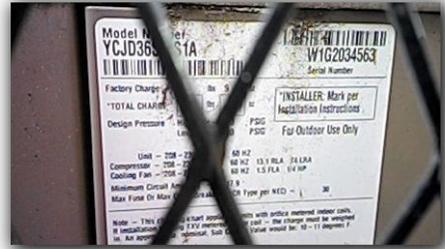
There is no secondary drain for the air conditioning coil. If piping a secondary drain line to the exterior is impractical, installation of a condensate overflow switch or alarm is recommended to avoid damage from obstructed primary condensate lines.

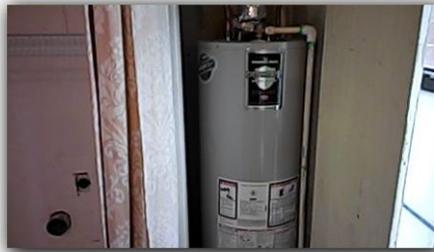
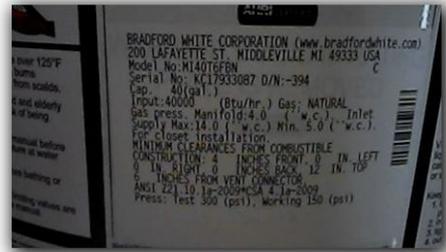
Temperature & Pressure Relief Valve (TPRV): **Tested, appeared to be performing adequately**

Flue material: Double wall B-vent, Partial, single wall vent

The equipment closet door should be sealed on all sides to prevent any combustion fumes or gas from entering the living space.

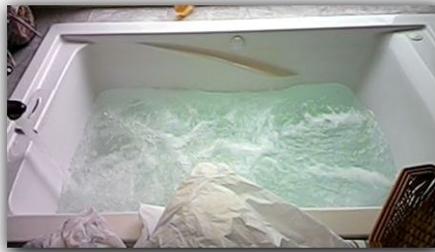
The hydro-tub in the master bathroom was filled with water and observed in operation for approximately ten minutes. This component appeared to be performing consistently with accepted industry practices for its age at the time of this inspection.

Operation of the GFCI breaker was verified in the master bathroom closet.

Although there is an access panel at the plumbing connections, the access to the hydro-massage therapy equipment motor and associated plumbing was not readily accessible and could not be visually inspected for proper configuration or leaks. This does not meet current installation standards.
