"Full" Reserve Study

Lakes at Deer Creek Deerfield Beach, FL

Report #: 36235-0
For Period Beginning: January 1, 2020
Expires: December 31, 2020

Date Prepared: August 28, 2019

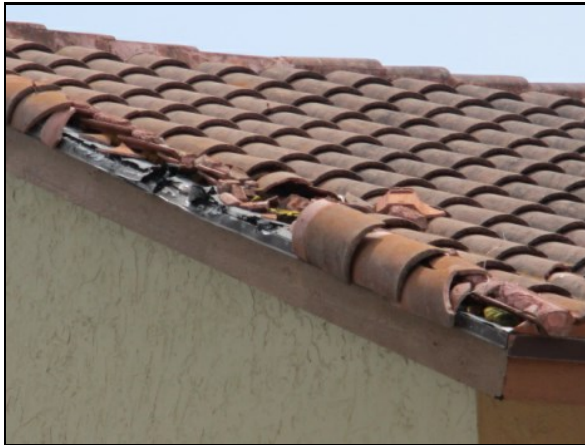
Comp #: 2383 Roofing (Tile) - Replace**Quantity: 160,000 GSF**

Be sure to repair or replace all damaged sections before pressure-washing. Keep any surrounding trees or vegetation trimmed away from the roof line to prevent debris buildup and allow for good sun exposure, which will help to keep roof dry and inhibit organic growth. In general, costs related to this component are expected to be included in the Client's Operating budget. No recommendation for Reserve funding at this time. However, any repair and maintenance or other related expenditures should be tracked, and this component should be re-evaluated during future Reserve Study updates based on most recent information and data available at that time. If deemed appropriate for Reserve funding, component can be included in the funding plan at that time.
