"Full" Reserve Study

Lakes at Deer Creek Deerfield Beach, FL

Report #: 36235-0
For Period Beginning: January 1, 2020
Expires: December 31, 2020

Date Prepared: August 28, 2019

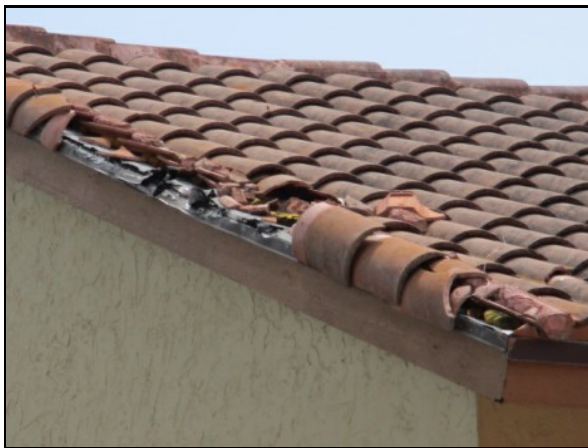
Comp #: 2383 Roofing (Tile) - Replace

History: Roofs were replaced in 2005 per information provided by client. Two unit roofs have reportedly been replaced in 2018.
