Feb 17th, 2026

123 SAMPLE STREET, SAMPLE, AL 00000

Home Inspection Report

Garrett Gamble / Gamble Home Inspections LLC

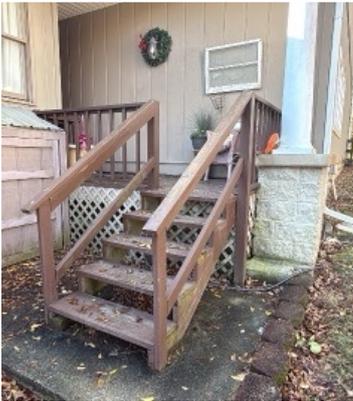
No balusters for the handrails on steps

The steps lack balusters on the handrails, which is a safety concern, especially for children and pets. It is recommended to have balusters installed to meet safety standards and ensure proper protection. Consult a qualified contractor for installation.

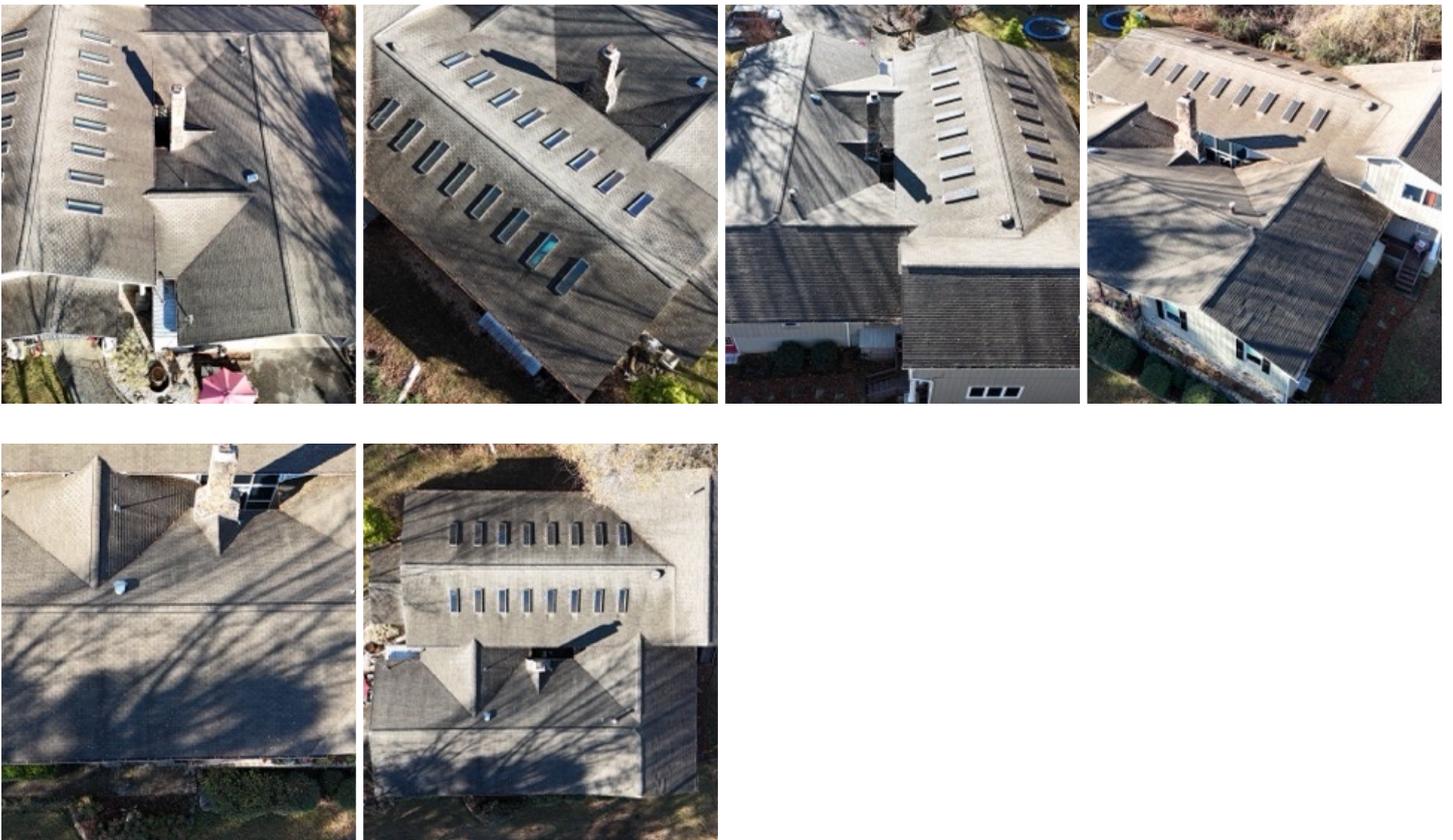
The roof covering exhibited visible waviness, localized dipping, and areas of shingle lift. These conditions are commonly associated with uneven or deteriorated roof decking, structural deflection, or improper installation. Lifted shingles may be more susceptible to wind

damage and water intrusion. Further evaluation by a qualified roofing contractor is recommended to assess the roof decking and underlying structure and to make necessary repairs.

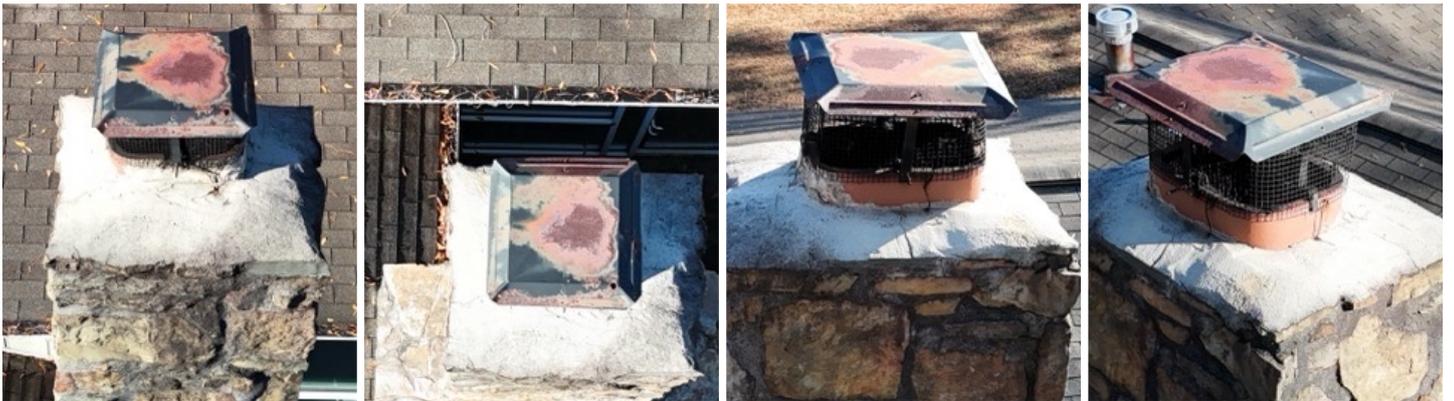
Chimney crown has crack/s

Observed cracks in the chimney crown, which can lead to water intrusion and further damage. Recommend having a qualified mason assess the situation and perform necessary repairs to prevent potential deterioration.

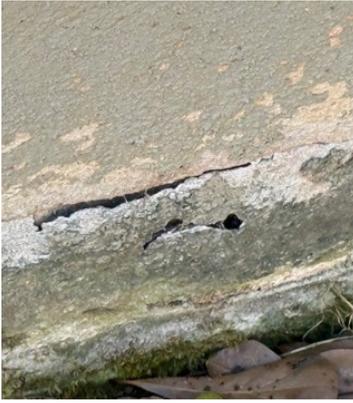
Exterior Surface Cracking and Damage

The exterior surface shows signs of cracking, spalling, and peeling paint, with visible holes and potential water damage at the base.

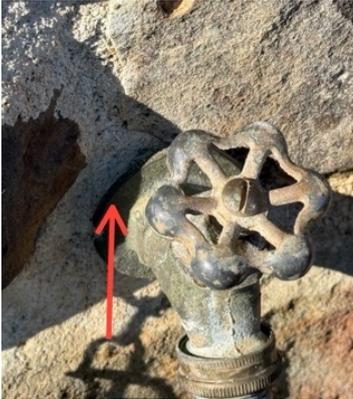
Caulk around gap of hose bib

The hose bib has been caulked to seal the gap, which helps prevent water intrusion and potential damage. Regularly check the caulking for deterioration and reapply as necessary to maintain an effective seal.

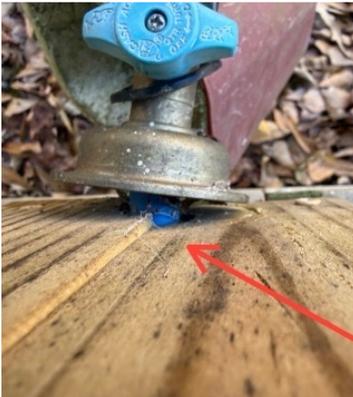
Not secure to home

Hose bib is not securely attached to the home.

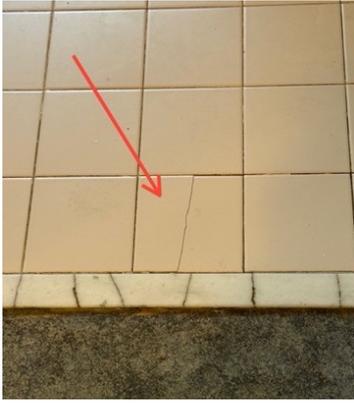
Cracked bathroom floor tile

Observed a cracked bathroom floor tile. Recommend replacing the damaged tile to prevent water infiltration and potential subfloor damage. Consider consulting a professional for precise repair.

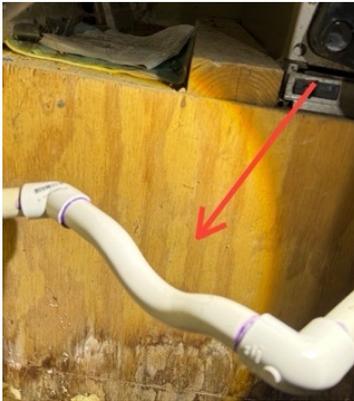
Condensate line should have downward slope and not a dip

The condensate line was observed to have an improper dip instead of a continuous downward slope. This can lead to water accumulation and potential blockage. It is recommended to have a qualified HVAC technician evaluate and adjust the line to ensure proper drainage.

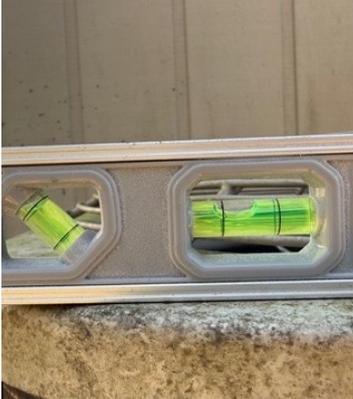
Unit is unlevel

The HVAC cooling unit is not level, which can lead to operational inefficiencies and potential damage. It is recommended to consult a qualified HVAC technician to properly level the unit to ensure optimal performance and longevity.

Very minor but keep an eye on it.

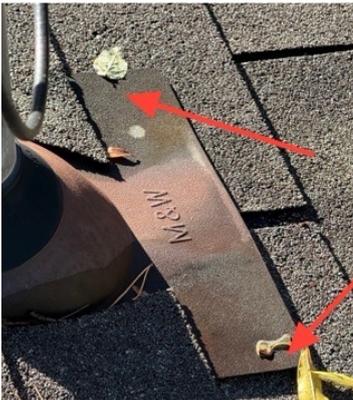
Service mast fasteners have missing/deteriorating caulk

The service mast fasteners have missing or deteriorating caulk, which could lead to water infiltration. Recommend re-caulking these areas to prevent potential damage and ensure weatherproofing. Consult a qualified electrician for repairs.

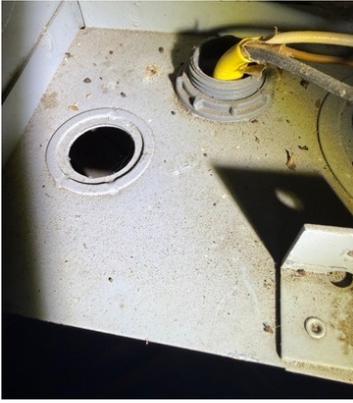
Open knockout hole. Insert blank to cover opening.

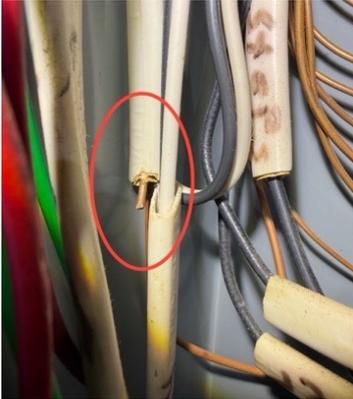
Exposed neutral thats cut

Observed an exposed and cut neutral wire in the electrical subpanel. This poses a safety hazard and may lead to electrical malfunctions. Recommend immediate evaluation and repair by a licensed electrician to ensure proper functionality and safety.

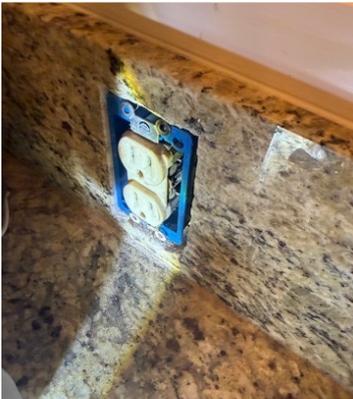
Master bath

One or more outlets missing a cover

One or more electrical outlets are missing a cover, posing a safety risk by exposing wiring. It is recommended to install proper covers to prevent electrical hazards and ensure compliance with safety standards.

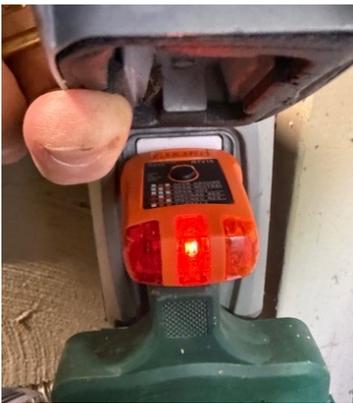
One or more outlets miswired

One or more electrical outlets were found to be miswired. This can lead to electrical hazards, including potential shock or fire risks. Recommend having a licensed electrician evaluate and correct the wiring to ensure safety and compliance with current electrical codes.

Open ground exterior

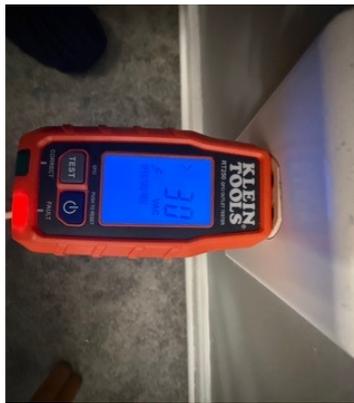
Open ground bonus room above pool

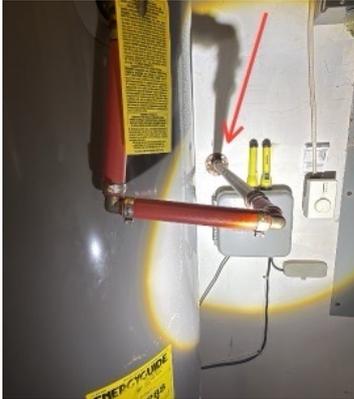
Termination end not in the same room

The TPR valve extension terminates outside the same room as the water heater. It's recommended to have a licensed plumber assess and correct the termination to ensure safety and compliance with local building codes.

Should be to the floor and no more than 4" from the ground

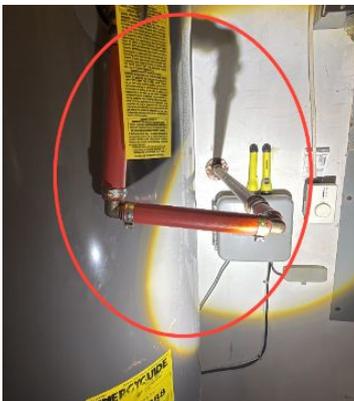
Improper extension material

The water heater's TPR valve extension is made from improper material, which may compromise its function and safety. Recommend consulting a licensed plumber to replace it with a material approved by local codes to ensure proper operation.

Material should be rigid

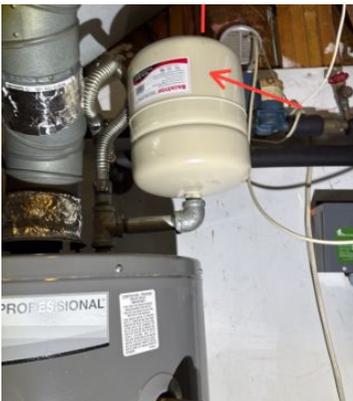
Expansion tank not supported

The expansion tank for the water heater is not properly supported. This can lead to potential strain on the plumbing connections, increasing the risk of leaks or damage. It is recommended to have a qualified plumber install proper support to ensure the expansion tank is securely held in place, reducing stress on the piping and ensuring system longevity.

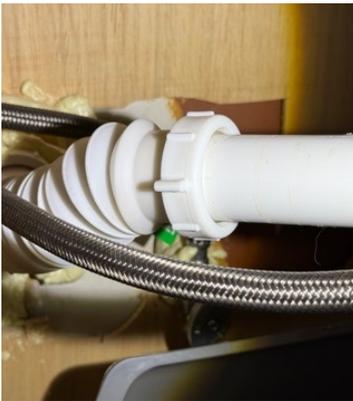
Sink drain pipe is using flex corrugated

The sink drain pipe is using flexible corrugated pipe, which is not recommended for permanent plumbing installations due to its tendency to clog and restrict water flow. Recommend replacing with smooth, rigid piping for improved performance and compliance with plumbing standards.

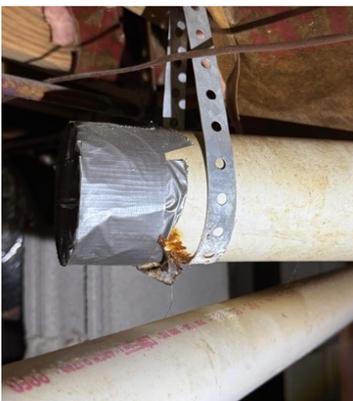
Improper end cap

An improper end cap was observed on the plumbing drain pipe, which could lead to leaks or contamination. Recommend having a licensed plumber assess and replace the end cap with the appropriate fitting to ensure proper sealing and function.

Duct tape is a no go

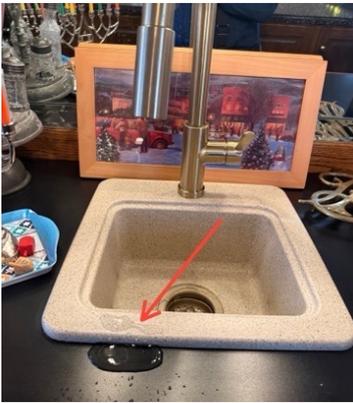
Faucet water terminates partly outside the sink

The faucet's water flow partially extends outside the sink area, which may lead to water damage on surrounding surfaces. Recommend repositioning or replacing the faucet to ensure proper alignment and water containment.

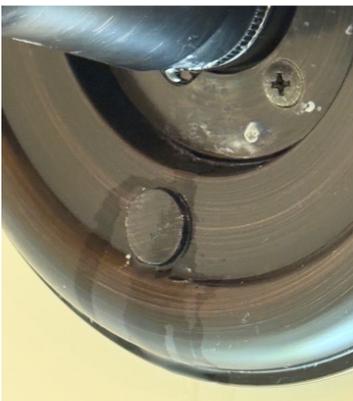
Shower in pool bathroom

Leaking faucet

During the inspection, a leak was observed in the faucet. It is recommended to have a licensed plumber assess and repair the issue to prevent potential water damage and increased utility costs. Consider replacing worn washers or components to ensure optimal performance.

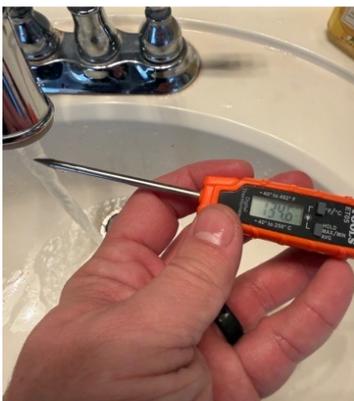
Water temperature above 120 degrees

The water temperature at the faucets was measured above 120 degrees Fahrenheit, which poses a risk of scalding. It is recommended to adjust the water heater thermostat to a maximum of 120 degrees to ensure safety and prevent burns. Consider consulting a licensed plumber to make the necessary adjustments and to verify that the temperature is maintained at a safe level. Regular checks are advised to ensure continued safety.

Max temp should be 120 degrees

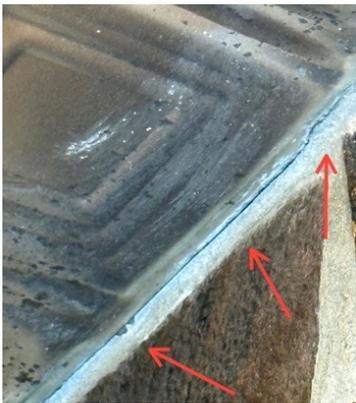
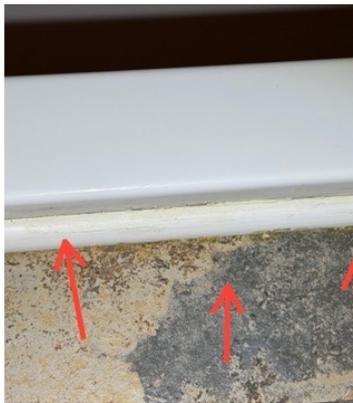
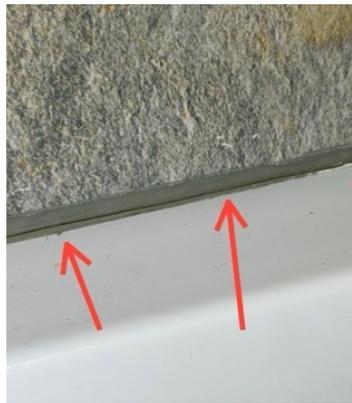
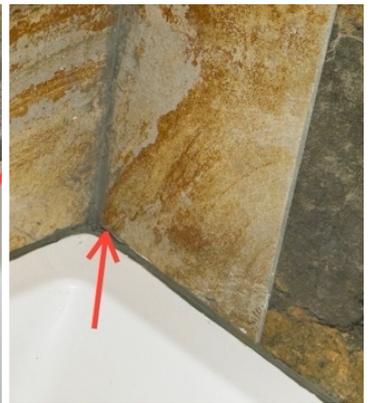
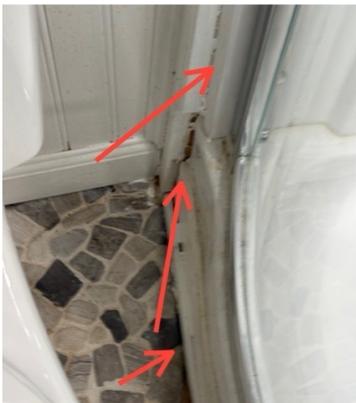
Missing/Deteriorating caulk around shower/tub

Caulking around the shower/tub is missing or deteriorating, which can allow water infiltration and cause damage. Recommend re-caulking to prevent future leaks and maintain the integrity of the area.

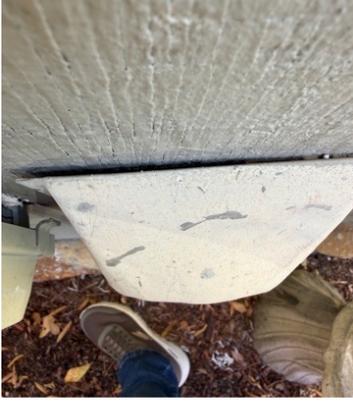
Caulk around vent missing

The caulk around the dryer vent is missing, which could lead to moisture intrusion or pest entry. Recommend reapplying an outdoor-grade caulk to ensure a proper seal and prevent potential issues.

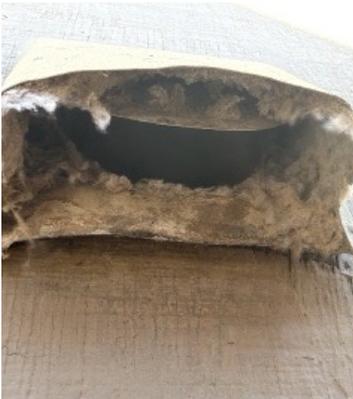
Recommend cleaning

The dryer vent shows signs of lint buildup and should be cleaned to ensure proper airflow and reduce the risk of fire. It is recommended to schedule a professional cleaning service or clean the vent yourself at least once a year.

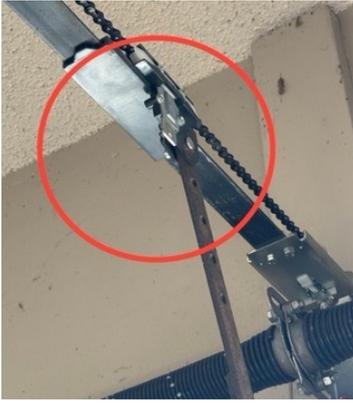
Emergency release missing

The garage door is missing an emergency release mechanism, which is essential for safety during power outages or mechanical failure. Recommend installing a manual release to ensure safe and quick access in emergencies.

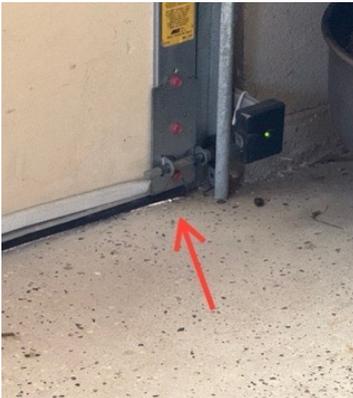
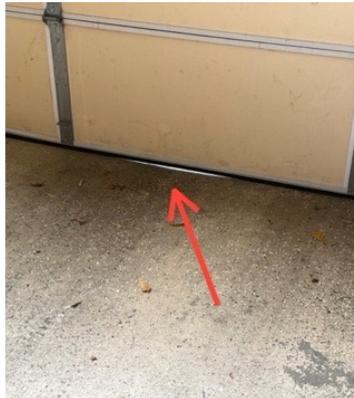
Weather seal(s) loose or damaged

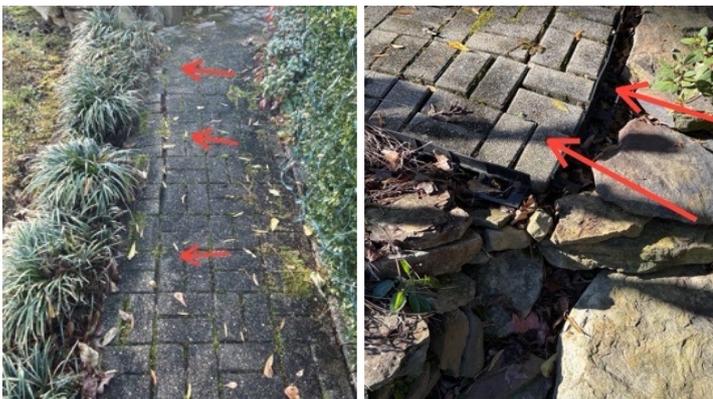
Walkways slippery, uneven, and/or unlevel

The walkways are observed to be slippery, uneven, and/or unlevel. It is recommended to address these issues to prevent potential tripping hazards. Consider resurfacing or leveling the walkways and applying a non-slip coating for improved safety.

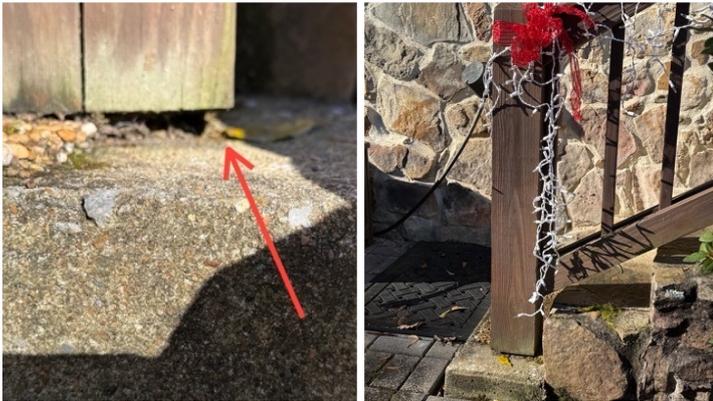
Handrail loose

The handrail on the steps/stoop is loose and may pose a safety hazard. Recommend securing or replacing the handrail promptly to ensure stability and prevent potential injuries. Please consult a qualified contractor for repairs.

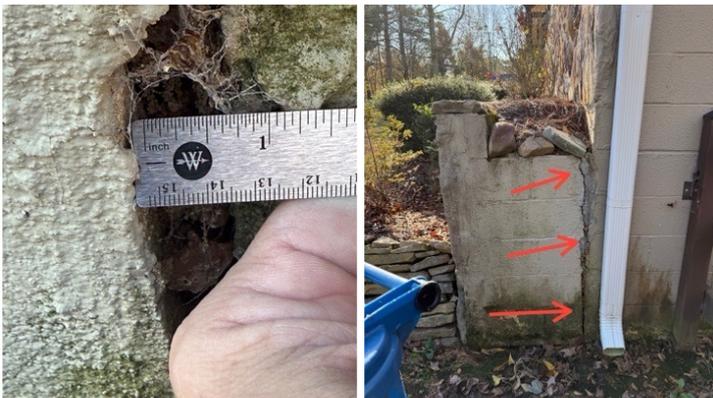
Retaining wall separating from home

The retaining wall is observed to be separating from the home. This may compromise both the wall's structural integrity and the surrounding soil stability. It is recommended to consult with a structural engineer or qualified contractor to assess the situation and perform necessary repairs.

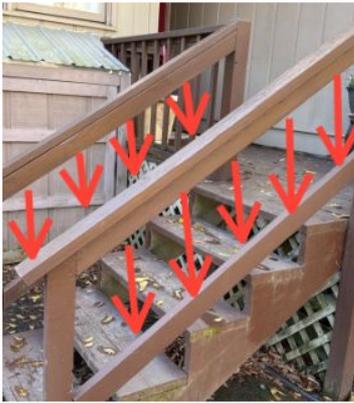
No balusters for the handrails on steps

The steps lack balusters on the handrails, which is a safety concern, especially for children and pets. It is recommended to have balusters installed to meet safety standards and ensure proper protection. Consult a qualified contractor for installation.

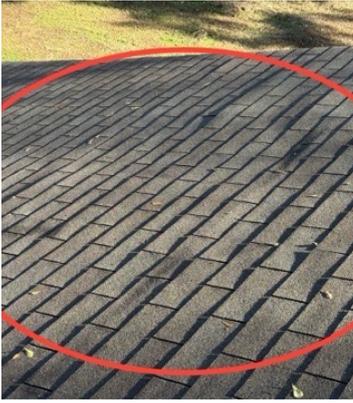
Uneven roof surfaces/shingle irregularities

The roof covering exhibited visible waviness, localized dipping, and areas of shingle lift. These conditions are commonly associated with uneven or deteriorated roof decking, structural deflection, or improper installation. Lifted shingles may be more susceptible to wind damage and water intrusion. Further evaluation by a qualified roofing contractor is recommended to assess the roof decking and underlying structure and to make necessary repairs.

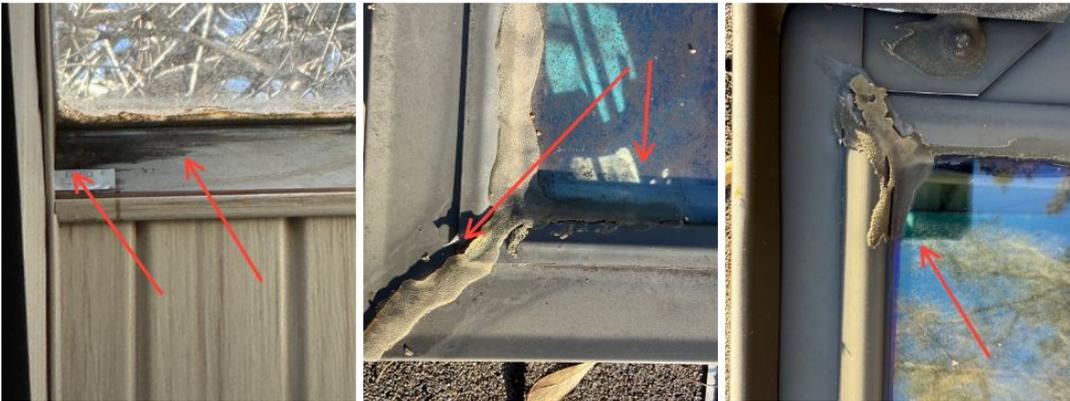
Skylight water intrusion/deteriorating caulk

One or more sky lights have deteriorating caulking around the seals and water intrusion on the interior frame.

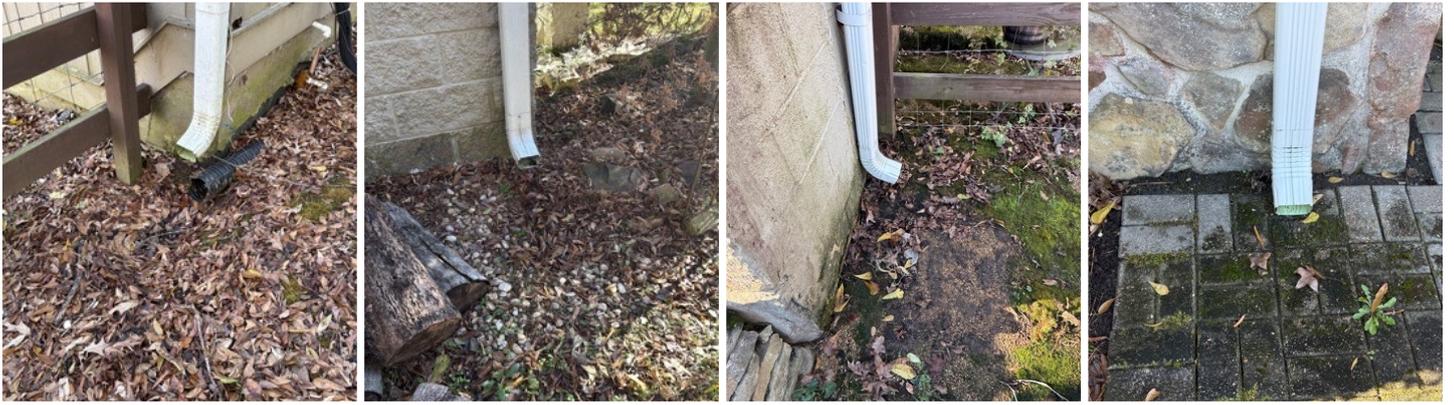
Missing splashblock/extension

Observed missing splashblock/extension at the downspout. Recommend installing a splashblock or extension to ensure proper water diversion away from the foundation and prevent potential water damage.

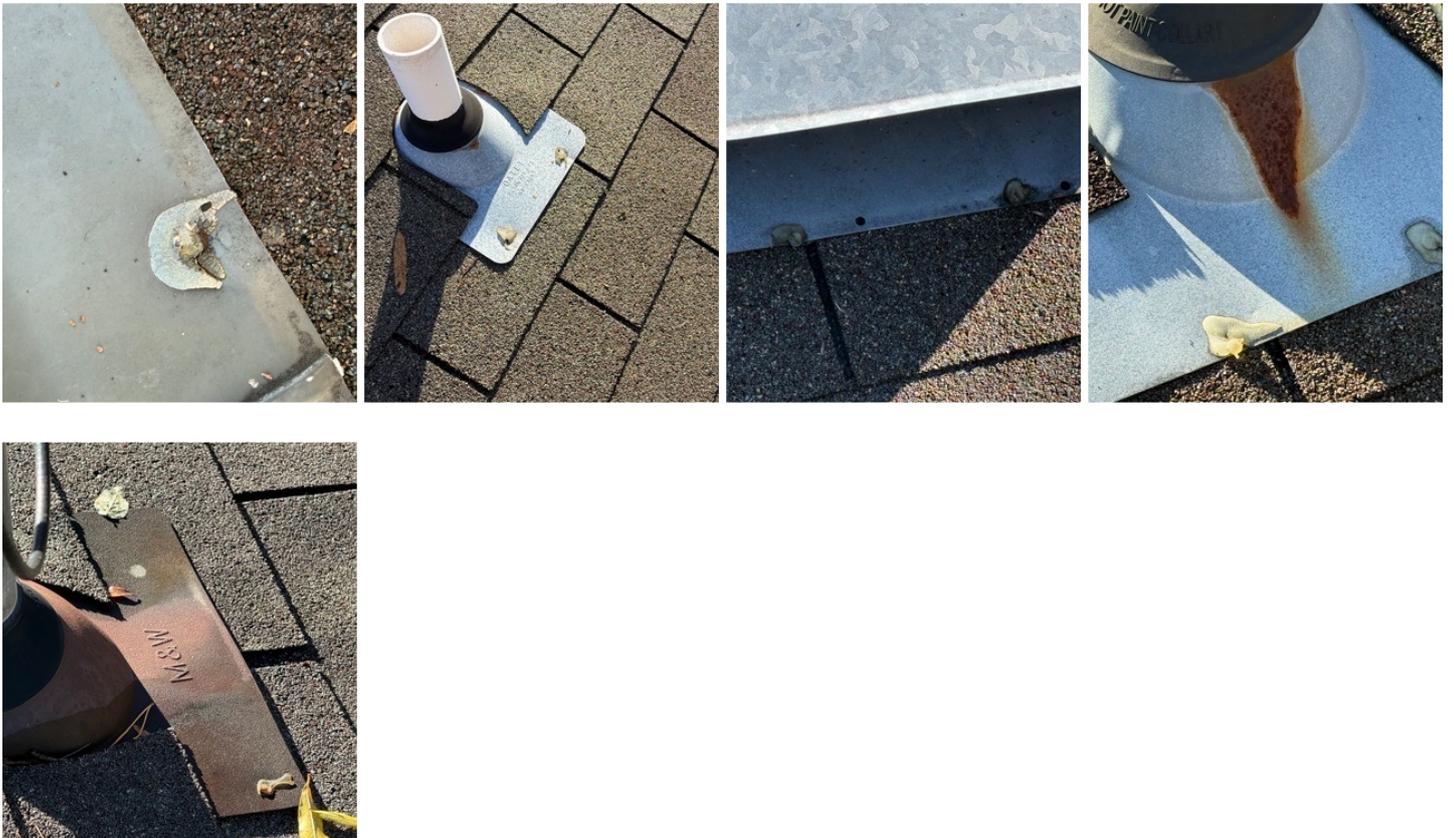
Fasteners have missing/deteriorating caulk

The roof plumbing vent fasteners have missing or deteriorating caulk, which could lead to potential water intrusion. Recommend resealing these areas with appropriate caulk to ensure proper weatherproofing and prevent leaks. Consult a qualified roofing professional for repairs.

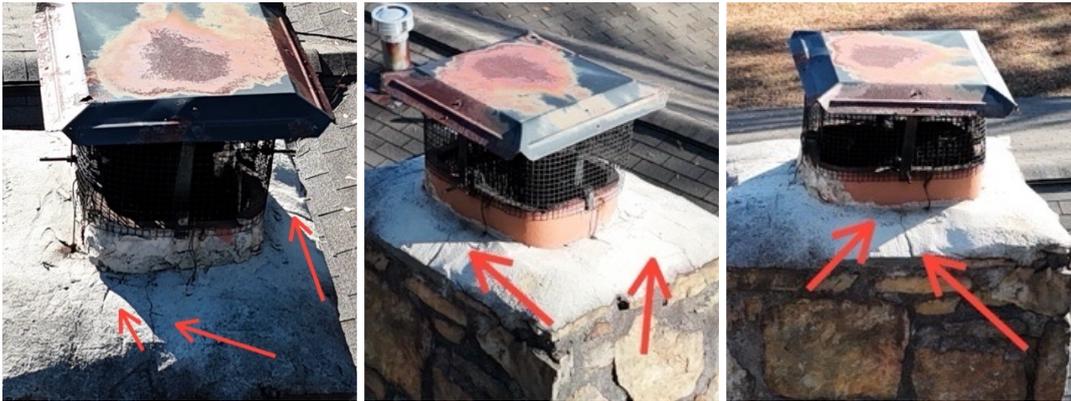
Chimney crown has crack/s

Observed cracks in the chimney crown, which can lead to water intrusion and further damage. Recommend having a qualified mason assess the situation and perform necessary repairs to prevent potential deterioration.

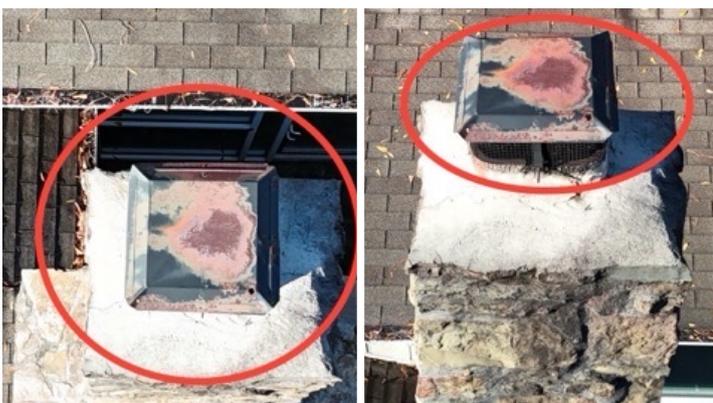
Rusted chimney cap

The chimney cap is rusted, which may lead to impaired functionality and potential water infiltration. Recommend contacting a qualified chimney specialist to assess the condition and replace the cap as necessary to prevent further deterioration and ensure proper operation.

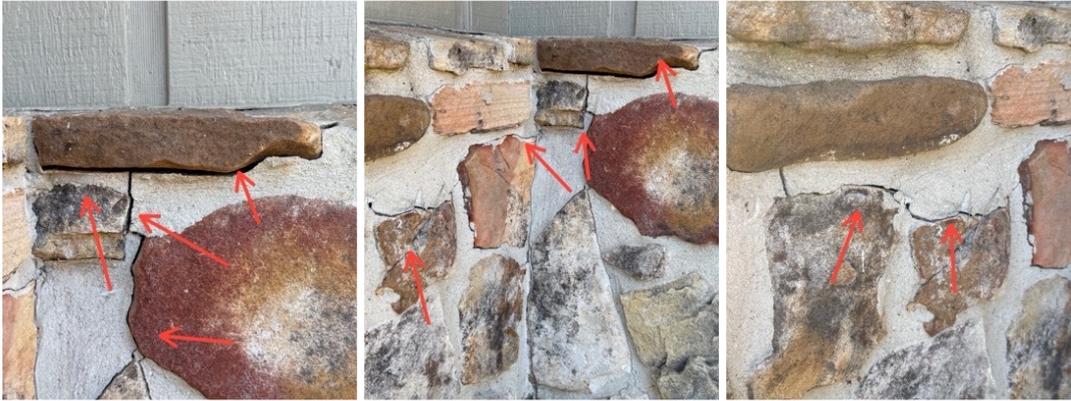
Mortar missing/deteriorating/stone separation

I observed areas where the mortar is missing or deteriorating, leading to stone separation. This condition can allow moisture intrusion and structural issues over time. I recommend consulting a professional mason to assess the damage and perform the necessary repairs to prevent further deterioration.

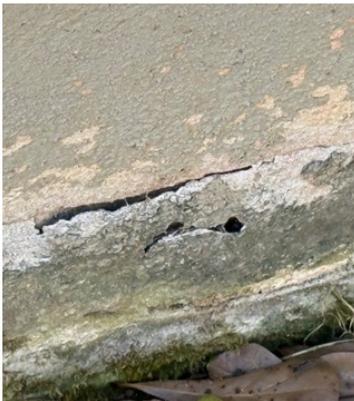
Exterior Surface Cracking and Damage

The exterior surface shows signs of cracking, spalling, and peeling paint, with visible holes and potential water damage at the base.

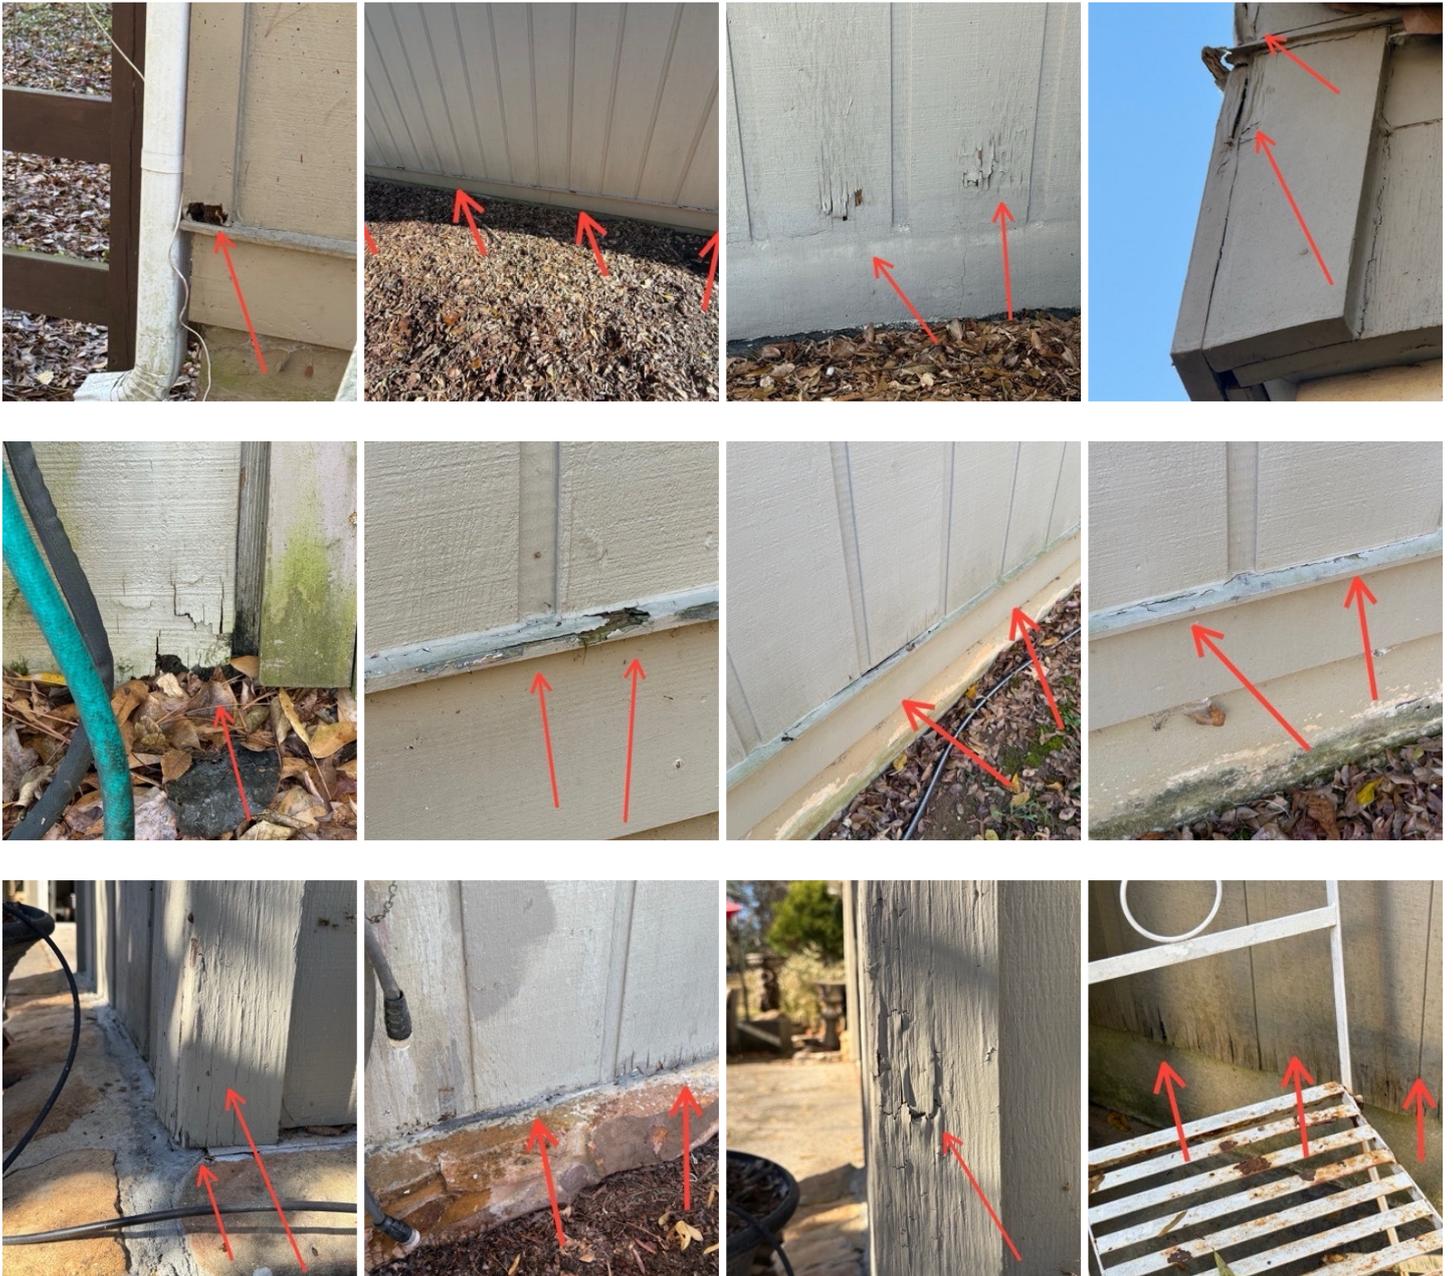
Rot noticed

Rot was observed on the exterior, which may compromise structural integrity and aesthetics. Recommend further evaluation by a licensed contractor to assess the extent of the damage and proceed with necessary repairs to prevent further deterioration.

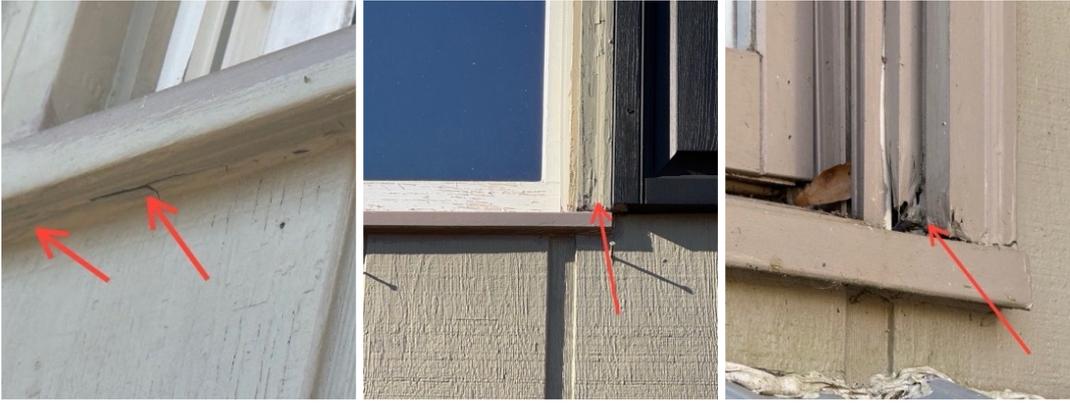
Some rot around windows

Noticed rot around some exterior windows. Recommend a professional evaluation to assess the extent of the damage. Repair or replacement may be necessary to prevent further deterioration and maintain energy efficiency. Regular maintenance is advised to avoid recurrence.

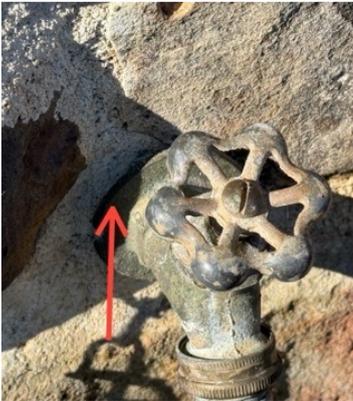
Caulk around gap of hose bib

The hose bib has been caulked to seal the gap, which helps prevent water intrusion and potential damage. Regularly check the caulking for deterioration and reapply as necessary to maintain an effective seal.

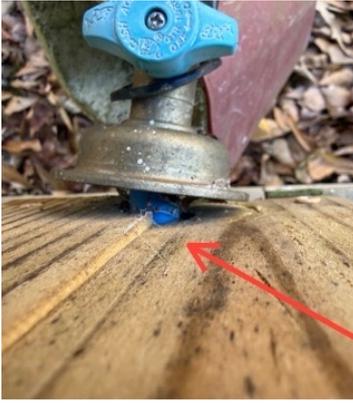
Not secure to home

Hose bib is not securely attached to the home.

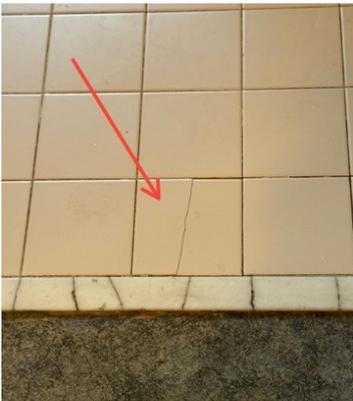
Cracked bathroom floor tile

Observed a cracked bathroom floor tile. Recommend replacing the damaged tile to prevent water infiltration and potential subfloor damage. Consider consulting a professional for precise repair.

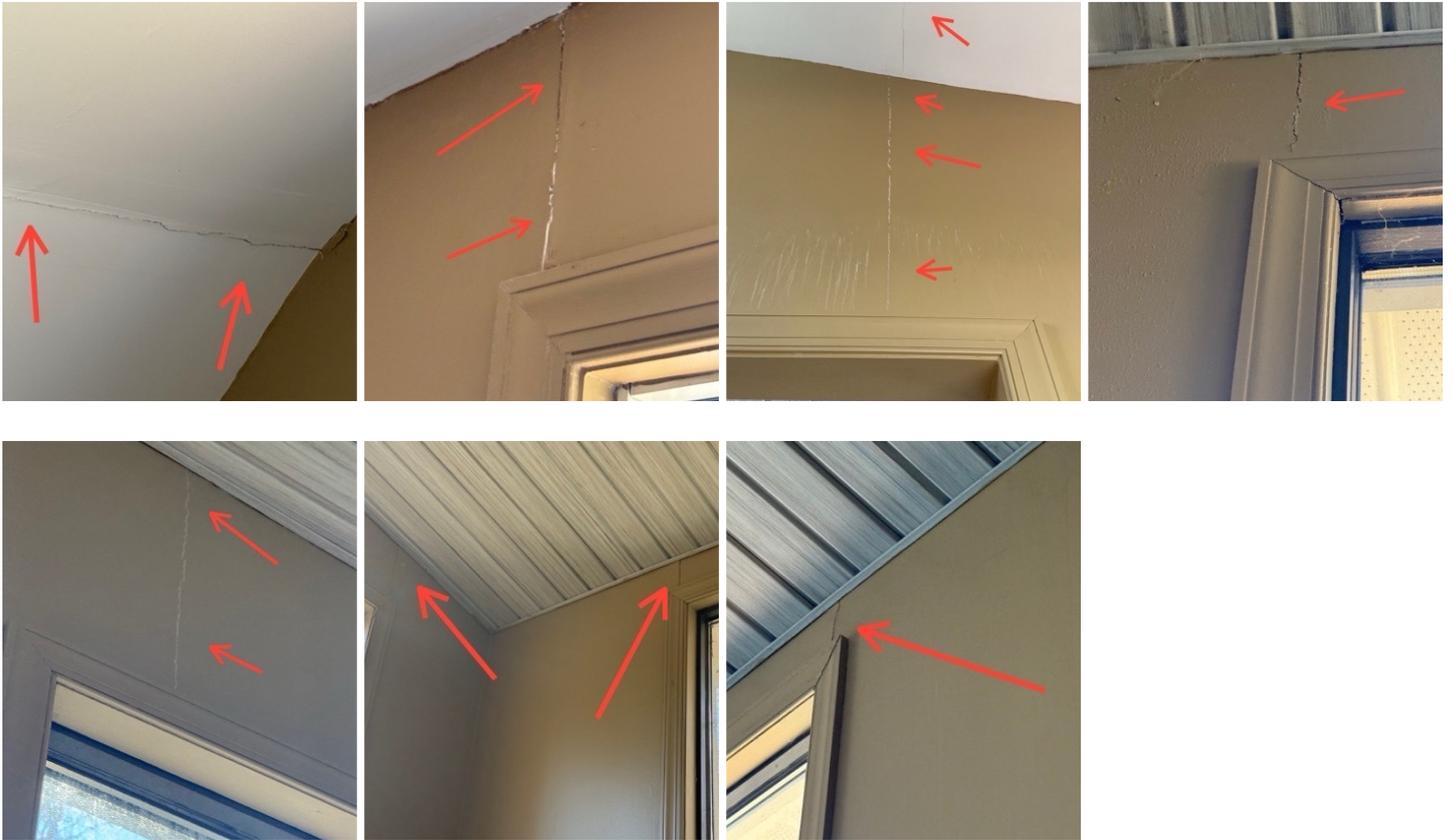
Cracks on walls, around windows, supports

Cracks observed on interior walls and around windows/supports may indicate settling or structural issues. Recommend consulting a structural engineer for further evaluation and necessary repairs to ensure structural integrity.

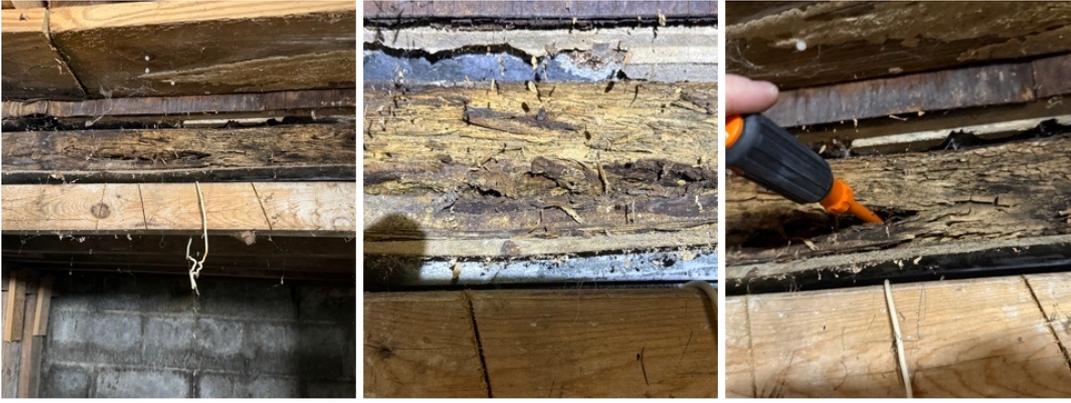
Rot/Damage

During inspection, rot/damage was observed in the structure. It is recommended to engage a licensed contractor to assess the extent of the damage and make necessary repairs to prevent further deterioration and ensure structural integrity.

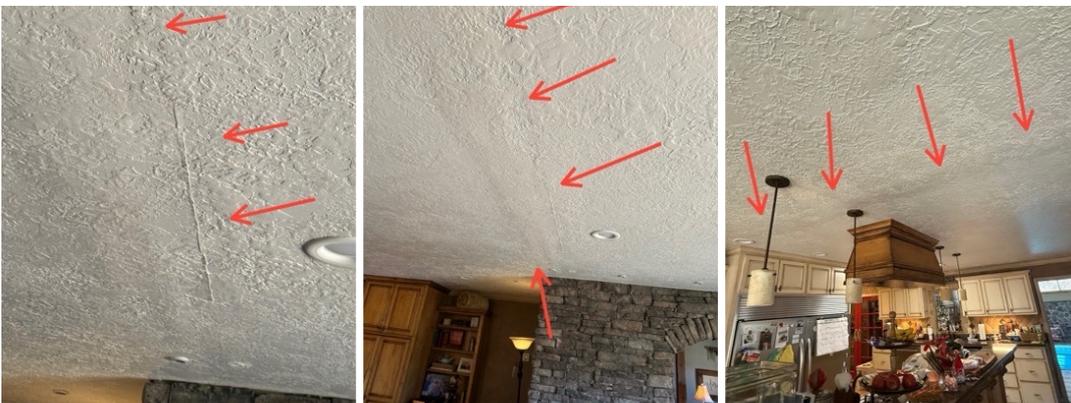
Support beam movement

A linear crack was observed in the ceiling finish. The cracking appears consistent with movement along a structural support line. Notably, alterations and notching were observed at a support beam in the crawlspace below this area. While the exact cause cannot be confirmed without further evaluation, the observed conditions may indicate structural movement. Evaluation by a qualified structural professional is recommended prior to repairs.

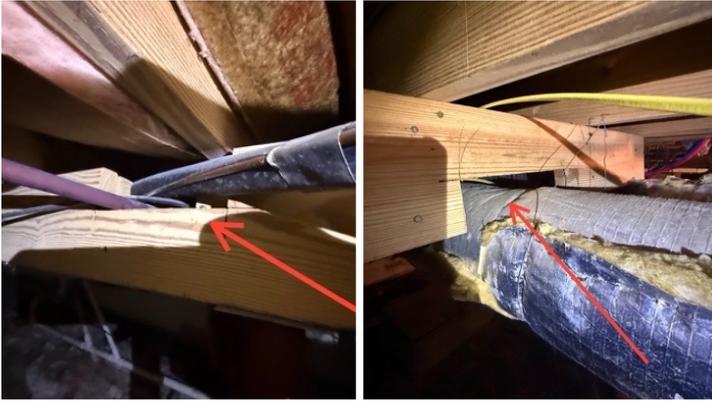
Beam has notches, cuts along edge

The beam exhibits notches and cuts along its edge, which could compromise its structural integrity. Recommend evaluation by a structural engineer to assess necessary repairs or reinforcements to ensure safety and compliance with building codes.

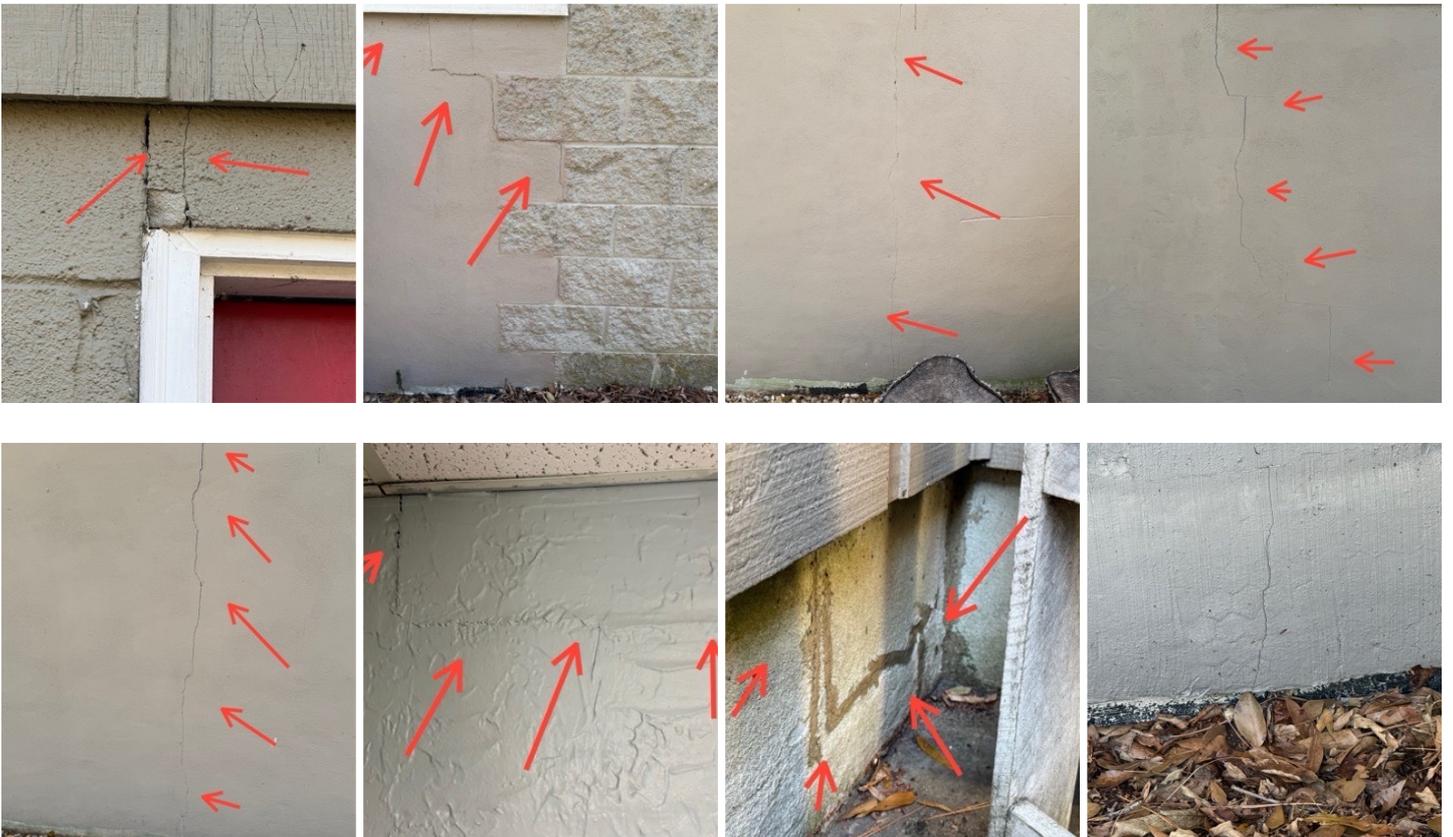
Movement/cracking/step cracking in block bearing wall

Observed movement and step cracking in the block bearing wall, indicating potential structural issues. Recommend consulting a structural engineer for a detailed assessment and to determine necessary repairs to ensure structural integrity.

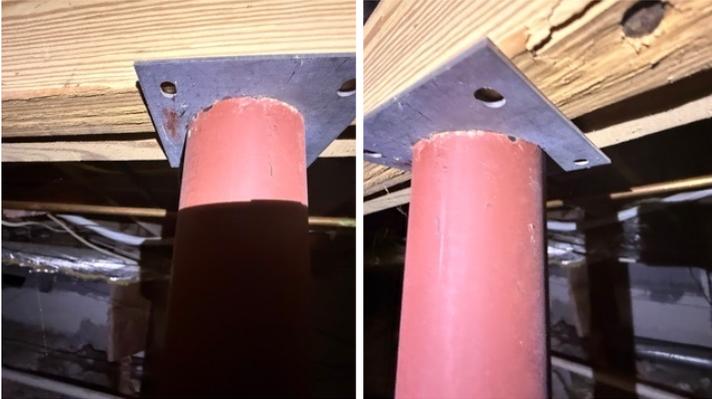
Supports not fastened to beam

The structure piers/posts are not fastened to the beam. This may lead to shifting or instability. Recommend securing them promptly to ensure structural integrity and safety. Consult a licensed contractor for proper fastening methods.

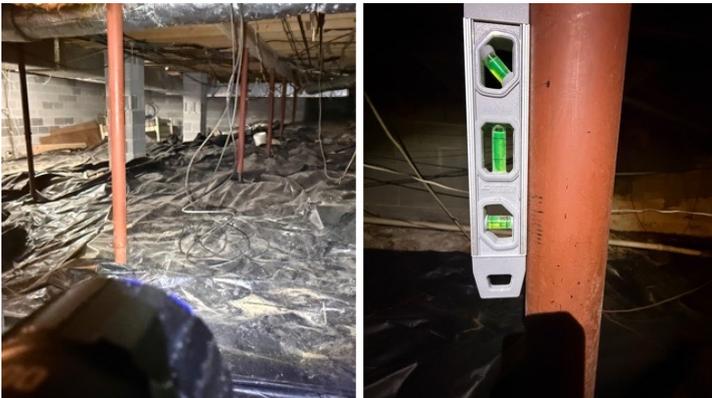
One or more steel support not plum and not secured

One or more steel support posts were observed to be not plumb and not adequately secured. It's recommended to engage a qualified contractor to evaluate and correct the alignment and secure the supports to ensure structural stability and safety.

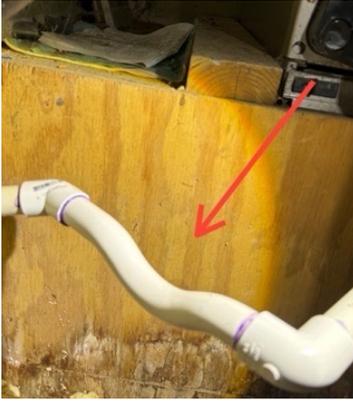
Condensate line should have downward slope and not a dip

The condensate line was observed to have an improper dip instead of a continuous downward slope. This can lead to water accumulation and potential blockage. It is recommended to have a qualified HVAC technician evaluate and adjust the line to ensure proper drainage.

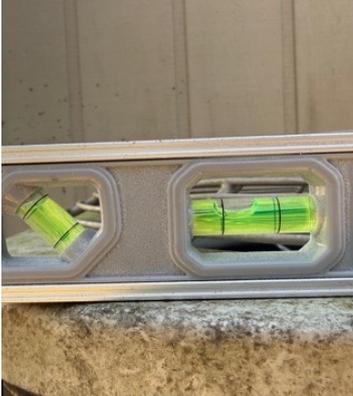
Unit is unlevel

The HVAC cooling unit is not level, which can lead to operational inefficiencies and potential damage. It is recommended to consult a qualified HVAC technician to properly level the unit to ensure optimal performance and longevity.

Very minor but keep an eye on it.

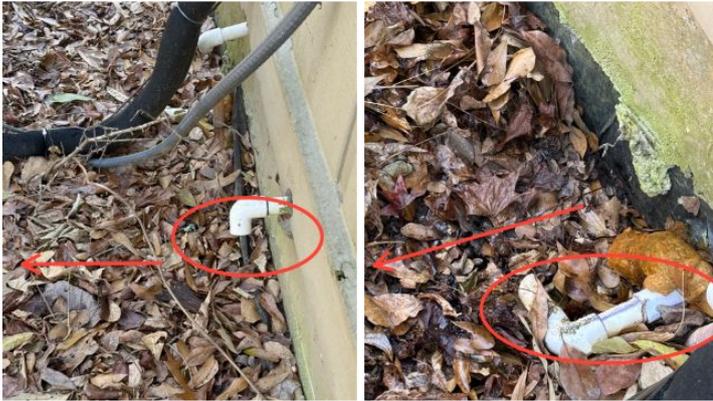
Extend condensate pipe away from unit/foundation

The condensate pipe currently discharges too close to the unit/foundation. It is recommended to extend the pipe to redirect the flow away from these areas to prevent potential

water damage or foundation issues. Consider consulting a professional for proper modification.

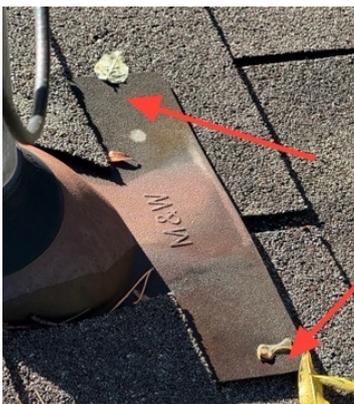
Service mast fasteners have missing/deteriorating caulk

The service mast fasteners have missing or deteriorating caulk, which could lead to water infiltration. Recommend re-caulking these areas to prevent potential damage and ensure weatherproofing. Consult a qualified electrician for repairs.
