Feb 17th, 2026

123 SAMPLE STREET, SAMPLE, AL 00000

Home Inspection Report

Garrett Gamble / Gamble Home Inspections LLC

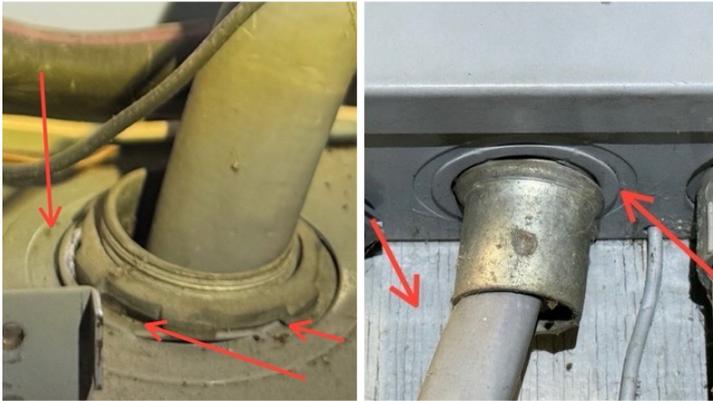
Service line into panel has no strain relief and loose hub

The service line into the main panel lacks strain relief, and the hub is loose. This could lead to wire damage or connectivity issues. Recommend engaging a licensed electrician to secure the hub and install appropriate strain relief to ensure safety and compliance.

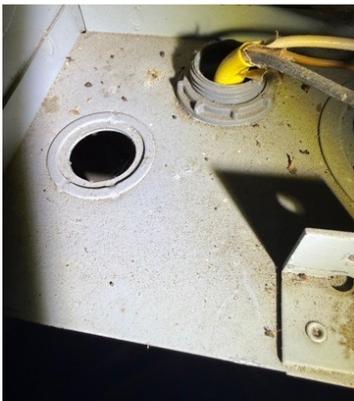
Open knockout hole. Insert blank to cover opening.

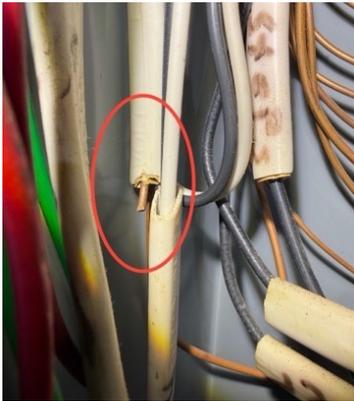
Exposed neutral thats cut

Observed an exposed and cut neutral wire in the electrical subpanel. This poses a safety hazard and may lead to electrical malfunctions. Recommend immediate evaluation and repair by a licensed electrician to ensure proper functionality and safety.

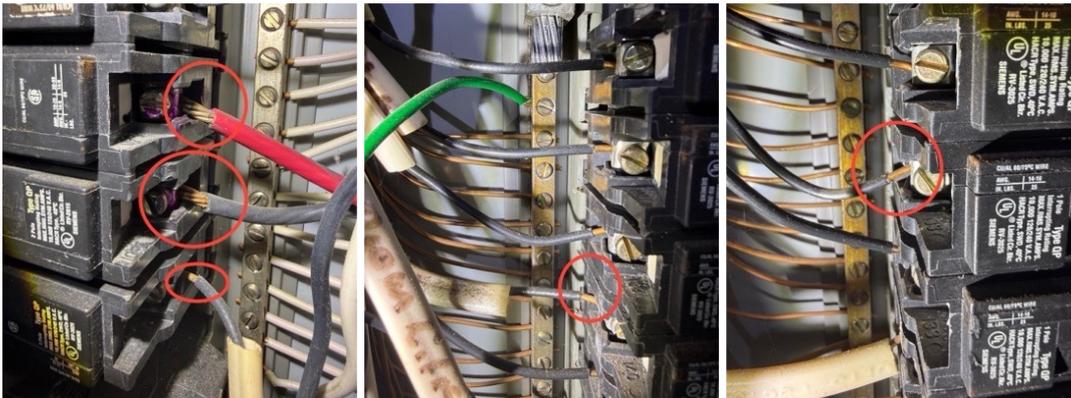
Too much sheathing cut off

The electrical sub panel has excessive sheathing removed from the wiring, which may expose conductors and present a safety hazard. Recommend evaluation and correction by a licensed electrician to ensure all wiring complies with safety standards.

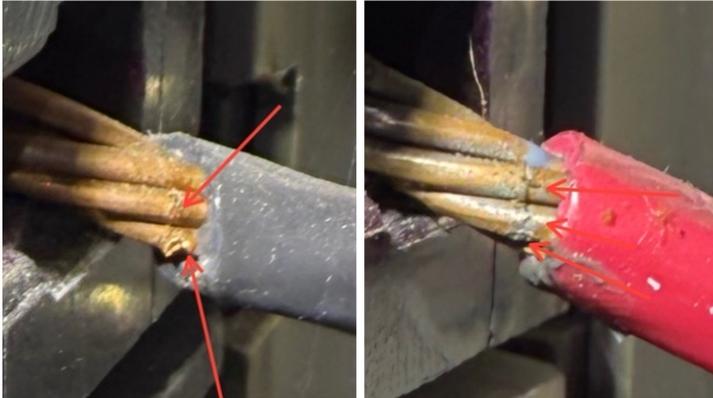
Damaged wires

During the inspection of the electrical sub-panel, damaged wires were observed. This poses a potential safety hazard and may lead to electrical malfunctions. It is recommended to have a licensed electrician assess and repair the damaged wiring to ensure safety and compliance with local electrical codes.

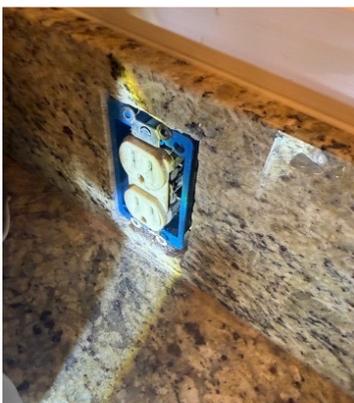
One or more outlets missing a cover

One or more electrical outlets are missing a cover, posing a safety risk by exposing wiring. It is recommended to install proper covers to prevent electrical hazards and ensure compliance with safety standards.

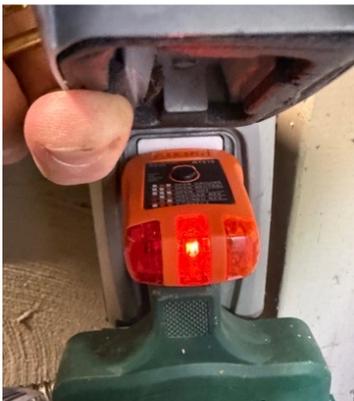
One or more outlets miswired

One or more electrical outlets were found to be miswired. This can lead to electrical hazards, including potential shock or fire risks. Recommend having a licensed electrician evaluate and correct the wiring to ensure safety and compliance with current electrical codes.

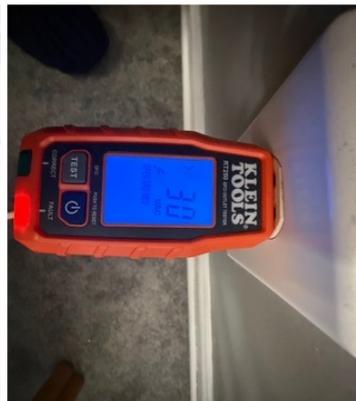
Open ground exterior

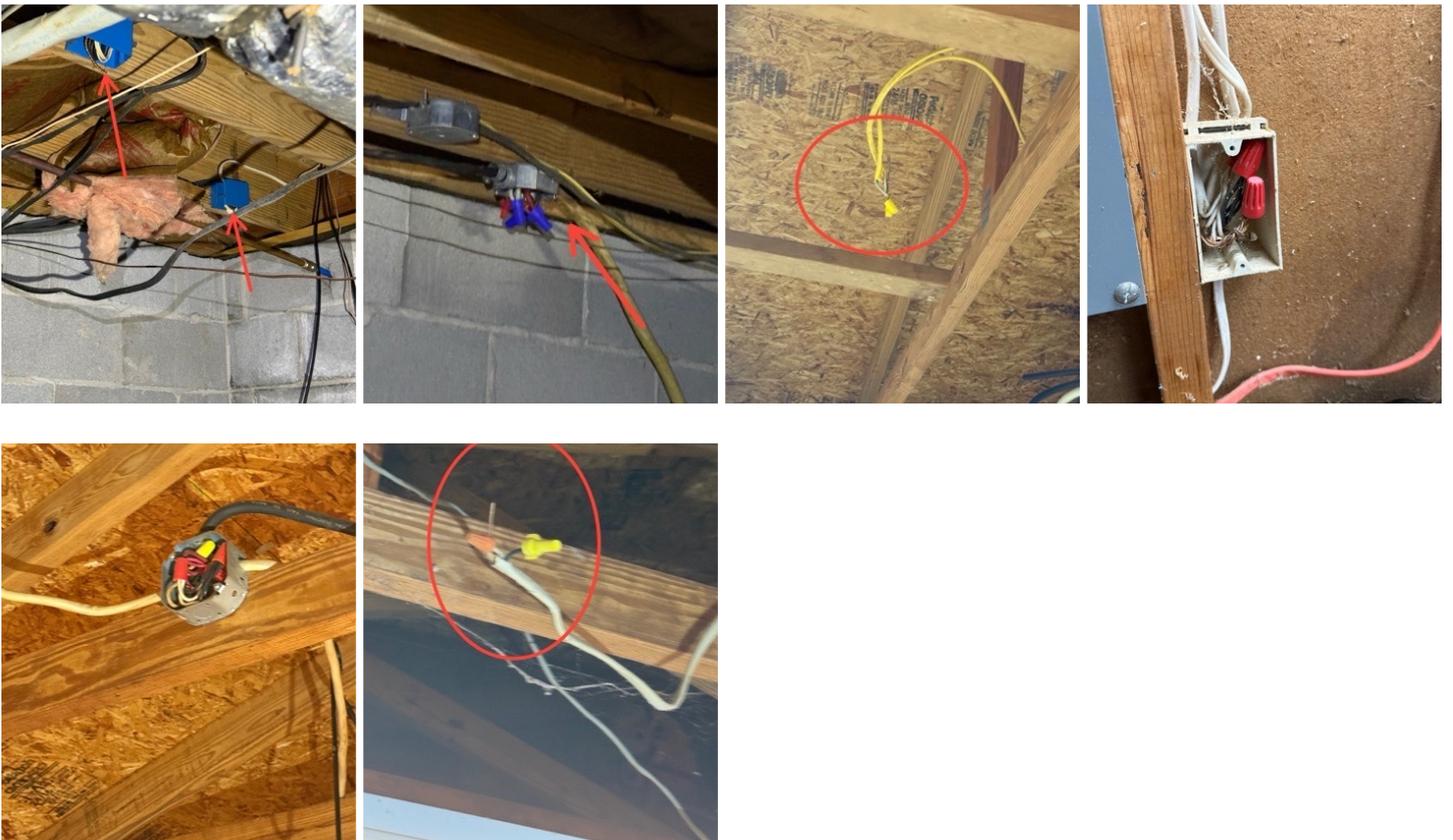
Exposed wiring

Exposed wiring was observed, which poses a safety hazard. It is recommended to have a licensed electrician evaluate and properly secure or enclose the wiring to ensure compliance with safety standards.

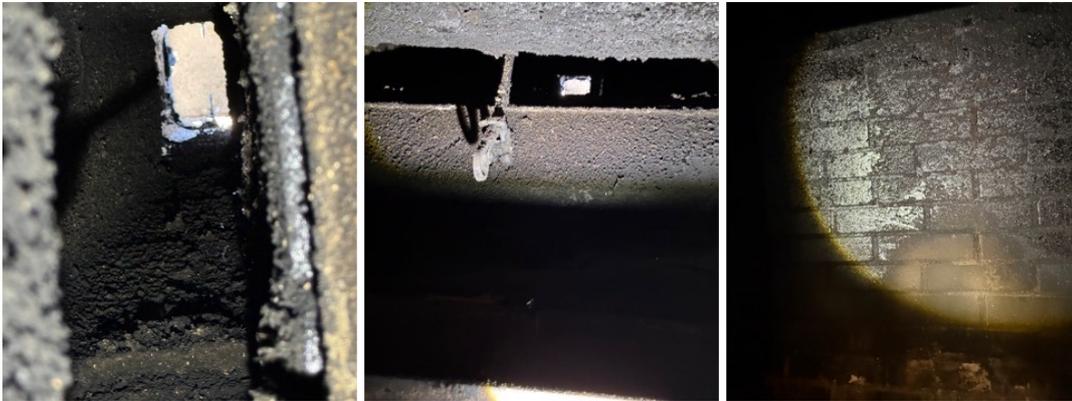
Creosote buildup

Recommend cleaning and inspection prior to use

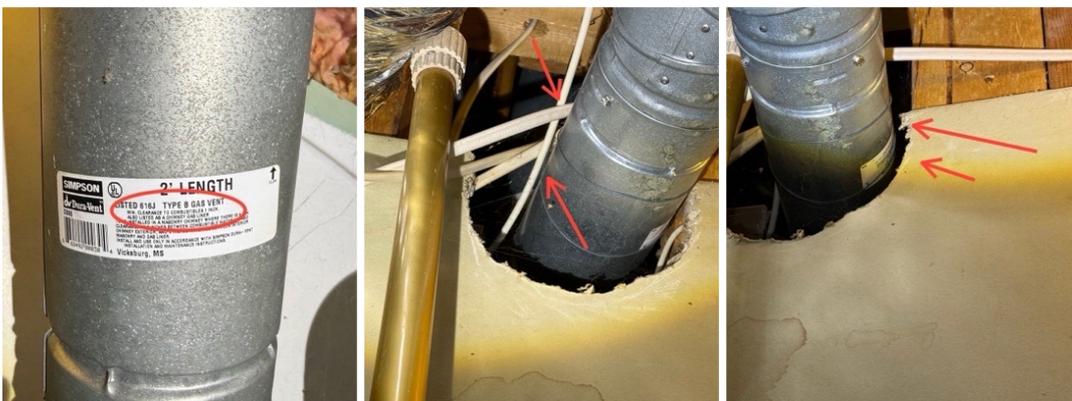
Flu vent pipe too close to combustible

The flu vent pipe is too close to combustible materials, posing a fire hazard. It is recommended to have a qualified technician relocate or shield the vent to ensure safety and compliance with local building codes.

Too close to wiring. Could heat up sheathing

Less than 1"

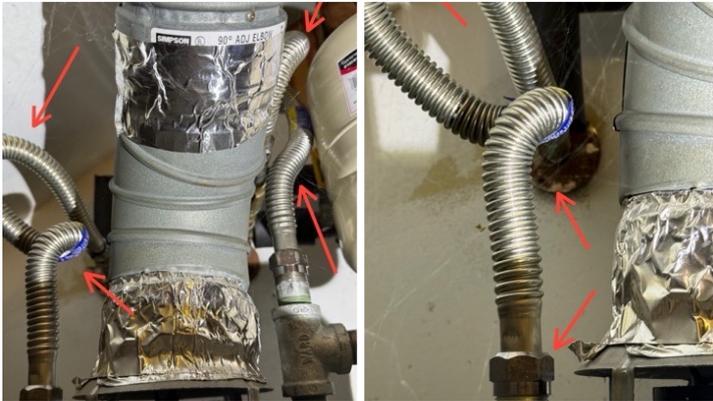
Water flex connectors excessive bending/stress

The water heater's flex connectors show excessive bending, which can lead to premature wear or leaks. Recommend having a licensed plumber evaluate and reposition the connectors to ensure proper alignment and reduce stress.

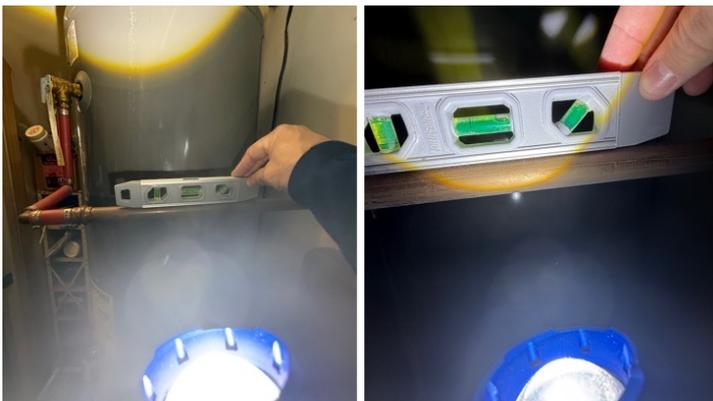
Extension has negative slope

The TPR valve extension on the water heater is improperly sloped, which may hinder proper drainage and safety function. Recommend adjusting the extension to have a downward slope to ensure effective pressure relief. Consult a qualified plumber for correction.

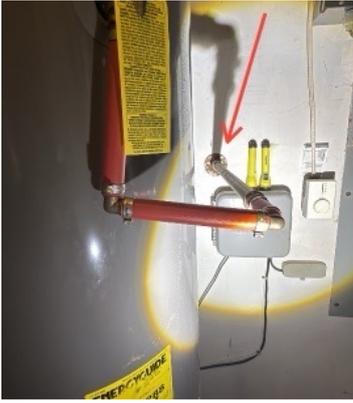
Termination end not in the same room

The TPR valve extension terminates outside the same room as the water heater. It's recommended to have a licensed plumber assess and correct the termination to ensure safety and compliance with local building codes.

Should be to the floor and no more than 4" from the ground

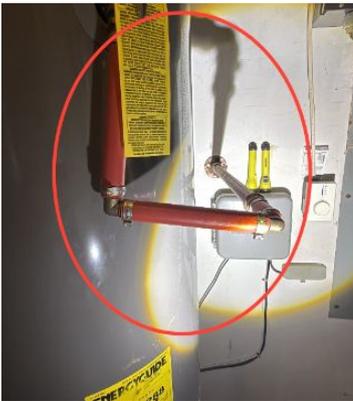
Improper extension material

The water heater's TPR valve extension is made from improper material, which may compromise its function and safety. Recommend consulting a licensed plumber to replace it with a material approved by local codes to ensure proper operation.

Material should be rigid

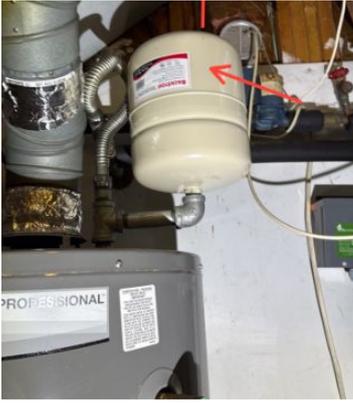
Expansion tank not supported

The expansion tank for the water heater is not properly supported. This can lead to potential strain on the plumbing connections, increasing the risk of leaks or damage. It is recommended to have a qualified plumber install proper support to ensure the expansion tank is securely held in place, reducing stress on the piping and ensuring system longevity.

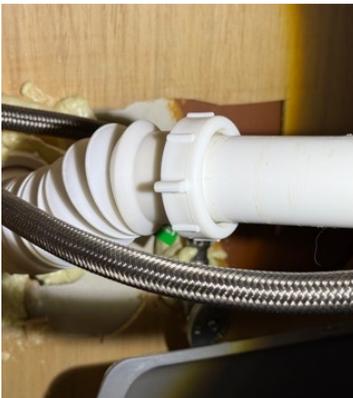
Hall full bath

Sink drain pipe is using flex corrugated

The sink drain pipe is using flexible corrugated pipe, which is not recommended for permanent plumbing installations due to its tendency to clog and restrict water flow. Recommend replacing with smooth, rigid piping for improved performance and compliance with plumbing standards.

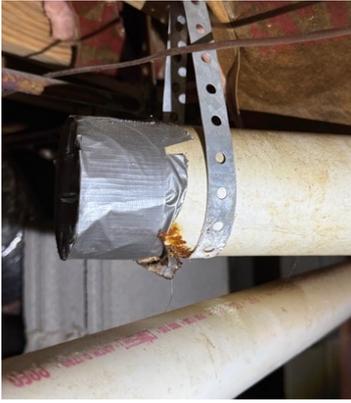
Improper end cap

An improper end cap was observed on the plumbing drain pipe, which could lead to leaks or contamination. Recommend having a licensed plumber assess and replace the end cap with the appropriate fitting to ensure proper sealing and function.

Duct tape is a no go

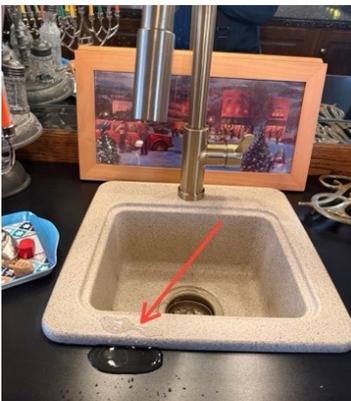
Faucet water terminates partly outside the sink

The faucet's water flow partially extends outside the sink area, which may lead to water damage on surrounding surfaces. Recommend repositioning or replacing the faucet to ensure proper alignment and water containment.

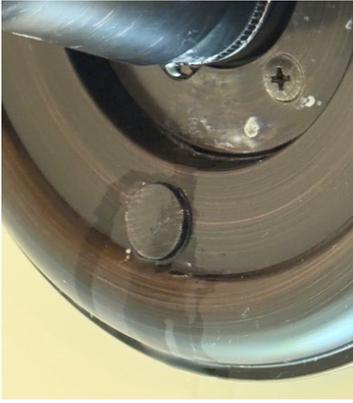
Shower in pool bathroom

Leaking faucet

During the inspection, a leak was observed in the faucet. It is recommended to have a licensed plumber assess and repair the issue to prevent potential water damage and increased utility costs. Consider replacing worn washers or components to ensure optimal performance.

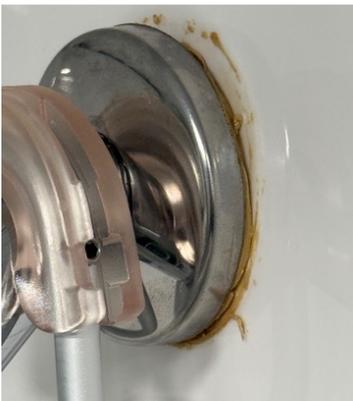
Basement bathroom

Caulk around faucet/fixture

Caulking is present around the faucet/fixture, helping to prevent water intrusion. Ensure caulking is intact and regularly maintained to avoid moisture-related issues. Reapply as needed if signs of cracking or wear appear.

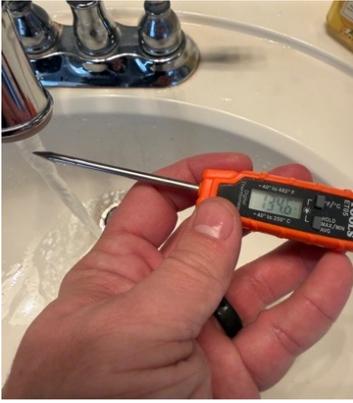
Water temperature above 120 degrees

The water temperature at the faucets was measured above 120 degrees Fahrenheit, which poses a risk of scalding. It is recommended to adjust the water heater thermostat to a maximum of 120 degrees to ensure safety and prevent burns. Consider consulting a licensed plumber to make the necessary adjustments and to verify that the temperature is maintained at a safe level. Regular checks are advised to ensure continued safety.

Max temp should be 120 degrees

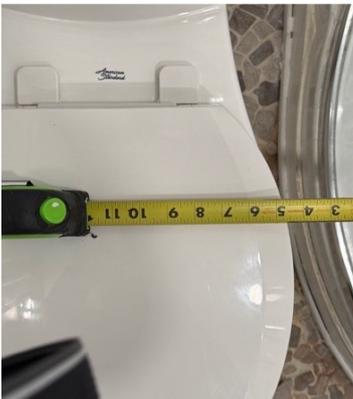
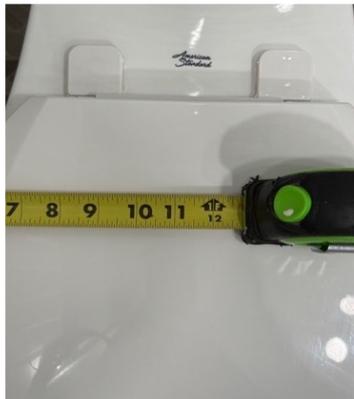
Location - Basement, Bathroom

The spacing from the center of the toilet to the side wall is insufficient, which may lead to accessibility issues. It is recommended to consult with a licensed contractor to adjust the toilet installation or layout to meet standard spacing requirements for comfort and compliance.

Not 15"

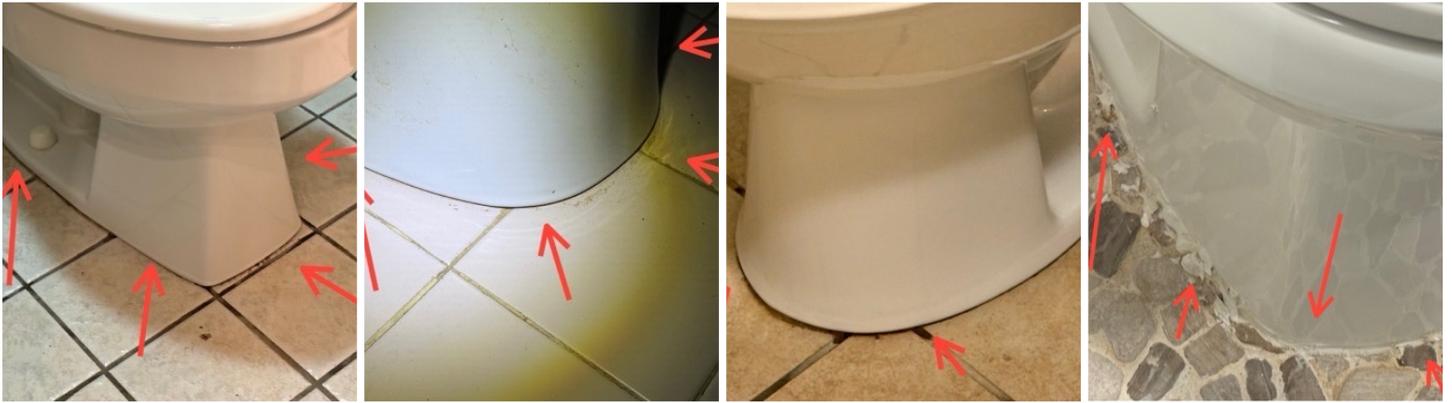
Caulk missing/deteriorating around toilet base

Caulking around the toilet base is missing or deteriorating, which can lead to moisture issues and potential damage to flooring. Recommend re-caulking to ensure a proper seal and prevent water intrusion.

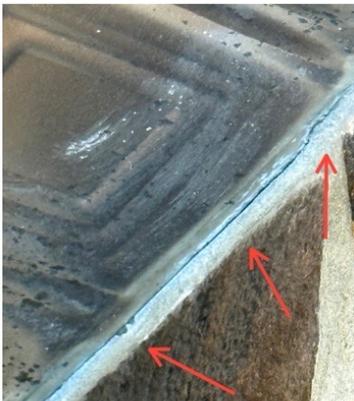
Master bath

Missing/Deteriorating caulk around shower/tub

Caulking around the shower/tub is missing or deteriorating, which can allow water infiltration and cause damage. Recommend re-caulking to prevent future leaks and maintain the integrity of the area.

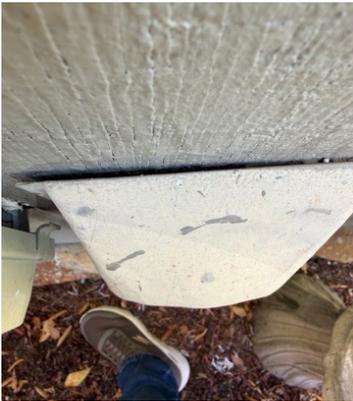
Caulk around vent missing

The caulk around the dryer vent is missing, which could lead to moisture intrusion or pest entry. Recommend reapplying an outdoor-grade caulk to ensure a proper seal and prevent potential issues.

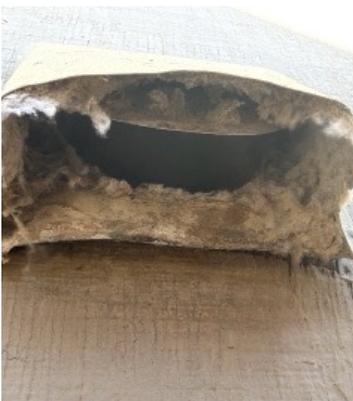
Recommend cleaning

The dryer vent shows signs of lint buildup and should be cleaned to ensure proper airflow and reduce the risk of fire. It is recommended to schedule a professional cleaning service or clean the vent yourself at least once a year.

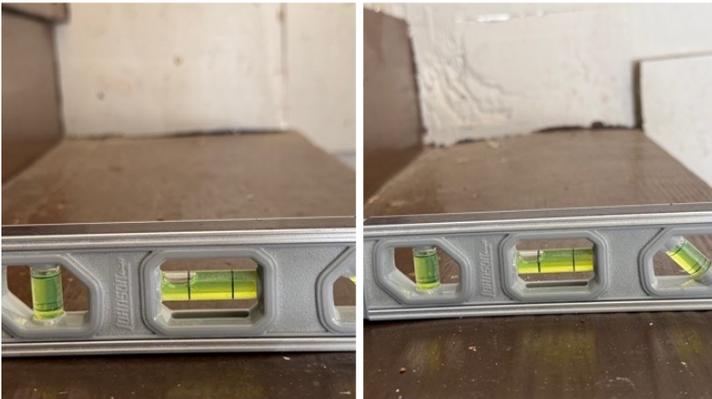
Steps to inside are not level

The steps leading from the garage to the interior are not level, which may pose a safety hazard. I recommend having a qualified contractor assess and correct the steps to ensure they are even and secure.

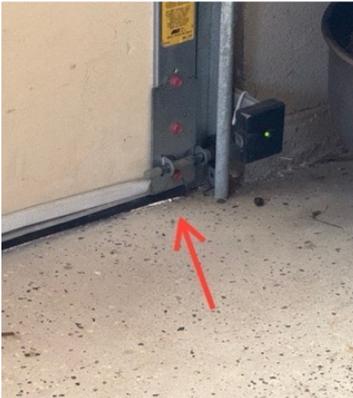
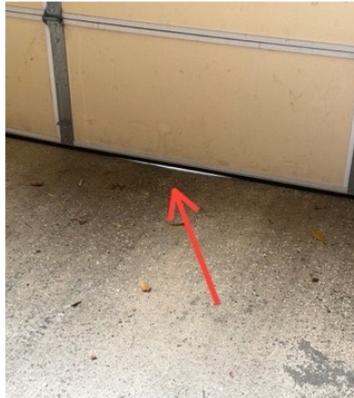
Weather seal(s) loose or damaged

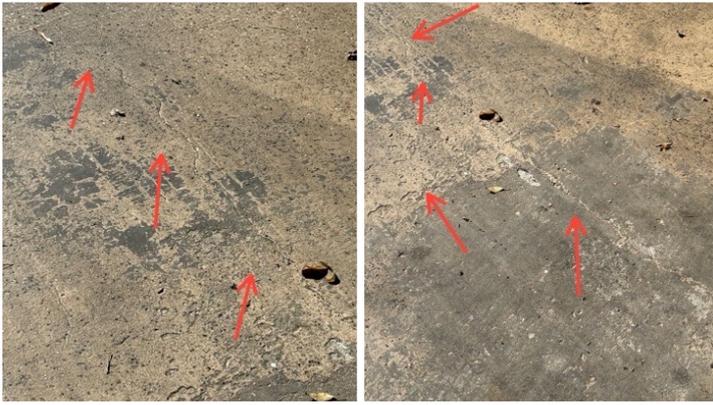
Minor floor crack(s)

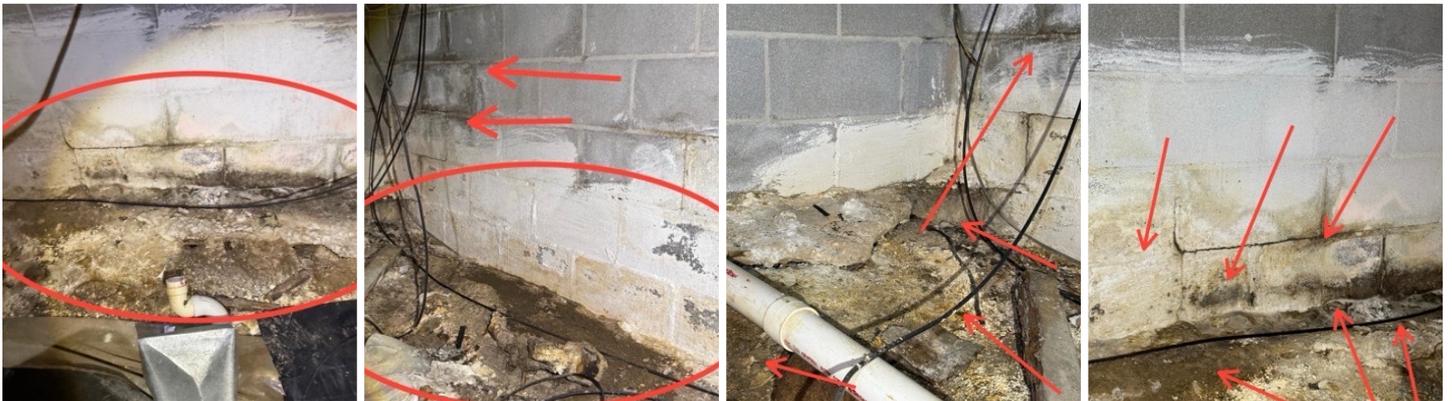
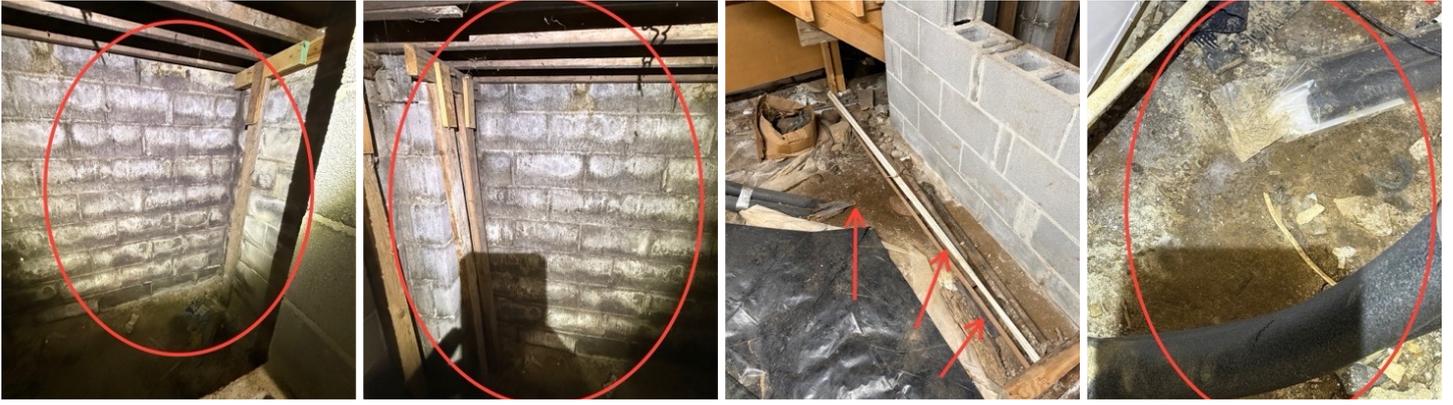
Water intrusion around wall and on ground

Water intrusion was observed on the walls and ground in the crawl space, indicating potential drainage or plumbing issues. Recommend further evaluation by a licensed contractor to identify the source and implement corrective measures to prevent damage and ensure structural integrity.

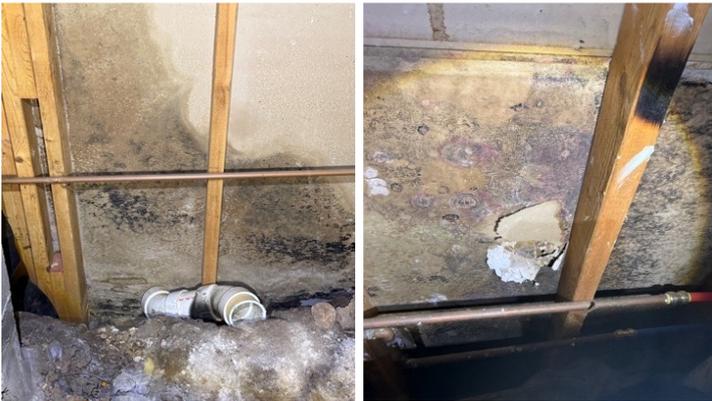
Evidence of possible mold

Evidence of possible mold was observed in the crawl space. Recommend further evaluation and remediation by a qualified mold remediation specialist to address the issue and prevent potential health concerns and structural damage. Ensure proper ventilation and moisture control going forward.
