## **Report of Marine Survey**

Wee Leda

1995 Nordic Tug 32

February 22, 2024

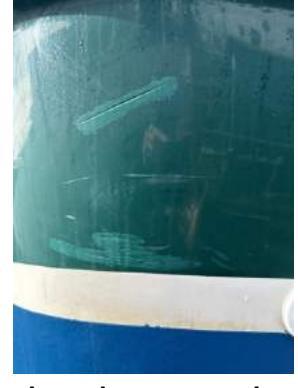
The topsides are green gelcoat with a white boot stripe at the waterline and a broad white stripe below the cap rail. The topsides have faux plank seams with green gelcoat. The gelcoat is found in good condition with minor scratches and chips. The owner reported that he would be repairing gelcoat scratches and chips once the boat was returned to its slip after the boat yard bottom painting. The topside's are free from impact damage. Hull length black rub rails are found at the cap rail and below the sheer.

Starboard quarter gelcoat

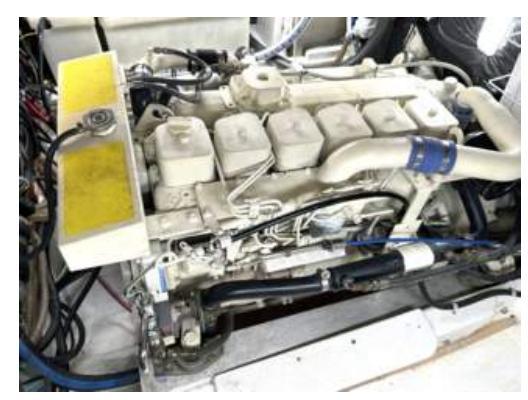
**Diesel engine**

Slight engine oil leaks were sighted from the fuel pump attachment at the engine and at the aft valve cover gasket. No oil was found in the engine room bilge.

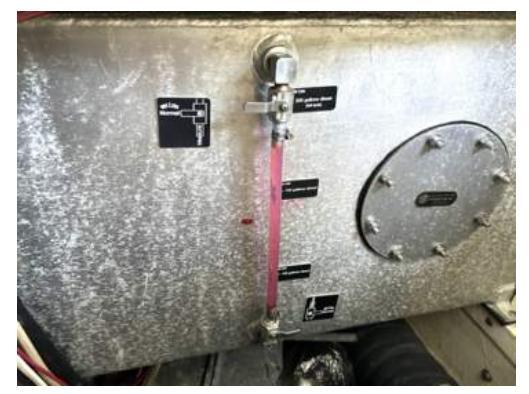
Fuel tank labeling

The 1995 Nordic Tug 32 has one aluminum 200 gallon diesel fuel tank located forward within the steering compartment. No leaks or fuel odor were detected from the fuel system. Custom labels where attached to the fuel tank to indicate the level of the fuel through a sight gauge.

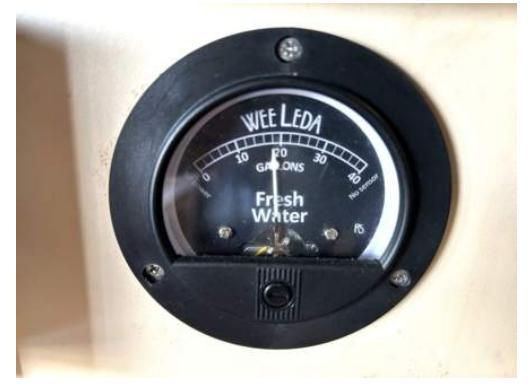
Custom water tank gauge

A custom water gauge has been added to the pilothouse dashboard. The gauge was modified by the owner to give accurate water measurement readings of the water tank to compensate for its unusual shape. All interior lighting has been upgraded to LED bulbs. All new electrical work as been installed and labeled with professional quality.

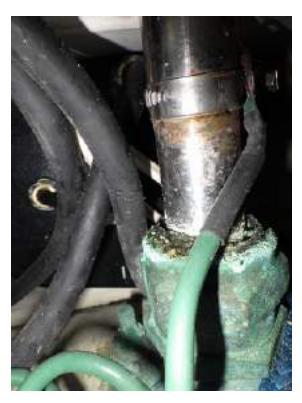
Rudder packing gland

The vessel is steered by a hydraulic ram arm system connected to the single rudder shaft. The hydraulic pump at the helm wheel, ram arm piston, hoses and mounts and are all found in serviceable condition. No hose wear or leaks were detected within the hydraulic steering system. The rudder packing gland is found in serviceable condition. A functioning rudder position indicator gauge was found at the helm and was reported by the owner to have been installed in 2021.

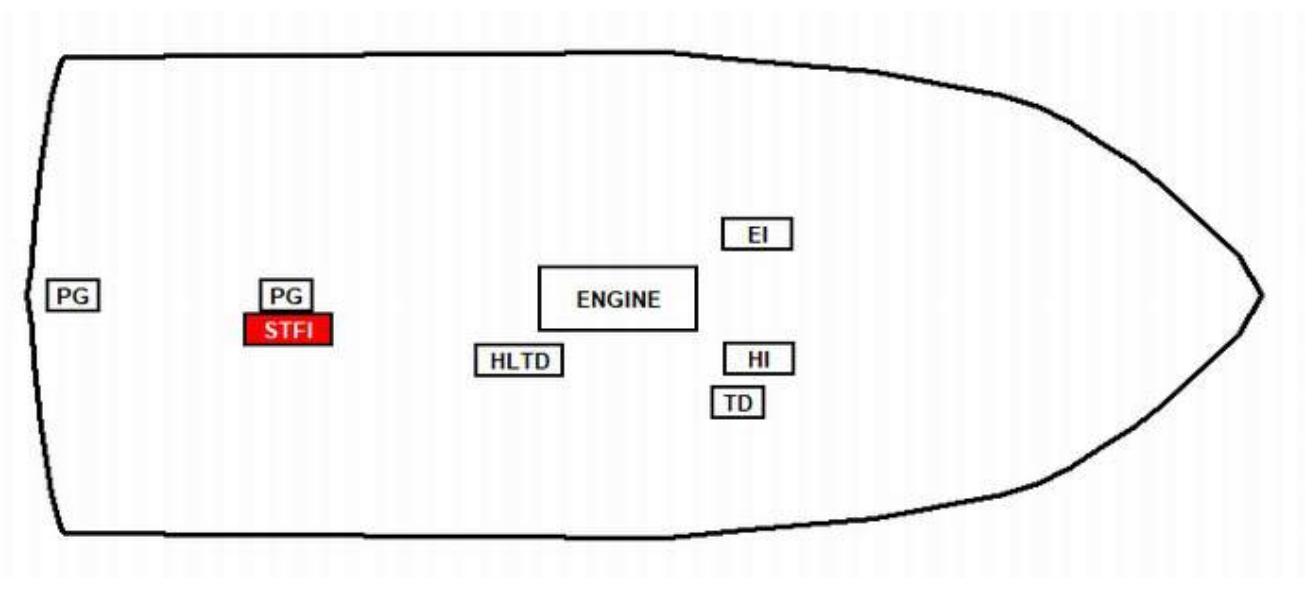
All below the water line seacocks are bronze but not connected to the ship's bonding system. A conventional stuffing box has renewed the dripless stuffing box. The dripless stuffing box intake seacock has been plugged. The head intake seacock also supplies water for the foredeck wash down system. All hoses, clamps, deck fittings and seacocks are found in serviceable condition, where accessible.

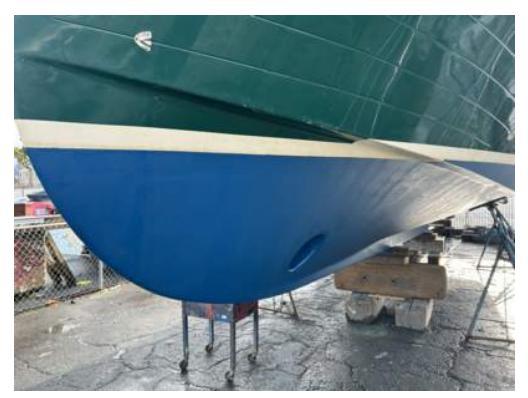
In general, the hull's wetted surface is found in good condition.

Wetted bow

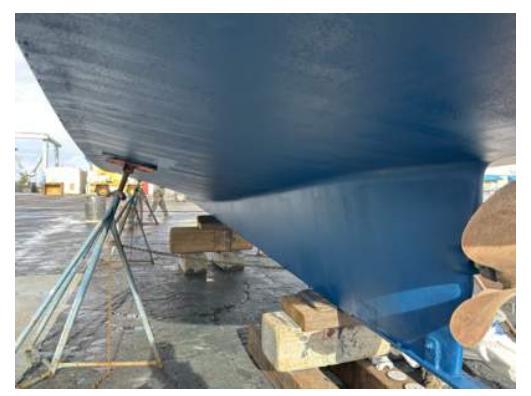
Wetted Stern

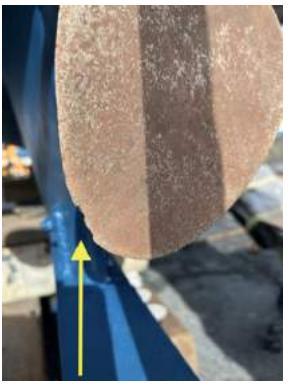
The engine shaft is 1-3/4" stainless steel with a stainless steel skeg and four blade bronze propeller. The shaft, skeg and propeller exhibit no impact damage. **Slight corrosion pitting was found on the tip of one propeller blade.** New anodes are attached to the shaft, rudder and skeg. The stern and bow thruster anodes were in the process of being renewed. No play was found in the cutlass bearing.

#### \*C.2

Slight corrosion pitting was found on the tip of one propeller blade.

**Propeller pitting**

FINDINGS	RECOMMENDATIONS
Slight corrosion pitting was found on the tip of	The propeller blade pitting is less than 1/16" deep
one propeller blade.	and is minor. The integrity and performance of the
	bronze propeller does not appear diminished. Closely
	monitor the condition of the propeller anode and
	renew if it becomes 50% wasted.

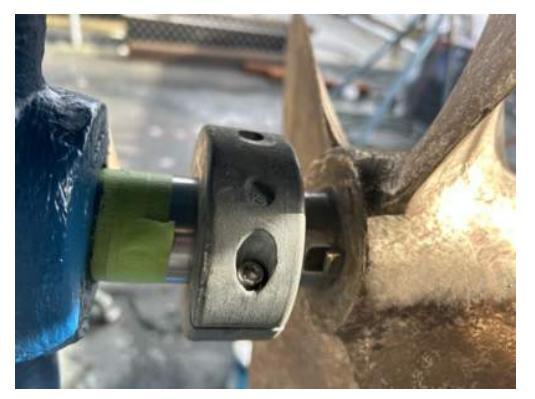
New shaft zinc

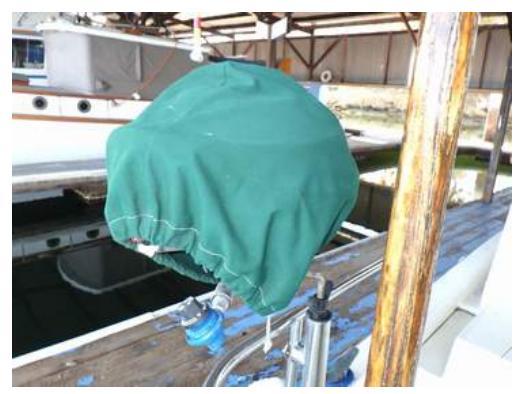
The LPG tank and storage locker are found in good condition, plumbed to ABYC standards with no damage or corrosion sighted.

**Propane BBQ**

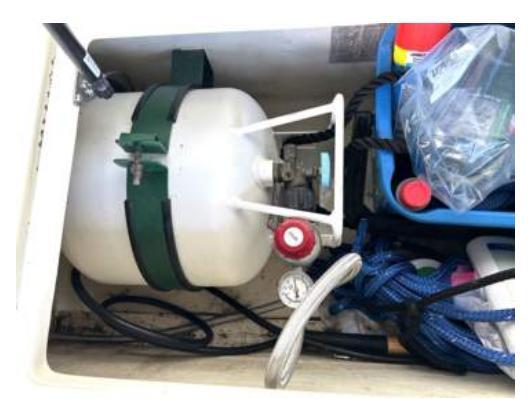
**Propane system**

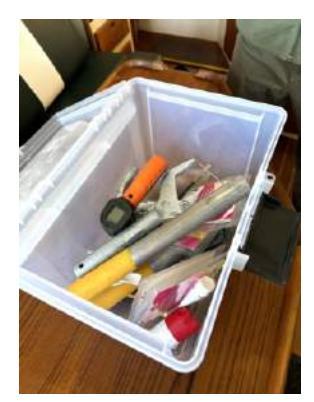
The engine started easily without excessive cranking. No unusually colored exhaust was sited and the cooling exhaust water appeared adequate and normal. The engine instruments operated within normal operating limits at idle, cruising speed, and maximum throttle. The throttle and transmission controls operated normally. The engine shifted smoothly into forward and reverse. No excessive vibration or sounds were produced from the engine at idle to maximum RPM. Slight engine oil leaks were sighted but no active leaks were detected while the engine ran. No oil was found in the engine room bilge. The alternator metered 13.33 constant charge voltage while the engine was running. The stuffing box leaked approximately 3 drips per second while the shaft rotated. A custom stuffing box adjustment kit was found under the dinette in the salon.

Stuffing box tool kit
