COLLISION ANALYSIS AND RECONSTRUCTION REPORT

Incident No.: 2010-R87-NE
Incident Date: April 20, 2010

Location: USH-41 / Memorial Dr.
Village of Howard
Brown County, Wisconsin

Trooper Jeremy VerGowe
Wisconsin State Patrol Academy – Technical Reconstruction Unit

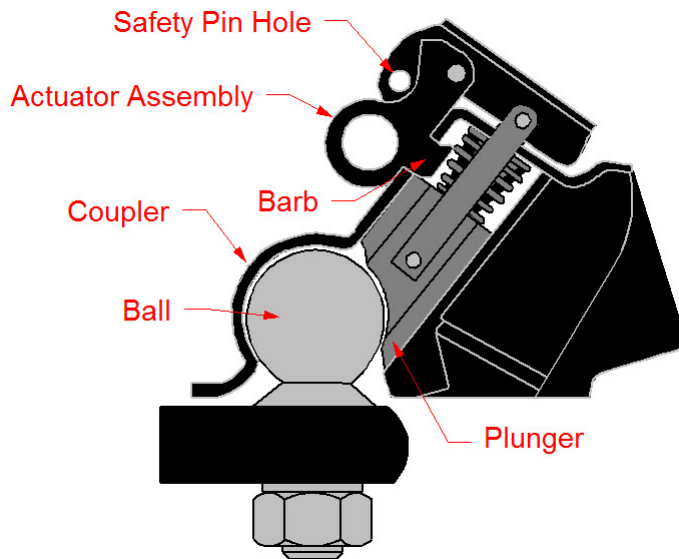
FIGURE 5

Figure 5 is intended to give a general idea of how the latching system works on the Atwood 80131 coupler. The system is very similar to that which was used by the coupler involved in the collision being investigated.

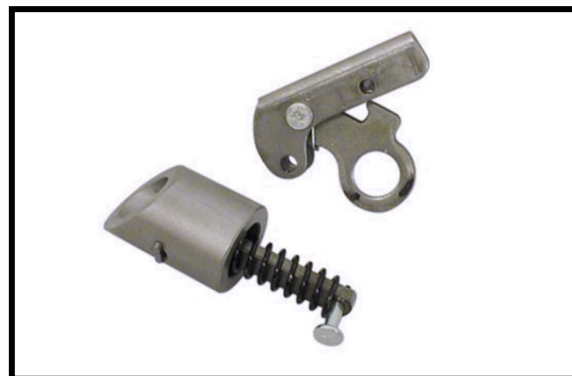
FIGURE 9

The appearance of the coupler suggested that it had been in service for some time as it did exhibit wear from usage. In particular, the end of the plunger appeared to be somewhat worn and did not have much of a curved shape to it. Based on the visual appearance of the plunger, it would seem possible that it did not "cup" the bottom of the ball sufficiently enough to prevent the ball from "popping" out of the coupler under the right circumstances (such as a jolt experienced as the vehicle combination traveled over a rough portion of roadway) even if the actuator assembly was latched. Since the manufacturer of this particular coupler is unknown, no comparisons can be made to determine the actual extent of the wear to the latching system's components. In addition, the coupling capability cannot be checked due to collision damage.

For comparison purposes, this photo shows the components of a coupler repair kit for an Atwood 80131 coupler. The end of the plunger appears much more slanted than the one from the coupler involved in the collision. This geometry would appear to allow the end of the plunger to be more effective in "cupping" the ball when compared to the one from the collision.

- The coupler from the trailer exhibited wear from usage. Based on the probable collision damage sustained by the coupler and the exhibited wear, it would appear possible that the ball could have released from a latched coupler if the hitch was jolted by rough spots in the roadway.

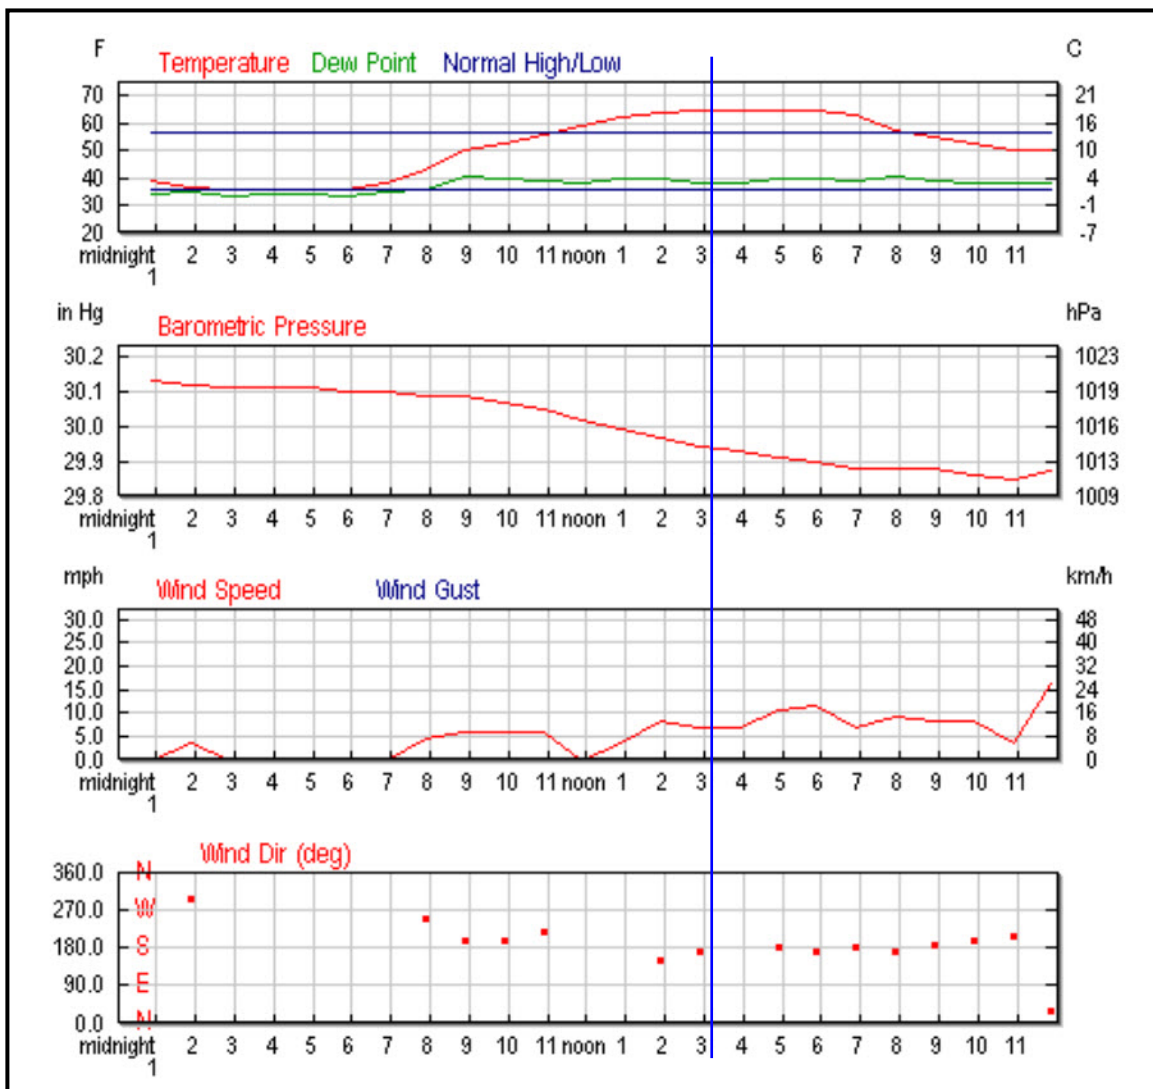
FIGURE 9

Historical weather data recorded at a nearby airport indicates the sky was clear with no precipitation around the time of the crash. The atmospheric conditions were clear and should not have caused any visibility problems. The temperature was approximately 65 °F with southern winds blowing at approximately 5 to 10-mph (See Figure 9).

Figure 9 charts the weather conditions in the Green Bay area throughout the day of the crash. The data was recorded at the Austin Straubel Airport and was obtained from www.weatherunderground.com. The blue line represents the approximate time of the crash.

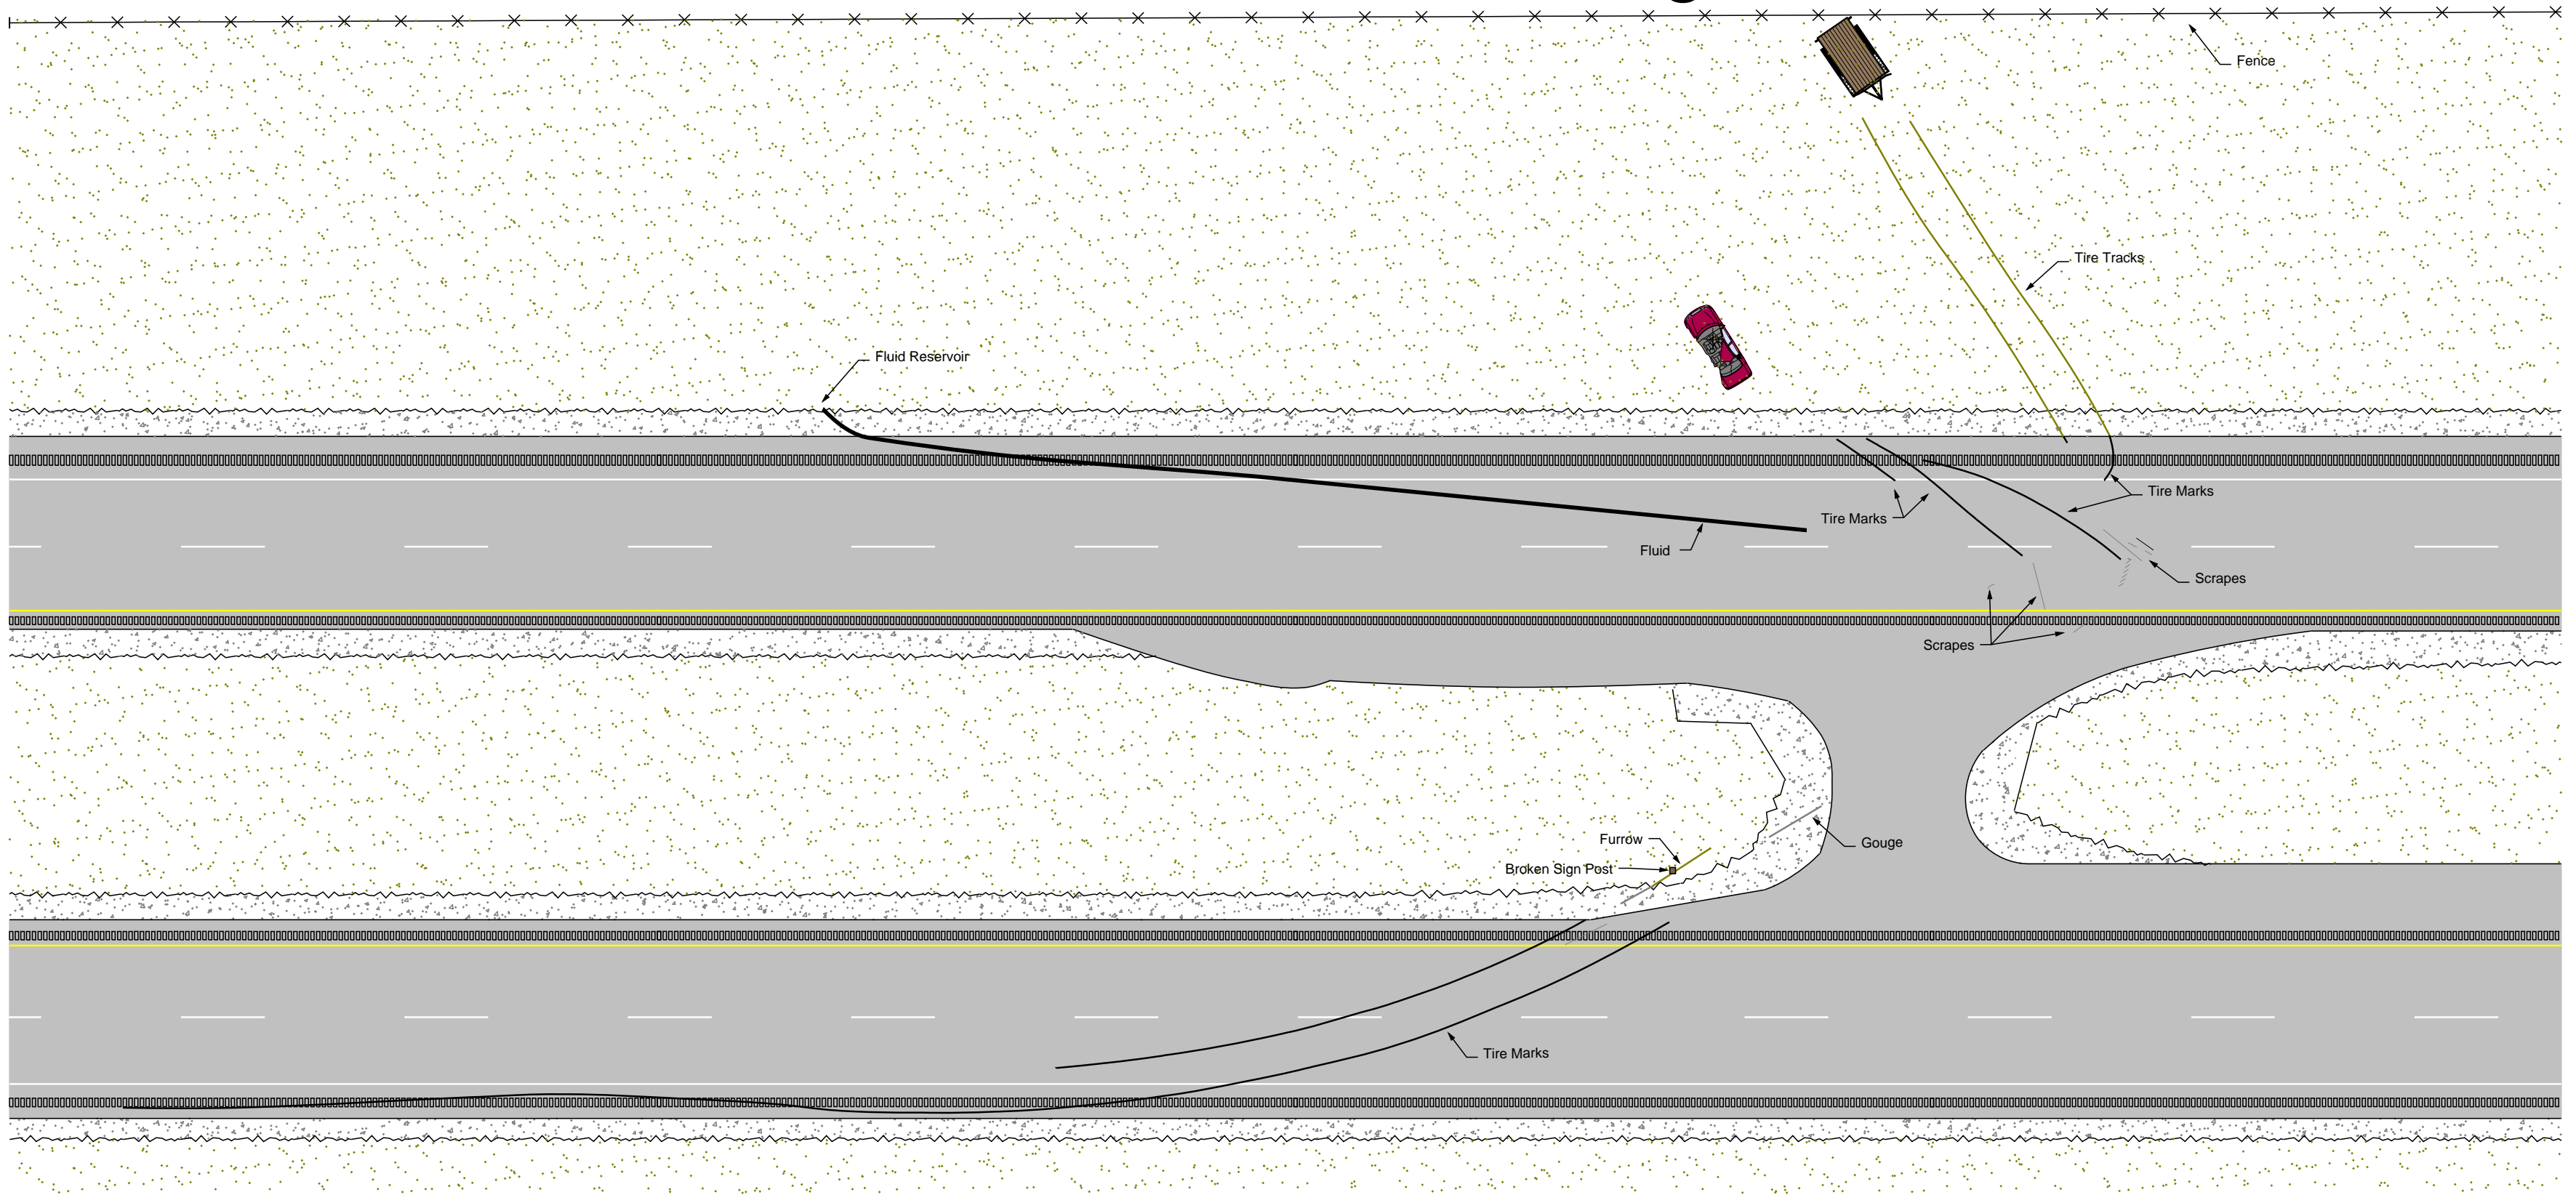
Post-Collision Drawing

- The roadway was composed of bituminous concrete. The surface was dry and appeared to be in relatively good condition.
- The collision occurred within the median lane of northbound USH-41. The physical evidence indicates that the front of the utility trailer impacted the driver's side of the Chevrolet Cavalier, primarily between the front and rear axle, at an acute angle.
