COLLISION RECONSTRUCTION UNIT

Case # 07L004697

LOCATION: Route 50/301 Westbound Span of the Bay Bridge at Mile-marker 34.2

CASE TYPE: Seven vehicle collision with three fatalities and multiple injuries (Involving two commercial motor vehicles)

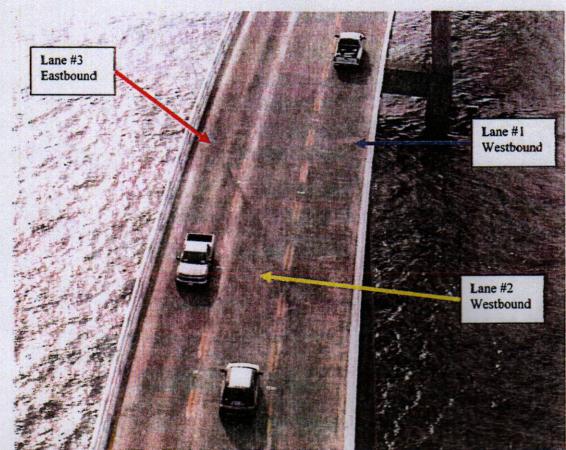
The above photograph was provided by Cpl. Russell of the Anne Arundel County Police Department and was taken from Anne Arundel County Police Helicopter.

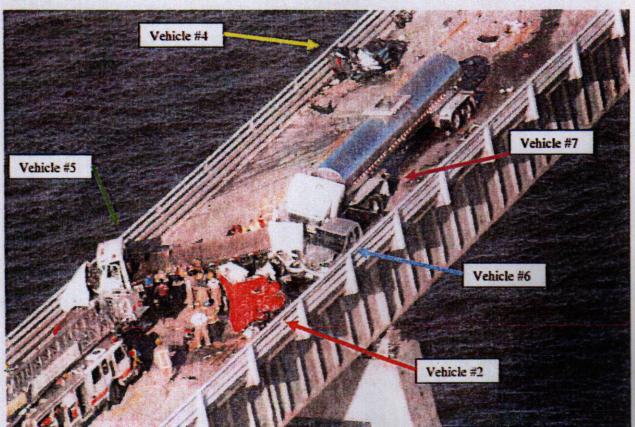
The above photograph was taken from Maryland State Police Medi-vac Unit (Trooper #6) to show the final rest of Vehicle #3, Vehicle #4, Vehicle #5, Vehicle #6, and Vehicle #7.

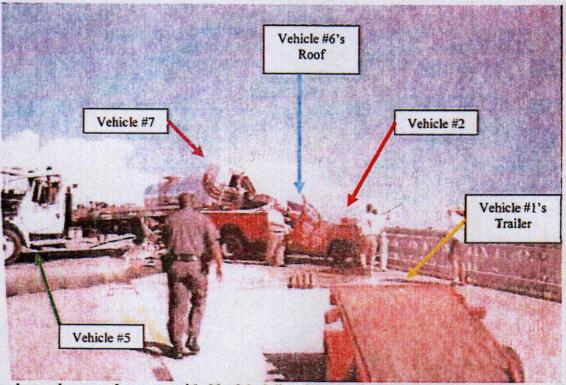
The above photograph was provided by Mr. Miguel Ascencio Heredia's disposal camera. The photograph shows the final rest of the trailer prior to the Fire Department moving it, and the final rest of Vehicle #2, Vehicle #5, Vehicle #6, and Vehicle #7. The photograph was taken facing eastbound.

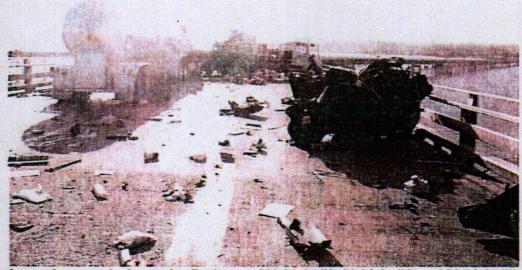
The above photograph shows the final rest of Vehicle #3, Vehicle #5, and Vehicle #7. The photograph was taken facing westbound.

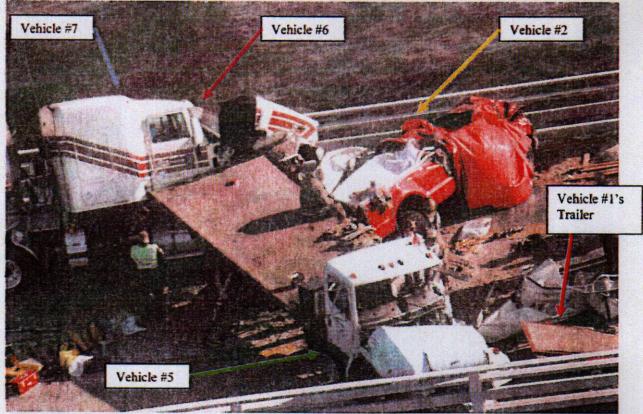
The above photograph was taken from Maryland State Police Medi-vac Unit (Trooper #6) to show the final rest of Vehicle #3, Vehicle #5, Vehicle #6, and Vehicle #7.

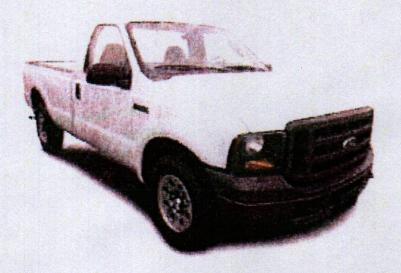
The above photograph is an exemplar of a 2006 Ford F-250, similar to Vehicle #2.

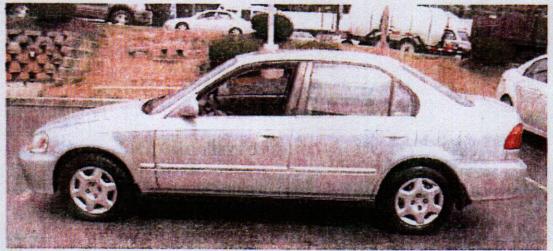
The above photograph is an exemplar of a 1999 Honda Civic, similar to Vehicle #4.
