## Property Inspection Report #20240269

**Date of Inspection: 2/5/2024**

**For the Property located at:**  
2572 Virginia Street unit #5, Berkeley, CA 94709

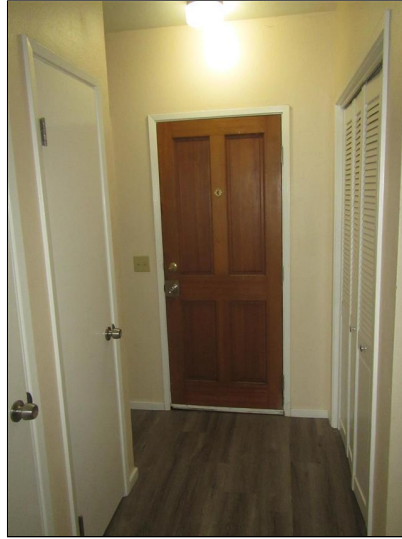
2

The overall condition of the entranceway was noted to be serviceable (Picture 1). The concrete walkway was examined and found to be in serviceable condition with light to moderate staining. The entry door was in serviceable condition, was securely fitted, and swung easily on its hinges (Picture 2). The latch, dead bolt and door hardware were fully functional and were smooth to operate. The exterior lighting fixture was working.

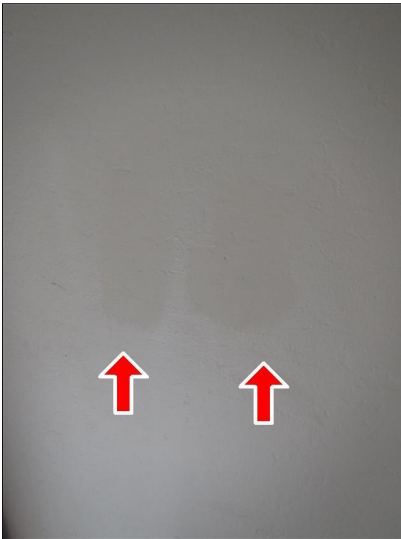
1

The interior was found to be in generally serviceable condition. The overall condition of the interior walls was noted to be generally serviceable with a number of examples of cosmetic damage - chips, marks, minor holes, small cracks etc. (Picture 1-3). The overall condition of the ceilings was noted to be serviceable with no signs of water intrusion or serious marks.

*Maintenance: Make appropriate minor repairs to walls and/or ceilings prior to re-painting.*

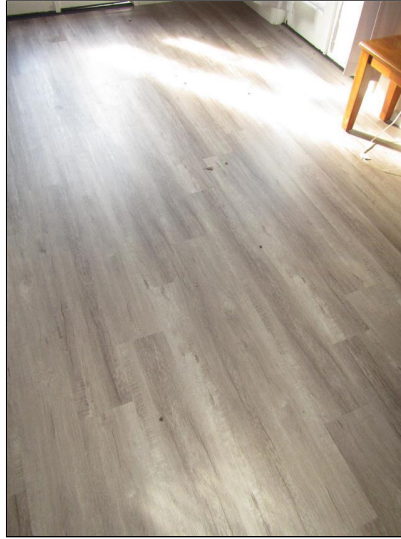
2

(2) Laminate floor coverings throughout the interior were in generally good condition with no significant marks or scratches in the visible areas (Picture 2).

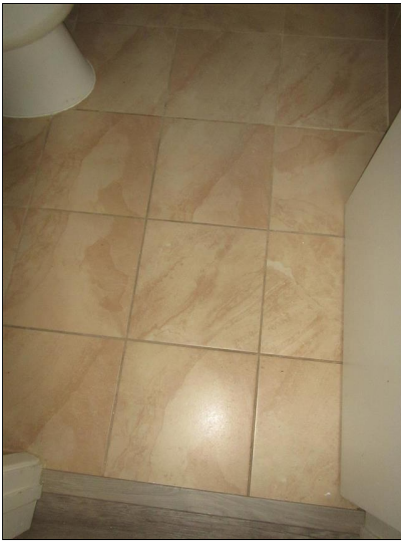
3

(3) The floor tile in the kitchen and both bathrooms was in good condition with no cracked or loose tiles (Picture 3-5). No loose or damaged grout was noted.

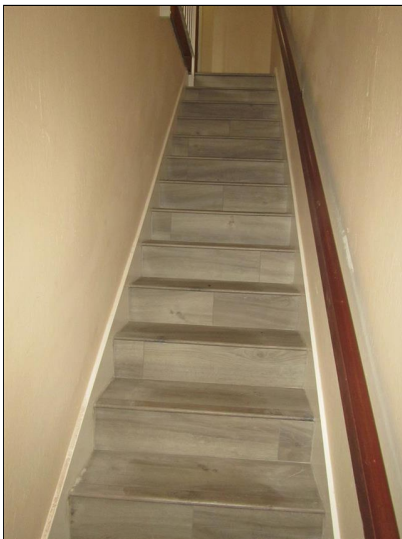
1

The surface of the stairs was in good condition (Picture 1). There was no significant wear in the high traffic areas. The wall-mounted handrail was securely fastened. The handrail has the recommended rounded-over ends (Picture 2). The enclosure at the upper level was secure and conforms to height recommendations (Picture 3). The gaps between railings at the enclosure are marginally greater than the recommended maximum of three (3) inches.

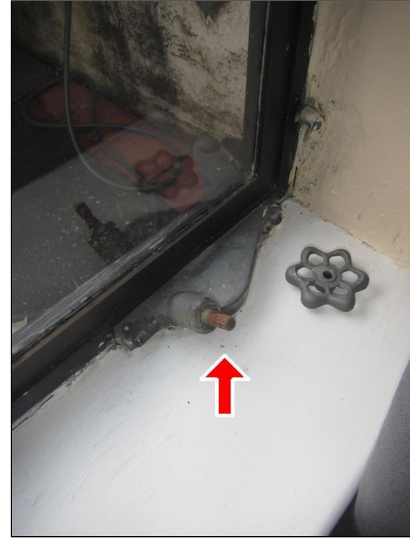
3

(1) With the exceptions noted below, all windows are single-pane aluminum-framed units with a mixture of casement, awning and fixed panels (Picture 1&2). The overall condition of the windows was noted to be serviceable. One (1) crack handles was missing from the principal bedroom (Picture 3). All other casement and awning windows were found to be fully operable. Window latches were intact and functional throughout. The paint was peeled at the window sill in the hallway bathroom (Picture 4). About half of the windows were fitted with screens which were found to be in serviceable condition where present.

(1) With the exceptions noted below, all windows are single-pane aluminum-framed units with a mixture of casement, awning and fixed panels (Picture 1&2). The overall condition of the windows was noted to be serviceable. One (1) crack handles was missing from the principal bedroom (Picture 3). All other casement and awning windows were found to be fully operable. Window latches were intact and functional throughout. The paint was peeled at the

*Recommendations: Replace damaged and/or missing window latch(es) and/or crank(s). Missing screens should be replaced or re-installed as appropriate. Replace any damaged wood in the window sill(s) and re-paint as required. All loose paint should be removed before repainting. Consult a specialist Wood Destroying Organisms (WDO; Termite) inspector with regard to the condition of these areas.*

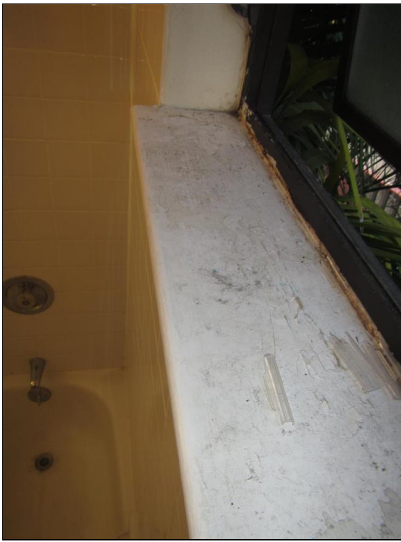
4

window sill in the hallway bathroom (Picture 4). About half of the windows were fitted with screens which were found to be in serviceable condition where present.

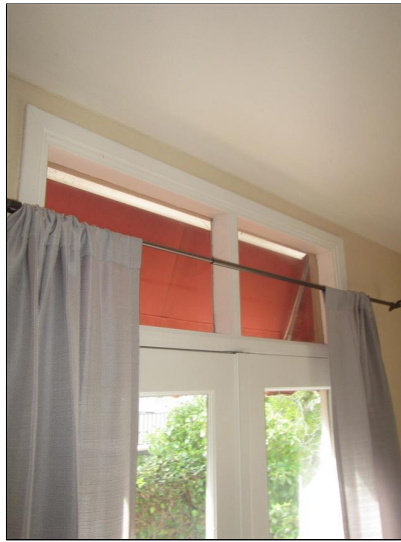
5

(2) The windows at the rear of the living area are single-pane wood-framed fixed panels (Picture 5).

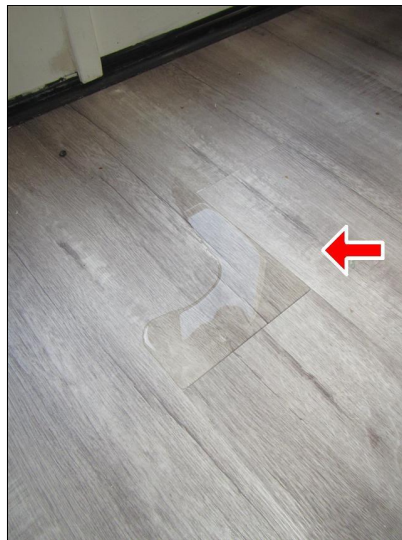
5

(2) Doors at the rear of the of the living area have been fitted with exterior safety bars which were found to be secure (Picture 4). Water was infiltrating into the living area in the area adjacent to these doors (Picture 5). It was not clear whether the water originates from the double doors however there was no other obvious source.

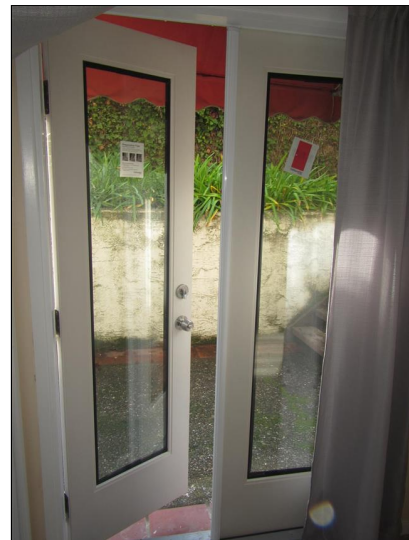
6

(3) The double exterior doors at the principal bedroom were examined and found to be in good condition (Picture 6). These doors are modern dual-pane units which were securely fitted and swung freely on their hinges. The latch, dead bolt and door hardware were intact and were smooth to operate. No screen doors were present.

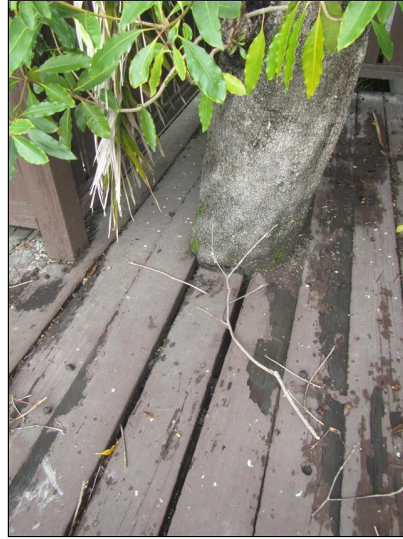
2

(1) The exterior deck and stairs were examined and found to be in adequate condition (Picture 1). The deck boards were in adequate condition with a number of examples of moisture-related damage.. The tree which passes through the deck has outgrown the space available resulting in lifting of the adjacent boards (Picture 2). The area below the deck was inaccessible. The supporting structure was not evaluated. Several sections of the enclosures were missing (Picture 3). There was no graspable handrail present at either section of the stairs.

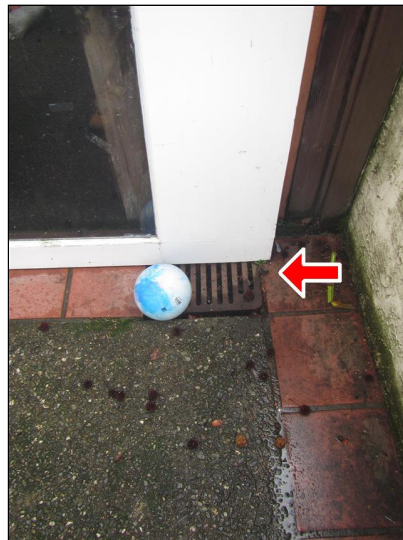
5

(2) The exterior patio was examined and found to be in serviceable to good condition. The surface of the patio was free from significant staining (Picture 4). A surface drain was present at the patio (Picture 5). A sump pump was also present which implies that the patio area is prone to flooding (Picture 6). The sump pump discharges to the front of the lot.

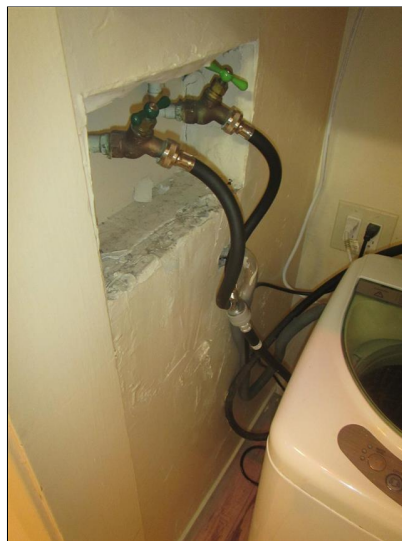
2

(1) The laundry area is located inside the hallway bathroom (Picture 1). Plumbing supply and drain connections were available for the washing machine. The washing machine water supply hoses are rubber/plastic (Picture 2). This material is prone to failure. The capacity of the washing machine is extremely small.

*Recommendations: Replacement of the rubber/plastic washing machine water supply hoses with braided steel hoses is advisable.*

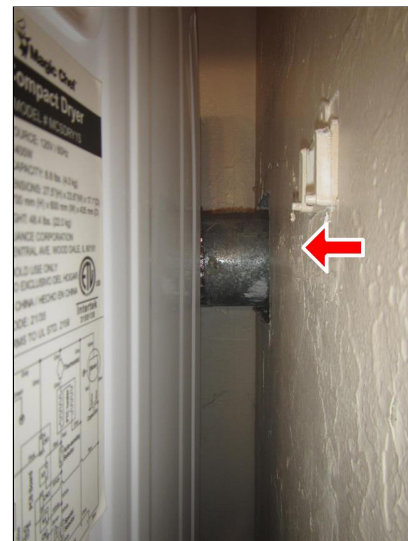
3

(2) The presently installed clothes dryer has an extremely small capacity. This type of unit is powered by a standard 110 Volt electrical outlet. There was no 220 Volt outlet in the laundry area and there was no connection to the natural gas line either. The dryer air vent is routed to the exterior via the wall in the laundry area (Picture 3). The inspector was not able to trace the entire route of the vent ducting.

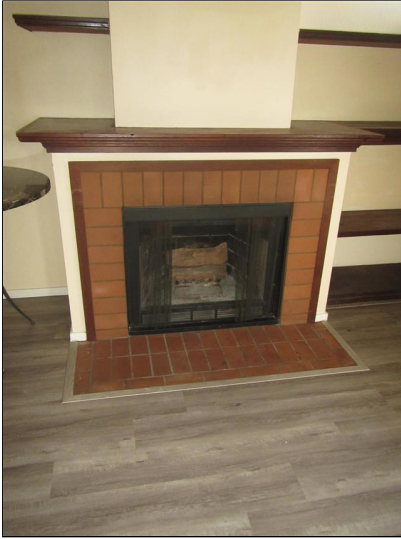
1

The fireplace, hearth and facing were found to be in serviceable condition (Picture 1). The firebox was found to be in serviceable condition. The damper was operated and found to be functional. There was some minor corrosion at the damper (Picture 2). The type of flue opening prevented a thorough inspection of the flue, and no opinion is offered as to the condition of the flue interior. No opinion is offered as to the shape and/or design of the fireplace and its ability to draw air.

Recommendations: Note: no opinion is offered as to the actual condition of the flue or its ability to draw air since it was not inspected. Inspection, and if necessary, cleaning of the fireplace and flue by an appropriate professional prior to operation is highly recommended.

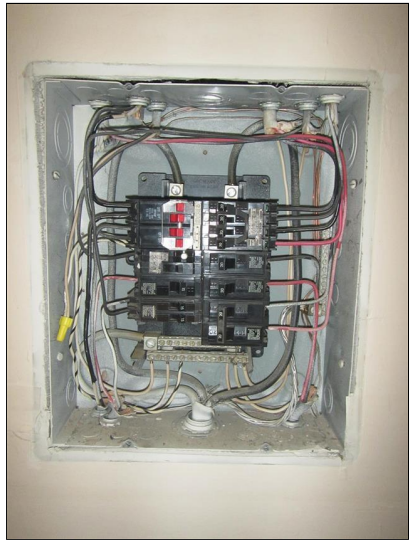
1

The circuit breaker panel is located in the entrance hallway closet and was noted to be in serviceable condition (Picture 1). No master electricity shutoff was present at the panel; the capacity of the system was not determined. All circuit breakers were labelled. Wire to breaker size appears to be correct, however, should a full evaluation of breaker sizes, load requirements and labeling for various circuits be desired, a State of California licensed electrical contractor should be consulted.

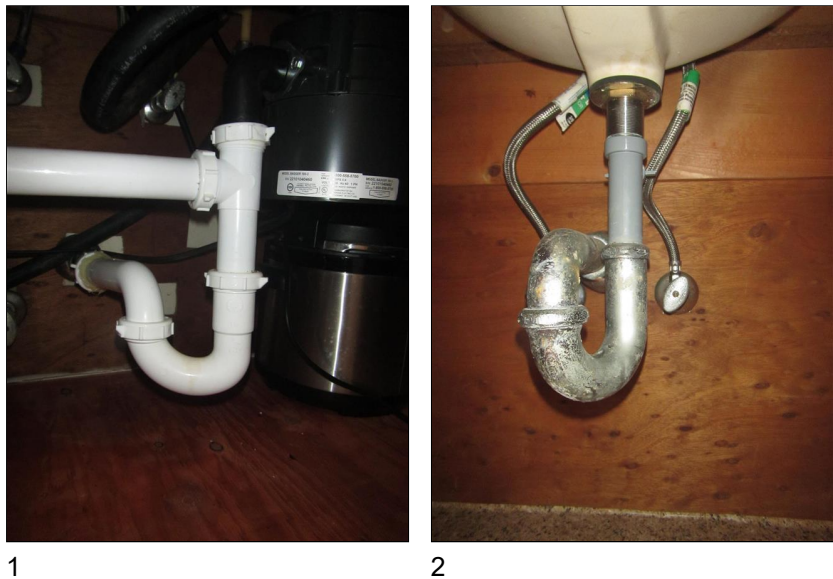
Incoming water pressure was adequate at all plumbing fixtures. Pipes were examined where visible, which was restricted to portions below sinks inside the unit. No evidence of any defect was noted in the areas observed. The waste lines accessible below sinks consist of a mixture of modern PVC plastic and older chrome-plated brass pipe (Picture 1&2).
