## Property Condition Report

### Couick's Marine

3613 Providence Rd S, Waxhaw, NC 28173

January 30, 2024

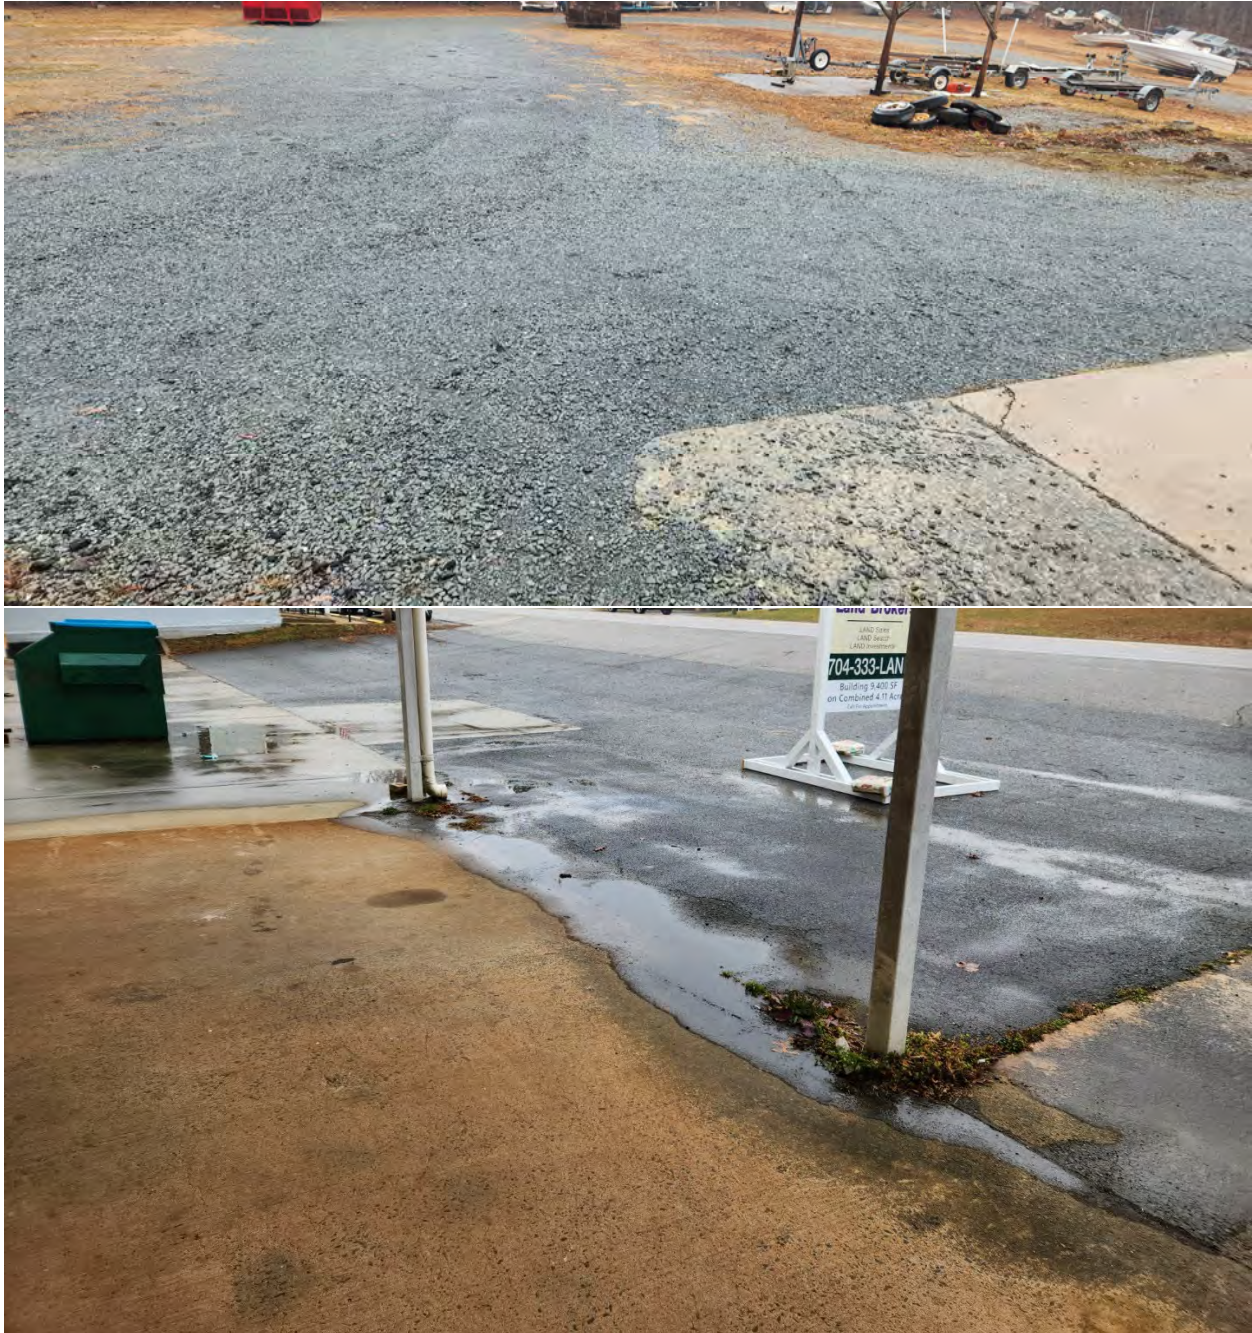
3.4 Paving, Curbing and Parking: Parking and driveways consist of asphalt, concrete and gravel. There are no marked parking spaces on the site.

- 1.3.1 The asphalt and concrete pavement is cracked, spalling and deteriorated in some places. There are no parking stripes. We recommend patching the worst sections, filling the cracks, and sealing and striping the asphalt.

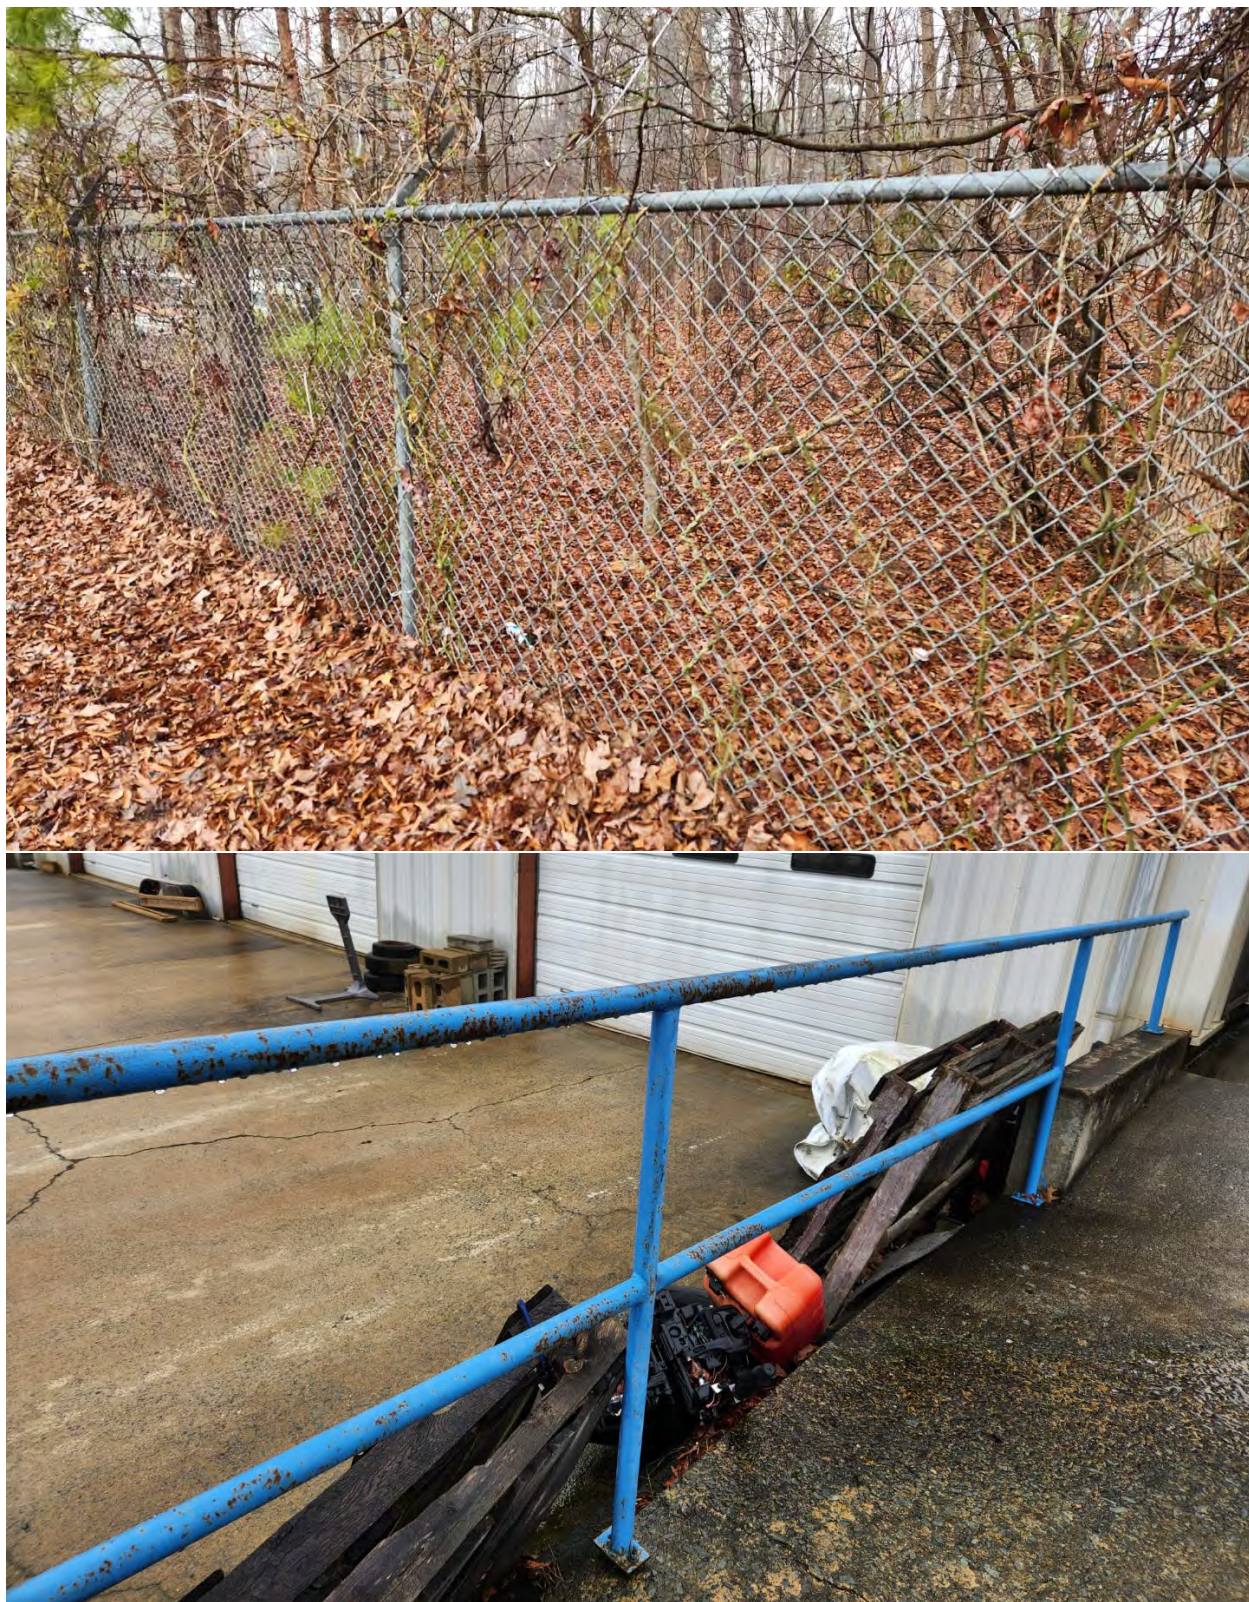
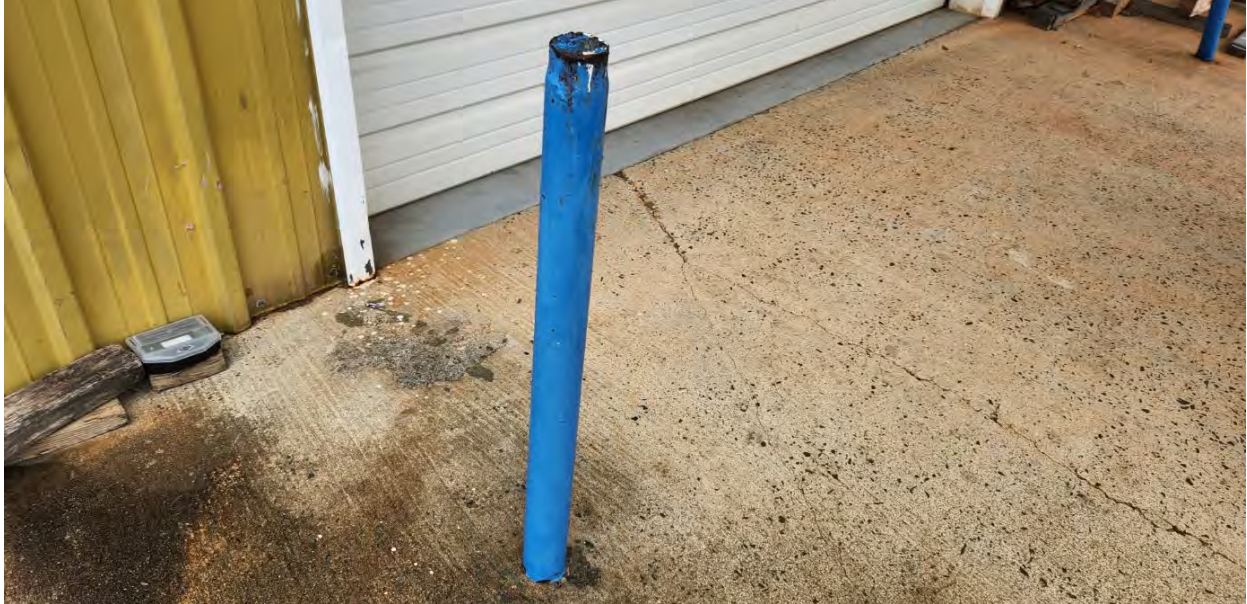
3.6.2 Fences and bollards: There is a chain link fence around the back perimeter of the property. There are steel railings installed. There are a few bollards installed.

- 1.3.2 The exterior steel rails need to be wire brushed and painted.
- 1.3.3 The owner is aware of one isolated spot where three to four cars (to his recollection) were buried many years ago. The owner can identify the location roughly. The owner does not recall any major fuel spills nor underground tanks. We recommend they are located, dug out and removed from site.

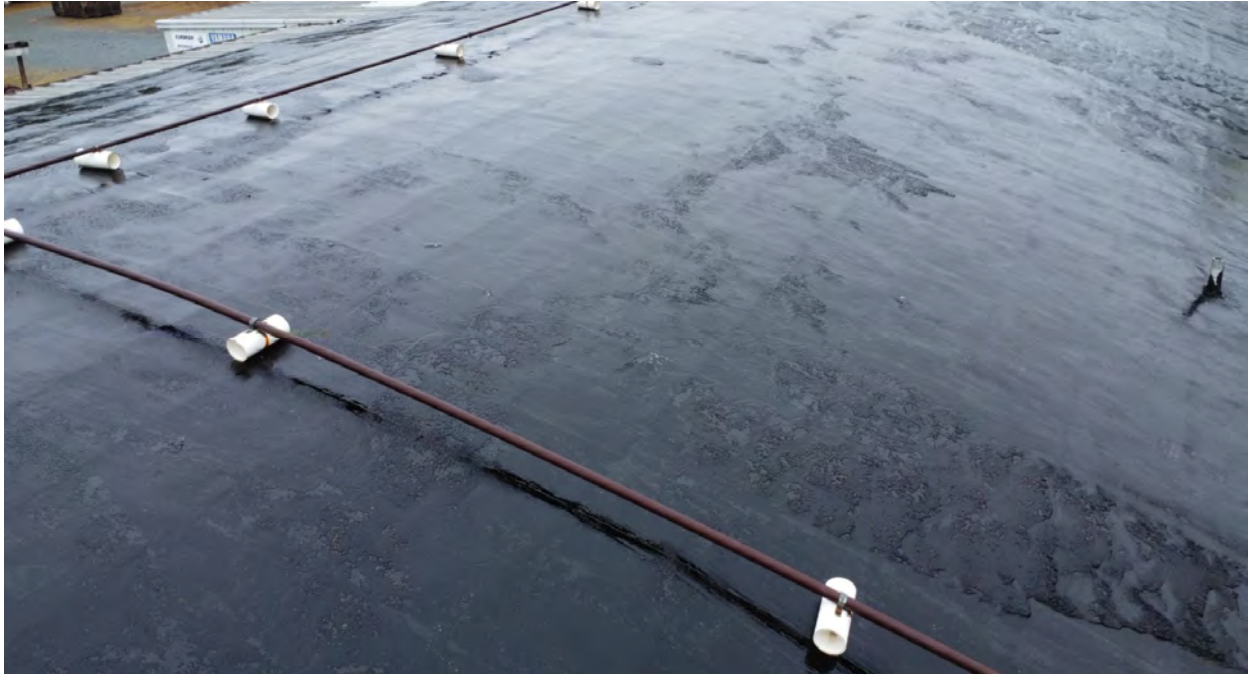
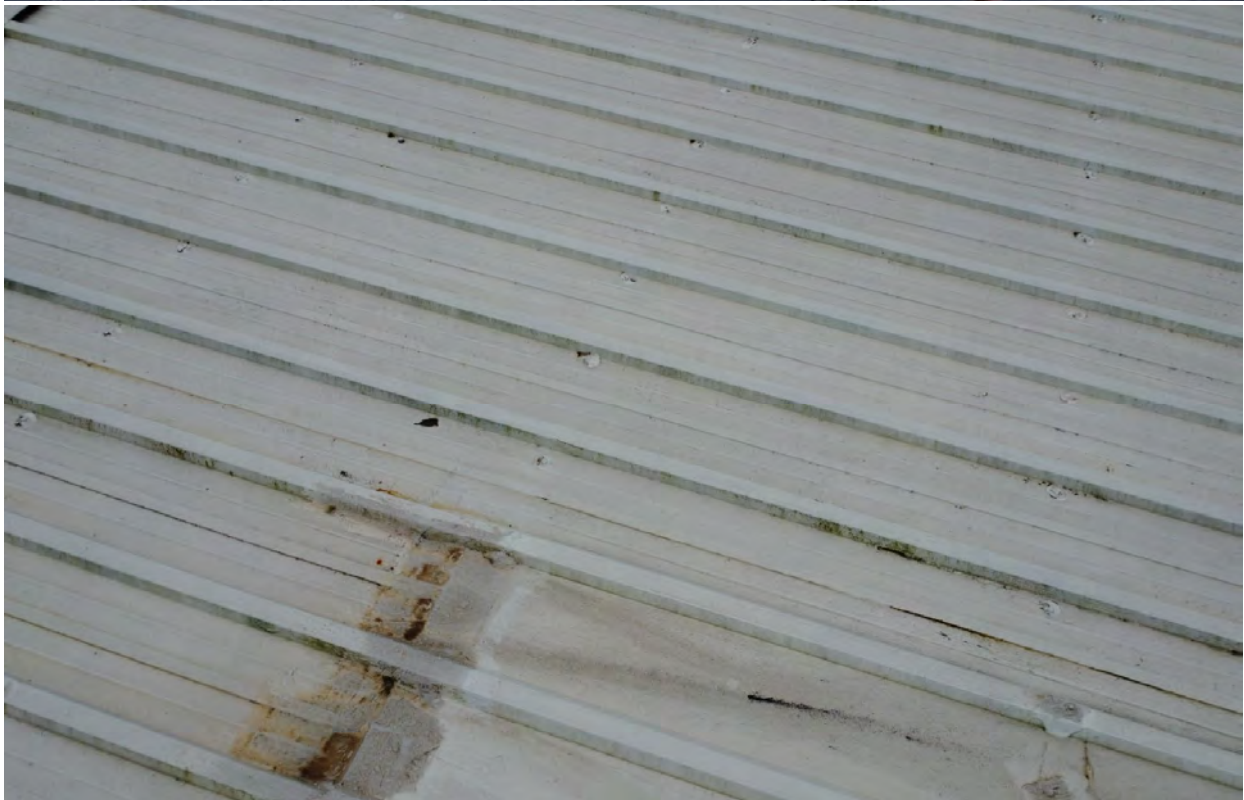
- 5.1 Type: The curved roof of the north building is covered with a membrane coated with tar. The flat roof of the north building and the roof of the south building consists of metal panels.

- 1.3.8 The curved roof membrane on the north building is starting to crack and deteriorate. The metal parapet wall coping is corroded or missing. Evidence of past roof leaks in this area was observed. We recommend replacement with a new membrane and coping in the next 0-5 years.

- 1.3.9 Past roof leaks under the metal roofing of the north building were reported. Multiple past repairs to this portion of roof were also observed. We recommend coating and sealing this entire section of roof with an elastomeric roof coating to stop any current leaks, prevent future leaks and extend the life of the metal panels.

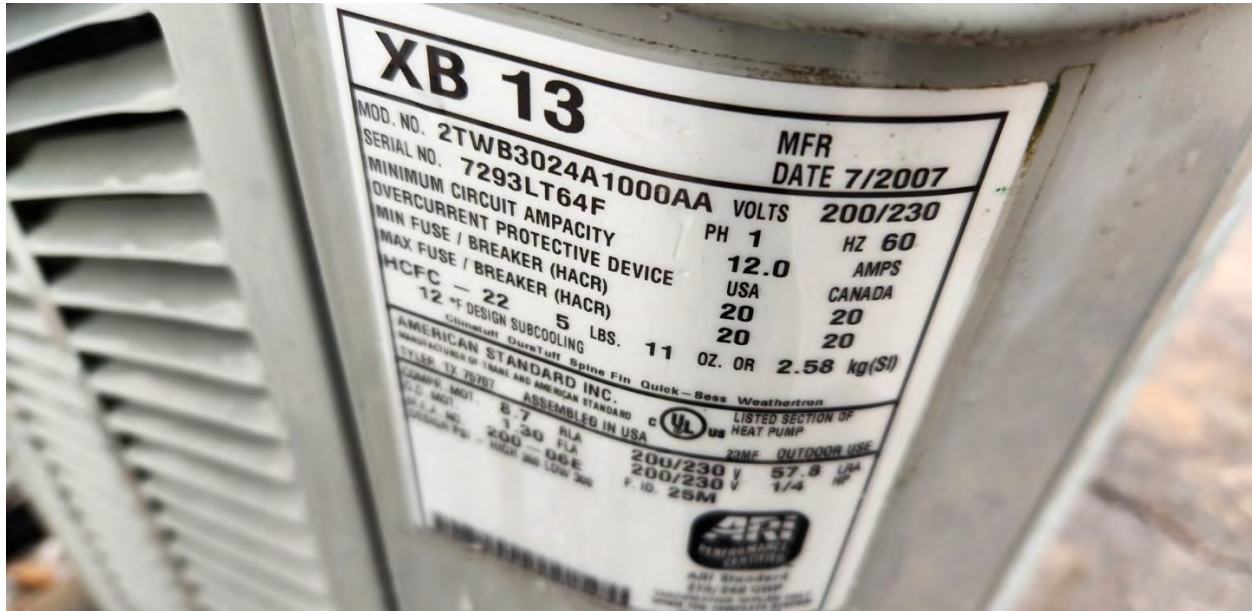
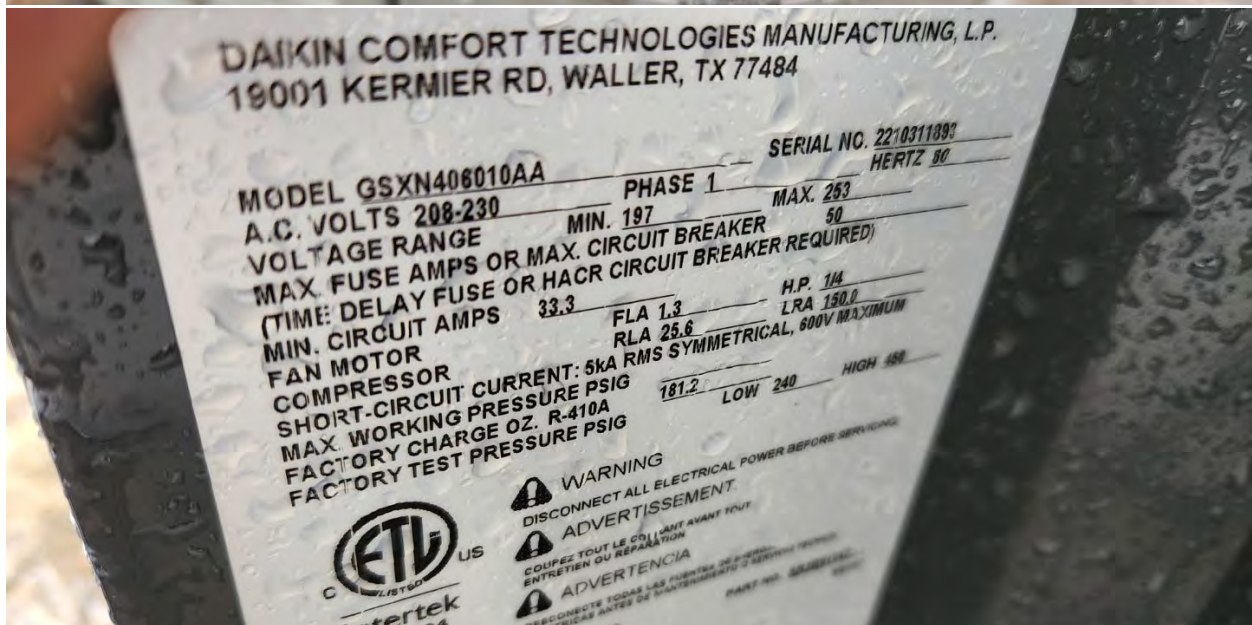
North Building Offices and Showroom: A split heat pump system and a split HVAC system with gas heat.

- 1.3.11 There is a split HVAC system for the north building that is 17 years old and near the end of its expected useful life of 15-20 years. It uses an obsolete refrigerant (R22) that is no longer being manufactured. We recommend replacement of this system in the next 0-3 years.

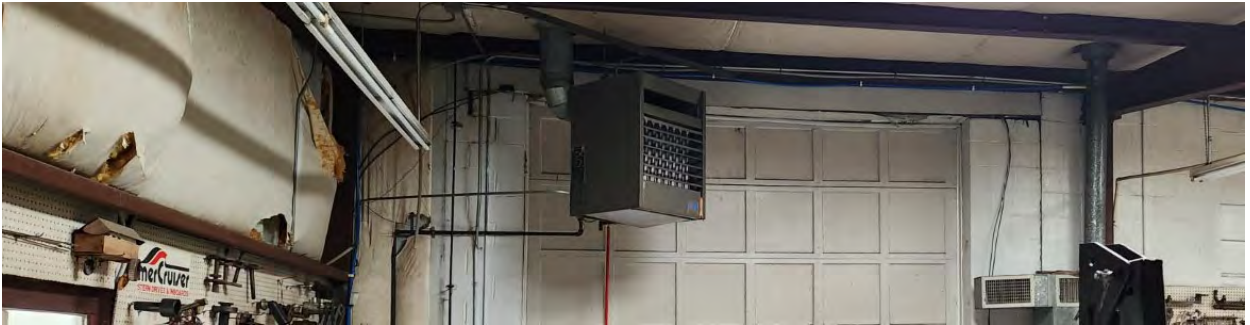
North Building Workshop: Heated with an overhead gas heater.

- 1.3.12 There is a furnace in the workshop area of the north building that no longer functions and needs to be removed.
- 1.3.13 There is some tile floor that probably contains asbestos. Due to the age of some portions of the building, there is likely to be more asbestos containing materials. We recommend conducting a full asbestos survey of the property and properly removing or encapsulating any remaining asbestos.

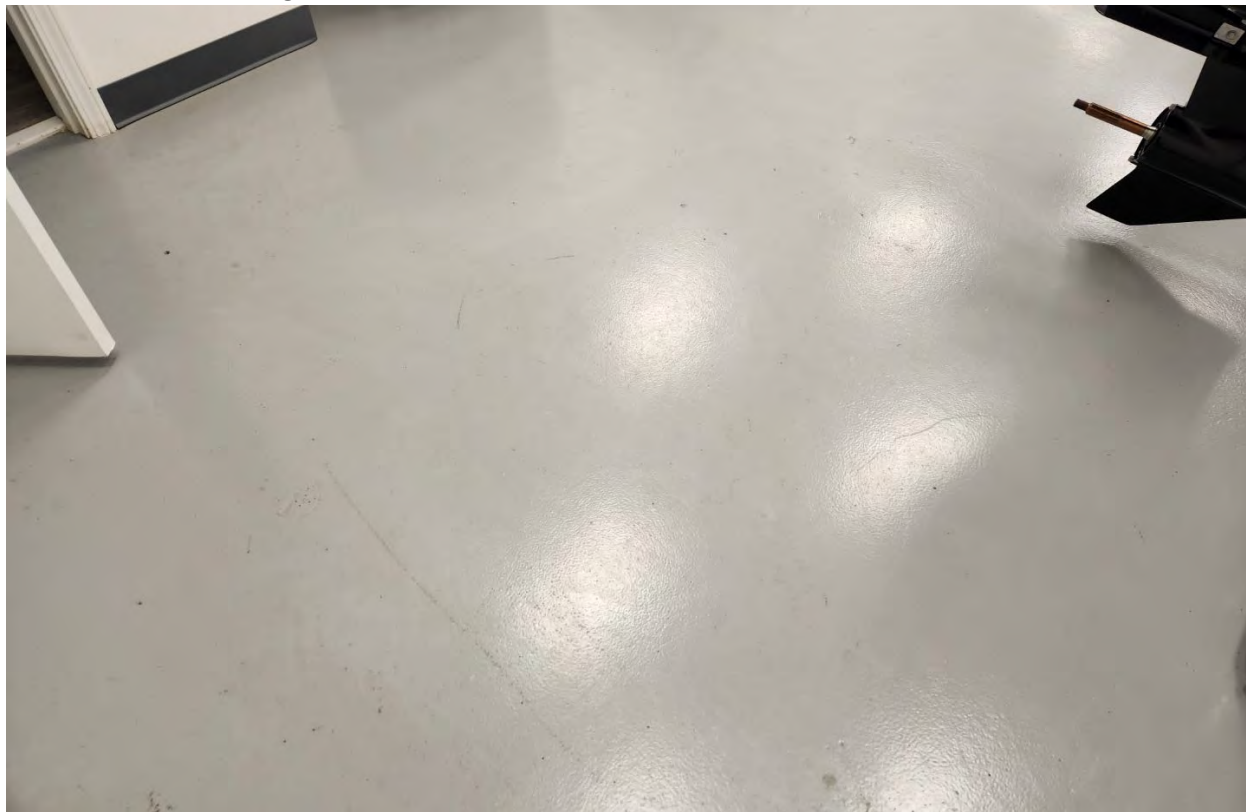
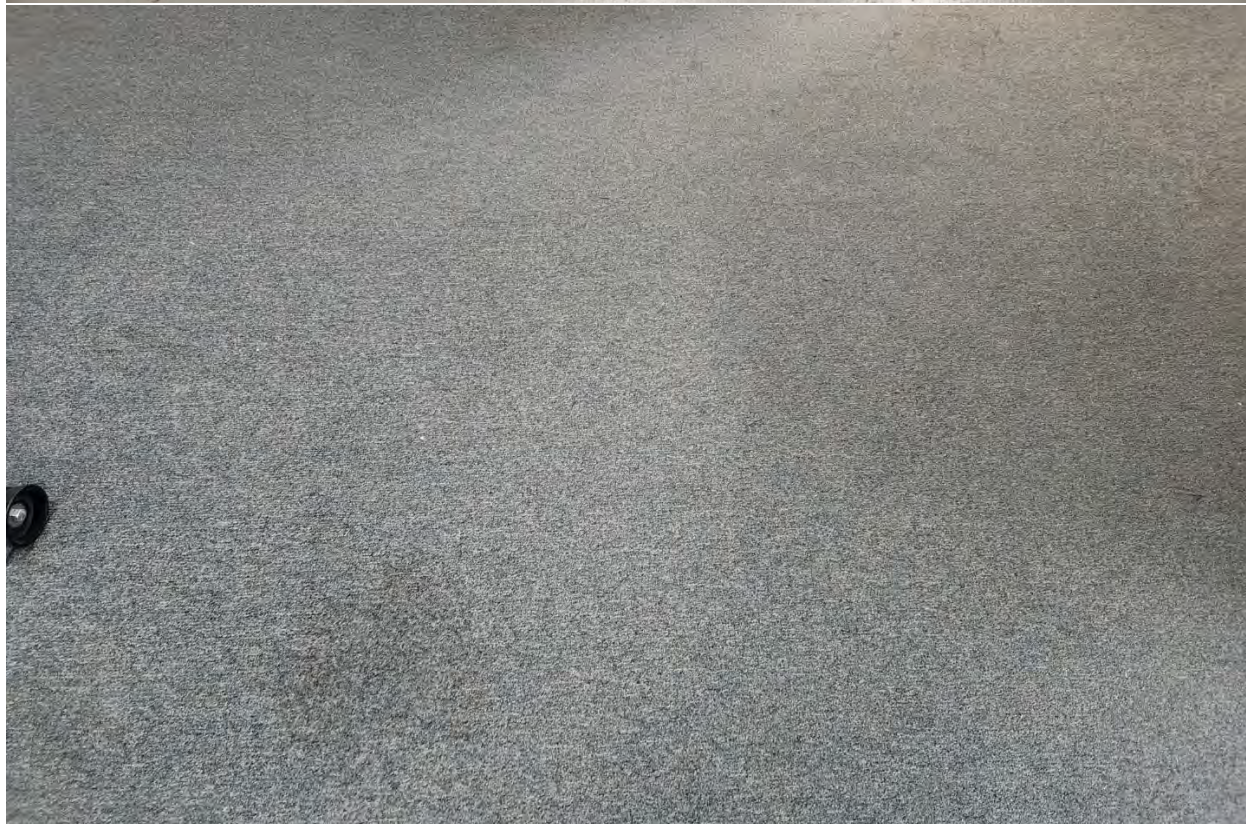
### 11.1 Flooring:

11.6.1 There is some tile floor that probably contains asbestos. Due to the age of some portions of the building, there is likely to be more asbestos containing materials. We recommend conducting a full asbestos survey of the property and properly removing or encapsulating any remaining asbestos.

11.6.3 The carpet in the showroom is worn and frayed and needs to be replaced.

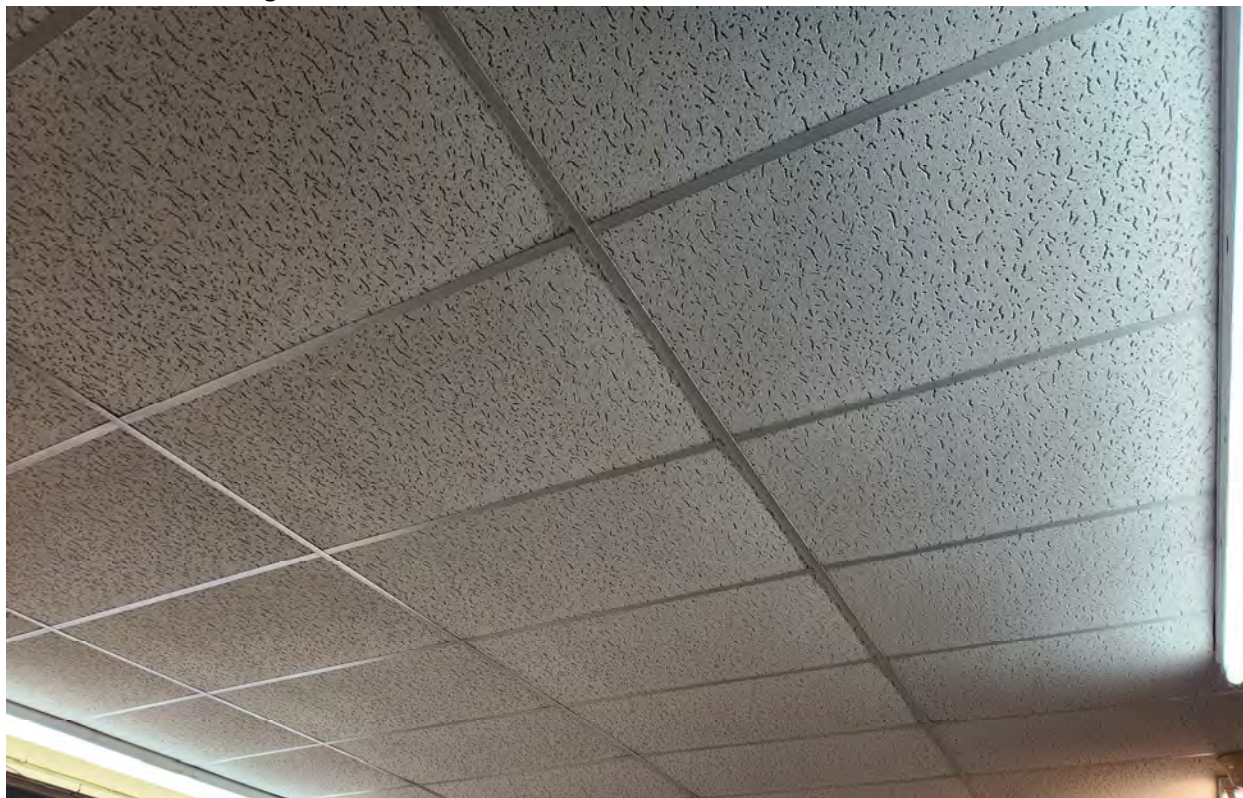
11.2 Ceilings:

11.6.2 There are numerous stained ceiling tiles that need to be replaced.
