Elbow River Estates Cooperative Ltd

2026 Reserve Fund Study

4.1 Water | Distribution System

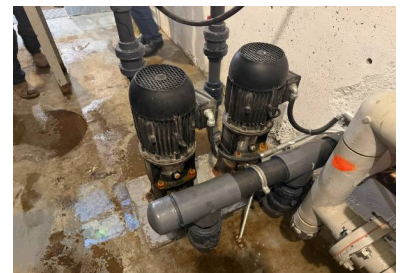
4.23 Treatment Plant | Pumps Sump

<div> <div>2 EA</div> <div>GRUNDFOS 3PH 60HZ 480V</div> </div> </div> </div>		
SERVICE TYPE	NEXT SERVICE YEAR	COST
Replacement	2031	\$4,400
