Inspection report for the property at  
**Sample Property, Washington**

This report is prepared exclusively for **Sample Report**  
Inspected On: **04-24-2026**

High Peak Home Inspections, LLC  
360-319-4245

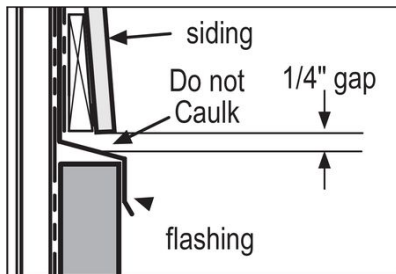
*This shows a proper head flashing.*

- Please note that flashings can be tricky to retrofit and it is often best to maintain this juncture with caulking and only retrofit a flashing if needed or if doing other siding repairs.

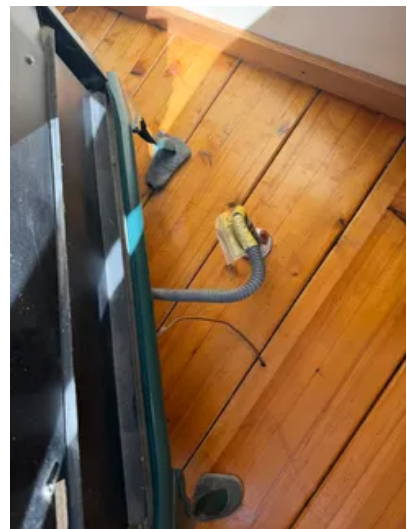
*This shows the gas shut-off for this fireplace.*

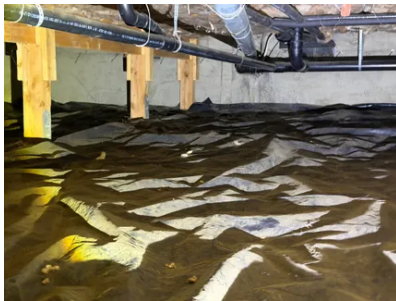
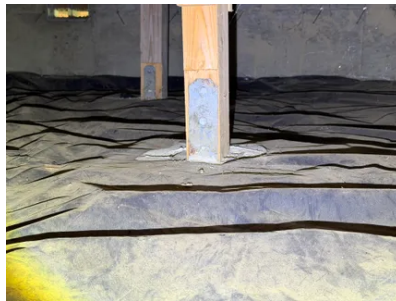
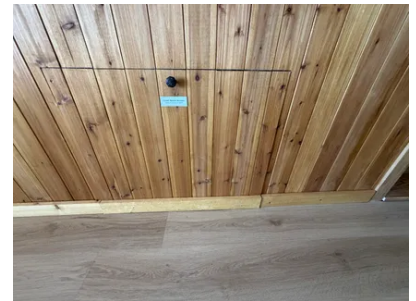
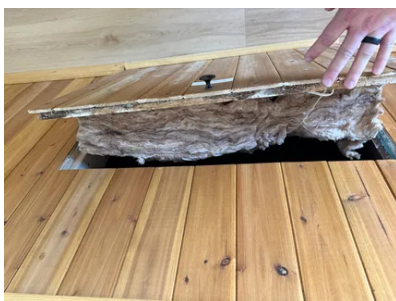
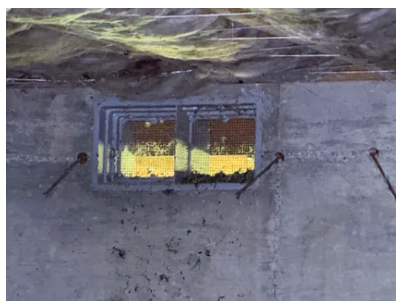
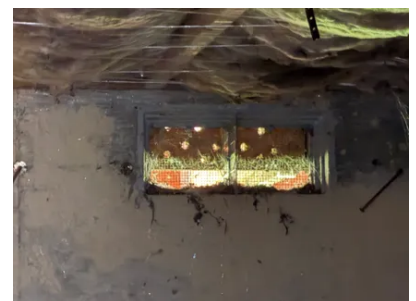
### ✂ (CS-1) Repair:

A power bar/strip was installed in the crawlspace with various cords powering crawlspace lights. If you feel incline to, I recommend having a licensed contractor re-evaluate and make
