# Mason & Oak

### RESIDENTIAL SURVEY REPORT

#### Level 3 Survey

Sample Report  
Sample Property  
Location Withheld

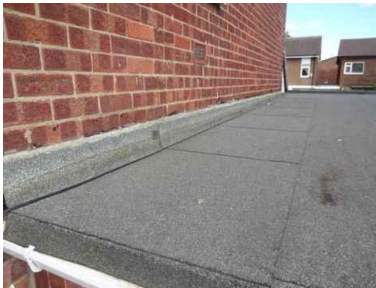
Condition Rating 2: The pitched roof coverings appeared to be in reasonable condition, but ponding was present on the felt-covered flat roof. Further inspection and planned remedial work are required to reduce the risk of accelerated deterioration and leakage.

- Persistent ponding could accelerate deterioration of the bituminous felt and its joints.
- Inadequate falls or restricted drainage may cause recurring standing water.
- Failure of the flat-roof covering could result in damp penetration and decay of the supporting roof structure.
- Deterioration or displacement of ridge bedding, dry-verge components or lead flashings could allow wind-driven rain to enter the roof.
- Concealed defects may be present beneath the dry-verge trims or in areas that could not be inspected closely.
- Loose tiles or verge components could become a hazard during severe weather.
- Roof repairs may reveal additional deterioration to battens, underlay or supporting timbers.
- High-level repairs are likely to require scaffolding or other suitable access equipment, increasing the overall cost.

VIEW FULL SIZE  
Ponding was seen

- Before legal commitment to purchase, appoint a competent flat-roofing contractor to inspect the felt covering, falls, outlets, junctions and underlying structure where accessible.
- Obtain a quotation for any recommended improvements or remedial work.
- Establish whether the ponding clears within a reasonable period following rainfall or remains for prolonged periods.
- Keep the flat-roof outlet and associated rainwater goods clear and free-flowing.
- Repair localised defects or improve the falls and drainage as advised by the contractor.
- Budget for periodic renewal of the bituminous felt covering due to its comparatively limited and uncertain remaining service life.
- Inspect the ridge mortar, dry-verge system, tiles, lead flashings and roof junctions periodically and after severe weather.
