John Client

123 Some Street
Somewhere, US 12345

Wiseman Home Inspection, LLC

1 of 25
04/12/2021 05:14 PM
Prepared for: John Client
123 Some Street

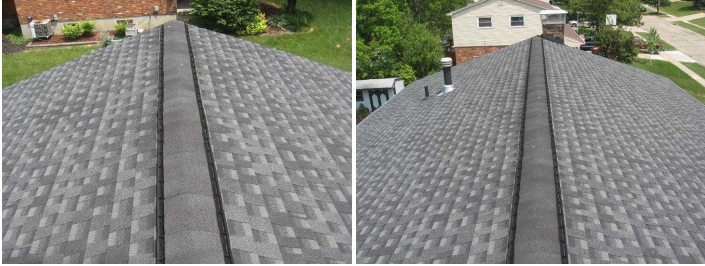
Main Roof Surface

- 2. Unable to Inspect: 0%
- 3. Material: Fiberglass shingle
- 4. Type: Gable
- 5. Approximate Age: 5
- 6. Flashing: Metal
- 7. Plumbing Vents: Copper
- 8. Electrical Mast: Underground utilities
- 9. Gutters: Aluminum - Loose nails, Sagging gutters at front and rear

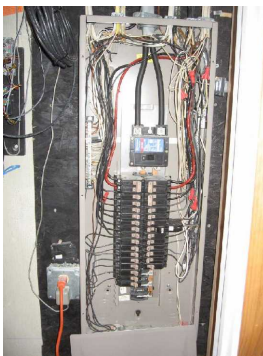
Basement Electric Panel

9. Manufacturer: Cutler-Hammer

10. Maximum Capacity: 200 Amps

11. Main Breaker Size: 200 Amps

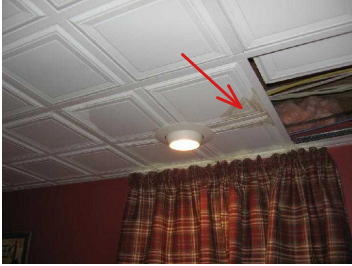
Main Basement

2. Ceiling: Suspended Acoustical System - Evidence of past water staining
3. Walls: Drywall
4. Floor: Carpet - Carpet stains noted
5. Floor Drain: Surface drain
6. Doors: Hollow wood
7. Windows: Vinyl casement
8. Electrical: 110 VAC - Loose junction boxes, missing and mis-sized covers, extension cord wiring to projector

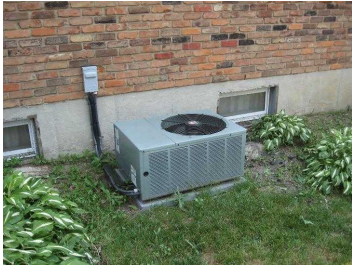
Main AC System

1. A/C System Operation: Appears serviceable
2. Condensate Removal: Plastic tubing
3. Exterior Unit: Pad mounted

4. Manufacturer: Rheem
5. Area Served: Whole house Approximate Age: 7
6. Fuel Type: 110 VAC Temperature Differential: 16 degrees
7. Type: Central A/C Capacity: 3 Ton
8. Visible Coil: Copper core with aluminum fins
9. Refrigerant Lines: Serviceable condition
10. Electrical Disconnect: Breaker disconnect
11. Exposed Ductwork: Metal
12. Blower Fan/Filters: Direct drive with electronic filter
13. Thermostats: Single Zone

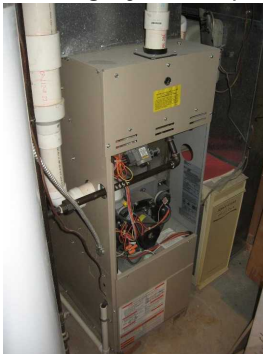
Basement Heating System

1. Heating System Operation: Appears functional

2. Manufacturer: Ducane
3. Type: Forced air Capacity: 100,000 BTUHR
4. Area Served: Whole house Approximate Age: 6
