Millbrook Homeowners Association
Littleton, CO

Report #: 43766-0
Beginning: January 1, 2025
Expires: December 31, 2025

RESERVE STUDY
"Full"

July 24, 2024

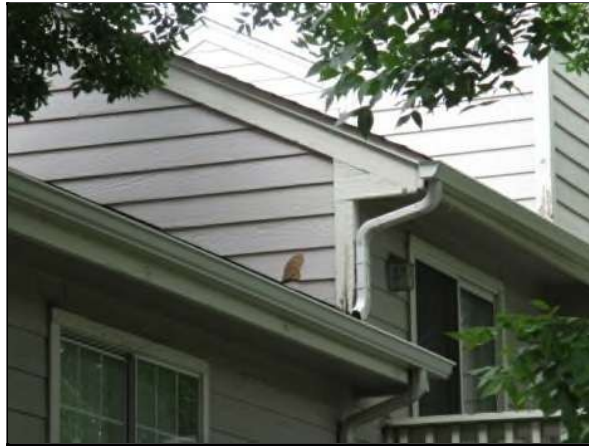
Comp #: 23320 Wood/Composite Siding - Replace (Ph 1)**Quantity: ~ 165100 GSF**

Comments: Wood siding determined to be in fair condition typically exhibits some color fading and inconsistency with minor isolated locations showing more advanced surface wear cracking splintering etc. Project costs can vary depending upon materials chosen and the condition of the underlying structural framing when exposed. We recommend the Board conduct research well in advance in order to define scope timing and costs including plan for some margin of contingency. Siding is horizontal clapboard. Surface was painted. No view of the critical underlying waterproofing was available as part of our limited visual review. Replacement may ultimately be needed due to the failure of the underlying waterproofing degrading over the decades and/or the end of the useful life of the siding materials from general aging. Many factors influence the useful life including exposure to (or protection from) wind driven rain and the quality of the waterproofing and flashing beneath the siding. Evaluate the siding and the critical underlying waterproofing (typically building paper or house-wrap) more frequently as the remaining useful life approaches zero years. Adjust remaining useful life as dictated by the evaluation. Align with window replacement for cost efficiencies and building envelope integrity when practical. Inspect annually and repair locally as needed using general maintenance funds. Keep the wood siding painted to protect the wood from decay caused by water. Another item that greatly influences useful life is the thoroughness of the original painting. Wood siding will last longer if each piece was painted on all six sides. Typically wood siding is painted on the two sides that are exposed and not on the back ends or top. Since we perform only a visual review we were unable to confirm the extents of the painting. It is reasonable to presume that not all six sides are painted. If the siding is not painted on all sides water can infiltrate and be absorbed into the wood on the unpainted sides which over time will lead to cupping warping and decay limiting its useful life.

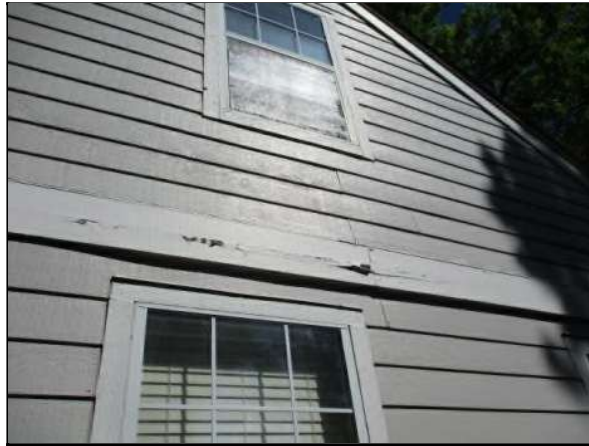
Comp #: 23320 Wood/Composite Siding - Replace (Ph 2)**Quantity: ~ 57900 GSF**

Comments: Wood siding determined to be in fair condition typically exhibits some color fading and inconsistency with minor isolated locations showing more advanced surface wear cracking splintering etc. Project costs can vary depending upon materials chosen and the condition of the underlying structural framing when exposed. We recommend the Board conduct research well in advance in order to define scope timing and costs including plan for some margin of contingency. Siding is horizontal clapboard. Surface was painted. No view of the critical underlying waterproofing was available as part of our limited visual review.

Replacement may ultimately be needed due to the failure of the underlying waterproofing degrading over the decades and/or the end of the useful life of the siding materials from general aging. Many factors influence the useful life including exposure to (or protection from) wind driven rain and the quality of the waterproofing and flashing beneath the siding. Evaluate the siding and the critical underlying waterproofing (typically building paper or house-wrap) more frequently as the remaining useful life approaches zero years. Adjust remaining useful life as dictated by the evaluation. Align with window replacement for cost efficiencies and building envelope integrity when practical. Inspect annually and repair locally as needed using general maintenance funds. Keep the wood siding painted to protect the wood from decay caused by water. Another item that greatly influences useful life is the thoroughness of the original painting. Wood siding will last longer if each piece was painted on all six sides. Typically wood siding is painted on the two sides that are exposed and not on the back ends or top. Since we perform only a visual review we were unable to confirm the extents of the painting. It is reasonable to presume that not all six sides are painted. If the siding is not painted on all sides water can infiltrate and be absorbed into the wood on the unpainted sides which over time will lead to cupping warping and decay limiting its useful life.

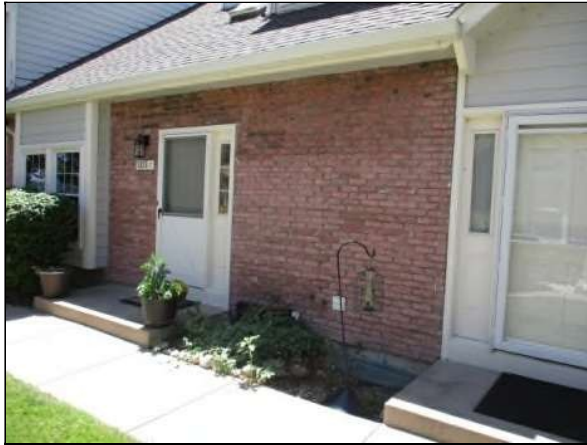
Comp #: 23370 Brick/Stone Veneer - Maintain/Repair**Quantity: ~ 22200 GSF**

Comments: Brick or other masonry siding is typically a low maintenance surface that requires minimal infrequent repair. However in some cases (usually after several decades or more) the original mortar between bricks may require repointing to restore appearance and adequately protect against water intrusion. Repointing involves raking out a portion of the existing mortar and installing new mortar and continuing on until all affected sections have been replaced. In our experience there is not a well-defined predictable timeline for repointing work usually making this project inappropriate for Reserve funding. If re-pointing is a concern we strongly recommend further inspection by a qualified engineer and/or masonry specialist to diagnose existing conditions and recommend a scope of work. If warranted the Reserve Study can be adjusted to include funding recommendations going forward.

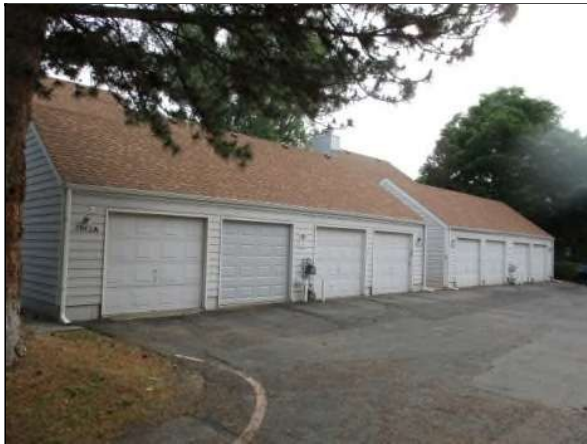
Comp #: 23490 Ext. Garage Doors - Replace**Quantity: ~ (190) Doors**

Comments: Based on limited review of the client's governing documents individual owners are believed to be responsible for garage door replacement. However our review is not intended to be a professional legal opinion and we reserve the right to revise this component if the client is otherwise found to be responsible for replacement. No recommendation for Reserve funding at this time.

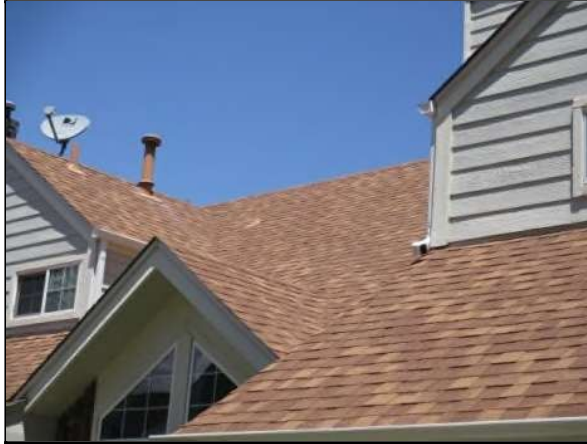
Comp #: 23570 Roof Shingle - Replace (Ph 2)**Quantity: ~ 88900 GSF**

Comments: Includes approximately half the GSF of Townhomes, Garages, Clubhouse, and Mail Kiosk. Closed valleys were observed. Ventilation (the lack of which can greatly reduce the roof's useful life) was observed at the eave and ridge. Eave venting consisted of soffit holes between the rafters. Ridge venting appeared to be provided by roof jacks and gable end louvers. Debris was not observed on the roof surface. Asphalt shingle roofs determined to be in fair condition and typically exhibit normal signs of wear and deterioration including some loss of granule cover and light to moderate curling/lifting especially in most exposed areas. Overall believed to be aging normally. A reserve study conducts only a limited visual review and many of the critical waterproofing and ventilation items of the roof are not readily viewable. For a full evaluation have a professional roof consultant/contractor perform a thorough up-close survey of your entire roof system including attic inspection (if any). Costs below factors replacement with an architectural grade laminated shingle. As routine maintenance many manufacturers recommend inspections at least twice annually (once in the fall before the snow season and again in the spring) and after large storm events. Promptly replace any damaged/missing sections or any other repair needed to ensure waterproof integrity of roof. Keep roof surface gutters and downspouts clear and free of debris. At the time of re-roofing we recommend that you hire a professional consultant to evaluate the existing roof and specify the new roof materials/design provide installation oversight. We recommend that all clients hire qualified consultants whenever they are considering having work performed on any building envelope (waterproofing) components including: roof walls windows decks exterior painting and caulking/sealant. There is a wealth of information available through Roofing Organizations such as: National Roofing Contractors client (NRCA) <http://www.nrca.net>, Asphalt Roofing Manufacturers client (ARMA) <http://www.asphaltroofing.org/> Roof Consultant Institute (RCI) <https://iibec.org/rci-becomes-iibec/>

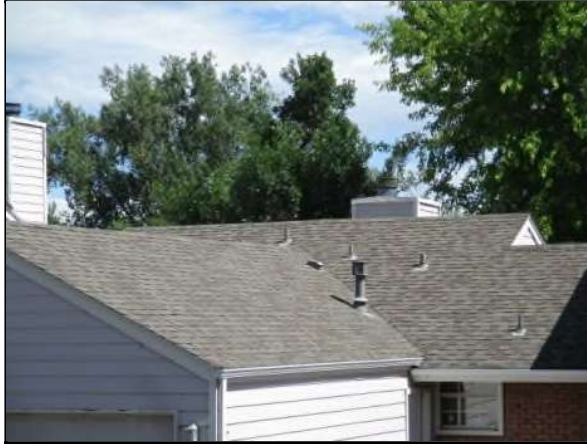
Comp #: 23570 Roof: Shingle - Replace (Ph 1)**Quantity: ~ 88900 GSF**

Comments: Includes approximately half the GSF of Townhomes, Garages, Clubhouse, and Mail Kiosk. Closed valleys were observed. Ventilation (the lack of which can greatly reduce the roof's useful life) was observed at the eave and ridge. Eave venting consisted of soffit holes between the rafters. Ridge venting appeared to be provided by roof jacks and gable end louvers. Debris was not observed on the roof surface. Asphalt shingle roofs determined to be in fair condition and typically exhibit normal signs of wear and deterioration including some loss of granule cover and light to moderate curling/lifting especially in most exposed areas. Overall believed to be aging normally. A reserve study conducts only a limited visual review and many of the critical waterproofing and ventilation items of the roof are not readily viewable. For a full evaluation have a professional roof consultant/contractor perform a thorough up-close survey of your entire roof system including attic inspection (if any). Costs below factors replacement with an architectural grade laminated shingle. As routine maintenance many manufacturers recommend inspections at least twice annually (once in the fall before the snow season and again in the spring) and after large storm events. Promptly replace any damaged/missing sections or any other repair needed to ensure waterproof integrity of roof. Keep roof surface gutters and downspouts clear and free of debris. At the time of re-roofing we recommend that you hire a professional consultant to evaluate the existing roof and specify the new roof materials/design provide installation oversight. We recommend that all clients hire qualified consultants whenever they are considering having work performed on any building envelope (waterproofing) components including: roof walls windows decks exterior painting and caulking/sealant. There is a wealth of information available through Roofing Organizations such as: National Roofing Contractors client (NRCA) <http://www.nrca.net>, Asphalt Roofing Manufacturers client (ARMA) <http://www.asphaltroofing.org/> Roof Consultant Institute (RCI) <https://iibec.org/rci-becomes-iibec/>

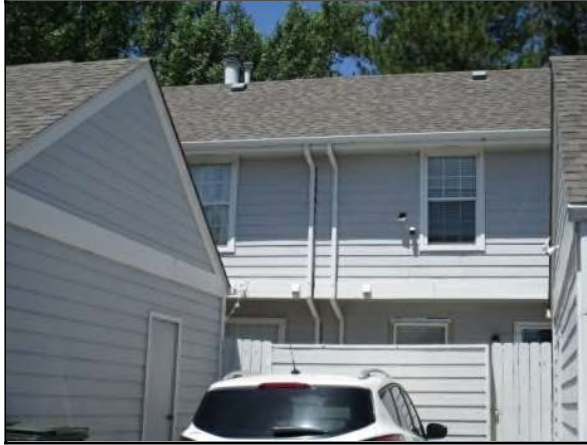
Comp #: 23650 Gutters/Downspouts - Replace - (Ph 1)

Comments: Includes approximately half the LF of Townhomes, Garages, Clubhouse, and Mail Kiosk. Gutters and downspouts determined to be in fair condition typically exhibit some normal wear and tear but drainage away from the roof and building appears to be adequate. Generally believed to be aging normally. Gutters and downspouts are assumed to be functioning properly unless otherwise noted. As routine maintenance inspect regularly and keep gutters and downspouts free of debris. If buildings are located near trees keep trees trimmed back to avoid accumulation of leaves on the roof surface which will accumulate in the gutters and increase maintenance requirements while reducing life expectancy. Repair or replace individual sections as needed as an Operating expense. We generally recommend that the gutters and downspouts be replaced when the roof is being resurfaced/replaced. National Roofing Contractor client (NRCA) roofing standard includes installing eave flashings at the gutters. We suggest to plan for total replacement of gutter and downspouts at the same intervals as roof replacement for cost efficiency. Unless otherwise noted costs shown here assume replacement with similar type as are currently in place.

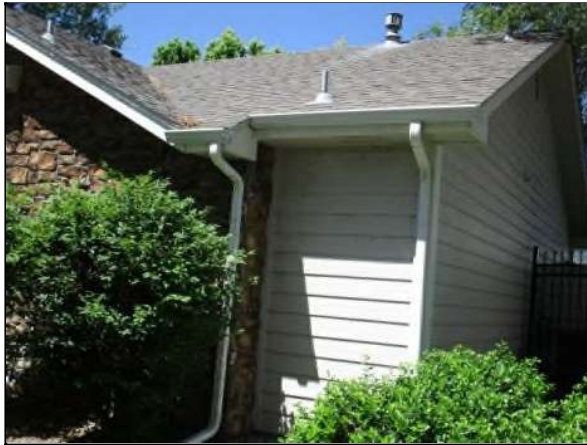
Comp #: 23650 Gutters/Downspouts - Replace - (Ph 2)**Quantity: ~ 9400 LF**

Comments: Includes approximately half the LF of Townhomes, Garages, Clubhouse, and Mail Kiosk. Gutters and downspouts determined to be in fair condition typically exhibit some normal wear and tear but drainage away from the roof and building appears to be adequate. Generally believed to be aging normally. Gutters and downspouts are assumed to be functioning properly unless otherwise noted. As routine maintenance inspect regularly and keep gutters and downspouts free of debris. If buildings are located near trees keep trees trimmed back to avoid accumulation of leaves on the roof surface which will accumulate in the gutters and increase maintenance requirements while reducing life expectancy. Repair or replace individual sections as needed as an Operating expense. We generally recommend that the gutters and downspouts be replaced when the roof is being resurfaced/replaced. National Roofing Contractor client (NRCA) roofing standard includes installing eave flashings at the gutters. We suggest to plan for total replacement of gutter and downspouts at the same intervals as roof replacement for cost efficiency. Unless otherwise noted costs shown here assume replacement with similar type as are currently in place.

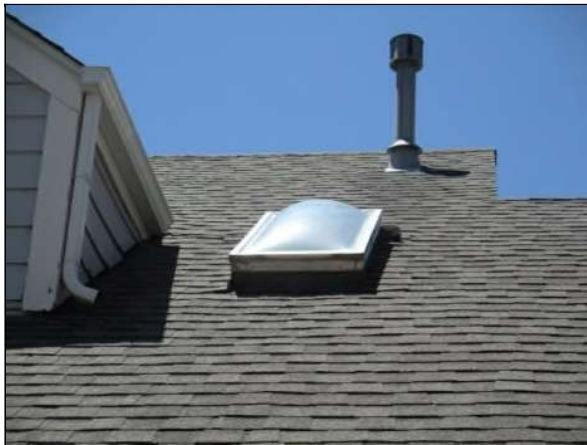
Comments: Inspect skylights during roof inspection and repair as needed to maintain waterproof integrity. Individual unit owners are believed to be responsible for repair and replacement of skylights at their units. No recommendation for Reserve funding at this time.

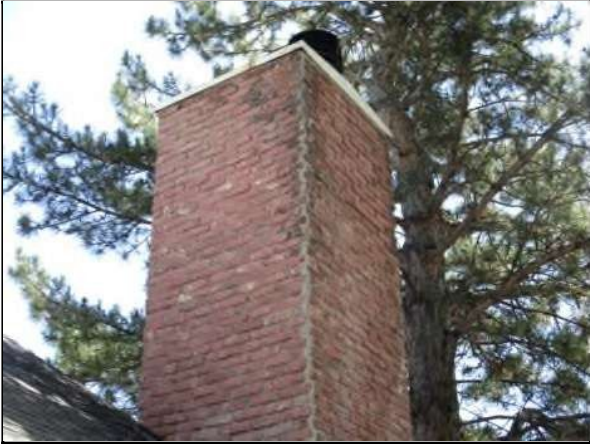
Comp #: 23710 Chimneys - Ongoing Repairs

History: Replaced in 2024.

Comments: It was reported that chimneys are repaired/replaced as needed. Generally poor conditions with some widespread damage/wear reported. Based on the age of the chimney pieces plan to replace soon. Chimney components should be scheduled for replacement at the approximate interval shown below. Best practice is often to coordinate replacement with the roof itself. Should be inspected maintained and repaired periodically to ensure good function. Extra attention should be paid to moving parts such as hinges and latches to ensure safety and functionality. Inspect periodically for leaks around frame and repair as needed.

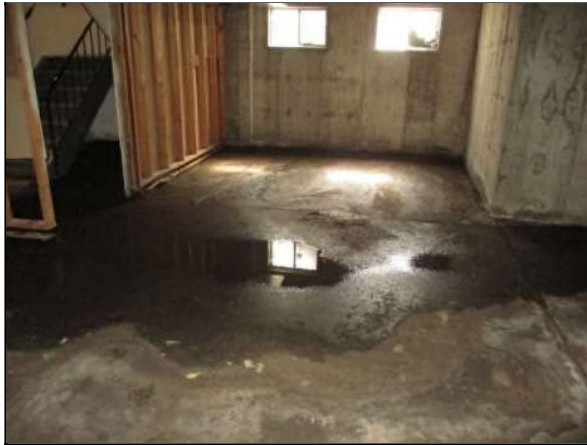
Comp #: 21030 Clubhouse Structure - Seal/Repair**Quantity: ~ (1) Clubhouse**

Comments: Forensic building evaluation is beyond the scope of this Reserve Study. There was evidence of flooding in the clubhouse basement. We are unable to inspect the issues causing this issue, however we recommend that the basement be inspected by an envelope specialist. A reserve study conducts a limited visual review, no observation or evaluation of the underlying waterproofing was available. Inspect, clean, and repair as needed. Update the Reserve Study when information from inspections becomes available.

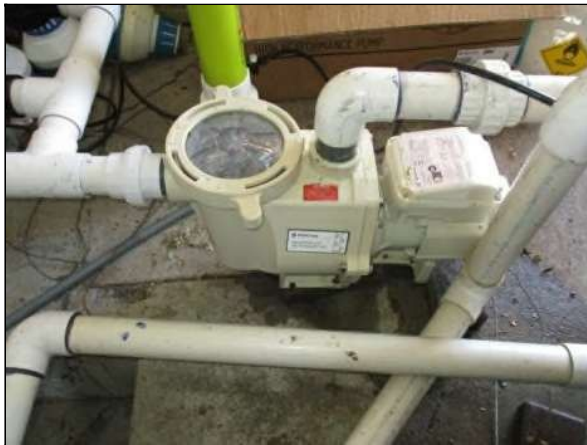
Comp #: 28220 Pool Pump – Repair/Replace**Quantity: ~ (1) Pump**

Comments: Includes (1) Pentair Whisperflo 1 HP. Pump should be inspected regularly for leaks and other mechanical problems. Cost shown is based on replacement with the same type and size unless otherwise noted and includes small allowance for new piping/valves/other repairs as needed.
