Millbrook Townhomes Canyon Trail & Depew Street Littleton, CO80128

Level 2, Platinum Reserve Analysis Report Period – 01/01/17 – 12/31/17

Client Reference Number - 7780
Property Type – Townhome Style

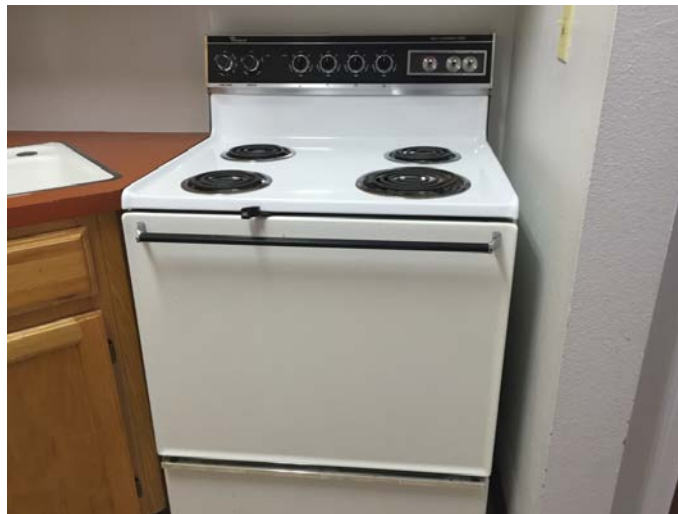
Comp #: 1402 Appliances - Replace

- All of the appliances were the same at the time of our site visit.
- Due to the minimal use these appliances receive expect a useful life of approximately 15 - 20 years from these units.
- Remaining life based on current age and condition.

Estimate to replace

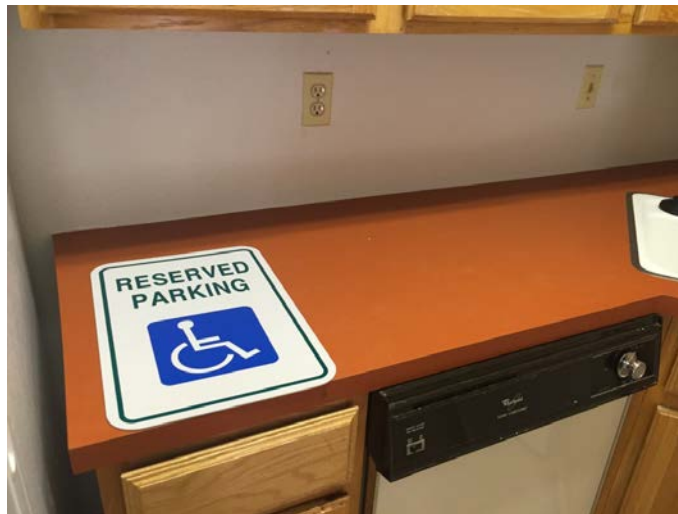
Comp #: 1403 Cabinets and Countertops -Replace

- At the time of our site visit, the cabinets and countertops were still the same and functional. However, these items have reached an age where they are no longer aesthetically pleasing and are out of date.
- When replacement is scheduled, we suggest replacing the countertops with an upgraded product that has a longer life expectancy than Formica.
- The timing of replacement is at the BOD's discretion since this is considered a cosmetic issue.
- We suggest updating kitchens every 20 - 25 years to maintain an appropriate and modern appearance for the community.

\$600/box, \$45/GSF; Estimate to replace and install

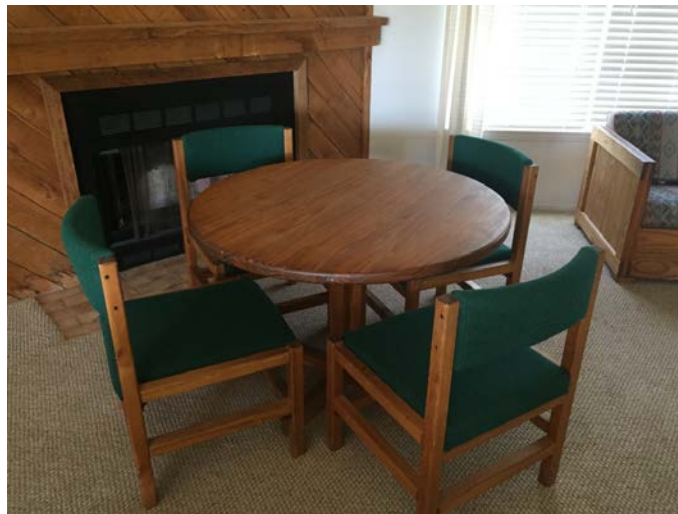
Comp #: 1415 Clubhouse - Remodel/Update

- In general, the lobby area of the clubhouse was dated, but functional. Overall, the area was in fair condition.
- General remodel of this area is suggested every 15 - 20 years in order to maintain current decorative trends and an appropriate appearance for the community.
- Remaining life is based on the current age and conditions of the lobby.

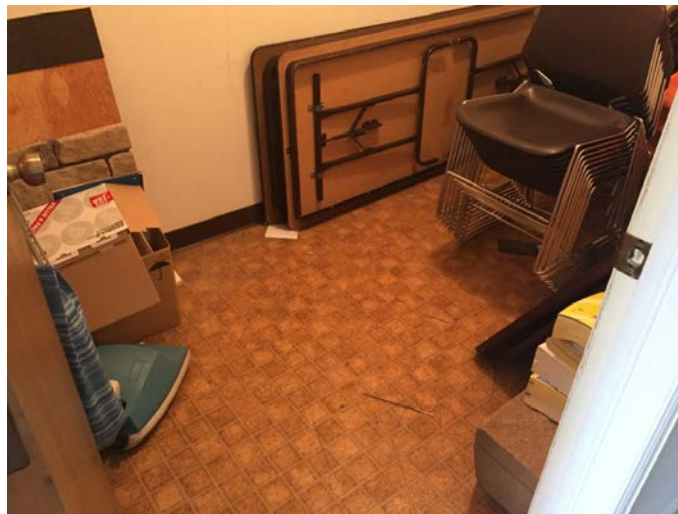
Comp #: 1417 Furniture - Replace

- This type of furniture is typically replaced on an as needed basis with general operating funds.
- Therefore, separate funding in the Reserve account is not necessary for this component.

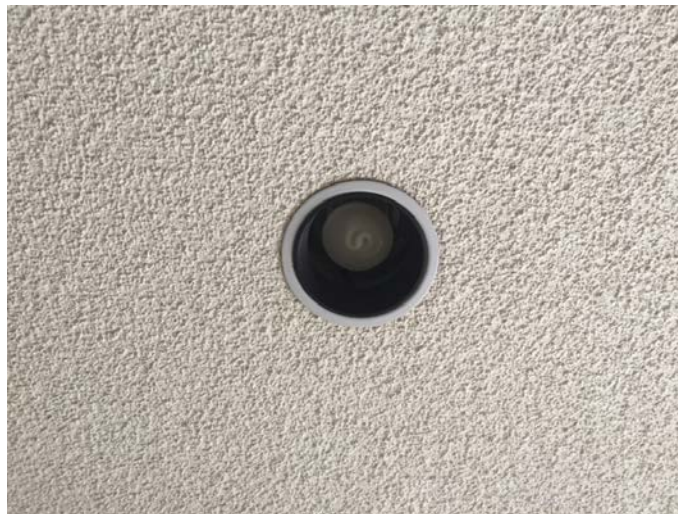
Comp #: 1601 Interior Lights - Replace

- There were no reported problems with the interior lighting at the time of our site visit. In general, the lights appeared to be in good working condition.
- Can lights and florescent lights are inexpensive to replace and should be replaced on an as needed basis with maintenance/operating funds.
- Reserve funds are not necessary at this time.

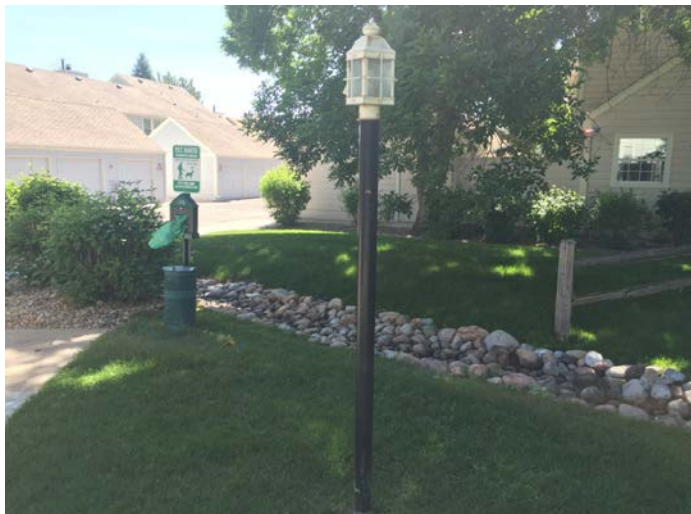
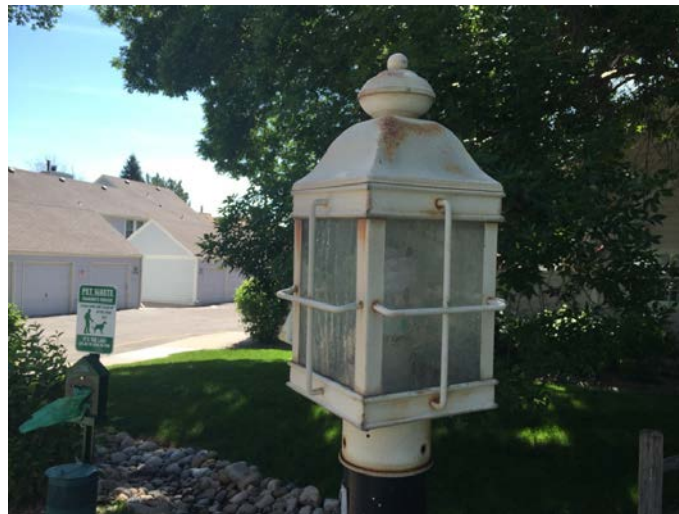
Comp #: 1604 Pole Lights - Replace

- There were no reported problems of the lights not working at the time of our site visit. However, we did note that several lights were damaged and one light was laying on the ground.
- Also, we noted minor rust and discoloration in areas.
- Remaining life is based on the current age and overall conditions.

\$750/light; Estimate to replace

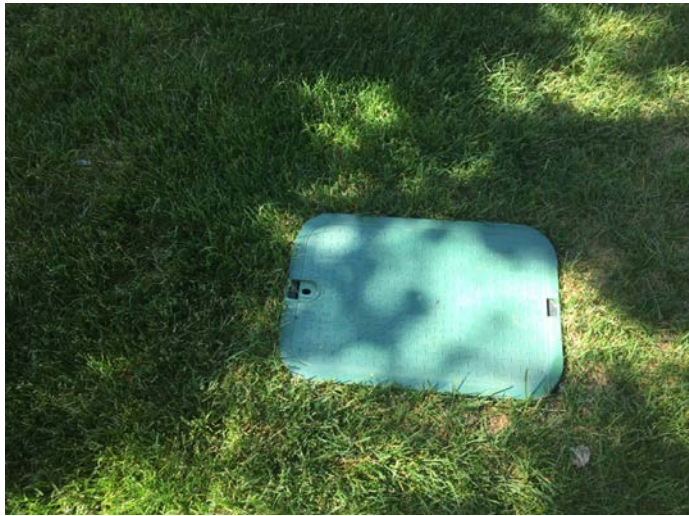
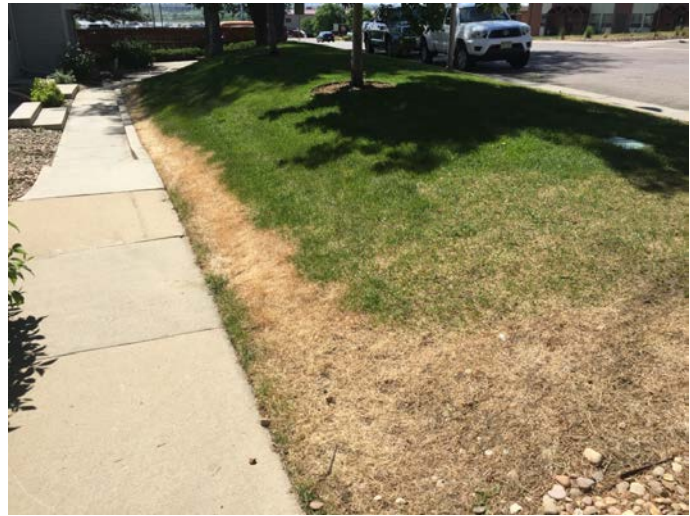
Comp #: 1701 Irrigation System - Rebuild

- There were no reported problems with the irrigation system at the time of our site visit.
- This line item is for repairs and replacement that lies outside the scope of routine maintenance: bulk sprinkler head replacement, bulk valve replacement, rerouting lateral lines, rewiring, etc.
- In order to ensure the funds are available for major repairs, we recommend reserving funds for these projects every 4 - 5 years.
- The funding on this line item is for major repairs and is not to be interpreted as complete irrigation system replacement.

Allowance for major repairs

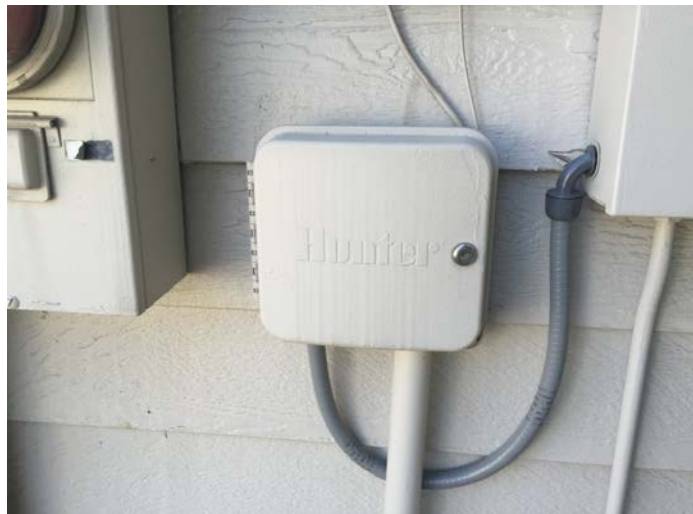
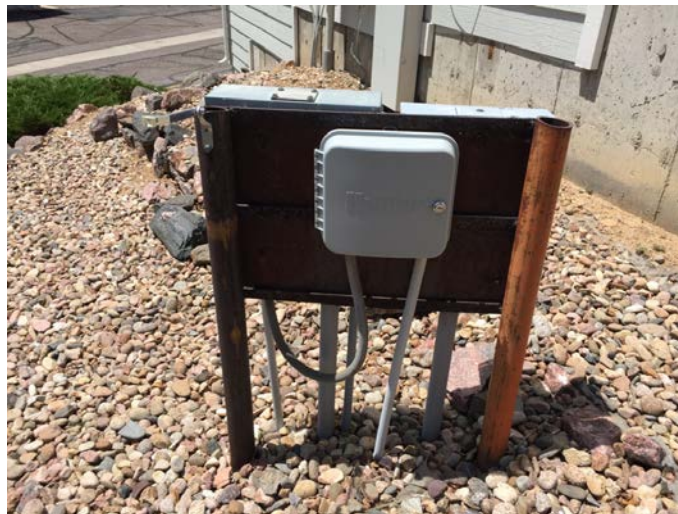
Comp #: 1703 Irrigation Controllers - Replace

- There were no reported problems with the irrigation time clocks at the time of our site visit. We could not locate installation dates, however, these clocks have been on the property for at least 8 years.
- Expect to replace irrigation controllers every 10 - 12 years if properly maintained and under normal conditions.
- Funding is for replacement with evapotranspiration based controllers as these are more efficient and can be controlled remotely by landscaping experts, saving the association irrigation water costs.

\$2,500/controller; Estimate to replace

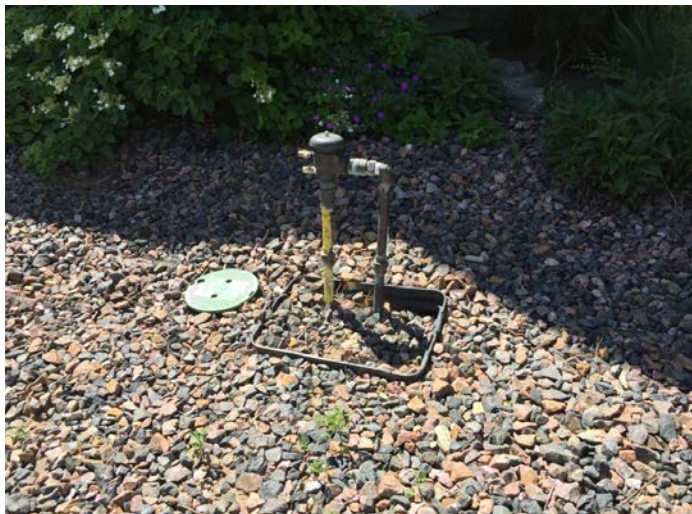
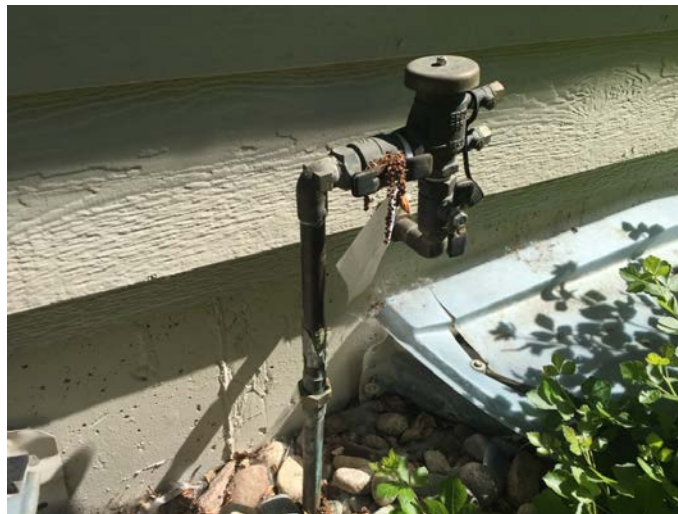
Comp #: 1706 Backflow Devices - Replace

- There were no unusual conditions and no major damages noted at the time of our site visit.
- Devices can be rebuilt and repaired when needed as a maintenance issue.
- It is very seldom that a complete system would need to be replaced due to normal wear and tear.
- Replacement would be as a result of freezing conditions if system is not winterized properly or in a timely manner.
- No Reserve funding is required due to difficulty of predicting a life expectancy and the fact that systems can be rebuilt an a minimal cost, as opposed to being replaced.

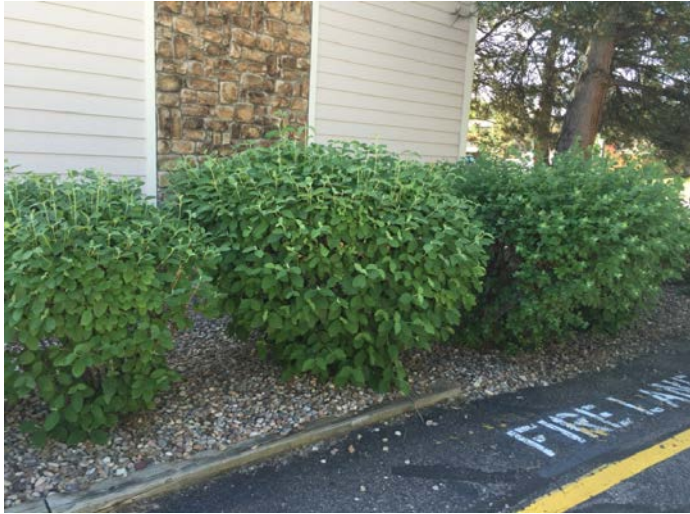
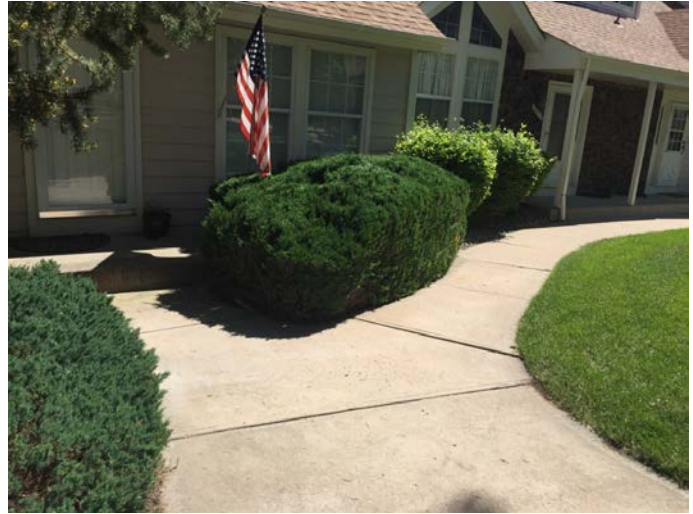
Comp #: 1801 Groundcover - Replenish

- This line item, similar to irrigation repairs, is for projects that lie outside the scope of routine maintenance.
- In order to preserve an attractive curb appeal and to maintain the health of the plants and shrubs, we recommend reserving for refurbishment projects every 4 - 5 years.
- This line item is for cyclical refurbishment and should not be considered as complete landscaping replacement.

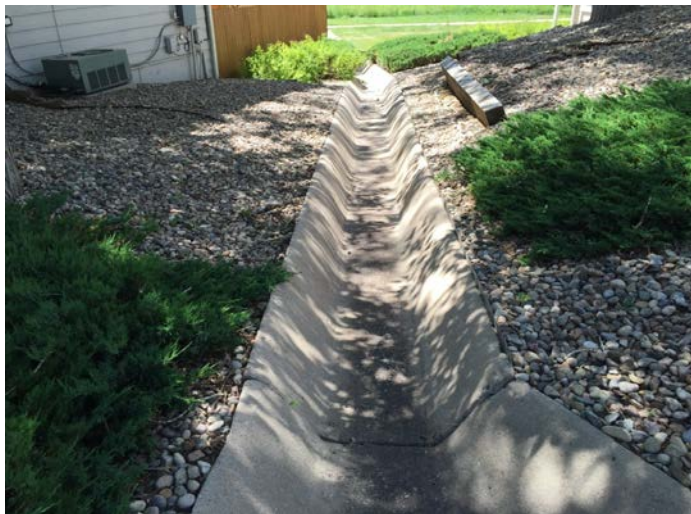
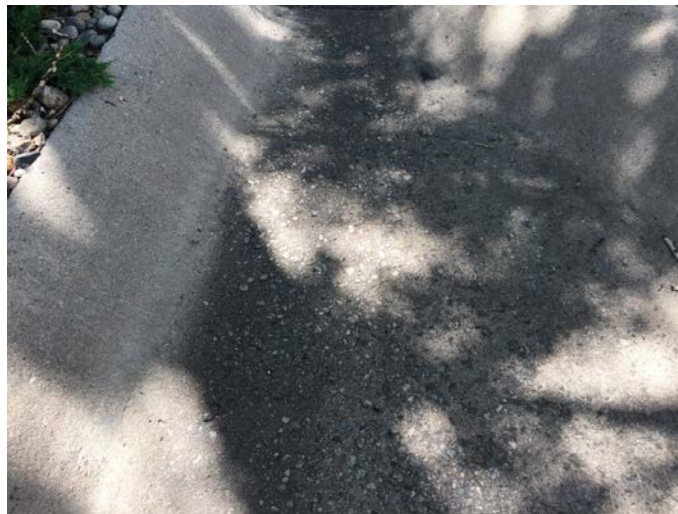
Comp #: 1811 Concrete Drain Swales - Repair

- At the time of our site visit, there were no major problems observed during our observations. We did not spalling and minor cracking.
- These areas are not subject to as much deterioration as the streets and driveways due to no heavy traffic.
- Due to small area, include with other concrete surfaces. Separate funding is not required for this component.

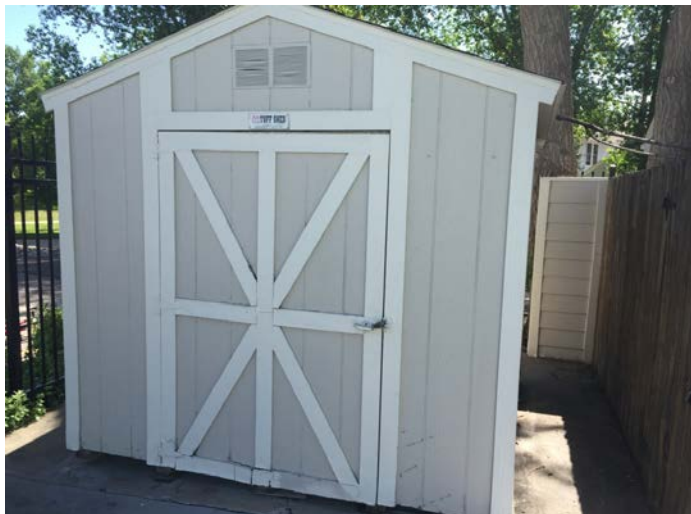
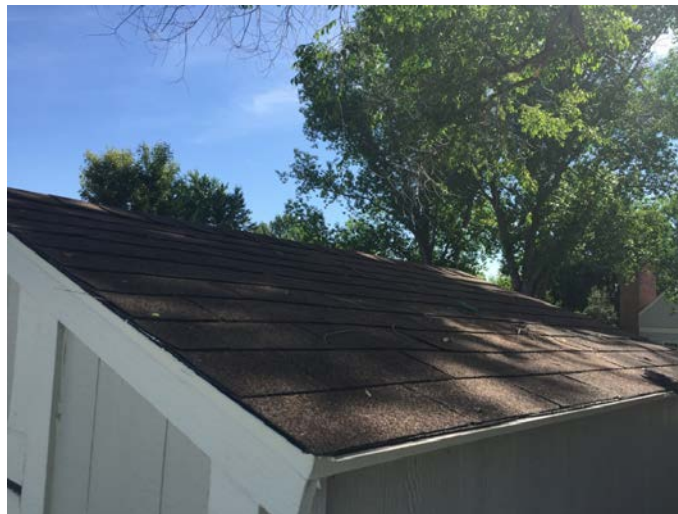
Comp #: 2020 Storage Shed - Replace

- There were no major problems with the storage shed at the time of our site visit. The shed is aging appropriately.
- Remaining life is based on the current age and conditions.

Allowance to replace
