## Homequest Home Inspections PROPERTY INSPECTED

El Paso, TX 79932

# PROPERTY INSPECTION REPORT

08/07/2019

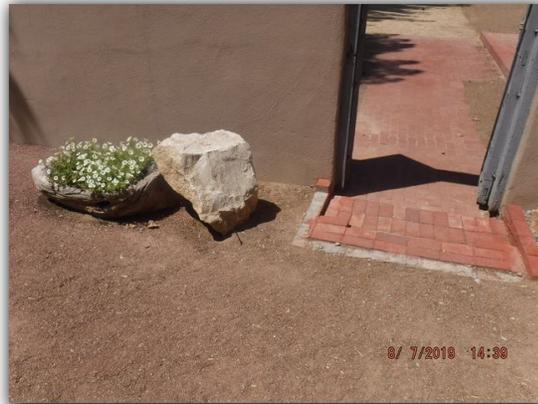
1. Grade slopes toward the structure at the front courtyard.

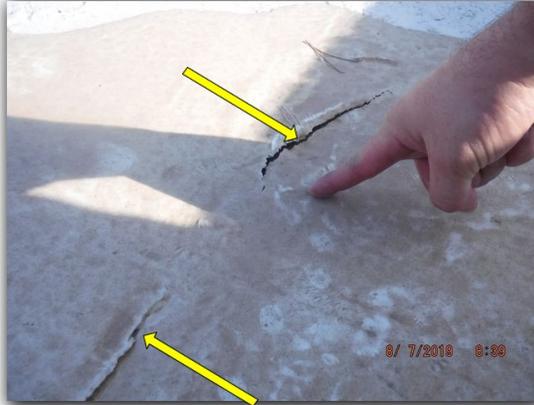
**UNDERLAYMENT DAMAGED**

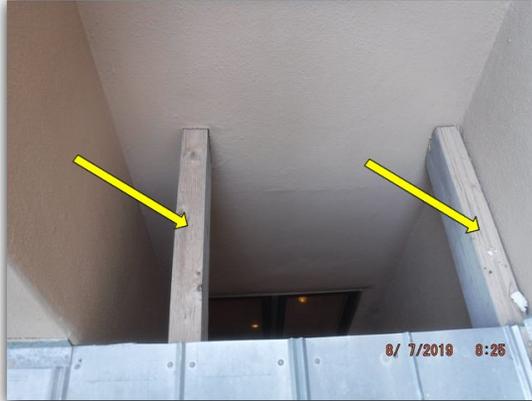
FLASHING CAPS RECOMMENDED

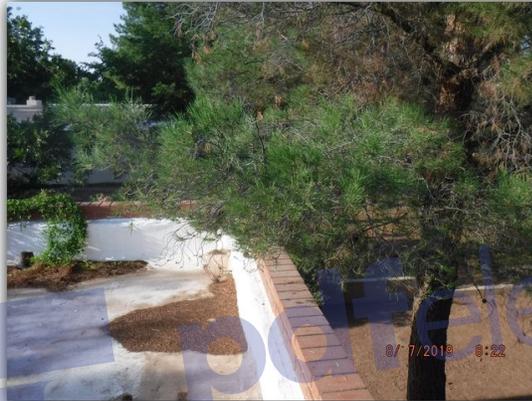
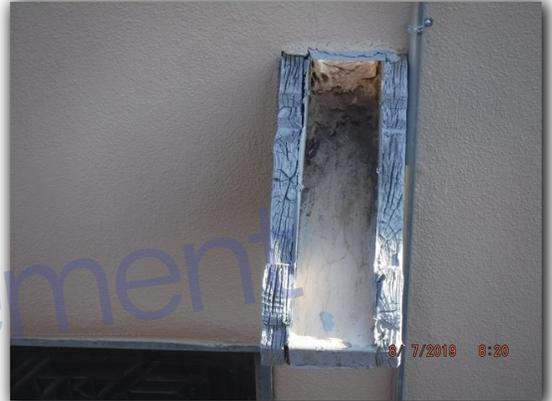
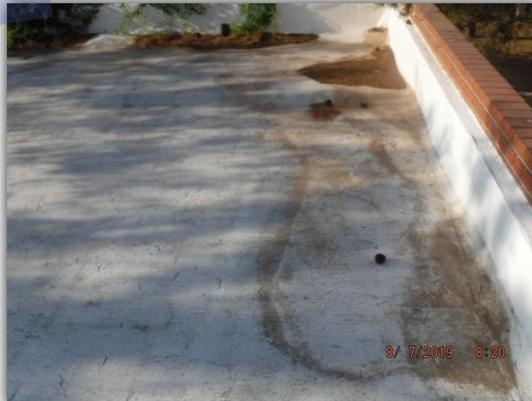
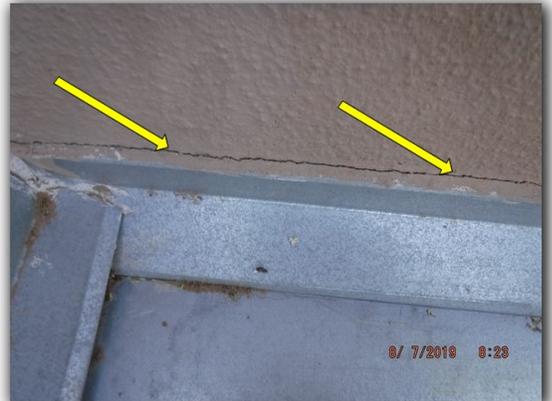
ALL WOOD SCUPPERS ARE DRY ROTTED

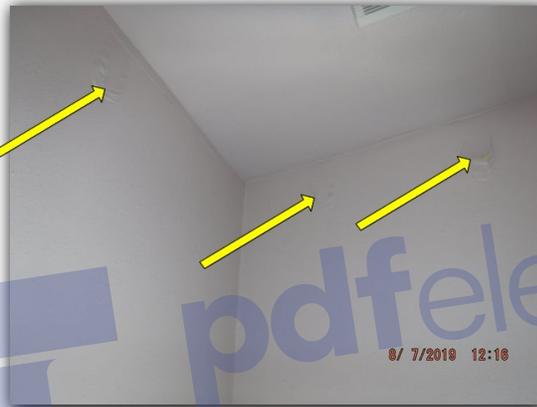
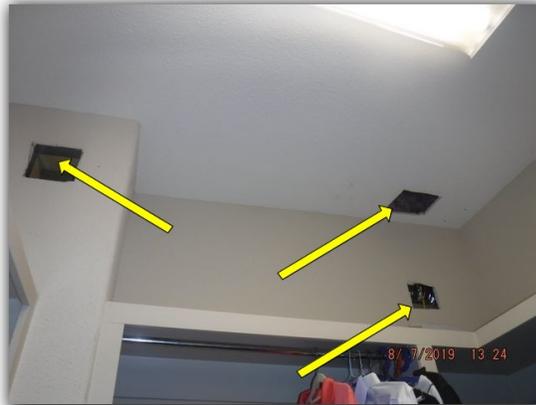
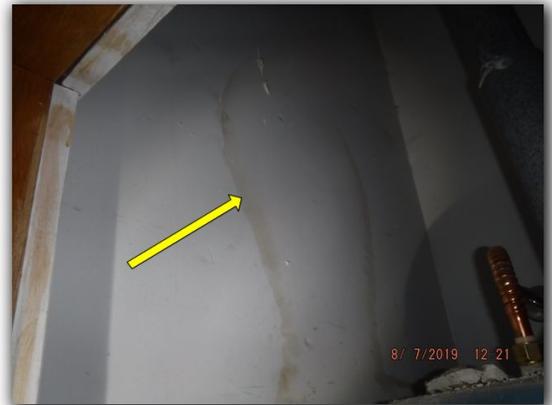
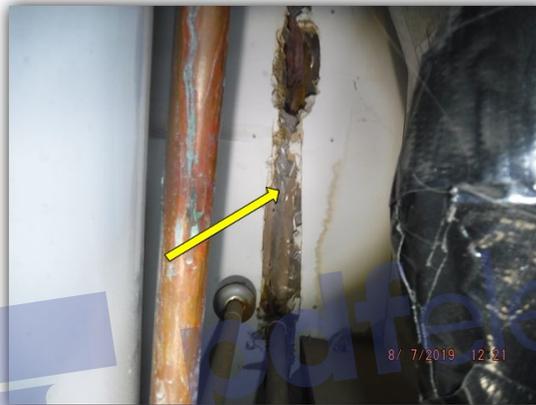
1. Bedroom 1: Evidence of prior moisture intrusion. Tested negative for moisture.
2. Bedroom 1 Upstairs : Evidence of prior moisture intrusion in the bathroom. Tested negative for moisture.
3. Bedroom 2 Upstairs : Drywall openings in the closet.
4. Main Hallway : Drywall is missing in the water heater/furnace closet and evidence of moisture intrusion on wall by the water heater.

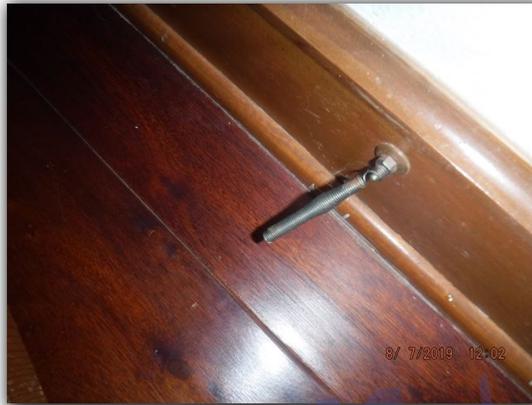
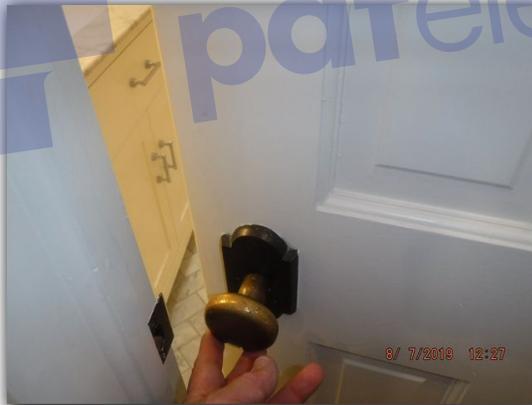
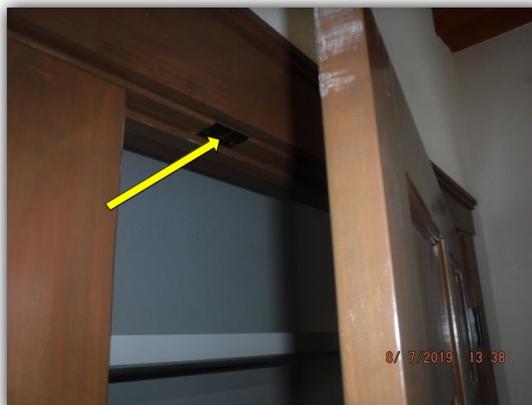
1. Bedroom 1 Upstairs : Does not latch.
2. Bedroom 2 : Door to bath does not latch and closet door mirror is cracked on lower left corner.
3. Some double closet latches are missing above the double door.
4. One or more door stops are missing or damaged and there is minor mechanical damage on some walls.
5. Bedroom 3 : Entry door drags on floor and does not open fully.
6. Main Hallway : Furnace closet door pull is missing.

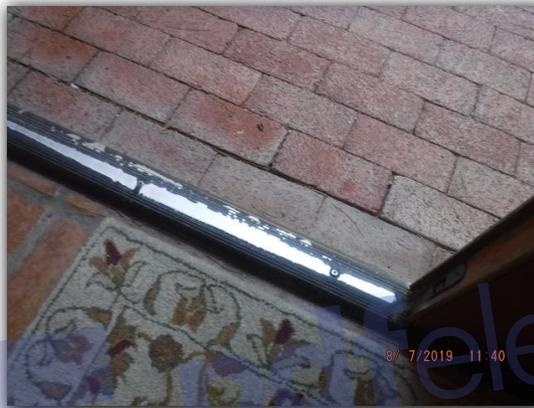
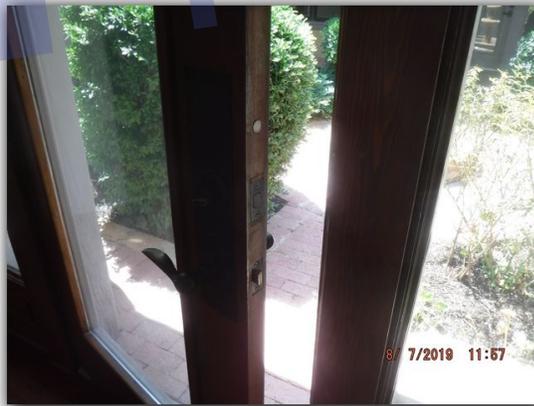
1. Front Entry : Unable to latch double door and main entry door rubs on threshold.
2. Central Courtyard : Several doors do not latch.
3. Kitchen : Door rubs on frame and is difficult to close.
4. Library : Difficult to lock.
5. Exterior doors and wood trim is weathered. Recommend re-paint.
6. Exterior doors to the upstairs verandas do not latch.
7. Laundry Room : Weather stripping is damaged.

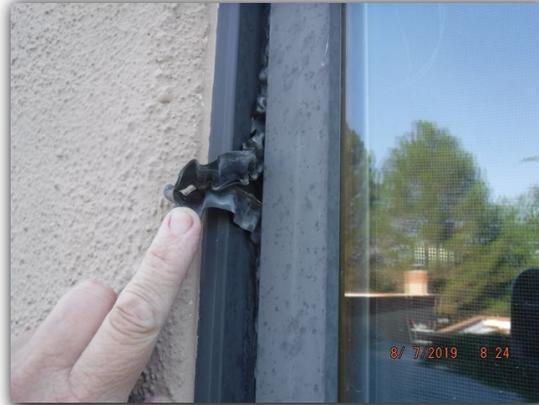
1. Several casement windows are missing crank handles and some windows are difficult to open, close and latch.

2. Some window crank handles are loose or damaged.
3. Bedroom 1 : Will not latch.
4. Bedroom 1 Upstairs : Evidence of moisture intrusion on the sill. Tested negative for moisture.
5. Bedroom 3 Bath : Window above exit door is cracked.
6. One or more screens are missing.
7. Game Room : Window seal is damaged and window does not latch.

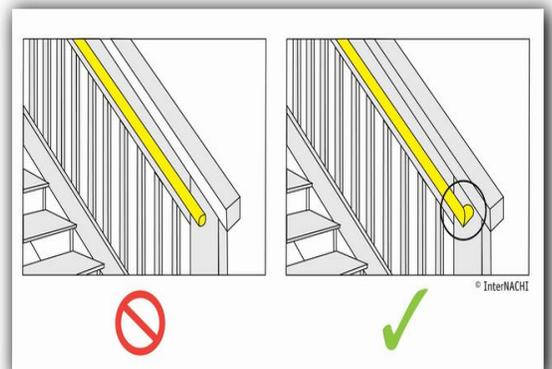
- Handrails were open on the ends; current building standards require turn backs on the ends. loose clothing can catch on the ends.

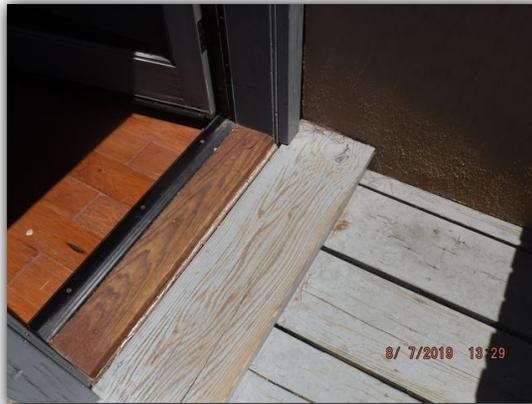
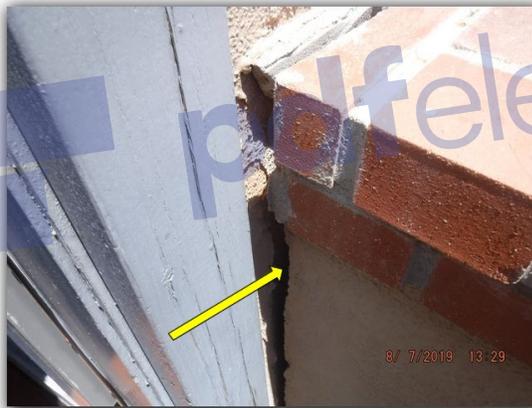
1. Hand railing is not terminated properly. Although home was constructed prior to this code revision, it must still be reported as a deficiency.
2. Wood is water damaged. Recommend sealing to prevent further damage.
3. Landing wall is separating from the main wall.

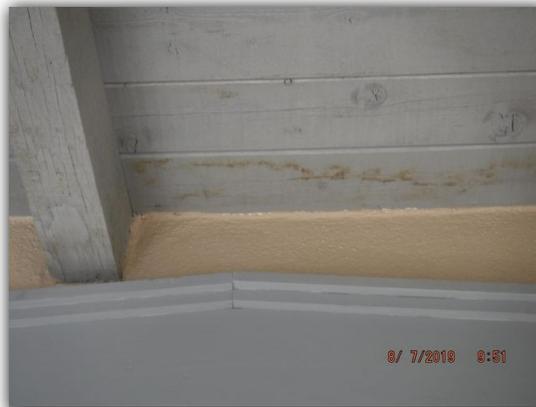
1. Some bricks are loose on the walkways around the home.
2. Uneven walking surface is creating a trip hazard in some areas.
3. Rear Patio : Evidence of moisture intrusion. Tested negative for moisture.
4. Front Entry : Bricks are separating.

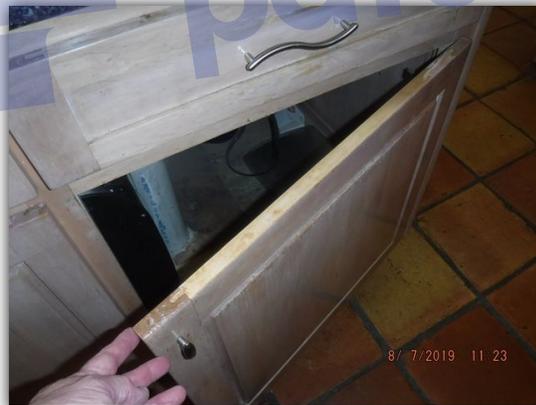
1. Kitchen And Bathrooms : Some cabinet door hinges are loose. Recommend tightening.
2. Cabinet under kitchen sink is water damaged. Tested negative for moisture.

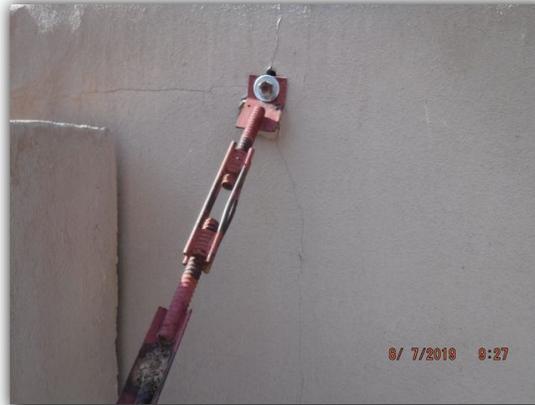
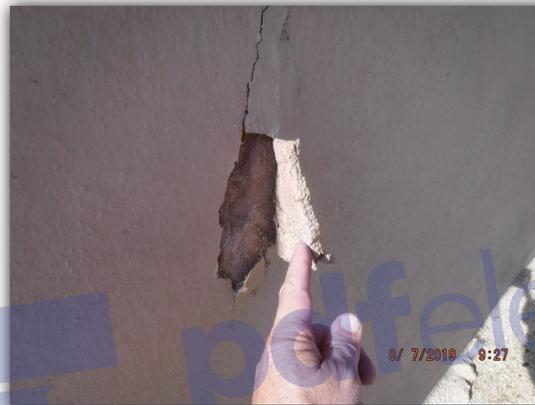
1. Wall by the pool equipment is leaning and bracing has been installed. Cracks are present in that area.
2. Right gate is damaged. Weld is broken on upper left corner.

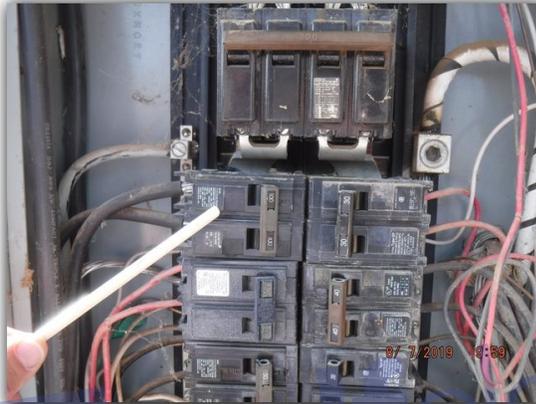
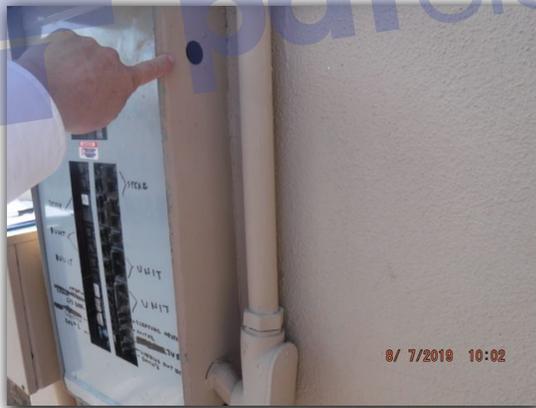
1. Service size for this home is not sufficient. Recommend upgrading service amperage. Further evaluation by a licensed electrician is recommended.
2. 200 amp main and one 100 amp circuit breaker (indicated) are hot to the touch. There is also a humming sound consistent with arcing. Confirmed temperature with IR imaging. Further evaluation by a licensed electrician is recommended.
3. Cover mounting screw is missing.
4. Blank offs are missing on right side of panel.
5. Some breakers are not labeled.

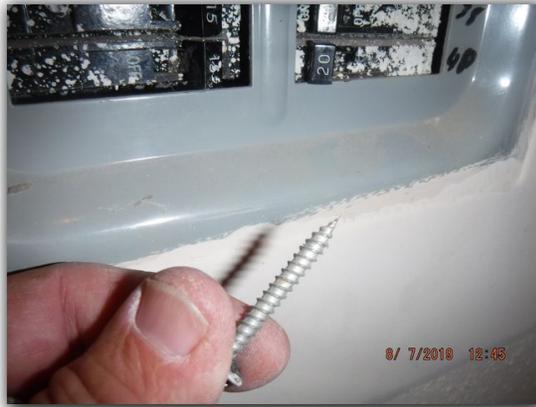
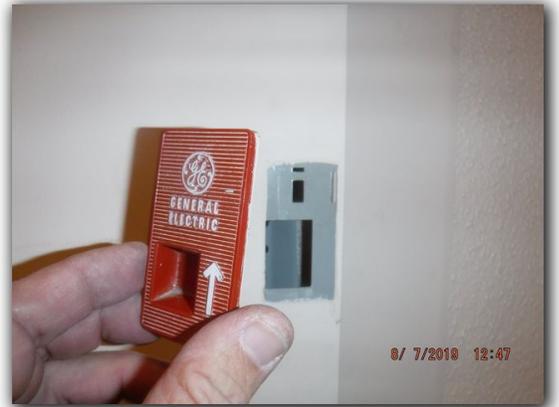
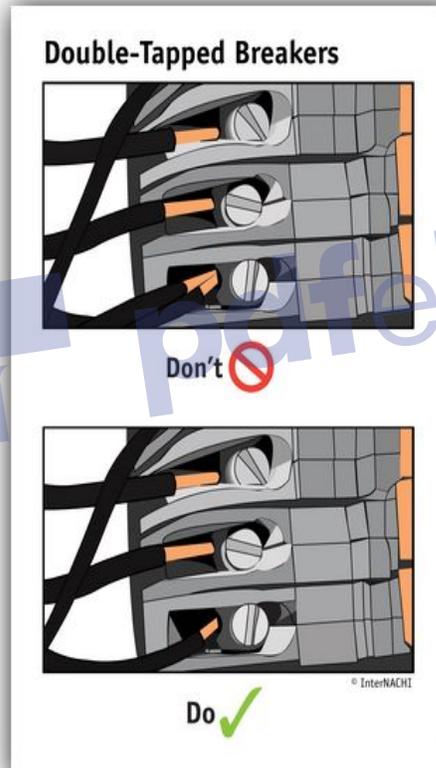
1. Some double tapped ground and neutral conductors inside both panels.
2. GE Panel : Pointed tipped screws are used. Recommend blunt tipped screws.
3. GE Panel : Latch is broken.

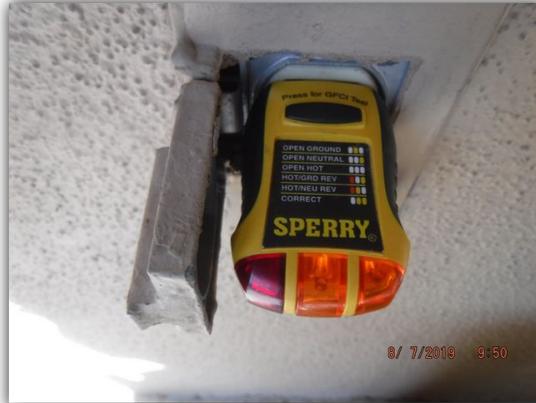
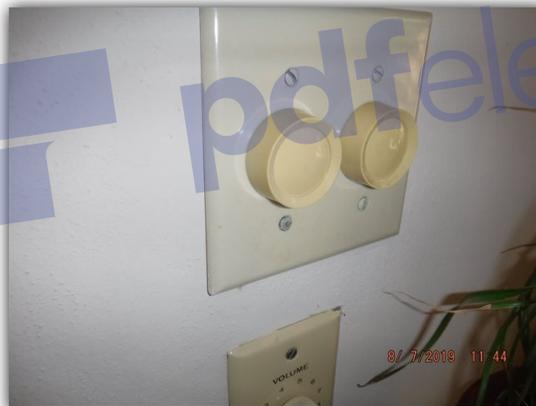
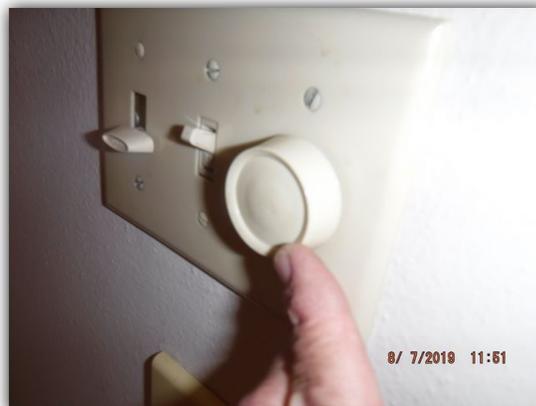
2. Exterior : No GFCI protection.
3. Laundry Room : GFCI is inoperable.
4. One or more outlets are loose.
5. Unable to determine what several switches operated.
6. Some light dimmer switches were inoperable.
7. There is an electrical line on roof above the kitchen that is enclosed in plastic sheathing. Must be enclosed in conduit.

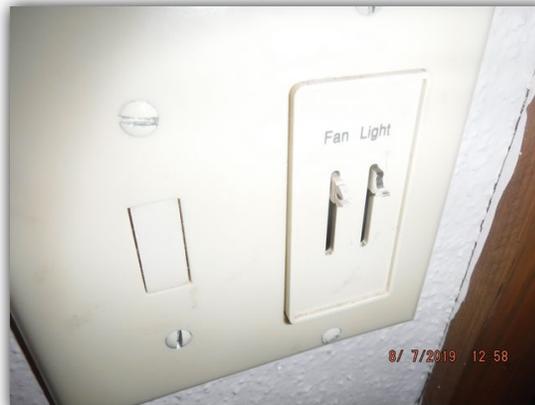
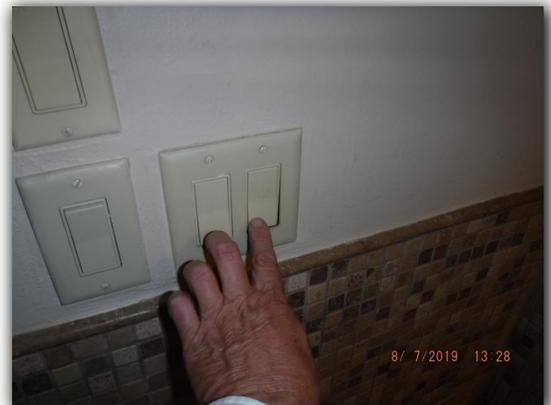
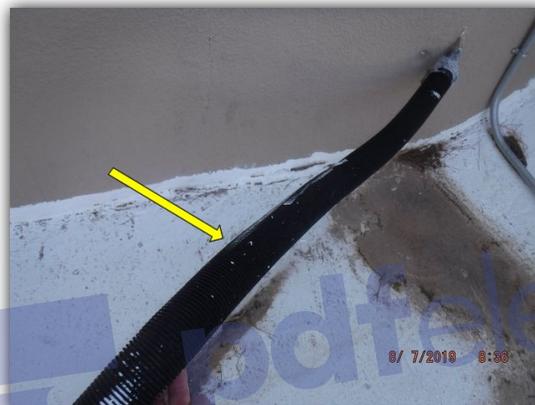
No GFCI/ARC Fault protection at one or more location. This is considered a recognized safety hazard.

Arc-Fault Protection (AFCI) : This home does not meet current arc-fault circuit-interrupter (AFCI) requirements. This is an "as-built" condition, but Per TREC standards of practice we are required to report this condition as a deficiency. Some items reported as Deficient may be considered upgrades to the property. For more information, refer to Texas Real Estate Consumer Notice Concerning Recognized Hazards, form OP-1.

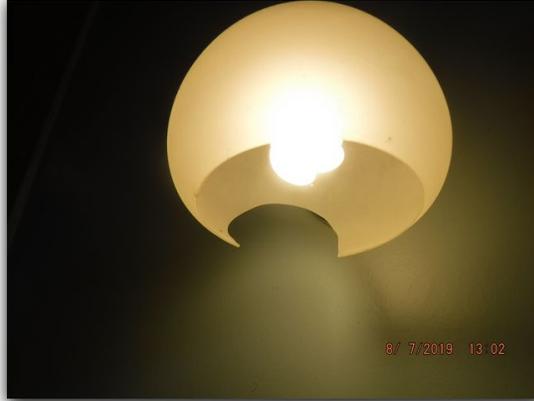
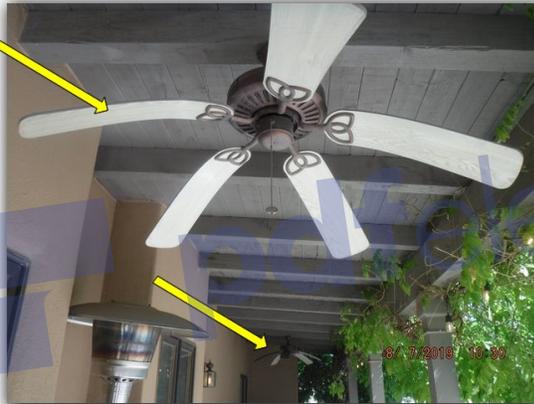
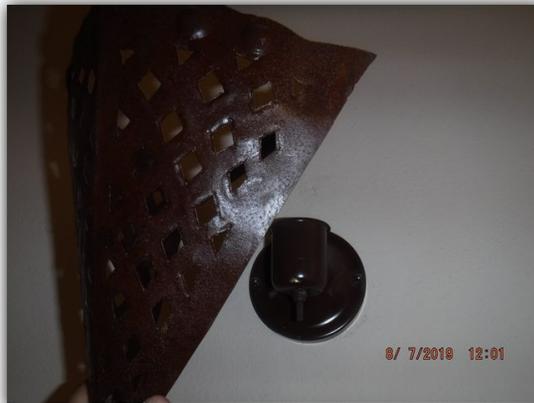
1. One or more recessed lights are not secured to ceiling.
2. Bedroom 3 Bath : Lens cover is broken.
3. Master Bedroom Hallway : Lense cover is missing mounting screw.
4. Rear Patio : Ceiling Fan paddles are warped.

- 5. Exterior : All lighting fixtures are loose. Recommend tightening and caulking around all exterior lighting fixtures.

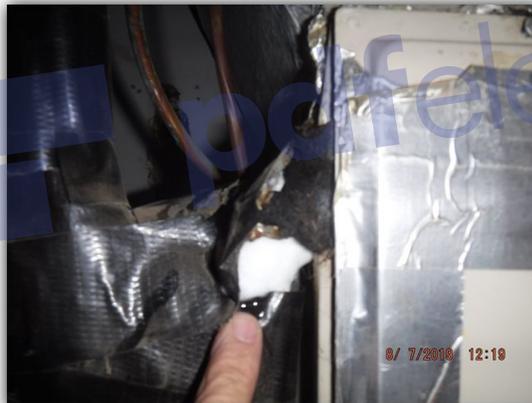
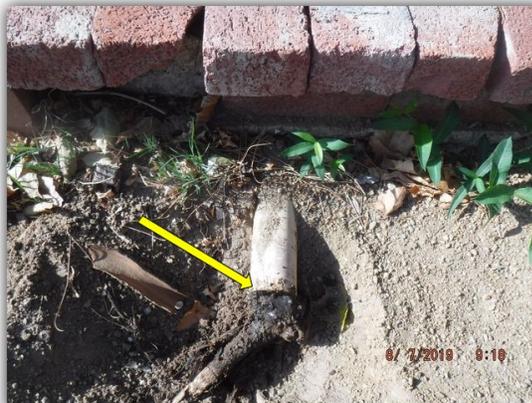
1. Main Hallway : Ice build up on refrigerant line. Recommend servicing.
2. Recommend installation of a Safe-T-Switch on the main condensate line of both split units to prevent condensate spill-over from the evaporator tray in event of blockage.
3. There is a condensate line at left side of home that is blocked by debris.

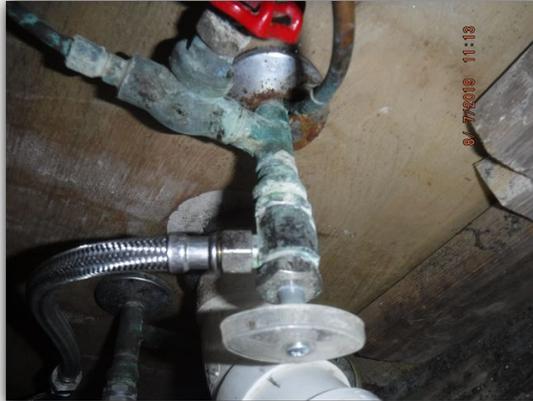
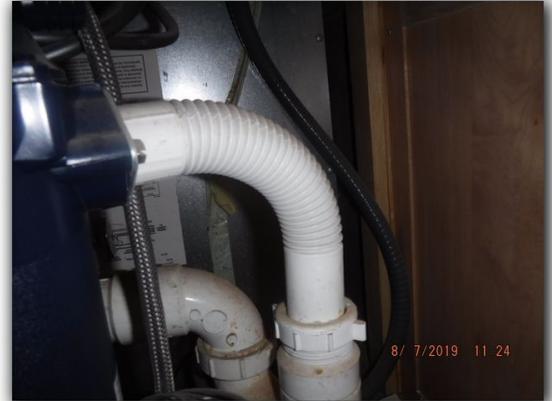
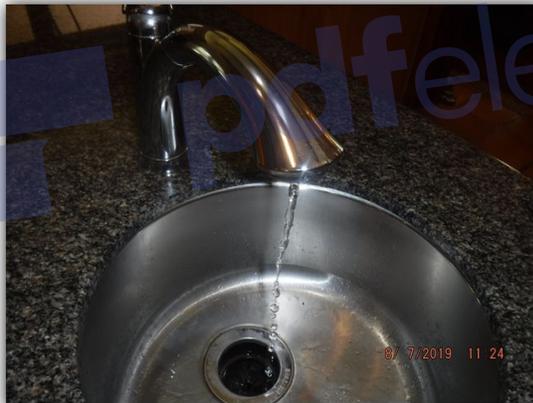
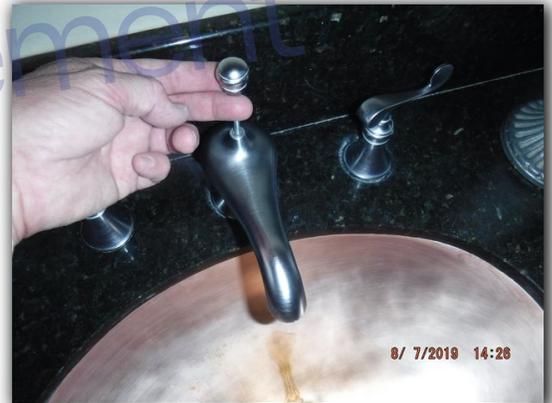
- 3. Formal Dining Room : Active leak under the wet bar sink.
- 4. Bedroom 2 and 3 Upstairs : Sink stopper is inoperable.
- 5. 1/2 Bath : Stopper linkage is disconnected.
- 6. Formal Dining Room : The wet bar drain line and trap under the sink is an incorrect corrugated plastic type that should be replaced with a smooth bore drain pipe to help prevent blockage.
- 7. Kitchen Island : Low cold and hot water output.

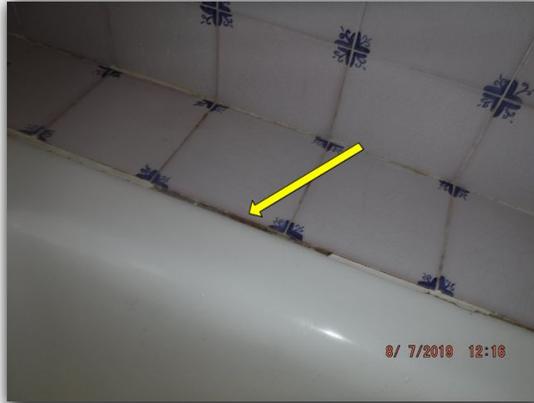
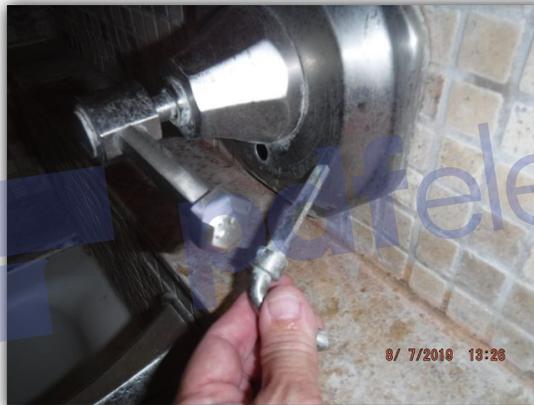
- 1. Recommend sealing around all tub and shower enclosures.
- 2. Bedroom 2 Upstairs : Tub diverter is inoperable. and stopper is missing.

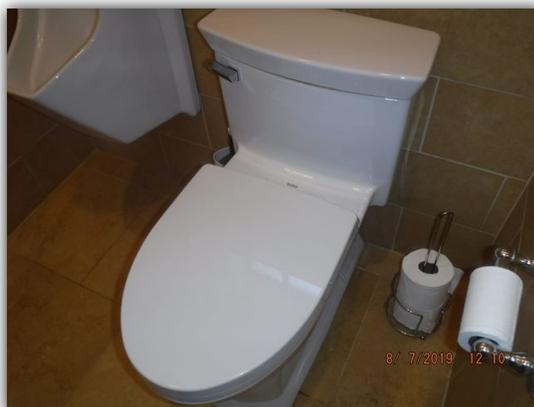
- 1. Master Bathroom : Commode is loose at the floor mount. Recommend re-seating with a new wax ring.
- 2. Corrosion or rust is present on shut off valves and/or fixtures.

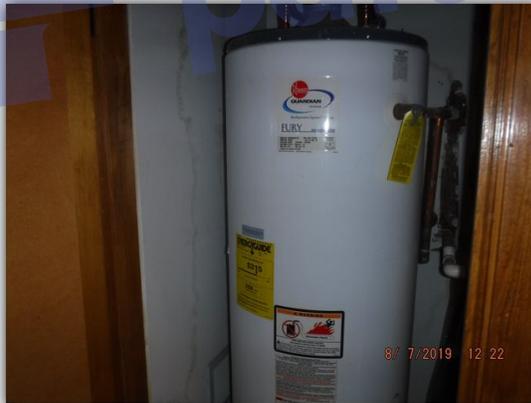
1. Main Hallway : Flue is incorrectly connected. CO risk.
2. Both Units : Pan is lacking a drain system. Recommend installing a moisture alarm available at Lowes or Home Depot.
3. Corrosion on plumbing fixtures.

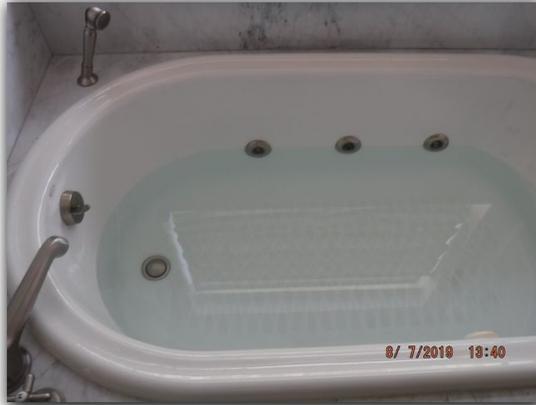
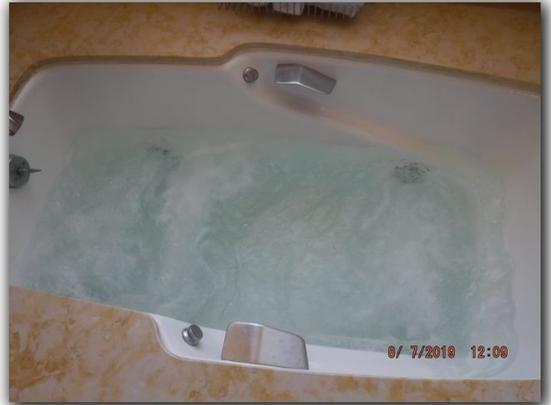
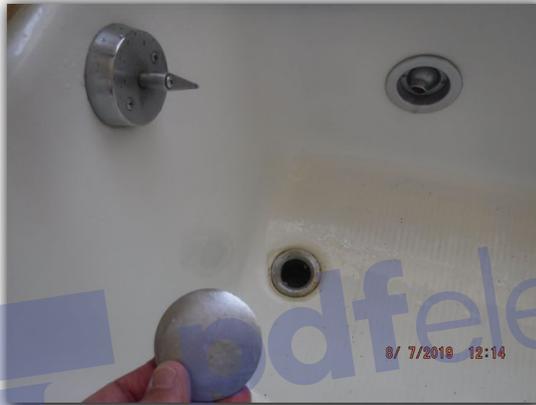
MASTER BATHROOM

1. Master Bathroom : Tub stopper is damaged.
2. Bedroom 1 Upstairs : Whirlpool tub did not turn on.

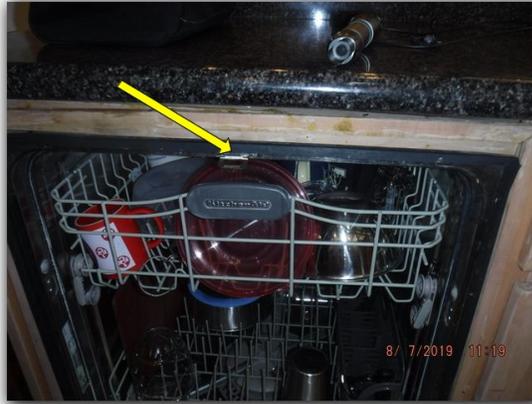
1. Unit is not properly secured to cabinet.

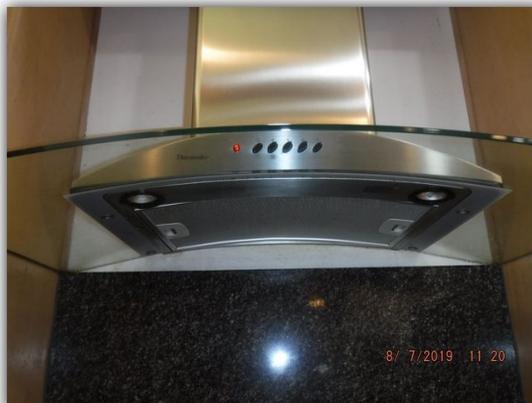
1. Light / lens not functional.

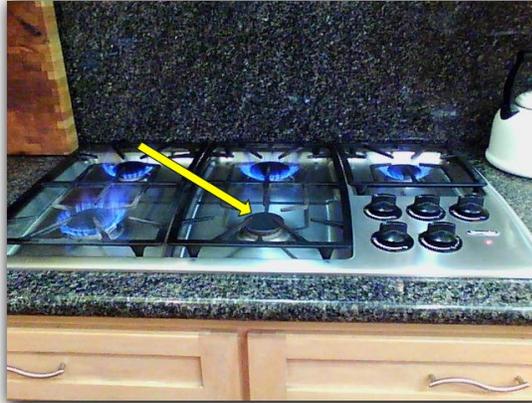
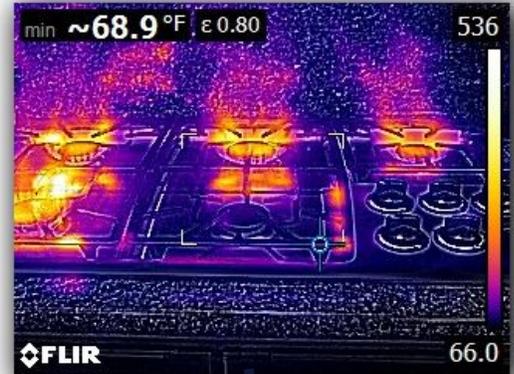
1. Right front burner did not ignite.

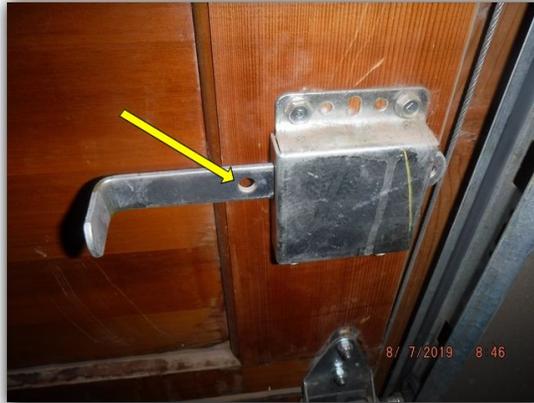
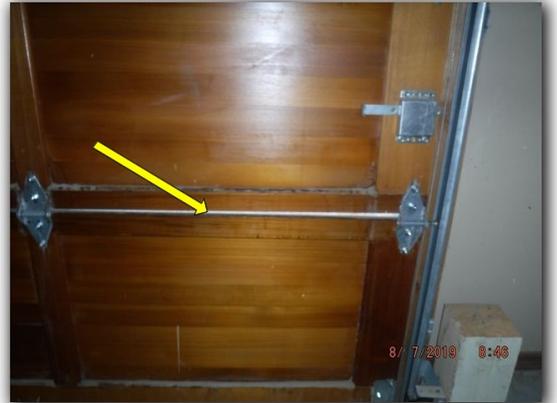
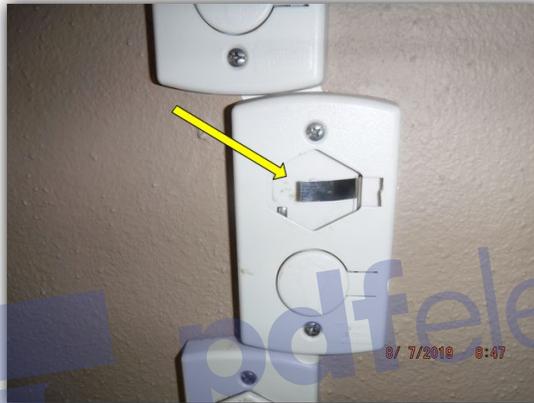
1. Door locks or side ropes have not been removed or disabled. Recommend removing or disabling to prevent door and opener damage.
2. Left Door : Gap in one section possibly from prior repair.
3. Center opener control switch cover is damaged.

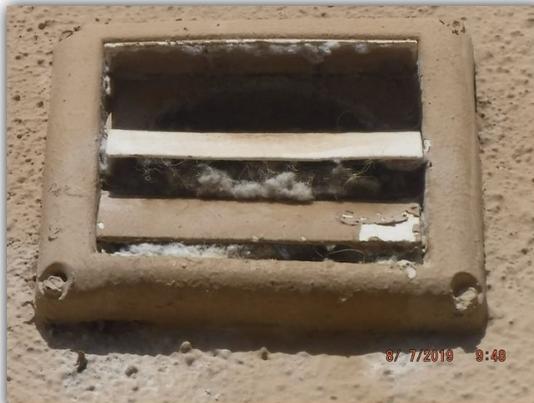
1. Dryer vent cover is damaged and vent is dirty.

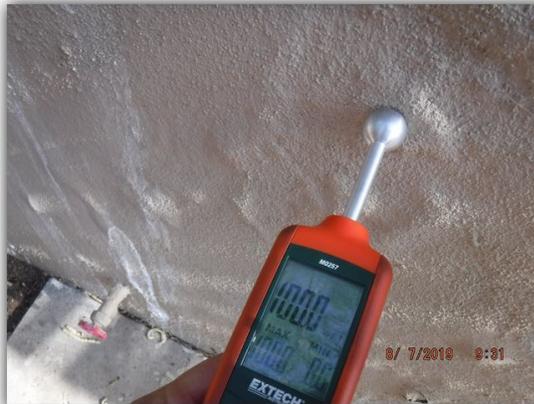
**Courtyard Fountain Deficiencies**

1. Active leak behind wall. Tested positive for moisture.

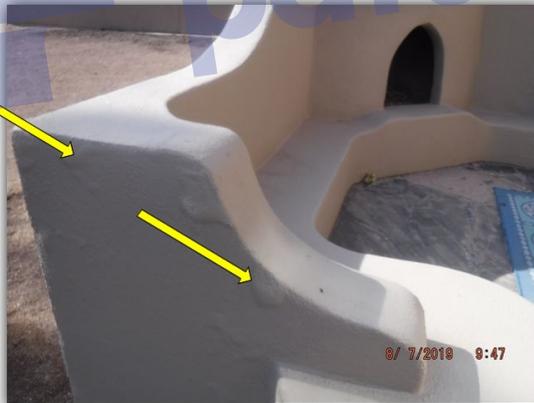
**Kiva Seating Area Deficiencies**

1. Evidence of moisture intrusion on structure. Tested negative for moisture.

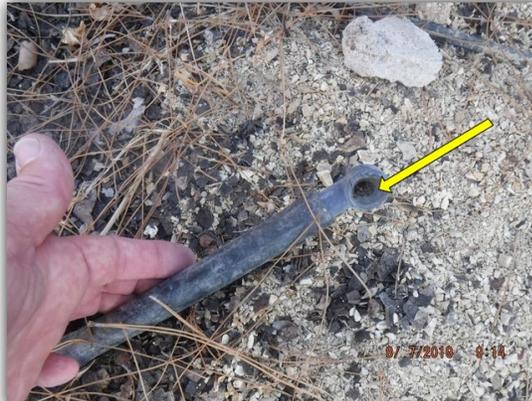
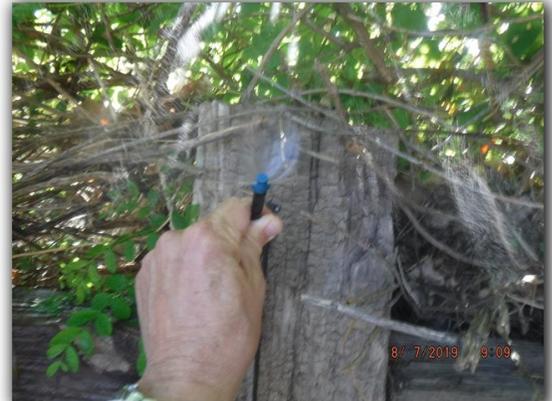
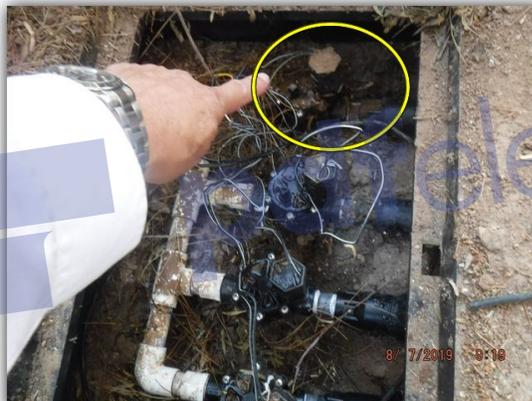
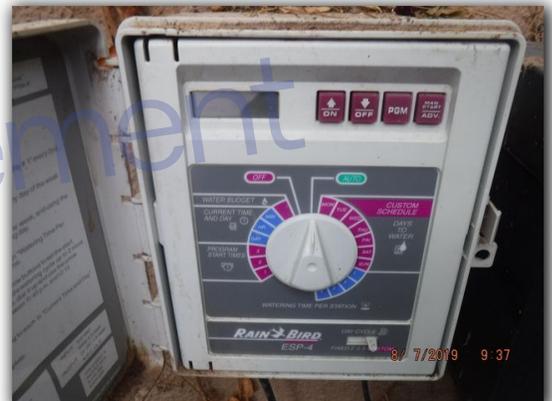
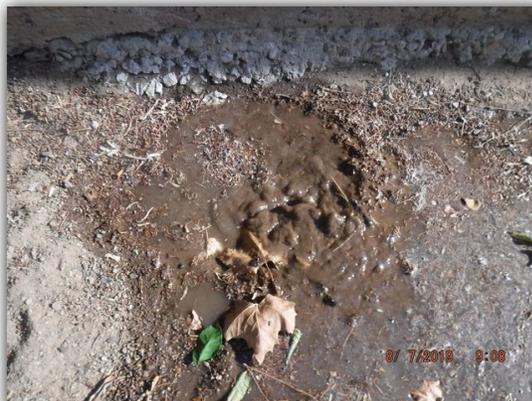
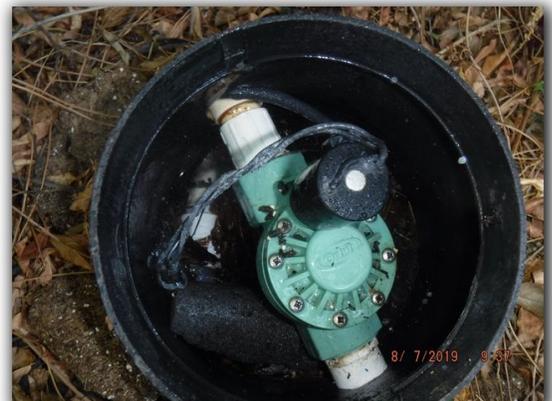
1. Surface water leaks: Left rear.
2. Sprinkler supply lines at the front are not insulated and subject to freeze damage.

- 3. The lack of a rain or freeze sensor.
- 4. There is a supply line break by the pool area. Did not observe any sprinkler or drip output.
- 5. Did not observe output from one valve.
- 6. It is unknown which zone one valve at the rear of home operates.

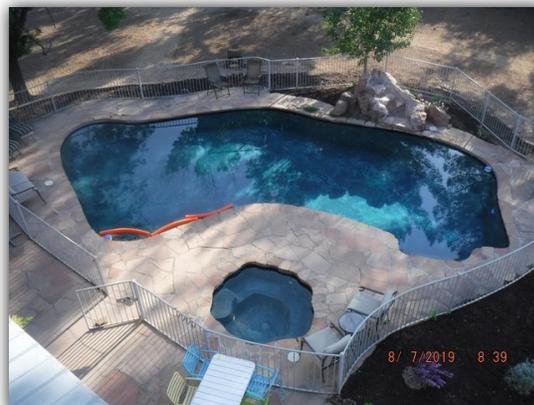
1. Decking around pool is cracked and flagstone is loose in various areas creating a trip hazard.
2. Pool surface is stained, making inspection difficult.
3. Skimmer weir(s) is missing.
4. Low flow into skimmers. Recommend cleaning DE grids to lower pump output pressure and improve flow.
5. Pump switch cover is loose.
6. Pressure gauge is weathered. Recommend replacement.

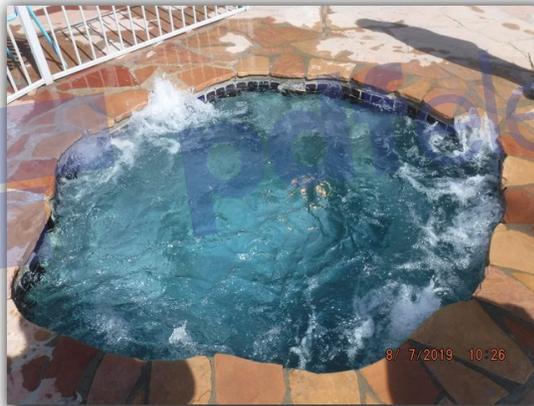
**Spa Deficiencies**

- 1. Excessive air after several minutes. Jets are not operating properly. Recommend further evaluation.
