Homequest Home Inspections PROPERTY INSPECTED

El Paso, TX 79902

D.O.M : 1955
SQ FT : 6,513
6 Bd 5 Ba

Inspector
Christopher Juarez
915-588-9399
www.homequesthomeinspections.com

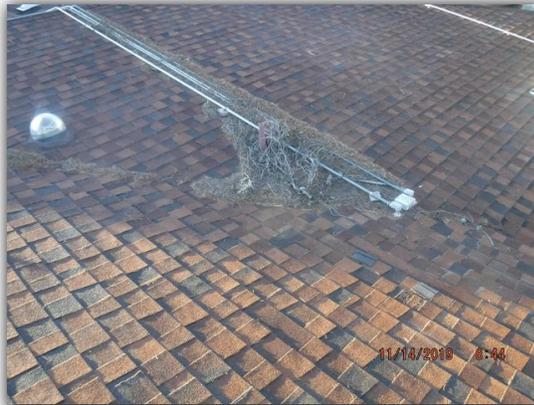
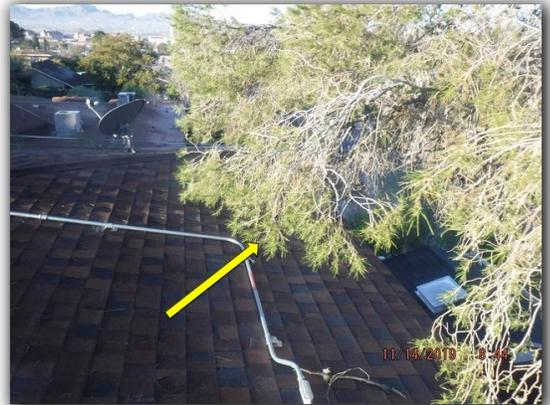
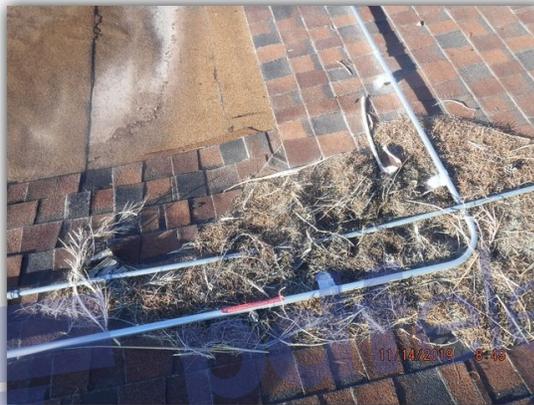
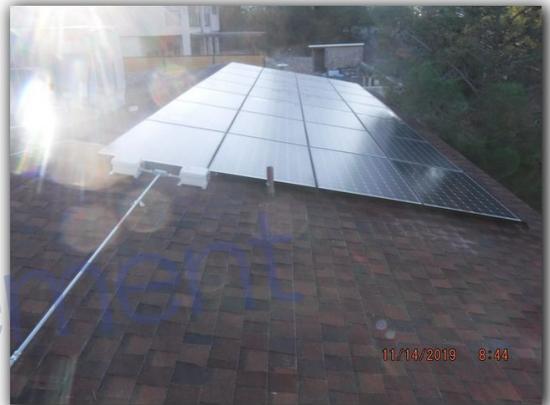
**Composition Roof
Deficiencies**

1. Granular loss throughout the shingle surface.
2. Debris in various areas. Recommend removal to prolong integrity of surface.
3. Tree branches overhang. Recommend trimming away from the roof.

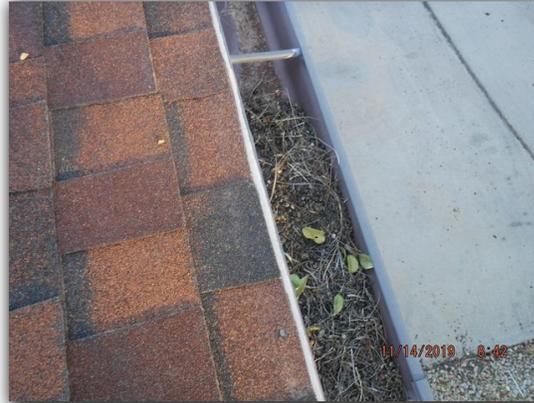
- Gutters / Downspout's at the front of home are dirty, or draining too close to foundation or roof system at the front.

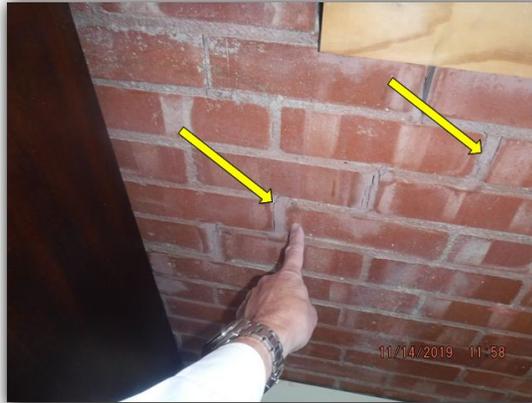
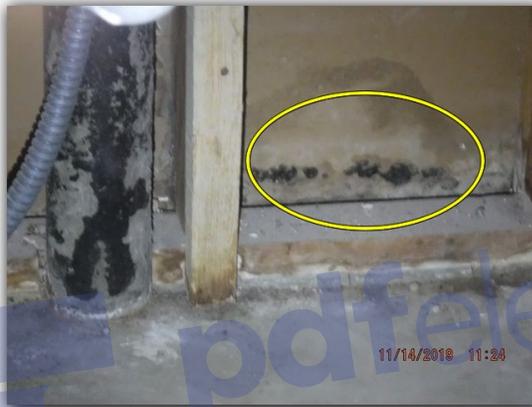
Interior Walls: Deficiencies

1. Dining Room : Settlement crack.
2. Master Bedroom : Step cracks on brick wall. Recommend monitoring.
3. Play Room : Crack below window.
4. Basement Utility Room : Evidence of prior moisture intrusion. Tested negative for moisture.
5. Front Furnace Room : Settlement crack.
6. There is a black substance below the stairwell, indicating prior moisture intrusion. Tested negative for moisture.

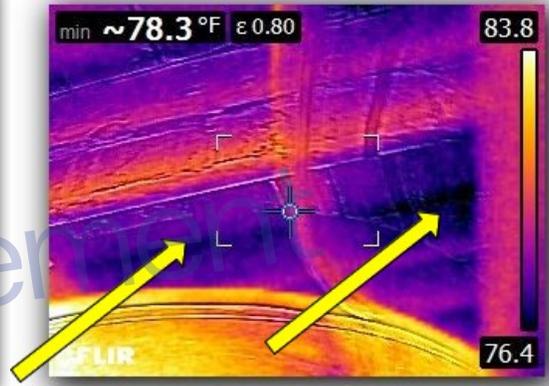
Deficiencies

1. Basement Utility Room : Joists are water damaged. There is evidence of active moisture in that area. Guest bathroom is located above.
2. Front Foyer Closet : Ceiling crack.
3. Front HVAC Closet : Drywall by the furnace plenum is damaged and missing in some areas.

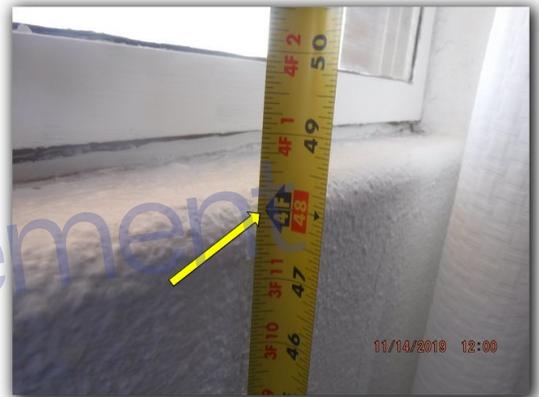
Deficiencies

1. Some windows are difficult to open, close or latch.
2. **Basement Conversion : Some windows do not open and all burglar bars are missing internal releases. Safety and egress concern.**
3. The wood trim on some windows are water damaged on the exterior.
4. Rear Corner Bedroom : Windows do not open.
5. All windows are missing screens.
6. Maids Bedroom : Windows do not open.
7. Window sill height exceeds 44" egress in the sleeping areas.

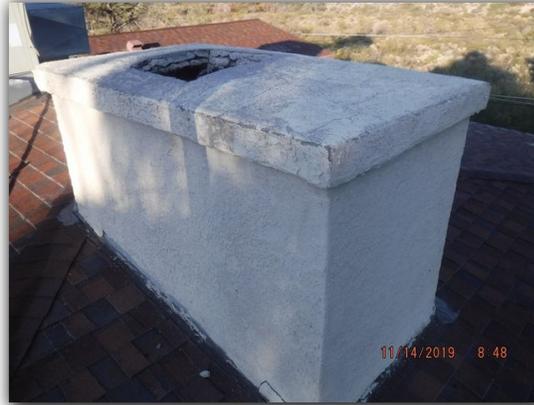
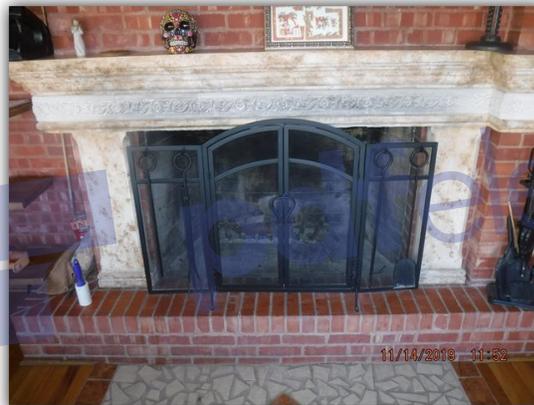
1. Creosote build up in firebox or flue.
2. Chimney crown is cracked and spark arrestor / chimney cap are missing.

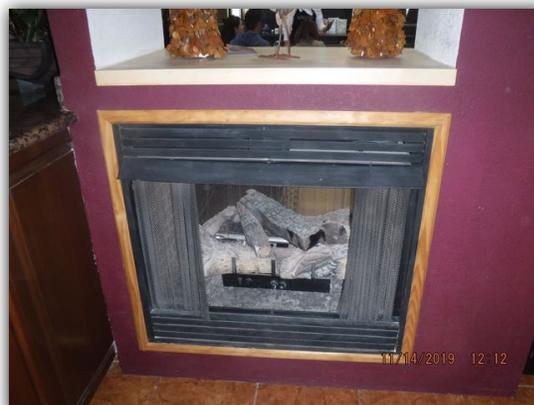
**Great Room
Deficiencies**

1. Unable to ignite after several attempts.

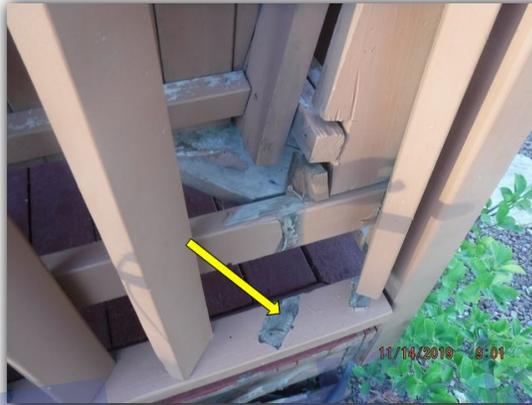
1. One balauster is missing at the front corner of the deck.
2. Gate is difficult to close. It is mis-aligned.
3. There is evidence of minor moisture intrusion on the deck joists. No evidence of rot observed.
4. The lattice around the deck is damaged in some areas.

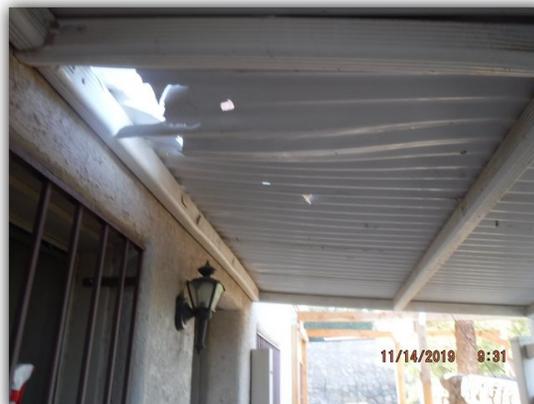
**Rear Patio
Deficiencies**

1. The PVC covering is worn and damaged. in some areas.

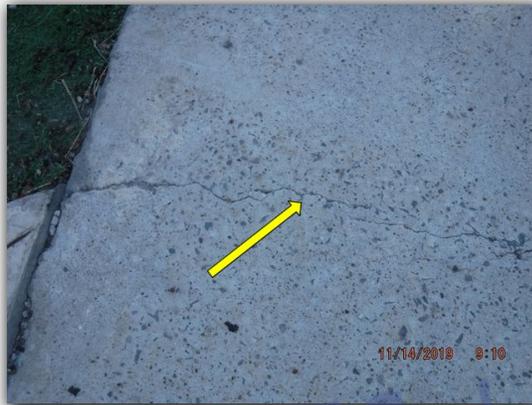
1. Minor cracking. Recommend seal and monitor.

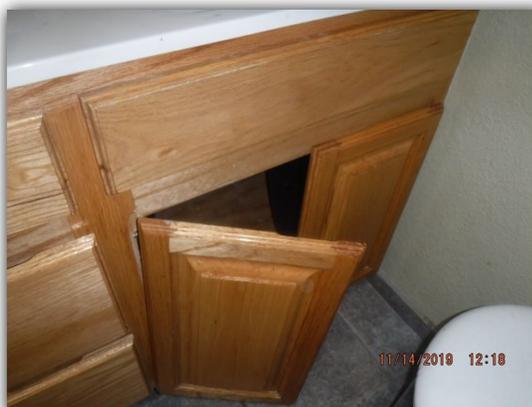
1. Guest Bath : Cabinet hinge is damaged.
2. Kitchen : Some hinges are loose.

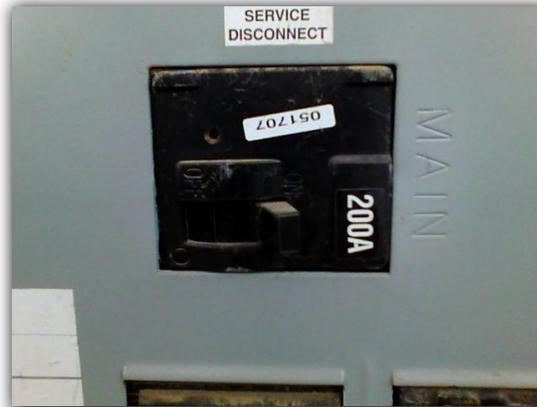
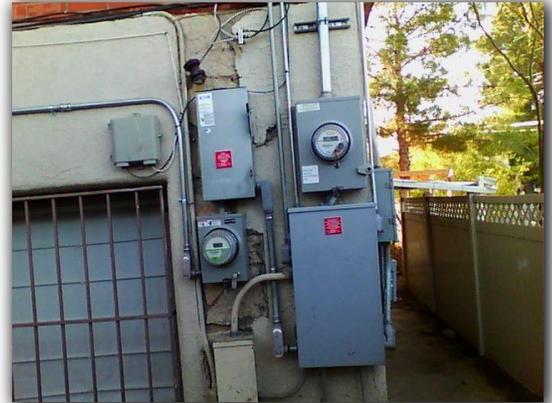
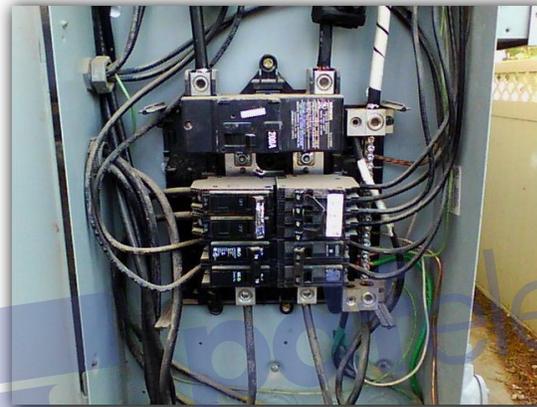
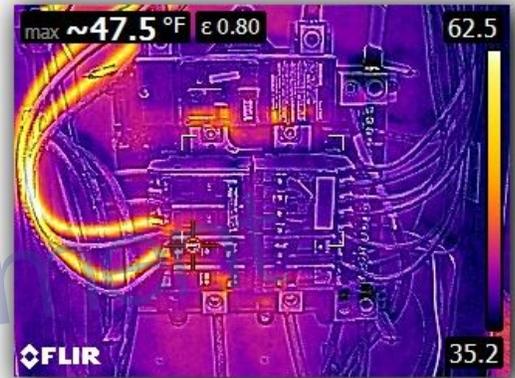
- 1. Service size for this home is not sufficient. Recommend upgrading service amperage. Further evaluation by a licensed electrician is recommended.

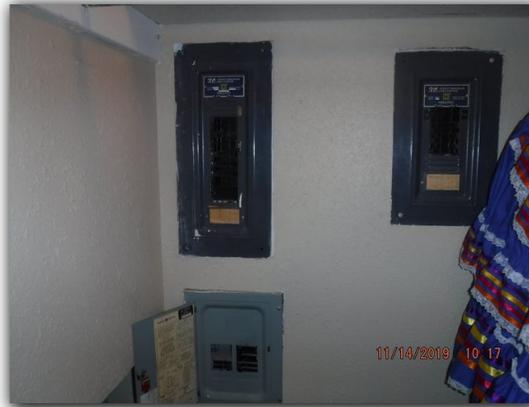
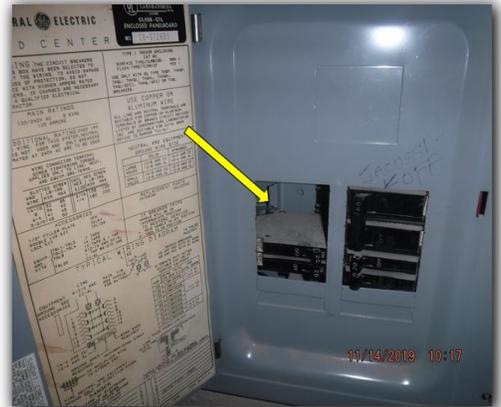
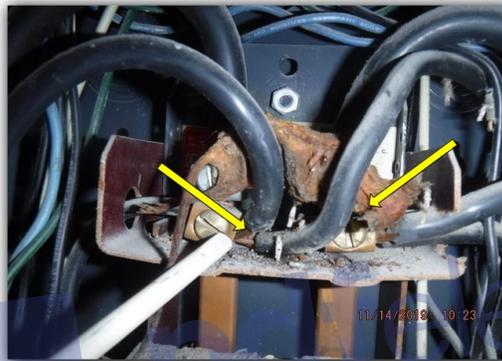
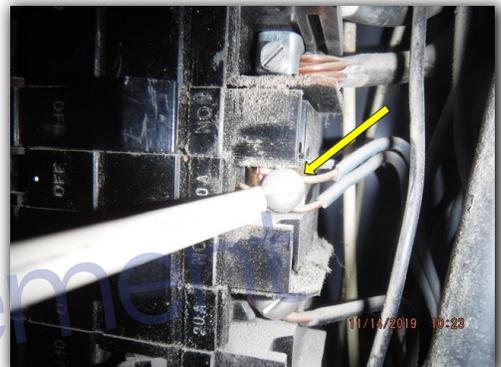
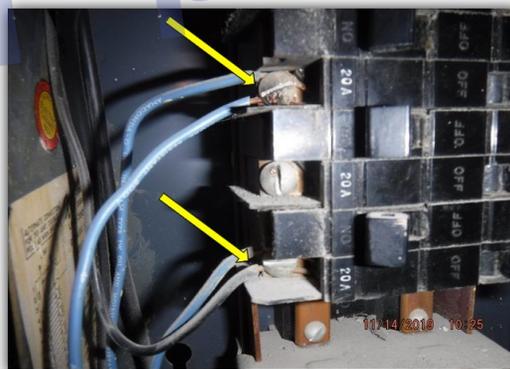
Sub Panels

1. Some dead front mounting screws are missing on all panels.
2. Double tapped service, breaker and neutral conductors. Recommend further evaluation by a licensed electrician.
3. Panels are not labeled.
4. The GE panel is missing knockouts, exposing the interior.

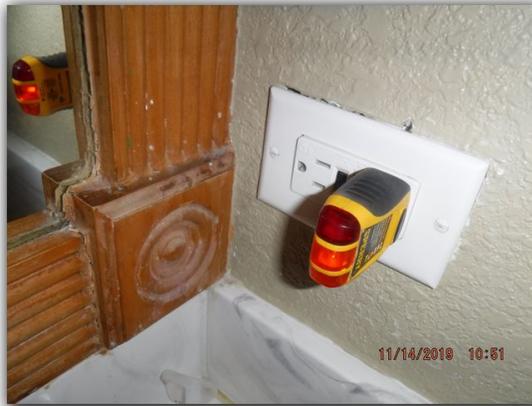
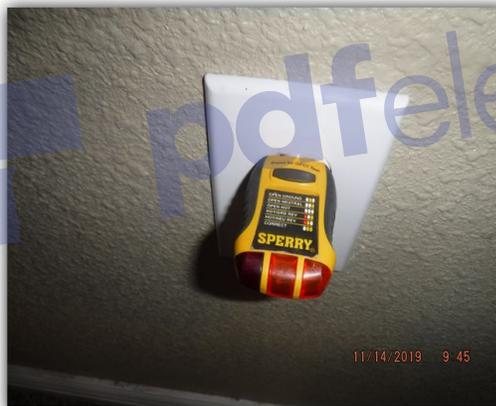
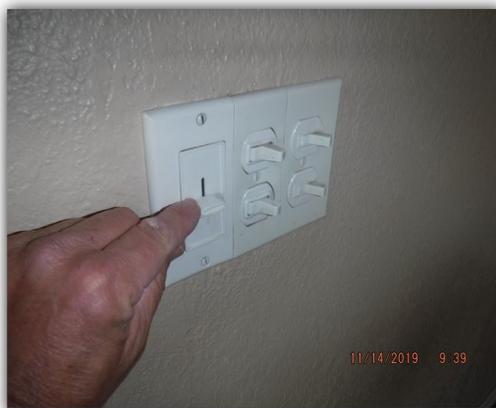
1. Master and Guest Bath : GFCI is inoperable.
2. Play Room : No power to outlets and light switch is loose.
3. Kitchen : No GFCI protection.
4. Some dimmer switches are inoperable.

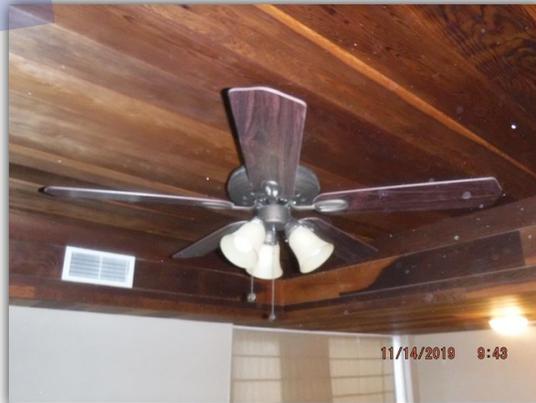
1. Basement Bedroom : Ceiling fan hums at low speed.
2. Some closet lighting fixtures are missing lens covers.

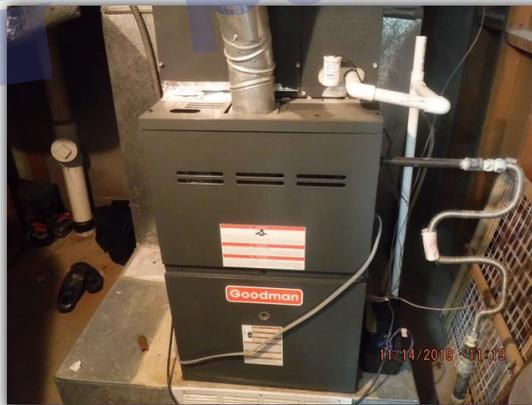
Basement Unit

1. All Units : The heater gas supply line is not equipped with a sediment trap just before the gas appliance connector. This condition does not meet current installation requirements and should be corrected.
2. Did not locate combustion air or supply air intakes in the closet. Recommend further evaluation by a licensed technician.

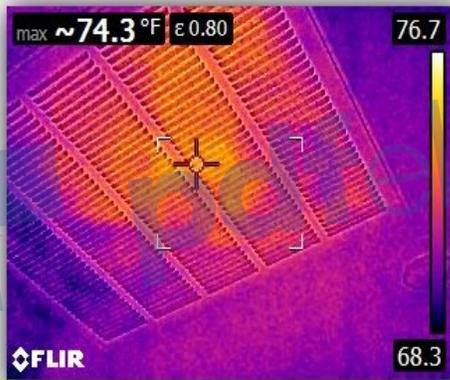
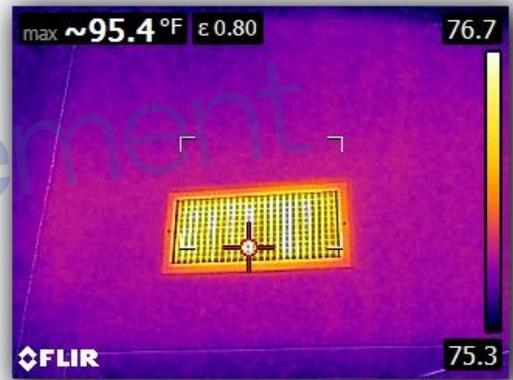
(Library, Kitchen, Dining)

1. Unit did not turn on using normal controls.
2. The intake filter is not properly installed.
3. Did not locate combustion air or supply air intakes in the closet. Recommend further evaluation by a licensed technician.

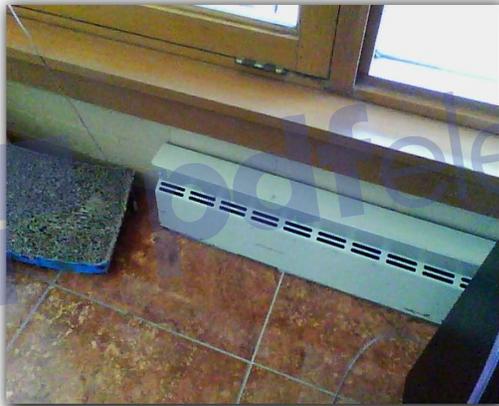
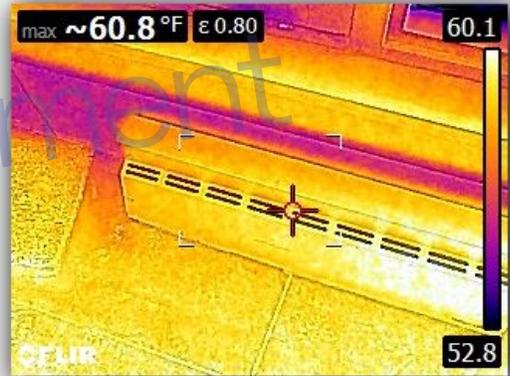
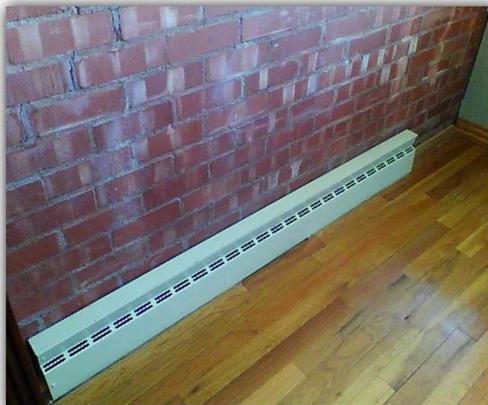
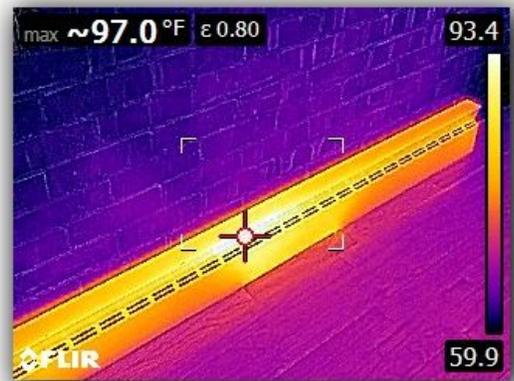
Electric Baseboard Radiant Heaters
Deficiencies

1. Some heaters are inoperative.

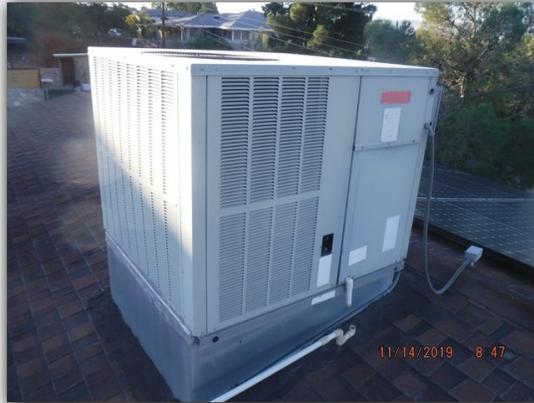
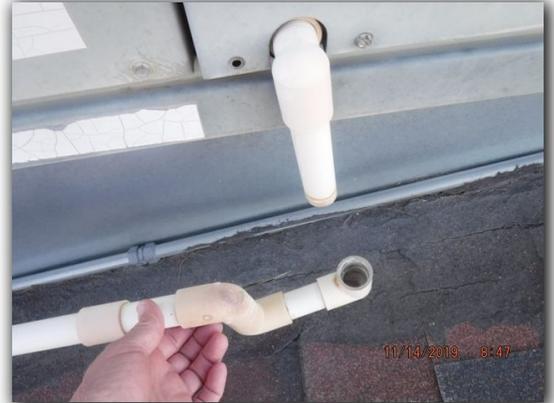
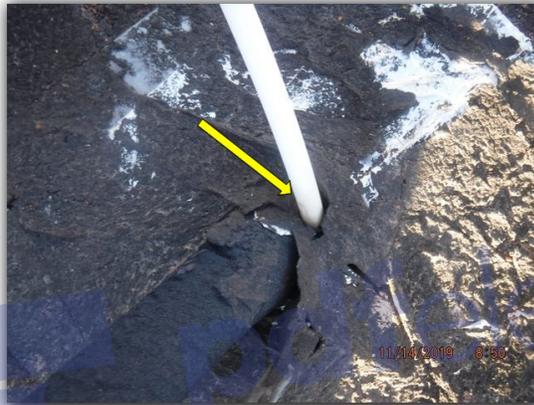
1. Garage Unit : Refrigerant lines not properly insulated at the condenser. Left exterior of home.
2. Garage Unit : Condenser is mounted on the ground. Recommend a mounting pad minimum 3"thick.
3. The condensate drain on one roof top unit is disconnected.
4. The condensate drain on one roof top unit is not terminated properly and the roof penetration needs to be re-sealed to prevent water intrusion.

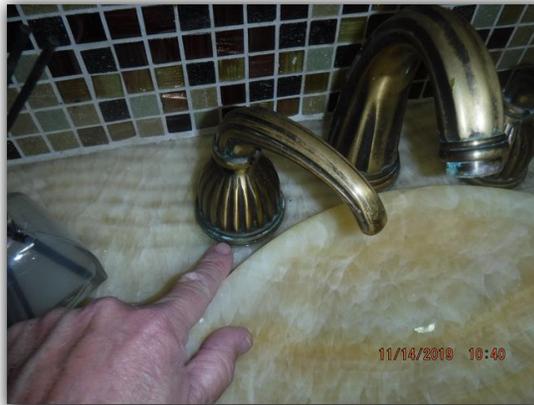
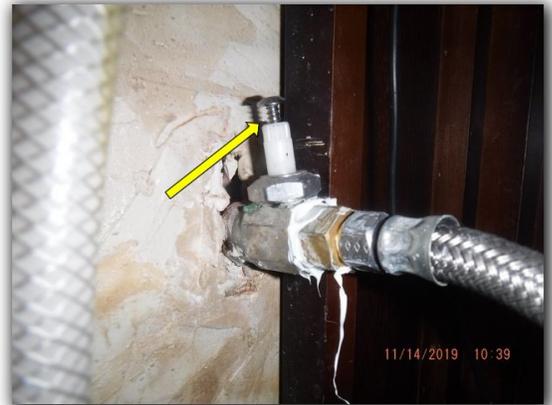
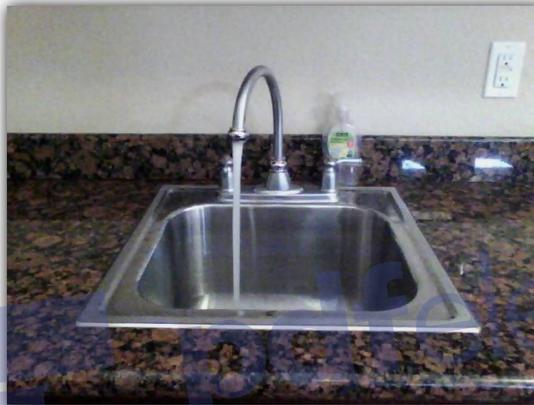
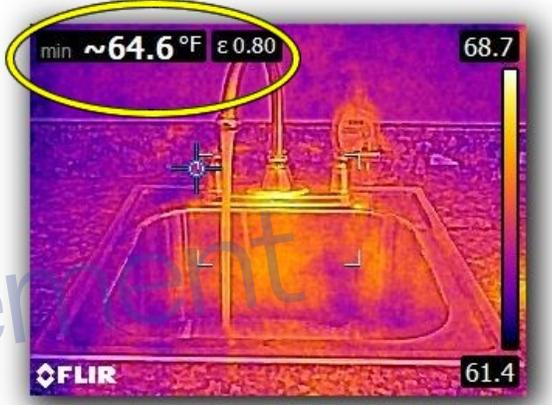
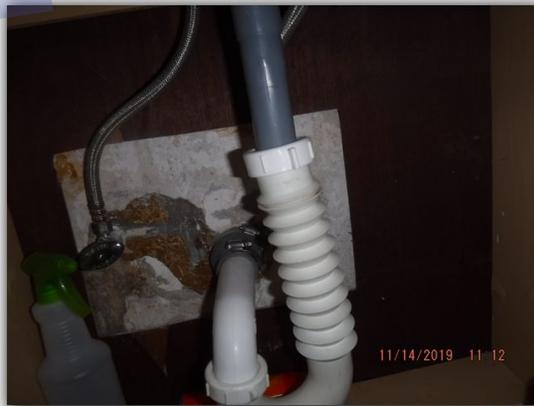
1. Guest Bath : Cold water to left sink does not turn off completely.
2. 1/2 Bath : Hot water faucet is loose.
3. Corrosion or rust is present on some shut off valves and/or fixtures. No active leaks detected.
4. 1/2 Bath : Cold water shut off handle is missing.
5. Wet Bar : No hot water output.
6. Maids Bath : The drain line under the sink is an incorrect corrugated plastic type that should be replaced with a smooth bore drain pipe to help prevent blockage.

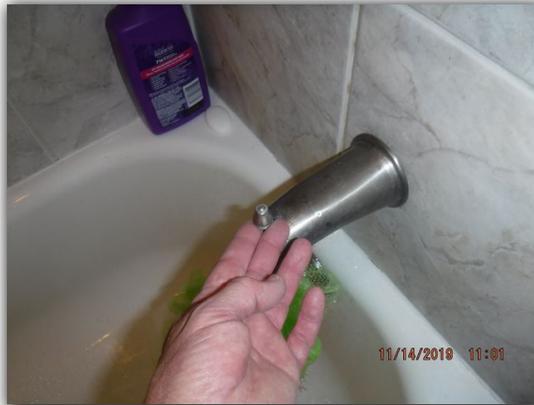
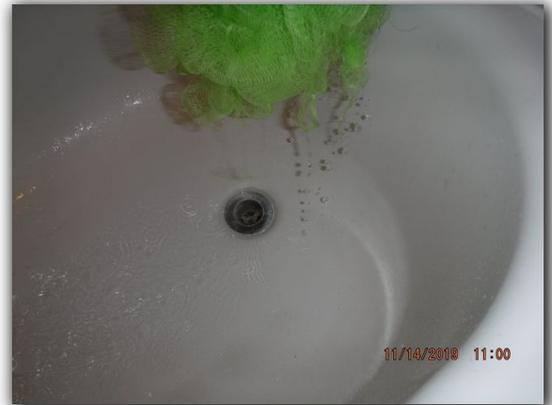
1. Guest Bath : Tub stopper is missing and diverter is inoperable.

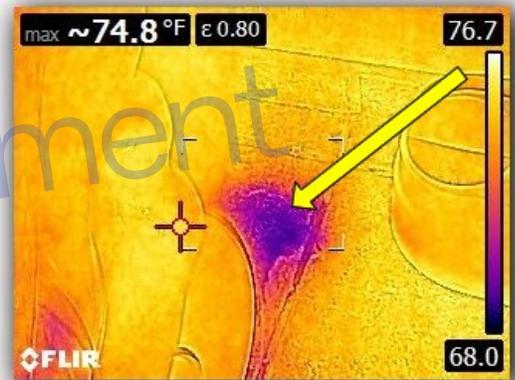
- 1. Guest Bath : Leakage around commode.

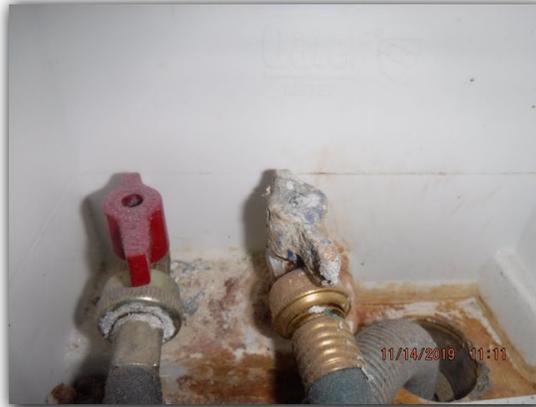
- 1. Washing machine connected at this time - faucets, drains not tested for proper operation. Some corrosion present but no leaks observed.

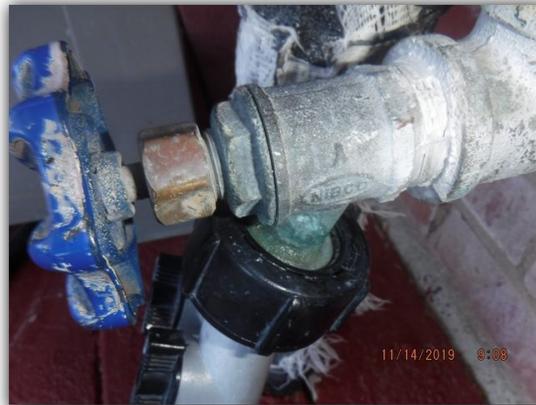
1. Some exterior hose bibs do not have back-flow prevention.

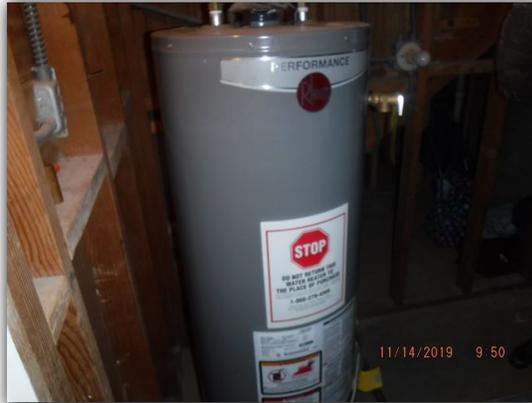
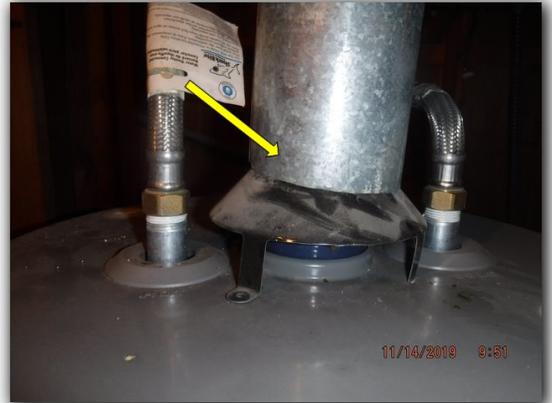
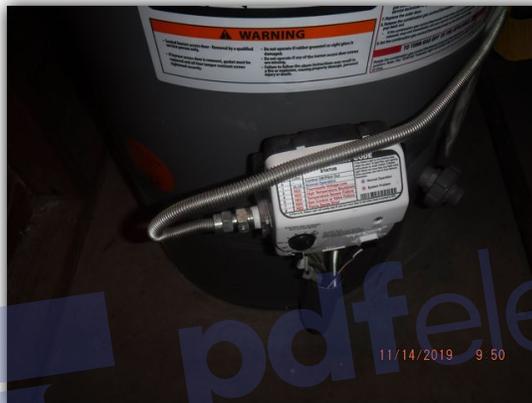
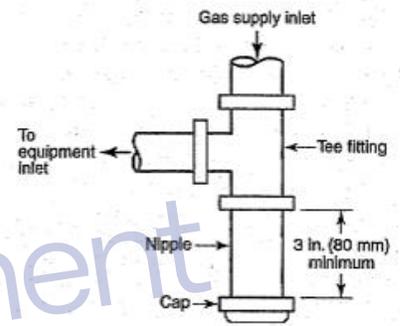
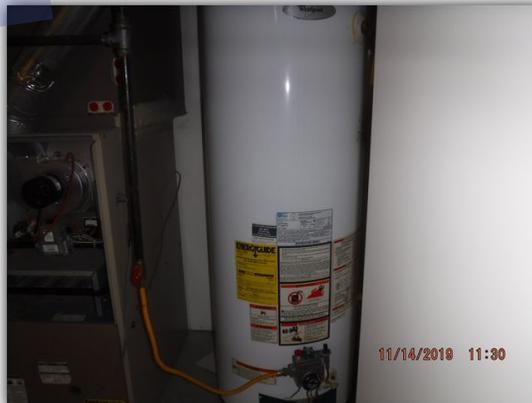
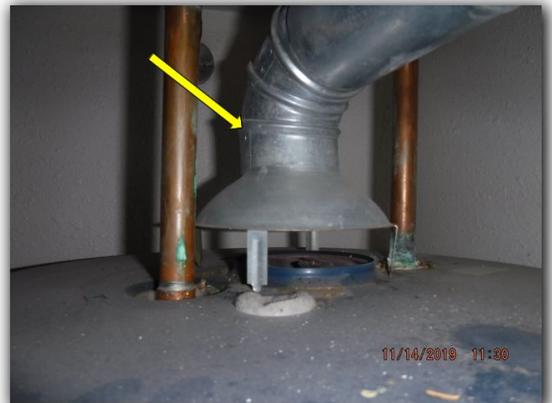
1. Draft hoods are missing mounting screws.
2. The water heater gas supply line is not equipped with a sediment trap just before the gas appliance connector. This condition does not meet current installation requirements and should be corrected.
3. Lack of drain pan and drain. It is recommended to install a water alarm available at Lowes or Home Depot.

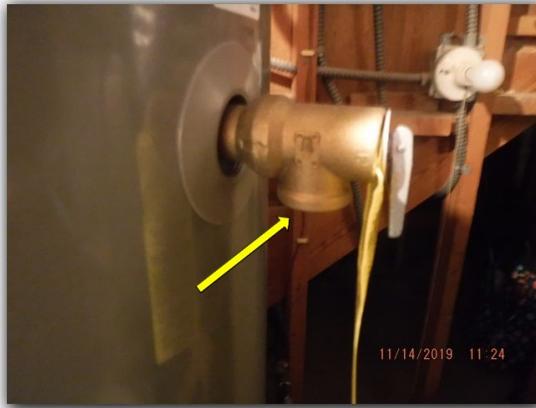
1. Basement : TPR is missing drain line. Safety concern.

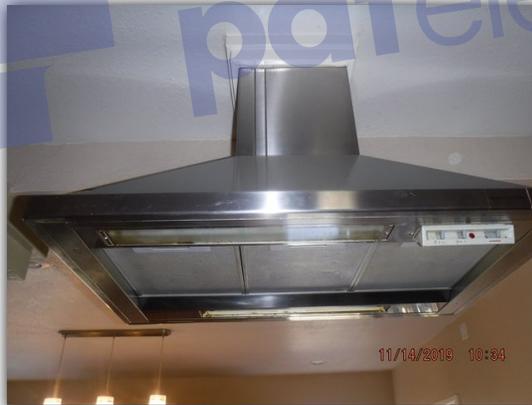
1. One lens is missing.

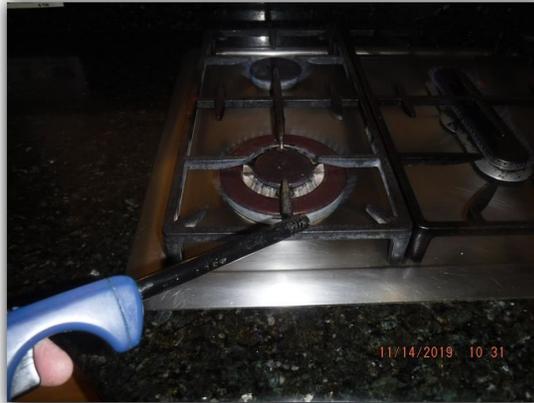
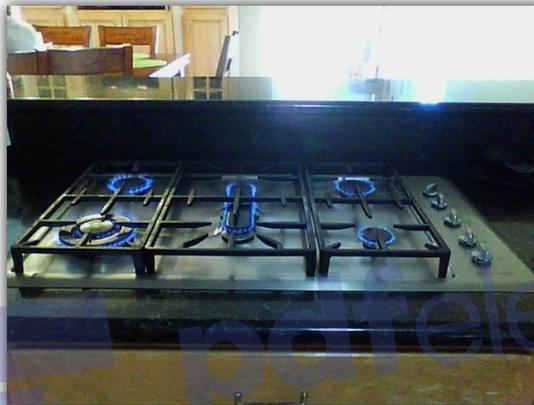
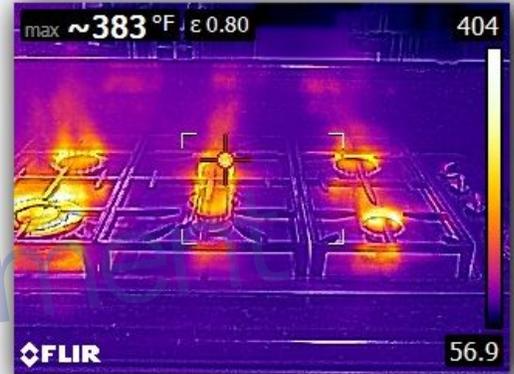
1. Igniter is not present. External lighter must be used to turn burners on. Safety concern.

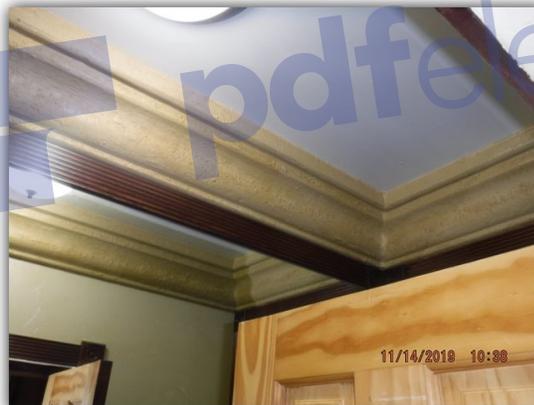
1. 1/2 Bath : No exhaust vent is present.
