Homequest Home Inspections PROPERTY INSPECTED

PROPERTY INSPECTION REPORT

El Paso, TX 79912

12/19/2019

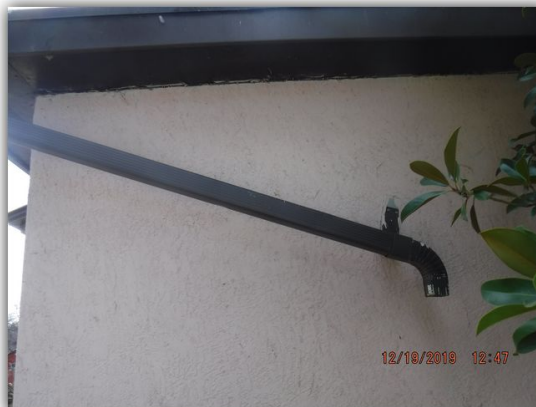
Roof Penetrations - Gutters.

1. Gutters / Downspout's draining too close to foundation at the rear. Refer to Comments above.
2. Gutter downspout is disconnected at the left side of home.

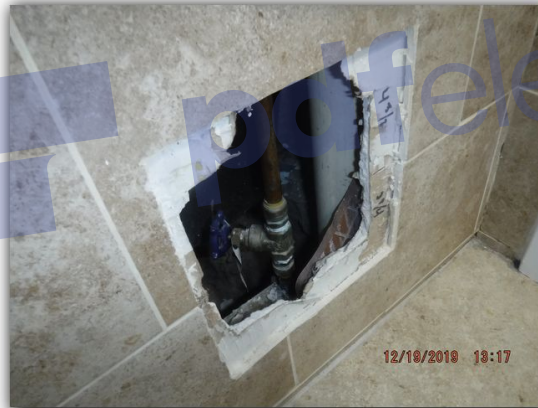
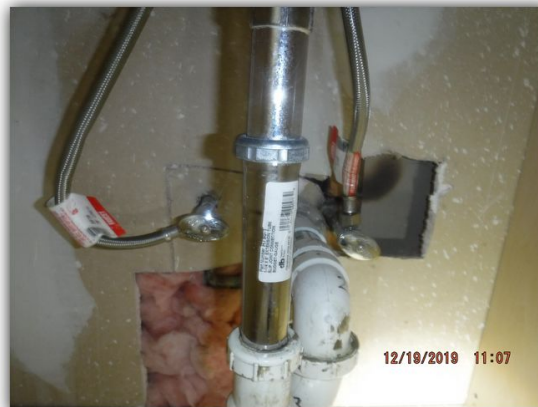
Interior Walls:

1. West Bedroom : Settlement crack by the window.
2. East Bathroom : Drywall is missing under the sinks and the access cover to tub plumbing is missing.

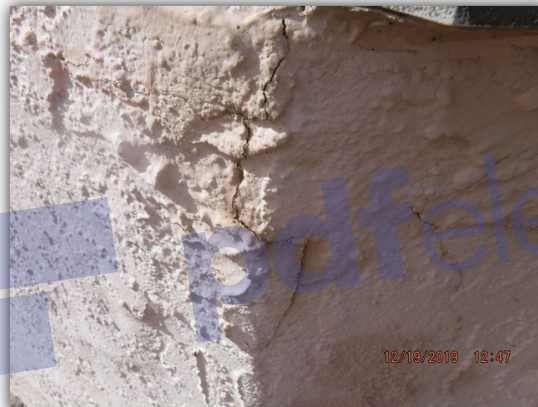
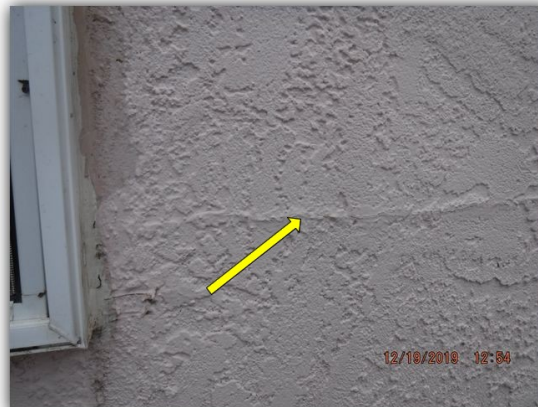
Exterior Walls:

1. Some cracks on the stucco siding in various areas. Recommend sealing to prevent moisture intrusion.
2. Rear : stucco is bubbled below the bay window. Tested positive for moisture. Recommend further evaluation.

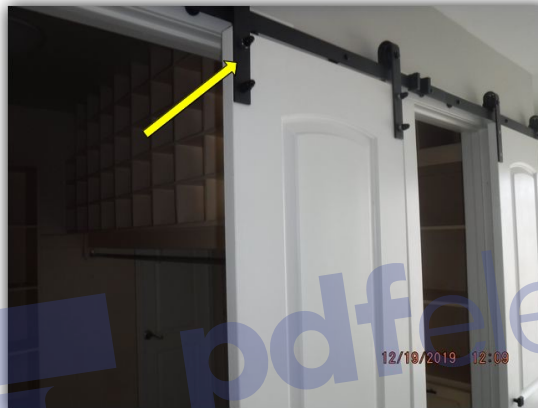
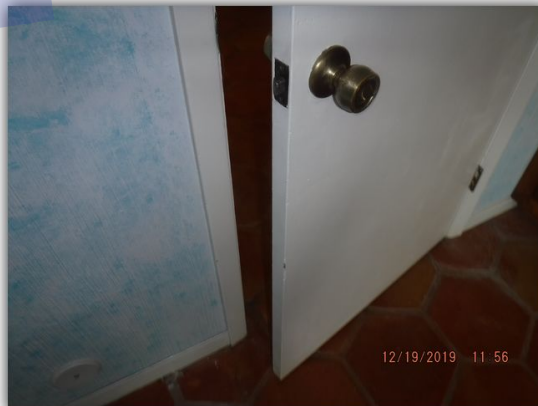
1. East Bedroom : Hits frame.
2. Master Bath : One barn door is difficult to slide and hardware is loose.
3. Office : Latch to French door is seized.

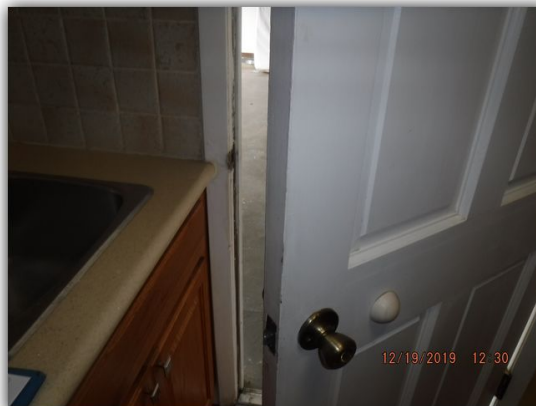
Garage Door(s) Into Residence Deficiencies

1. Door rubs or hits frame.

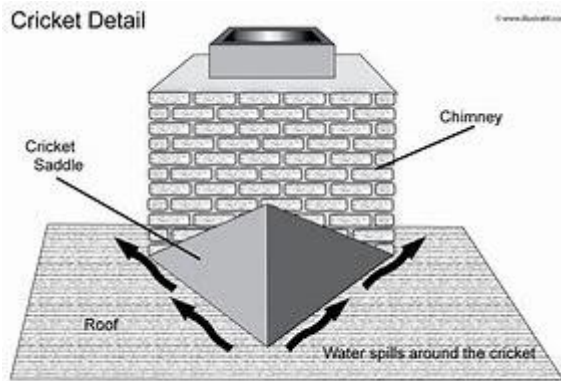
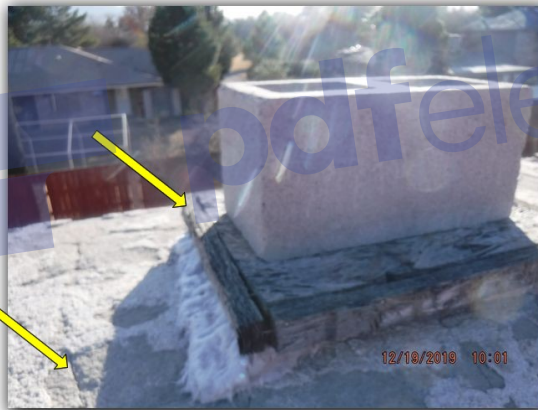
- 3. Rear hearth fire brick is cracked. Refer to Comments above.
- 4. Creosote build up in firebox or flue. Refer to Comments above.
- 5. It is recommended to install a cricket where the down slope of the roof connects to the chimney to channel water away from the chimney.
- 6. The clean out door does not close.

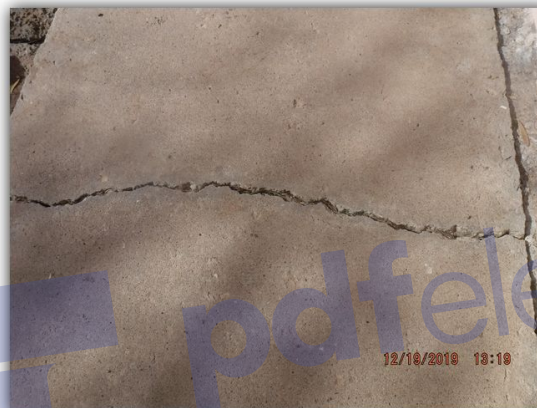
1. Minor cracking. Recommend seal and monitor.
2. Rear Patio : Some bricks are loose. Possible trip hazard.

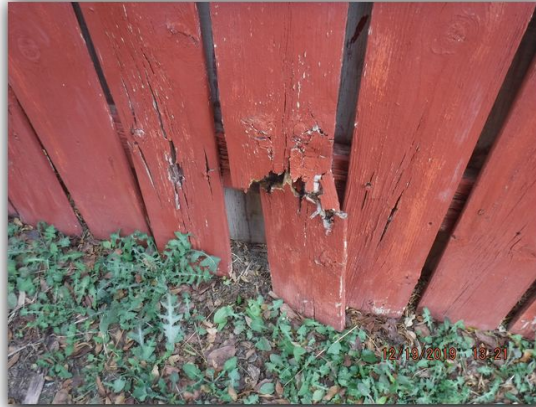
1. Typical cracks / voids in rock wall. Recommend seal and monitor.
2. Rear : Wood is damaged in various areas.
3. Bricks are missing in various areas.

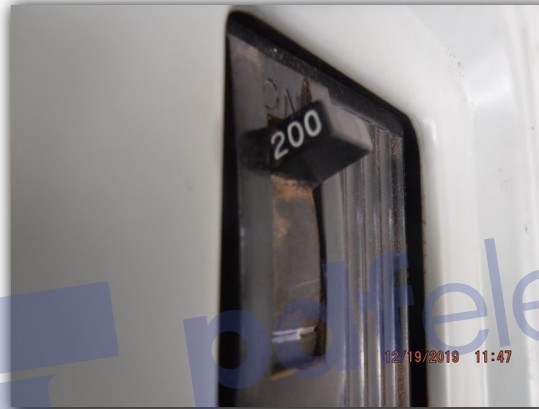
1. One doubled tapped breaker.
2. Two panel cover mounting screws are missing.

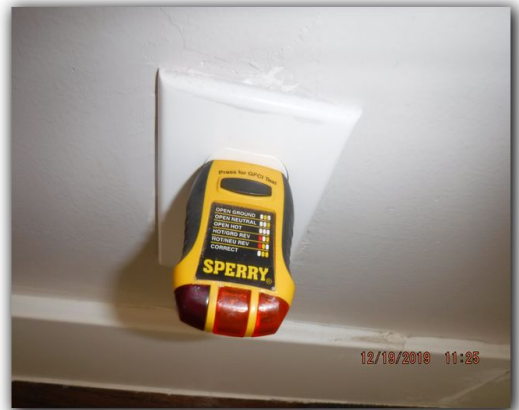
1. Wet Bar : Test indicated reverse polarity. Safety consideration. Further evaluation recommended.
2. Dining : Switch is taped. Unknown what it operates.
3. There is no GFCI protection in the garage, exterior. Safety consideration. Further evaluation recommended.
4. Family Room : One floor outlet housing is loose.
5. Dining : No power to two outlets.

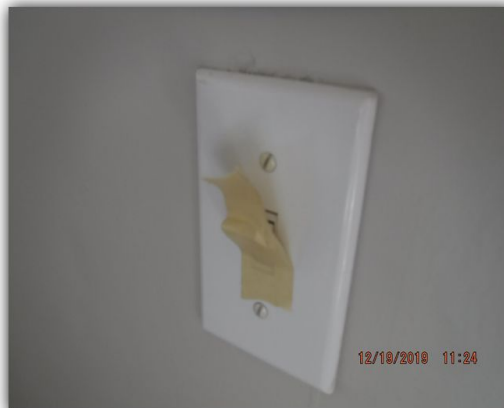
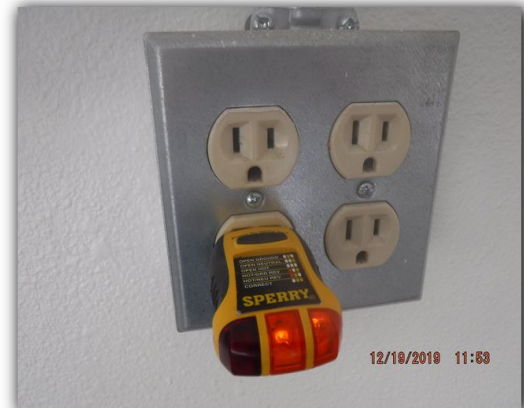
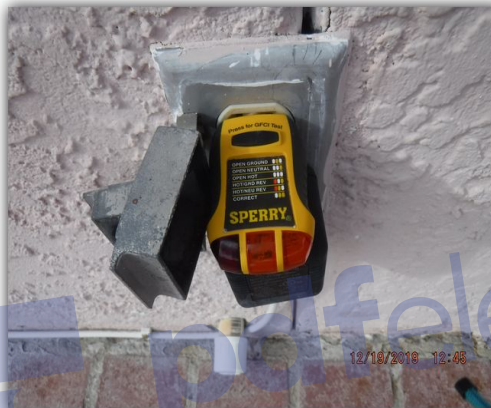
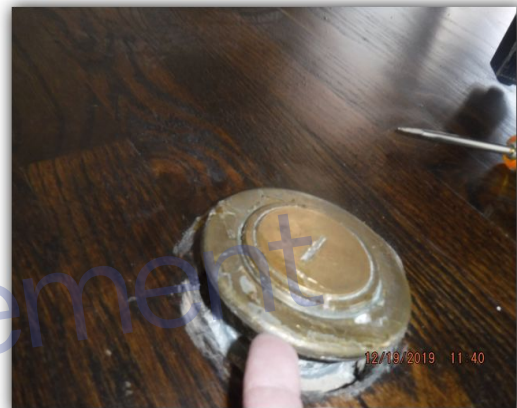
No GFCI/ARC Fault protection at one or more location. This is considered a recognized safety hazard.

Arc-Fault Protection (AFCI) : This home does not meet current arc-fault circuit-interrupter (AFCI) requirements. This is an "as-built" condition, but Per TREC standards of practice we are required to report this condition as a deficiency. Some items reported as Deficient may be considered upgrades to the property. For more information, refer to Texas Real Estate Consumer Notice Concerning Recognized Hazards, form OP-1.

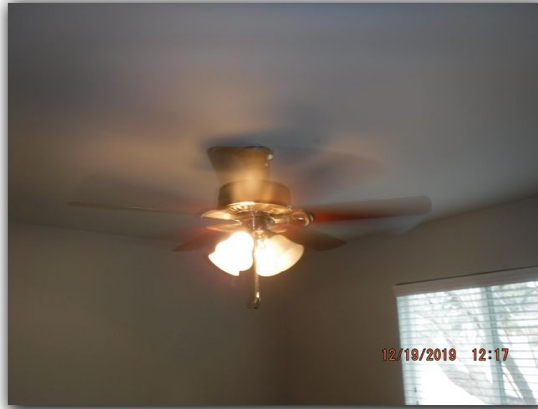
1. Front West Bedroom : Ceiling fan is not balanced.
2. West Bedroom : Light/fan does not turn on.
3. Kitchen : One recessed light did not turn on.

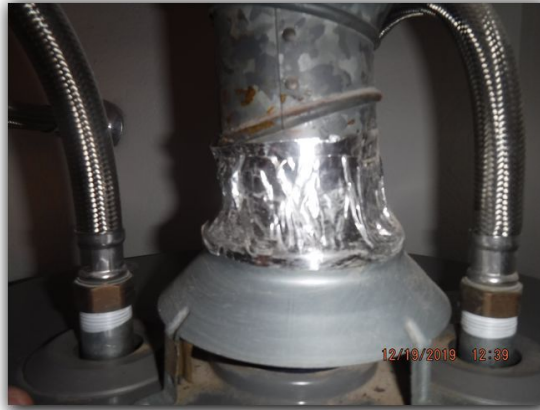
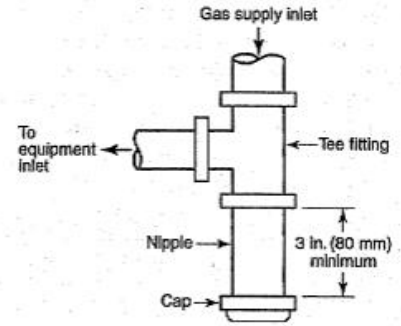
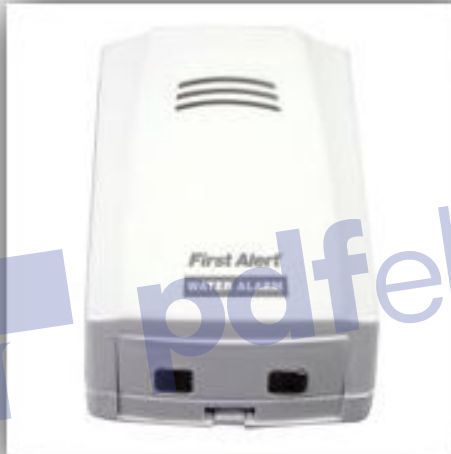
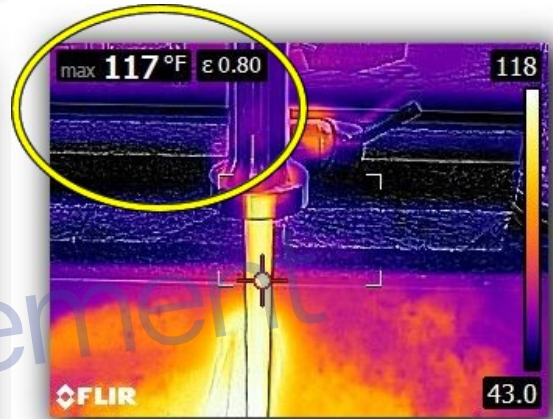
**West Unit
Deficiencies**

1. The water heater gas supply line is not equipped with a sediment trap just before the gas appliance connector. This condition does not meet current installation requirements and should be corrected.
2. Flue vent is not connected properly. Recommend correction to code.

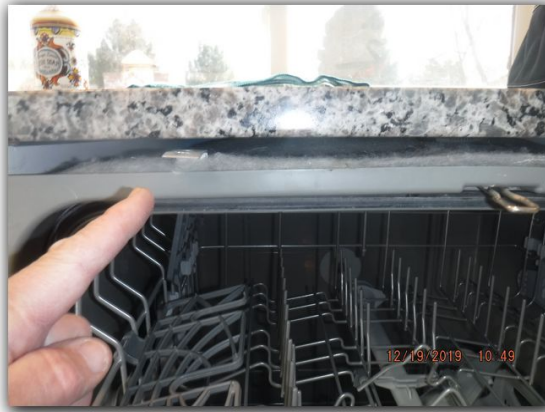
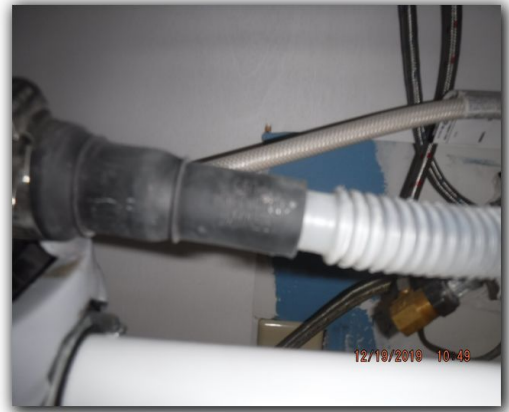
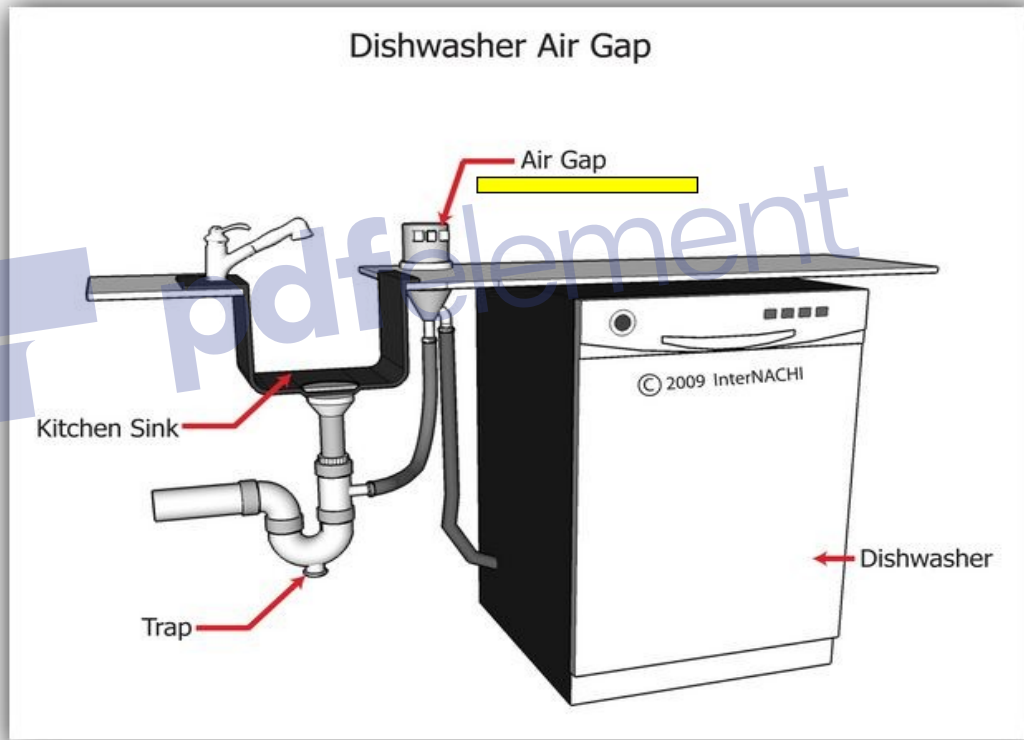
1. Unit is not properly secured to cabinet.
2. The dishwasher lacks an anti-siphon device installed in the drain line. This device prevents the wastewater from the dishwasher from being siphoned back into the dishwasher and contaminating it's contents. Inspector recommends installation of one. Please refer to illustration below.

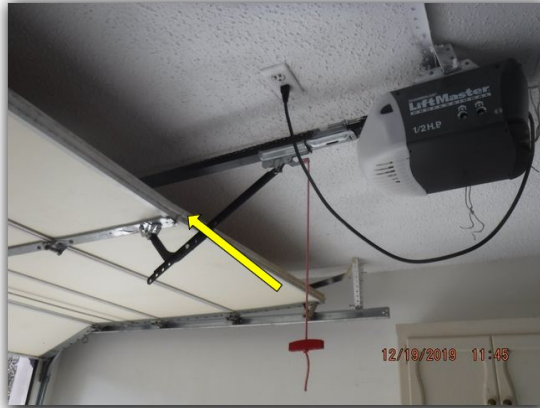
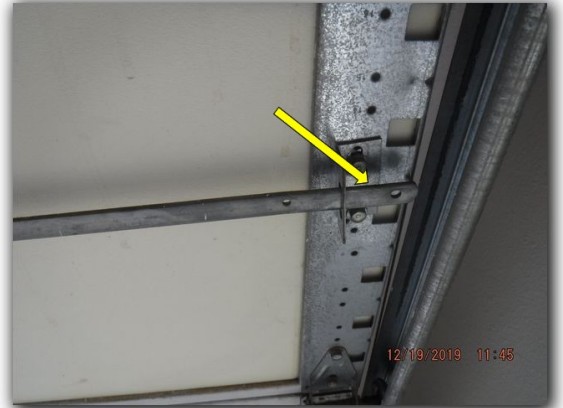
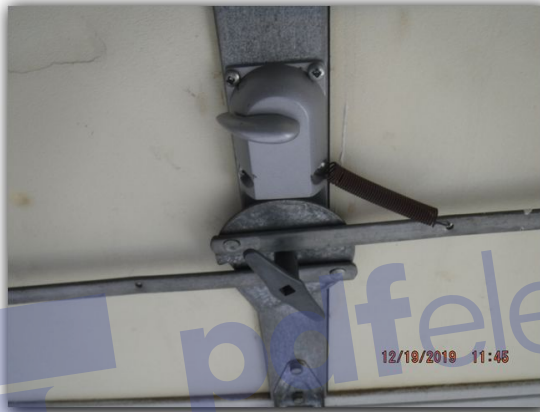
1. Left Door : Does not close automatically.
2. Both Doors : Door is damaged at the top.
3. Door locks or side ropes have not been removed or disabled. Recommend removing or disabling to prevent door and opener damage.
