Homequest Home Inspections PROPERTY INSPECTED

PROPERTY INSPECTION REPORT

El Paso TX 79936

12/26/2019

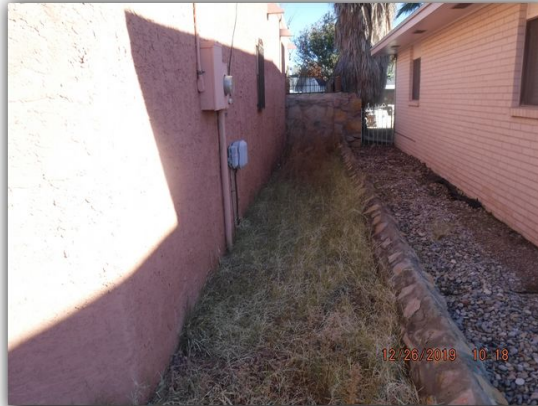
- Houses in the greater southwest area are typically built on almost flat grades, which could present problems with significant moisture buildup. This lot did not appear to have the proper slope for drainage at all points along the foundation at grade; this may lead to foundation distress. Lots should be graded to drain surface water away from the foundation walls. The grade should fall a minimum of 6" within the first 10'.

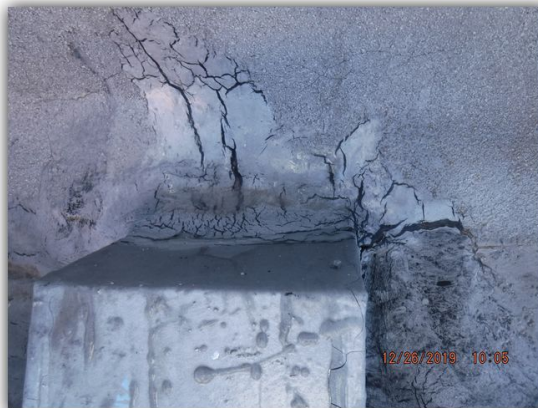
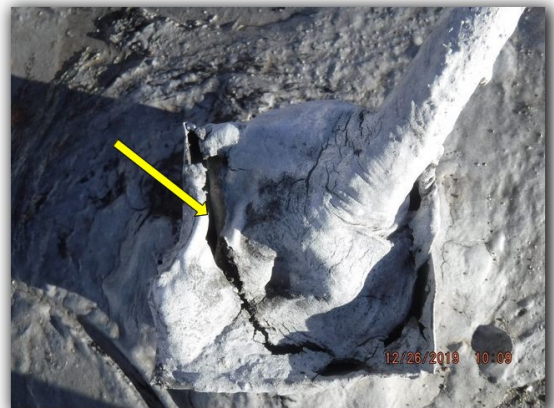
Roof Penetrations - Gutters

1. The tar seals at the roof penetrations need to be re-sealed and coated with a reflective coating or embedded with reflective granules. Refer to Comments above.

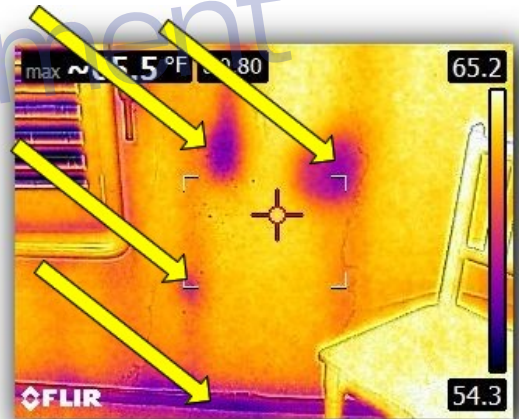
1. Water stains on wall in dining room. There is evidence of active moisture within the wall and observed a black substance. Recommend a qualified contractor to identify source of moisture and remedy.
2. Master Bath : Wall by the shower is water damaged. Tested negative for moisture.

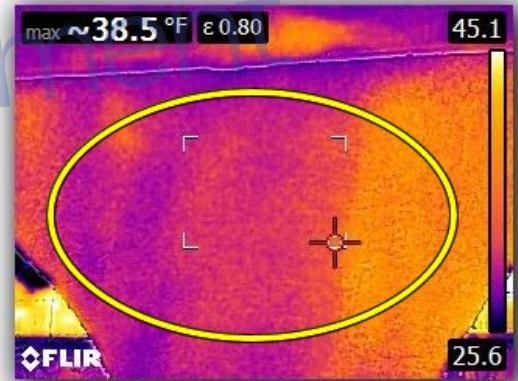
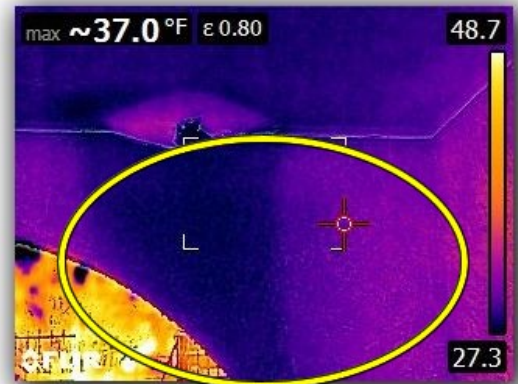
1. Water stains on wall in rear patio. There is evidence of active moisture within the wall. Recommend a qualified contractor to identify source of moisture and remedy.
2. Stucco terminating below grade. This item met building standards at the time the home was built. The building standards have changed and Per TREC standards of practice we are required to note this item as a deficiency.
3. Minor settlement crack on left side of home.
4. Wood trim is water damaged at the garage and exterior doors.

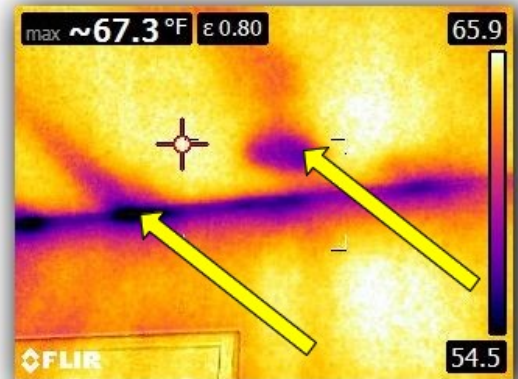
DINING ROOM

1. Ceiling structure showed signs of water intrusion, which could lead to more serious structural damage. All areas, with exception of the dining room, tested negative for moisture. Recommend a qualified contractor to identify source of moisture and remedy.
2. Ceiling drywall is sagged visibly at the time of the inspection in the hallway. This appears to be due to leakage from above. The source of moisture intrusion should be identified and corrected, and the damaged section of drywall replaced. Tested negative for moisture.
3. Dining Room : Evidence of active moisture. Recommend a qualified contractor to identify source of moisture and remedy.
4. Ceiling finish is stained or damaged in numerous areas.
5. Rear Patio : Drywall is water damaged. Tested positive for moisture.

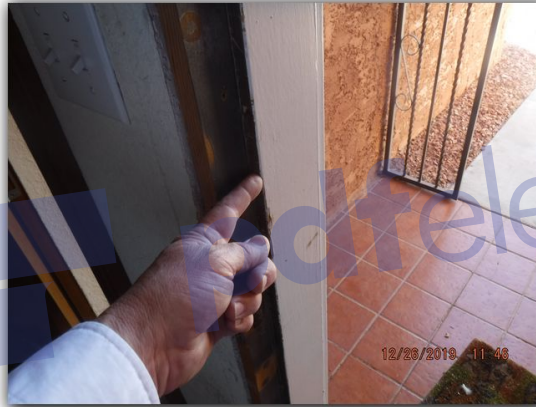
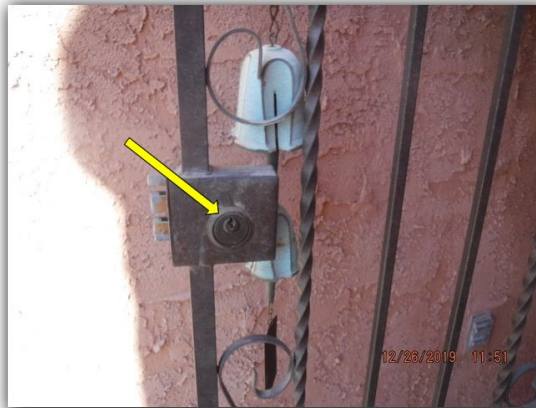
1. Front : Difficult to open, close, weather strip is missing, trim piece is missing.
2. Front Security Door : Double cylinder locks pose an egress issue in event of emergency.

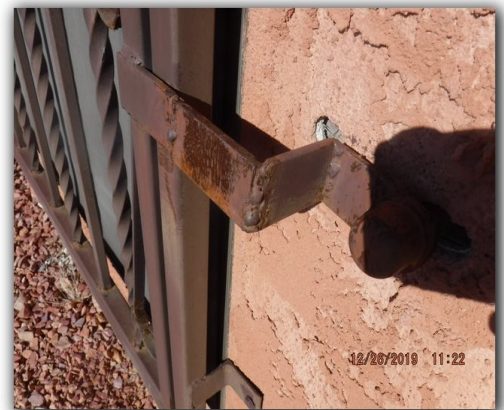
1. Some windows are difficult to open, close or latch.
2. Some windows are difficult to open or close due to dirt buildup in the tracks.
3. Some windows did not open.
4. Dining : Window does not stay open and screen is missing.
5. **Front Bedroom : Burglar bar did not release.**
6. **Master Bedroom : Burglar bar did not release.**
7. Thermal pane window seals have failed, moisture is present on kitchen and family room solar windows.
8. Security bars do not provide for adequate emergency egress. Safety consideration.
9. There is evidence of prior moisture intrusion on some sills. Recommend re-sealing around all windows on the exterior.

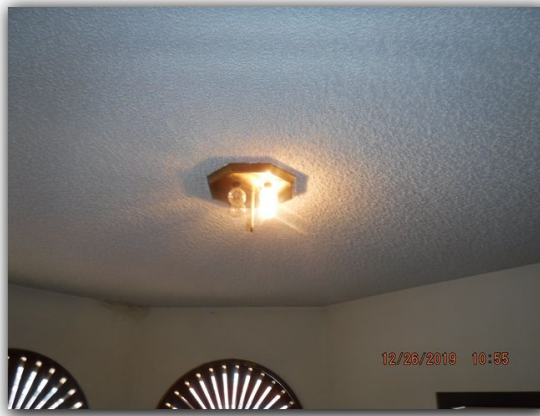
1. Smoke alarms are not present in each sleeping area.
2. No smoke alarm in hallway.
3. Carbon monoxide monitor is not present.

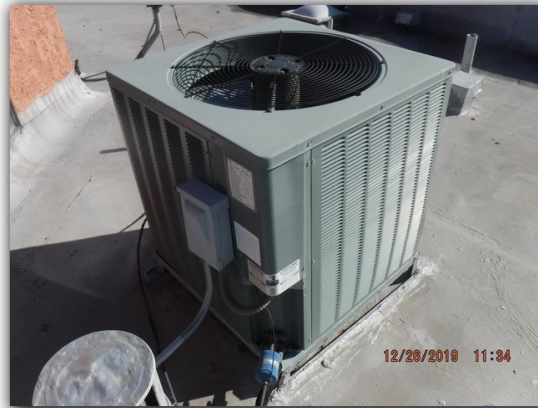
1. Condensate drain lacks a Safe-T-Switch interlock that will disable the unit in event of drain blockage from evaporator tray.

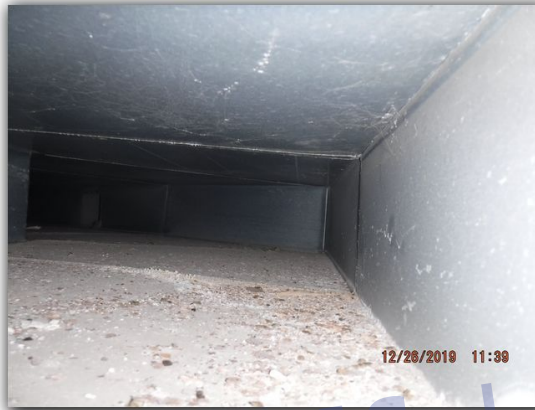
1. Ducting is dirty.
2. Ducting is corroded.

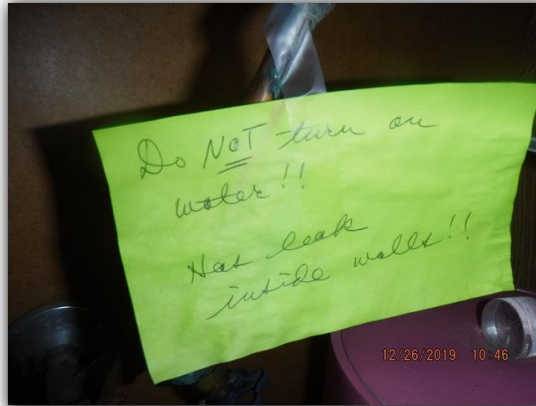
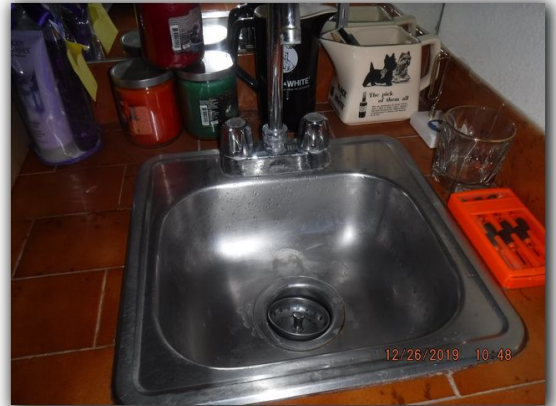
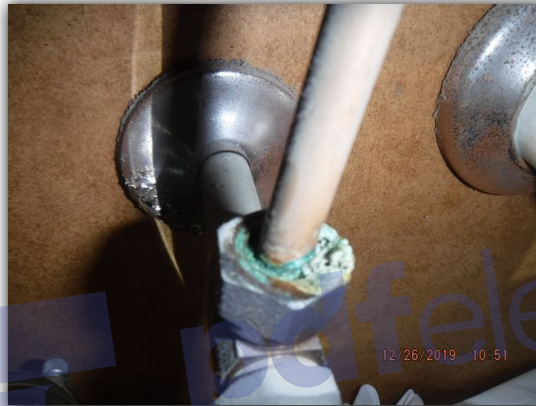
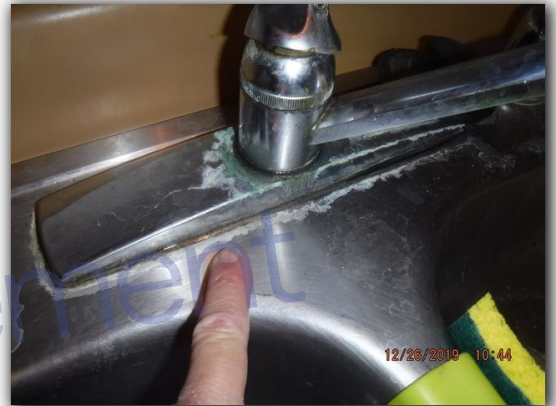
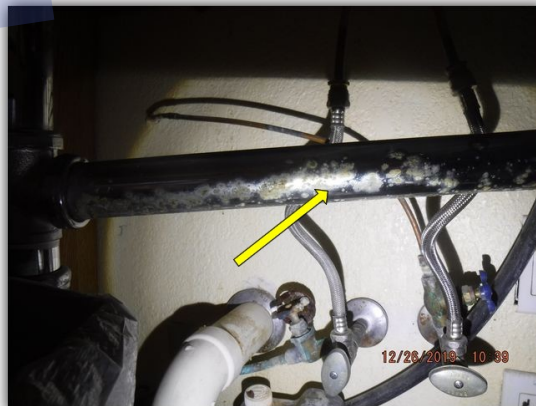
1. Wet Bar : There is a note under the sink stating that the plumbing leaks between the wall. Did not test.
2. Corrosion or rust is present on shut off valves and/or fixtures. No active leaks detected.
3. Kitchen : Recommend caulking around the faucet.
4. Kitchen : Drain is corroded. Recommend PVC drain line.

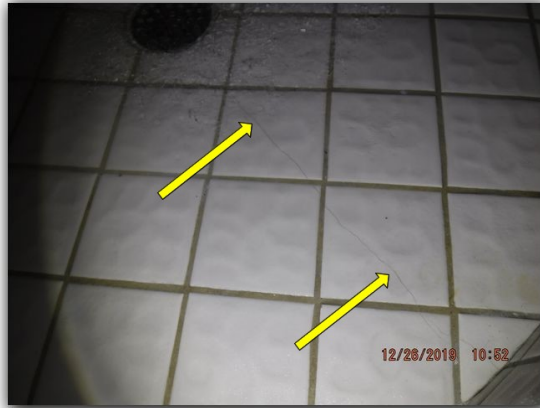
1. Master Bath : Small crack on shower pan. Recommend monitoring.

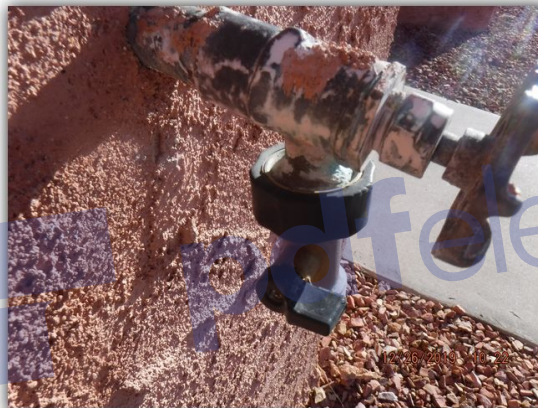
1. Exterior hose bibs do not have back-flow prevention.
2. Recommend insulating the sprinkler supply lines to prevent freeze damage.

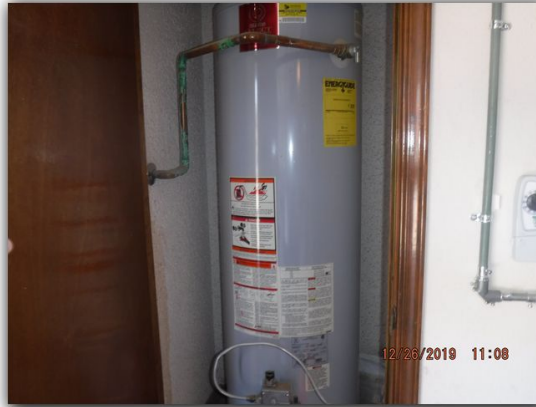
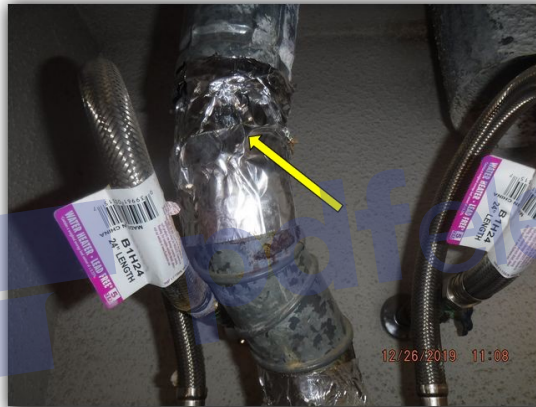
1. The water heater gas supply line is not equipped with a sediment trap just before the gas appliance connector. This condition does not meet current installation requirements and should be corrected.
2. Flue/Vent is loose, damaged or poorly connected.
3. Lack of pan and drain system/improper termination. Recommend installing a moisture alarm available at Lowes or Home Depot.

- 4. Draft hood is damaged and not connected properly.
- 5. Platform is warped and water damaged.

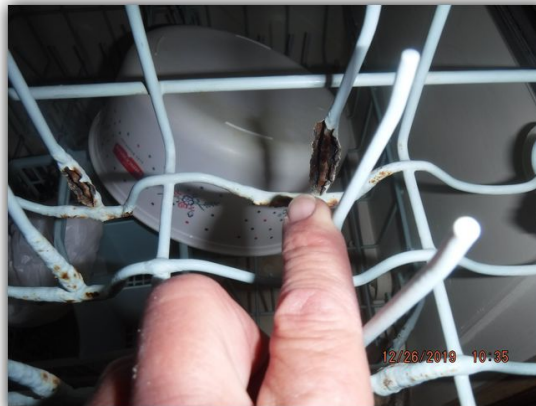
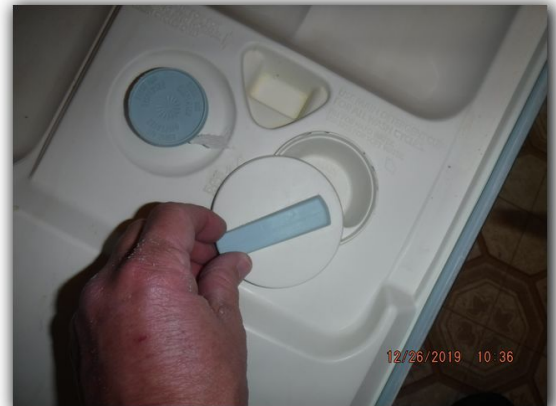
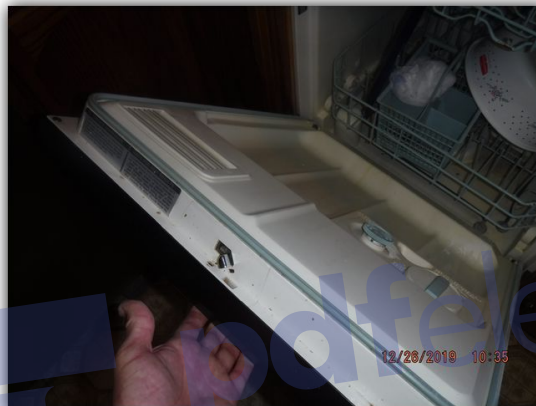
1. Soap dispenser not functioning properly. Does not lock.
2. Rust present in interior of unit.
3. Door spring is inoperable and door is loose.

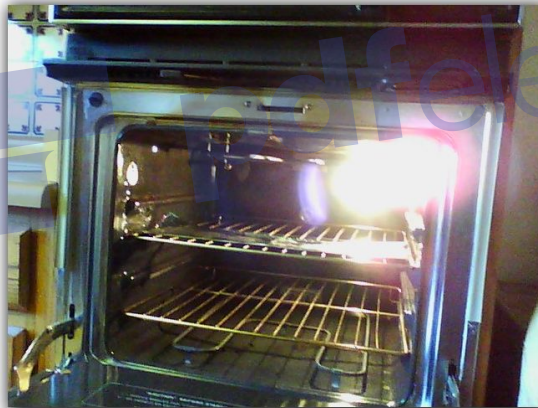
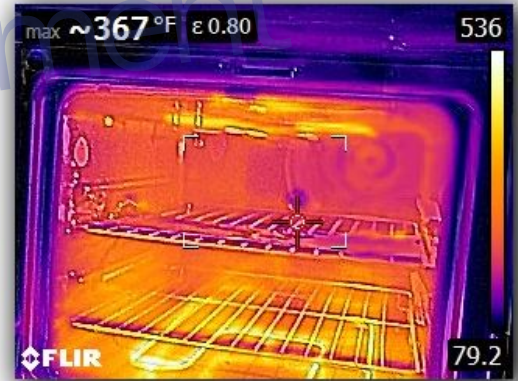
- 1. Oven door seal is worn.
