Marling Farms
Chester, MD

Report #: 50838-0
Beginning: July 1, 2023
Expires: June 30, 2024

RESERVE STUDY
"Full"

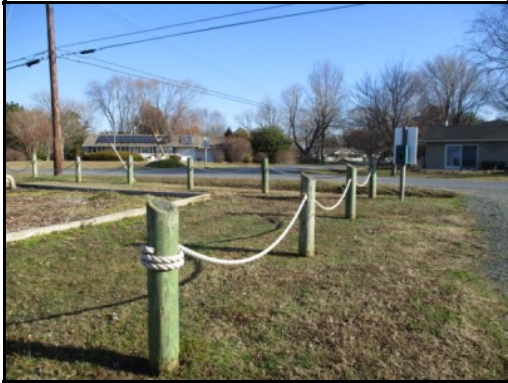
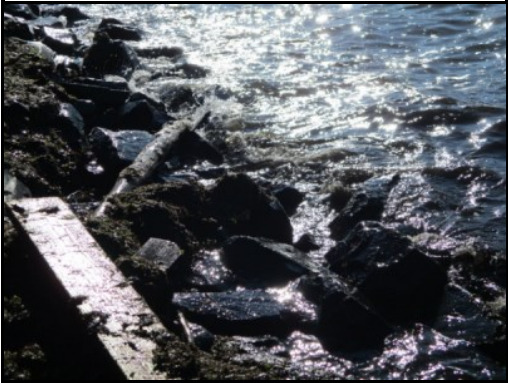
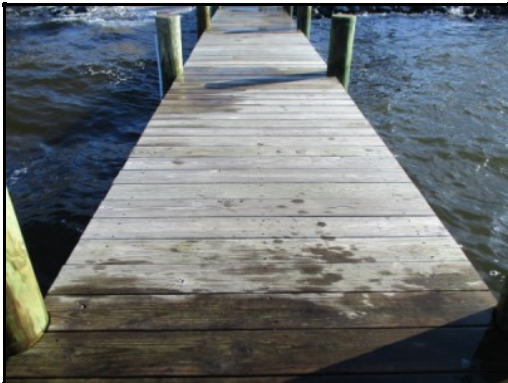
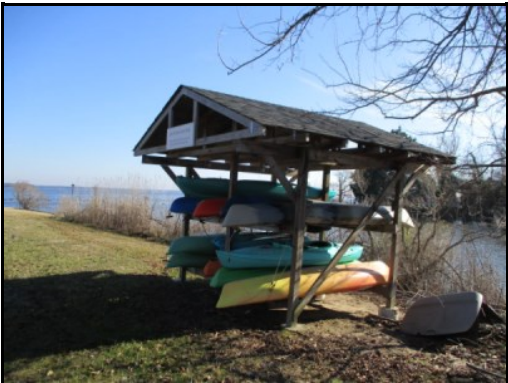
During our site visit on 2/1/2024, we started with a brief meeting with Mr. Kevin Moore, and then started the site inspection beginning with Beach 3. We visually inspected all the docks and piers, and were able to see all the beaches and the ball park. We noted that while some improvements have been made, there is significant deterioration that has been allowed to occur throughout the property. Please refer to the Photographic Inventory Appendix for additional information on each of your Reserve components.
