# Dam Safety Inspection Report

## Negaunee Lake Dam

**Dam identification Number: 2674**

June 29, 2023

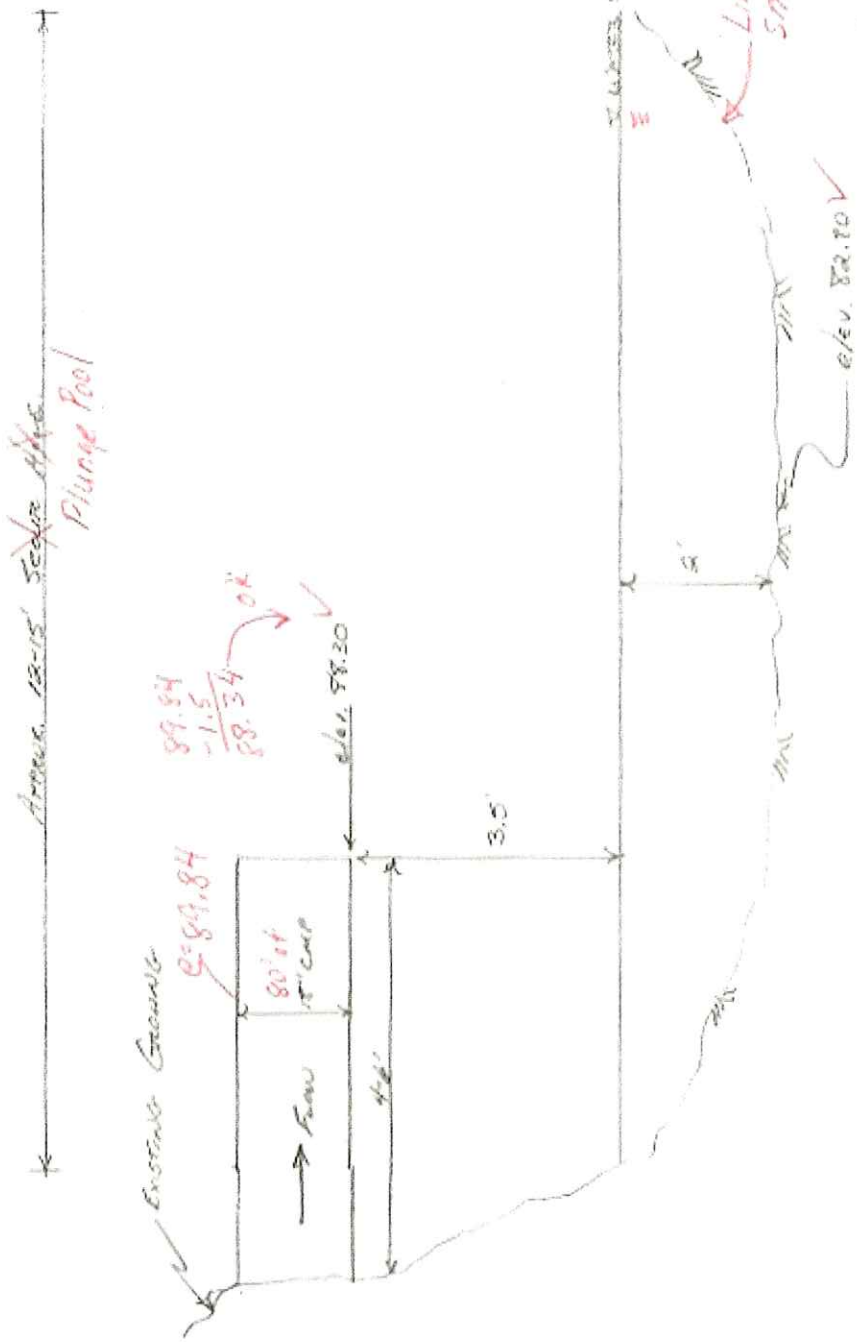
44  
 Figure 3

1. INNER PLASTIC TUBE SEID IN DUE TO MANY RIVOT HOLES LEAKING IN 24" CAP TUBE, 24" TUBE SHOWING SOME CORROSION.
2. ALL ELEVATIONS REFERENCE BENCH MARK SET @ 100.00 ILLUSTRATED ON PG 1 OF 3  
V Figure 2
